# BFX-UA300 EXCESS&MISSING MATERIAL REPORT

**FOXCONN CPEG JBD\_VN**  
**Sep.-2-2021**  
**Version 02**

# D2. Description of Problems

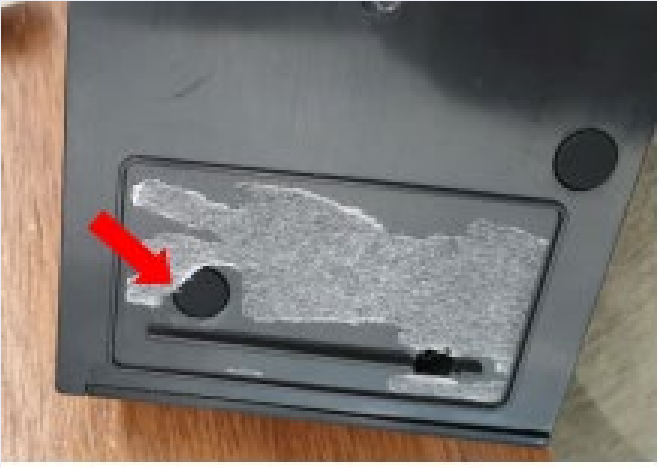
- 31-August-2021, Customer complained BFX-UA300 product contain excess & missing material issue inside product

| Serial Number | 2149695001202099000204 | 2149695001202099000343 | 2149695001202099000361 |
|---|---|---|---|
| Issue | Screw cover under rubber foot | Bushing inside speaker area | Missing tape |

| No. | Subject | Root cause | Corrective action | Evidence | Status | Owner | Due date |
|---|---|---|---|---|---|---|---|
| 1 | Occur root cause I | Operator adding two type material of a area in a work step | -Separate VI work step for two operator, one cover assemble by one operator. | <div>Visual Check&amp; screw cover Assembly</div> <div>↓</div> <div>Rubber foot Assembly and product wrapping</div> | Done | IE: Huyen Trang<br>SI: Wen Yong | 1-Sep |

| No. | Subject | Root cause | Corrective action | Evidence | Status | Owner | Due date |
|---|---|---|---|---|---|---|---|
| 1 | Escape root cause I | Operator makes cross check not clearly | <ul style="list-style-type: none"><li>- Add one Operator makes VI check whole bottom cover before assembly Top cover on.</li><li>- Add additional work step: flip over bottom cover before assembly Top cover to prevent drop parts in bottom cover side.</li></ul> | | Done | IE: Huyen<br>Trang<br>SI: Wen<br>Yong | 1-Sep |

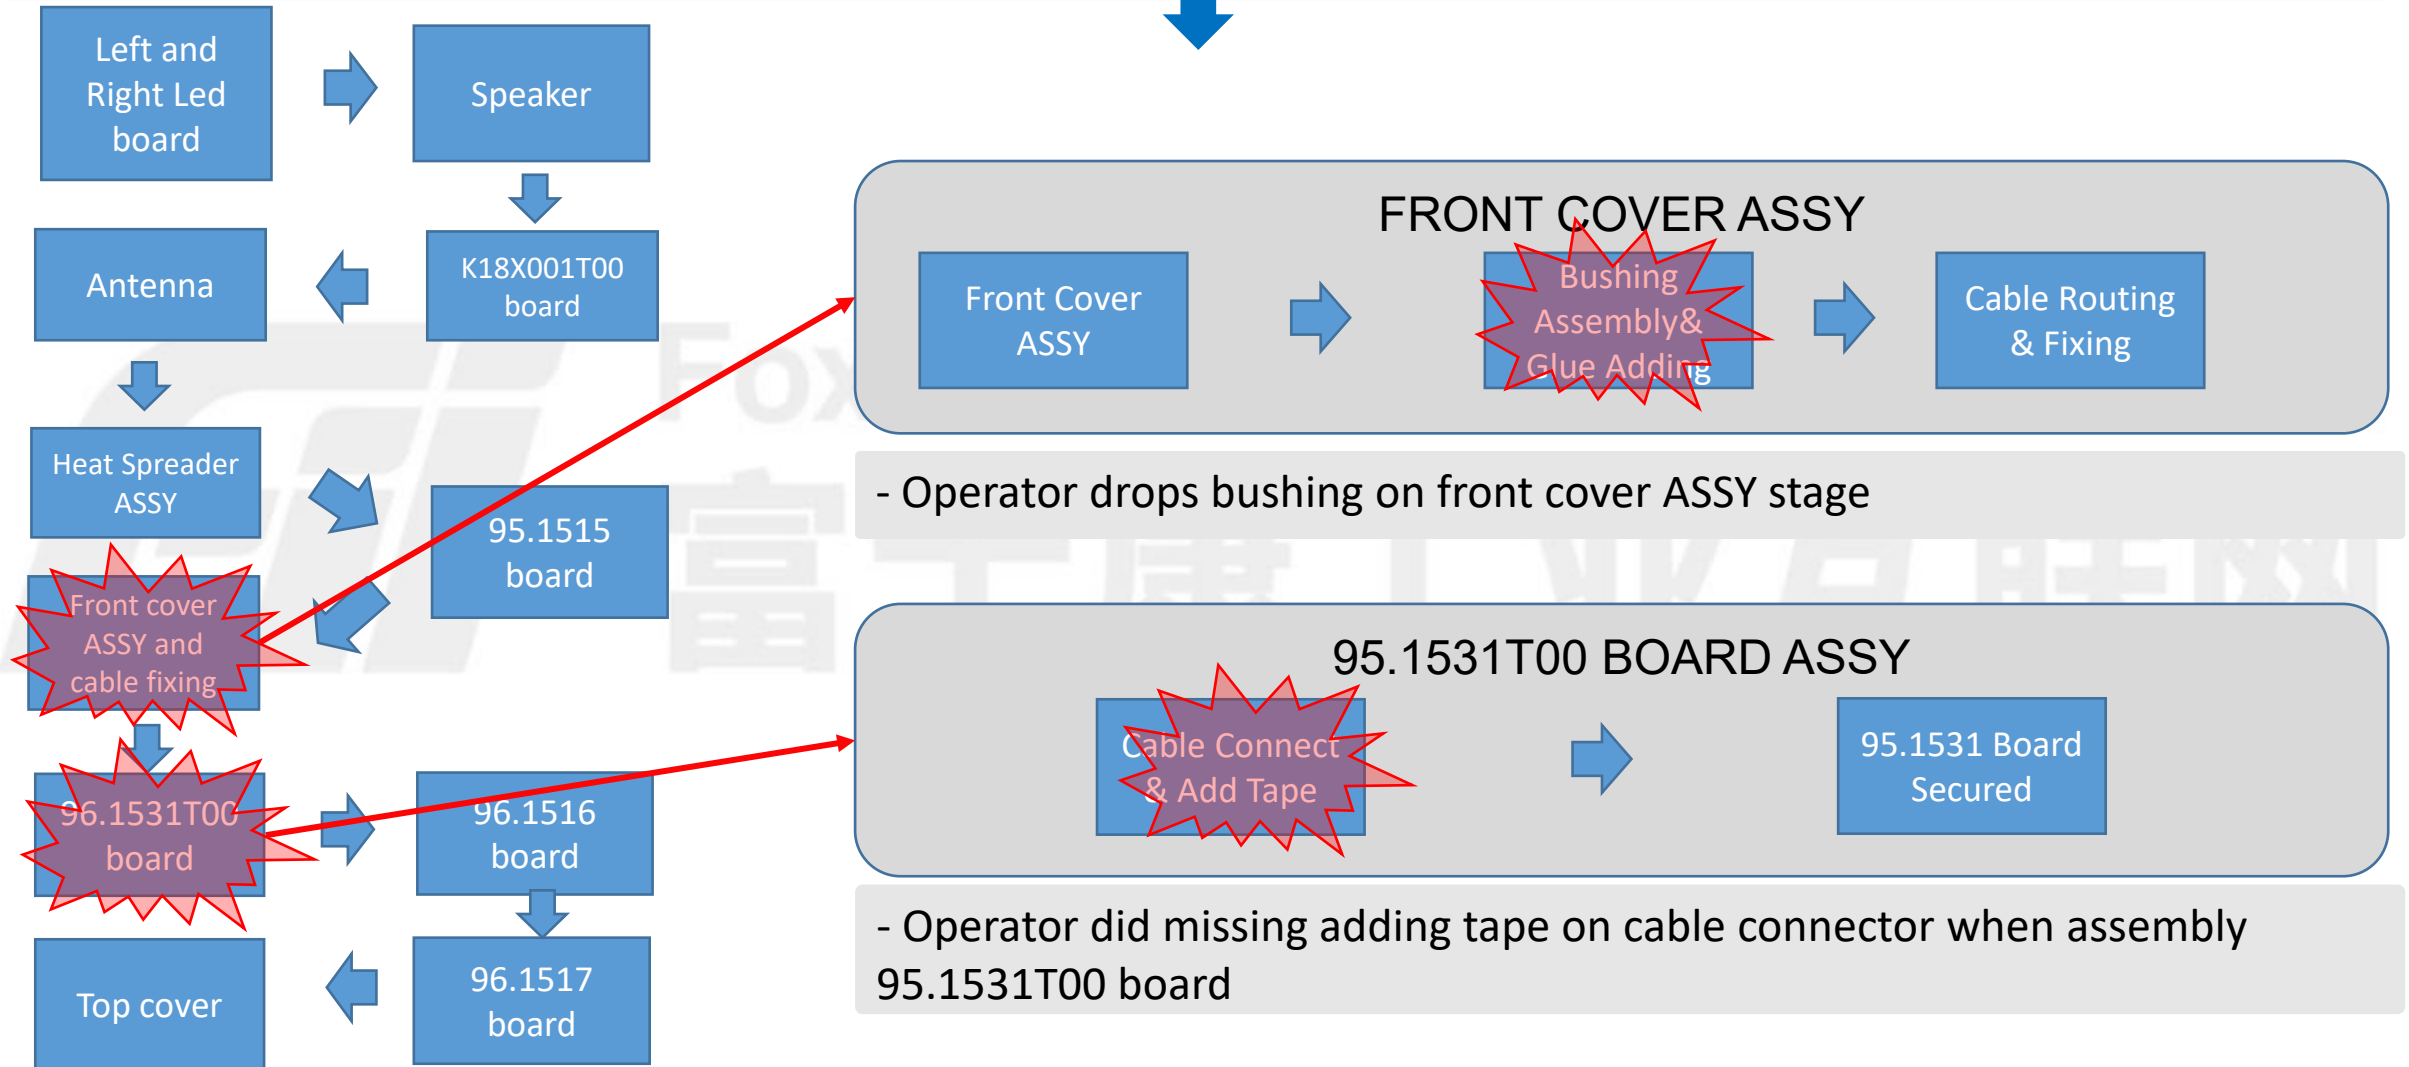
## Focus on Assembly process (Occur root cause)

**Conclusion:** - Operator drops part and missing adding tape in assembly stage

| No. | Subject | Root cause | Corrective action | Evidence | Status | Owner | Due date |
|---|---|---|---|---|---|---|---|
| 1 | Occur root cause III | Drop part happen in assembly procedure. | <div>- Separate material q'ty using with each product.</div> <div>- Add this issue as a CTQ in assembly SOP</div> | | Done | IE: Huyen Trang<br>SI: Wen Yong | 1-Sep |

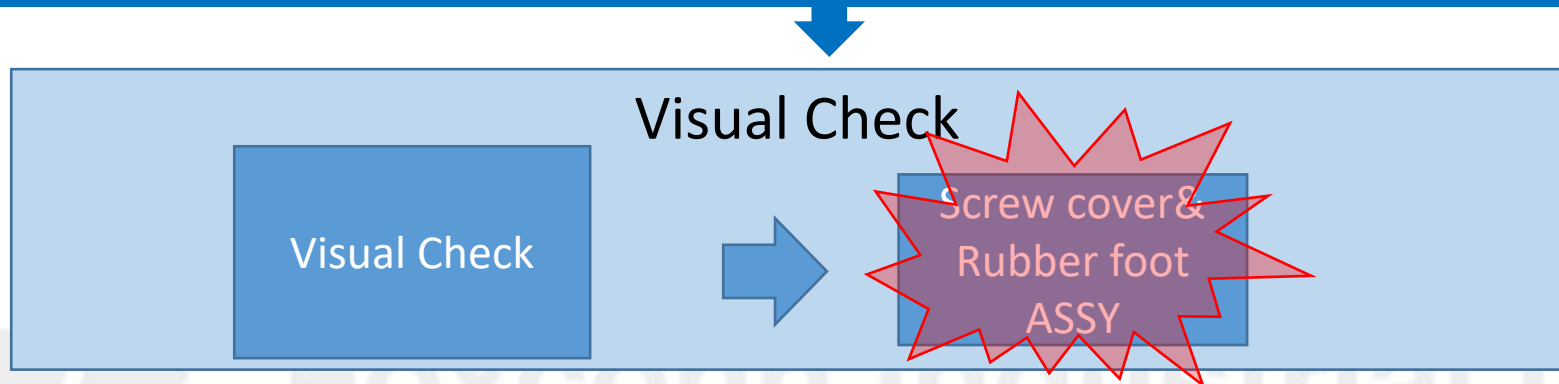
Focus on VI stage (Occur root cause)

- Screw cover assembly and Rubber foot assembly is doing by one operator => OP can add Screw cover in wrong hole.

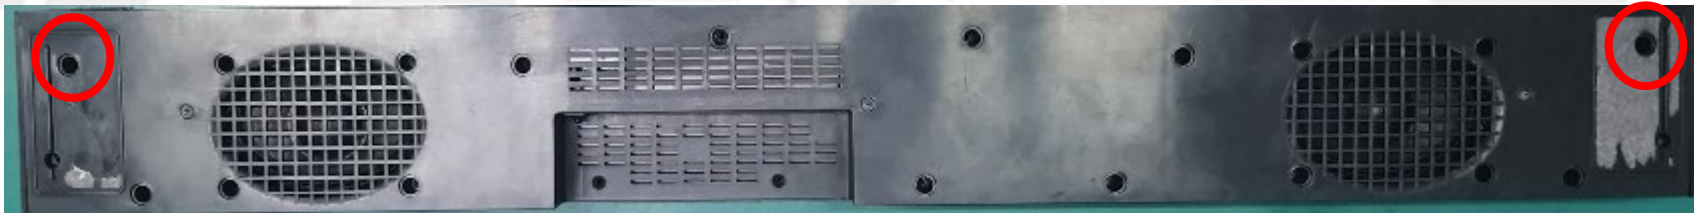
Checks bottom housing screw hole (Occur root cause)

- Screw hole under rubber foot is same size with out side screw hole

**Conclusion:** - One operator assemble two cover type => Cannot makes cross check in blind area (under Rubber foot)  
- Screw hole design under foot cover is same with other hole out side => Operator still can adding the cover on

| No. | Subject | Root cause | Corrective action | Evidence | Status | Owner | Due date |
|---|---|---|---|---|---|---|---|
| 1 | Occur root cause II | Screw hole under rubber foot is same size with outside foot area screw hole | - Design DFM: shall change the screw hole dimension in rubber foot area. (Fool-proofing) | | Open | ALT/Inkel | TBD |

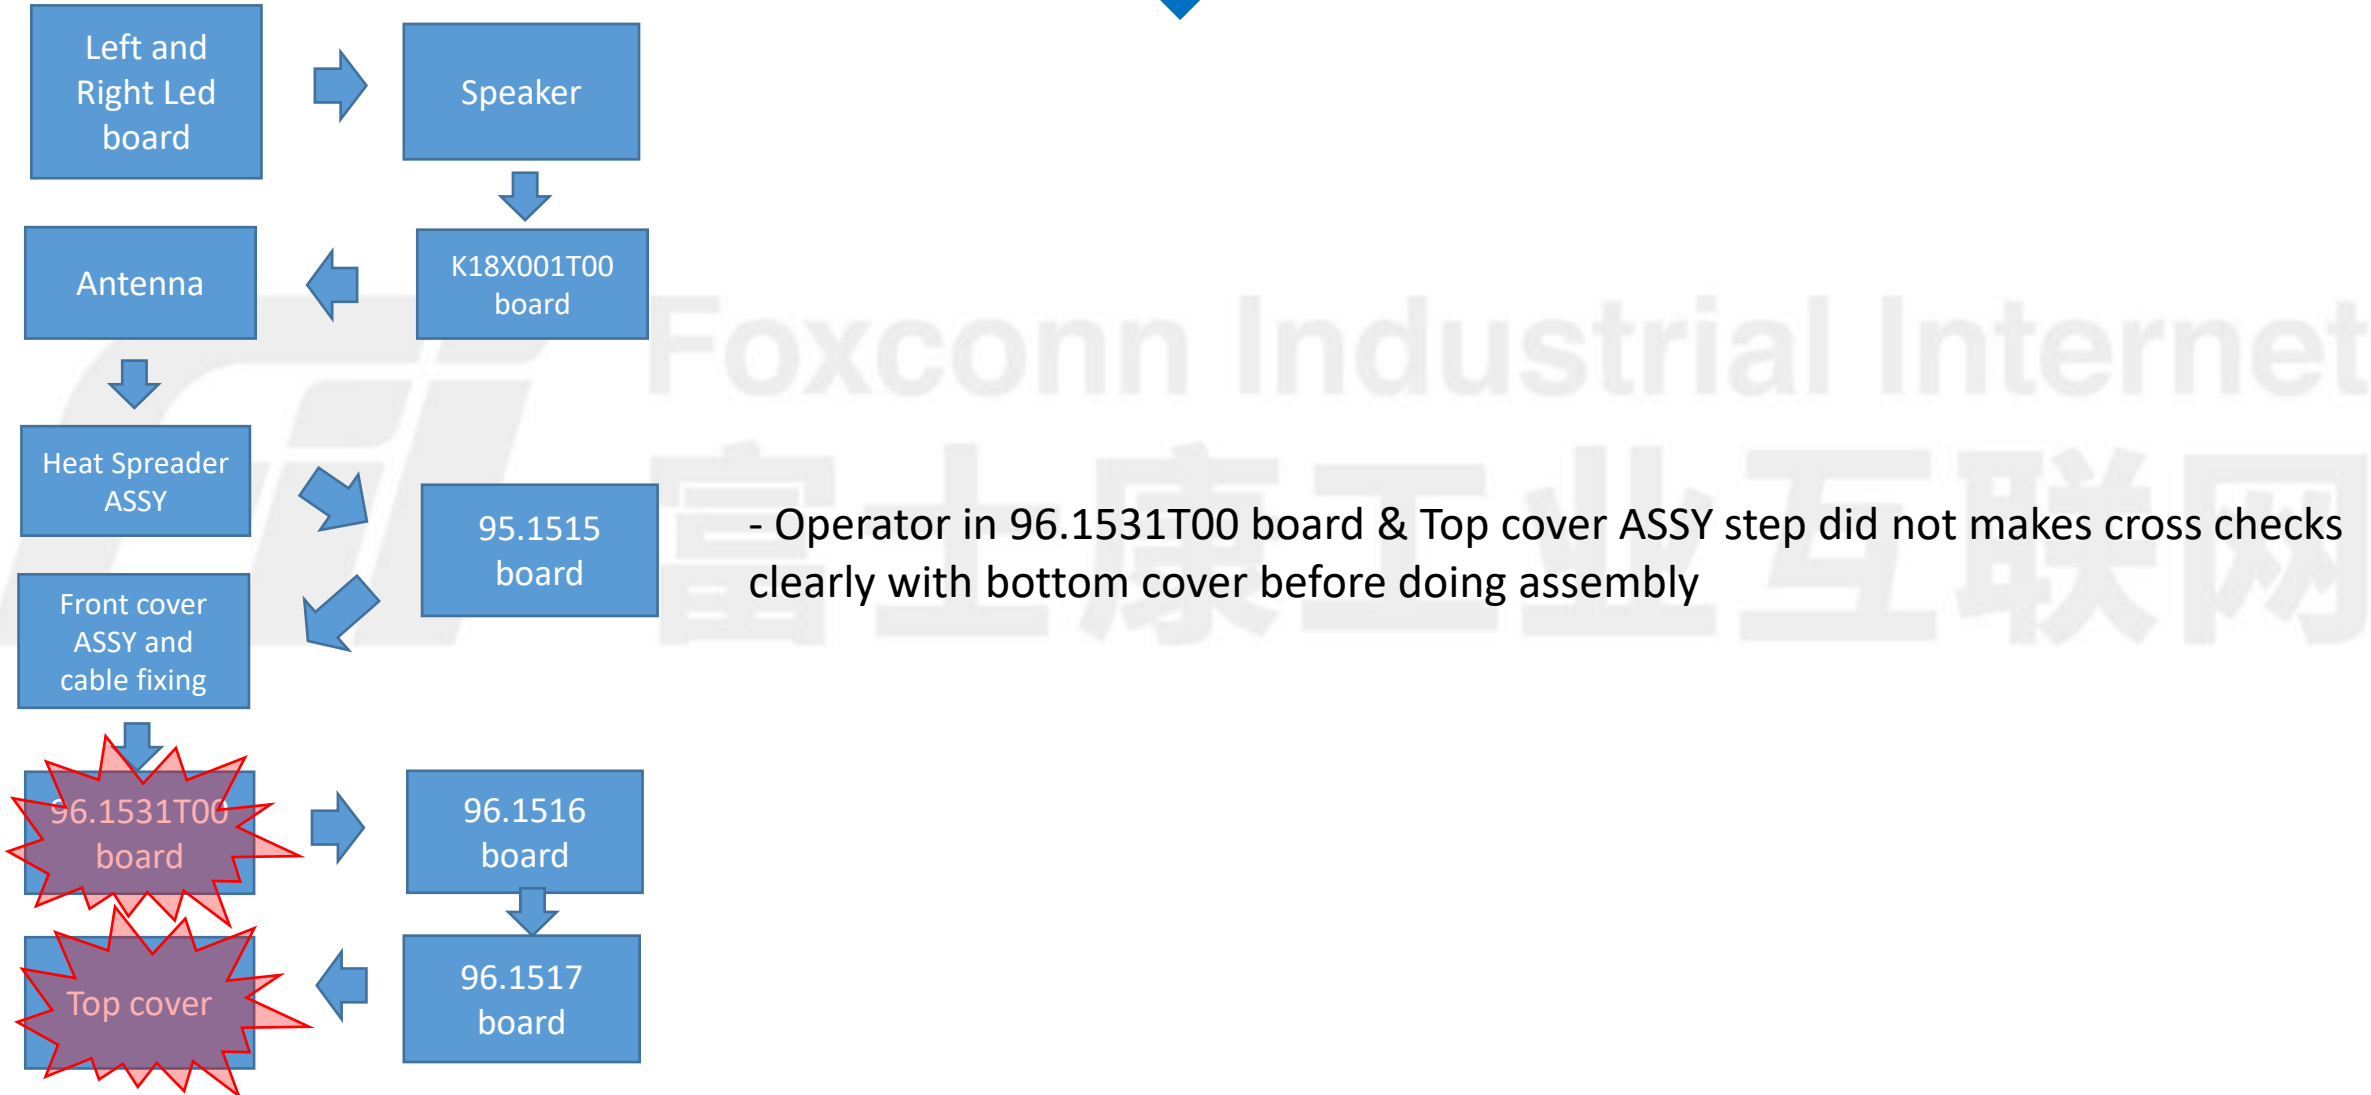
## Reason analysis for escape

- ✓ Operator makes cross check not clearly
