# BFX-UA300 Sound Leaked Report

**FOXCONN CPEG JBD\_VN**

**Sep-1-2021**

**Version 02**

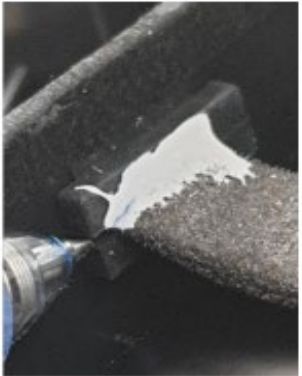
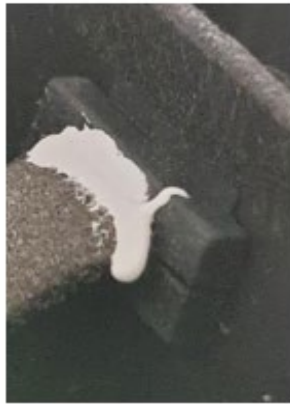
- 11-August-2021, Customer complained sound leaked when makes 50Hz test with DVT3 build in customer side cause by:

- Inner bushing glue apply defect

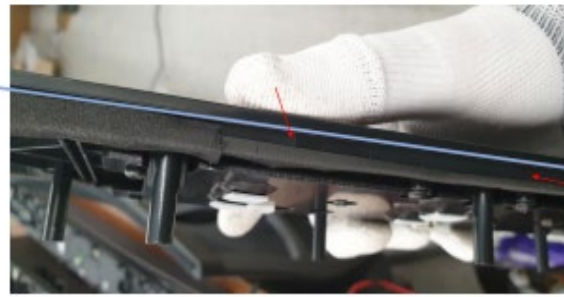
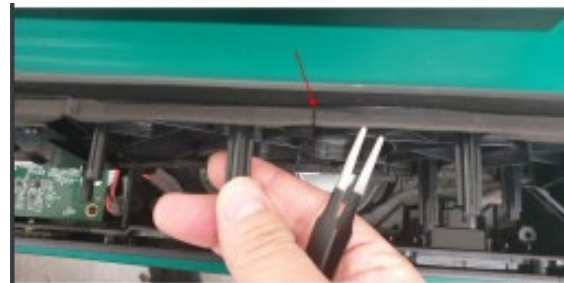
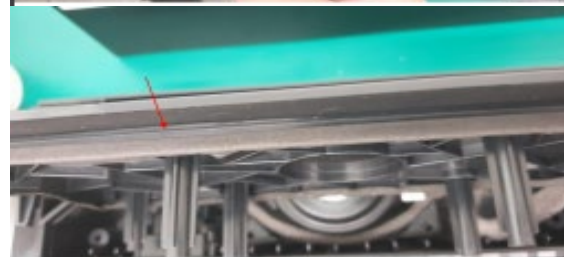
- Gasket attachment defect

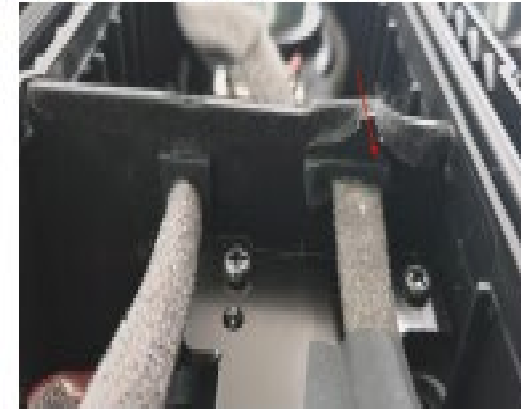
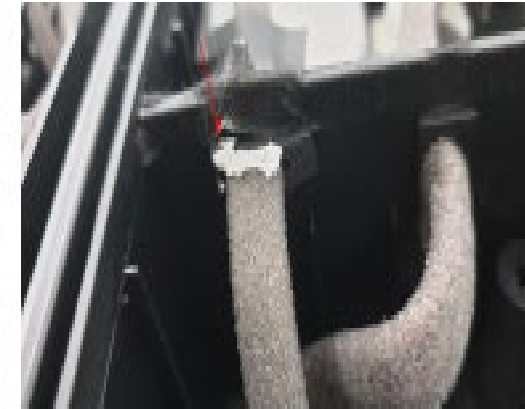
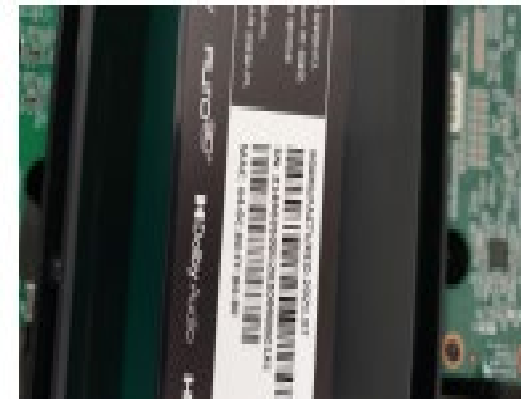
- Bushing defect - assembly or material

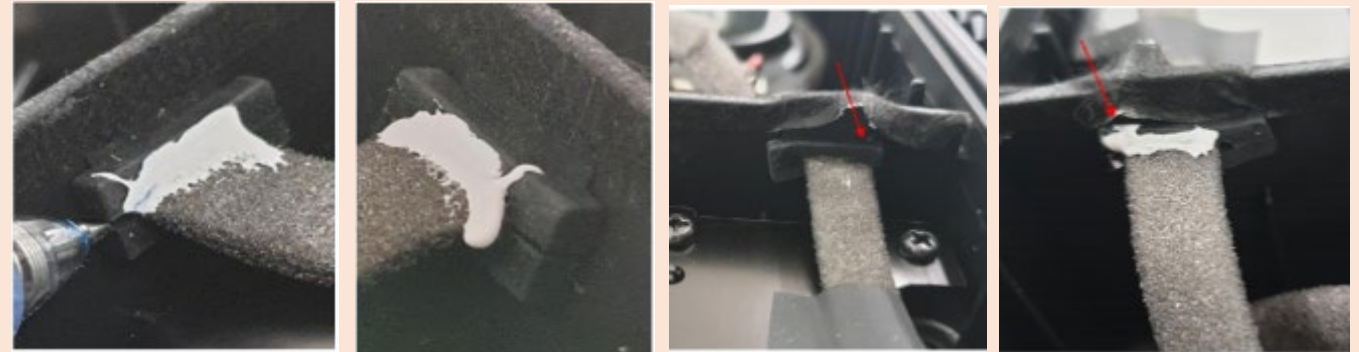
### Glue Applying/Bushing Defect

- Conclusion: All defect happen in Assembly stage

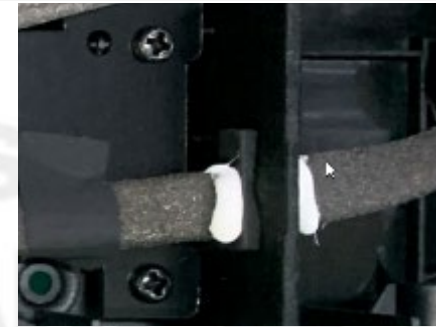
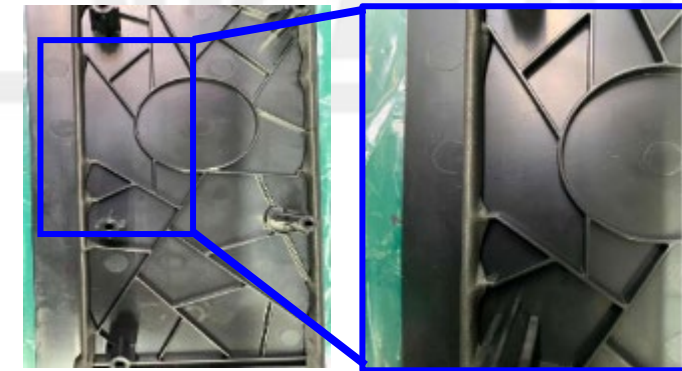
Inner Bushing/Top Gasket Assembly  
in PMD

- Check BFX UA300 Product Manufacture Document of Assembly:  
There are no remark with Adding Top Gasket Method and remark not clearly with Inner Bushing Glue in BFX UA300 Product Manufacture Document

| No. | Subject | Root cause | Corrective action | Evidence | Status | Owner | Due date |
|---|---|---|---|---|---|---|---|
| 1 | Occurrence-Manufacture Document | Operator follow Product Manufacture Document which did not define clearly the glue point/gasket attachment method | <div>1. ALT/RD to update the glue point/ gasket attachment method in Product Manufacture Document.</div> <div>2. Define specs of the glue point and gasket GAP</div> | <div>Gasket<br/>Critical To Quality for Acoustic performance</div> <div>Attachment tolerance : Max +1mm</div> <div></div> <div><div>▲ Glue application method suggestion<br/>To avoid air leakage through the bushing</div><div></div></div> | Done | ALT<br>Fii RD :<br>Jim Chen | 31-Aug |

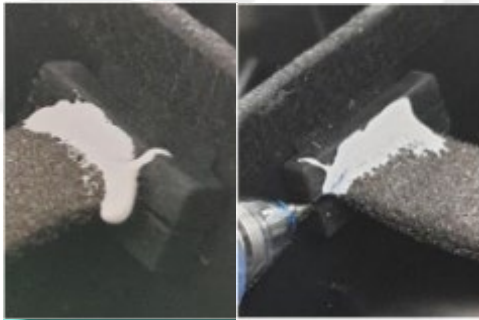
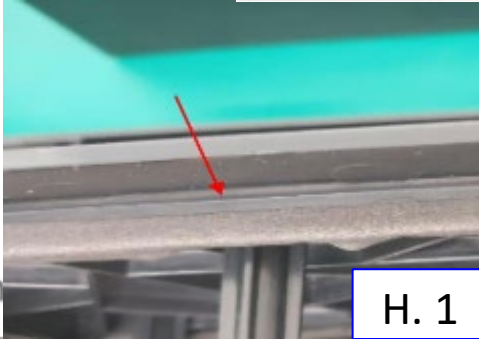
H. 1

- ✓ Factory line follow Product Manufacture Document which did not definitely the glue point/gasket attachment method => manufacture document issue.(H. 1)
- ✓ Operator did wrong when attach gasket on top cover cause intermittent => workmanship issue . (H. 2)
- ✓ Cable assembly operator missing one point when adding white glue in Inner bushing => workmanship issue . (H. 3)
