# BFX-UA300 FFC cable 8D report

FOXCONN CPEG JBD\_VN  
2022-March-10  
Version 02

## D2. Description of Problems

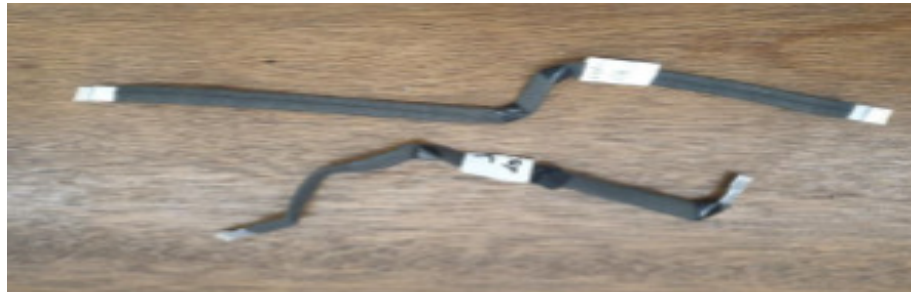
- 2021-Oct-21, ALT customer complain [BFX-UA300] defect 2 units BFX-AU300  
Symptom : No turn on the LED, No button operation.

| No. | MAC ID | Shipping SN | Production date | Failure Description Feedback from Customer | ALT Checked connections FFC cable |
|---|---|---|---|---|---|
| 1 | A8934AFE796F | 2149695001202199000013 | 2021-Sep-27 | Not turn on the LED | LED FFC : 14 Pin open |
| 2 | A8934AFE797E | 2149695001202199000010 | 2021-Sep-27 | Not operation the Button | Button FFC : 14, 15 Pin open |

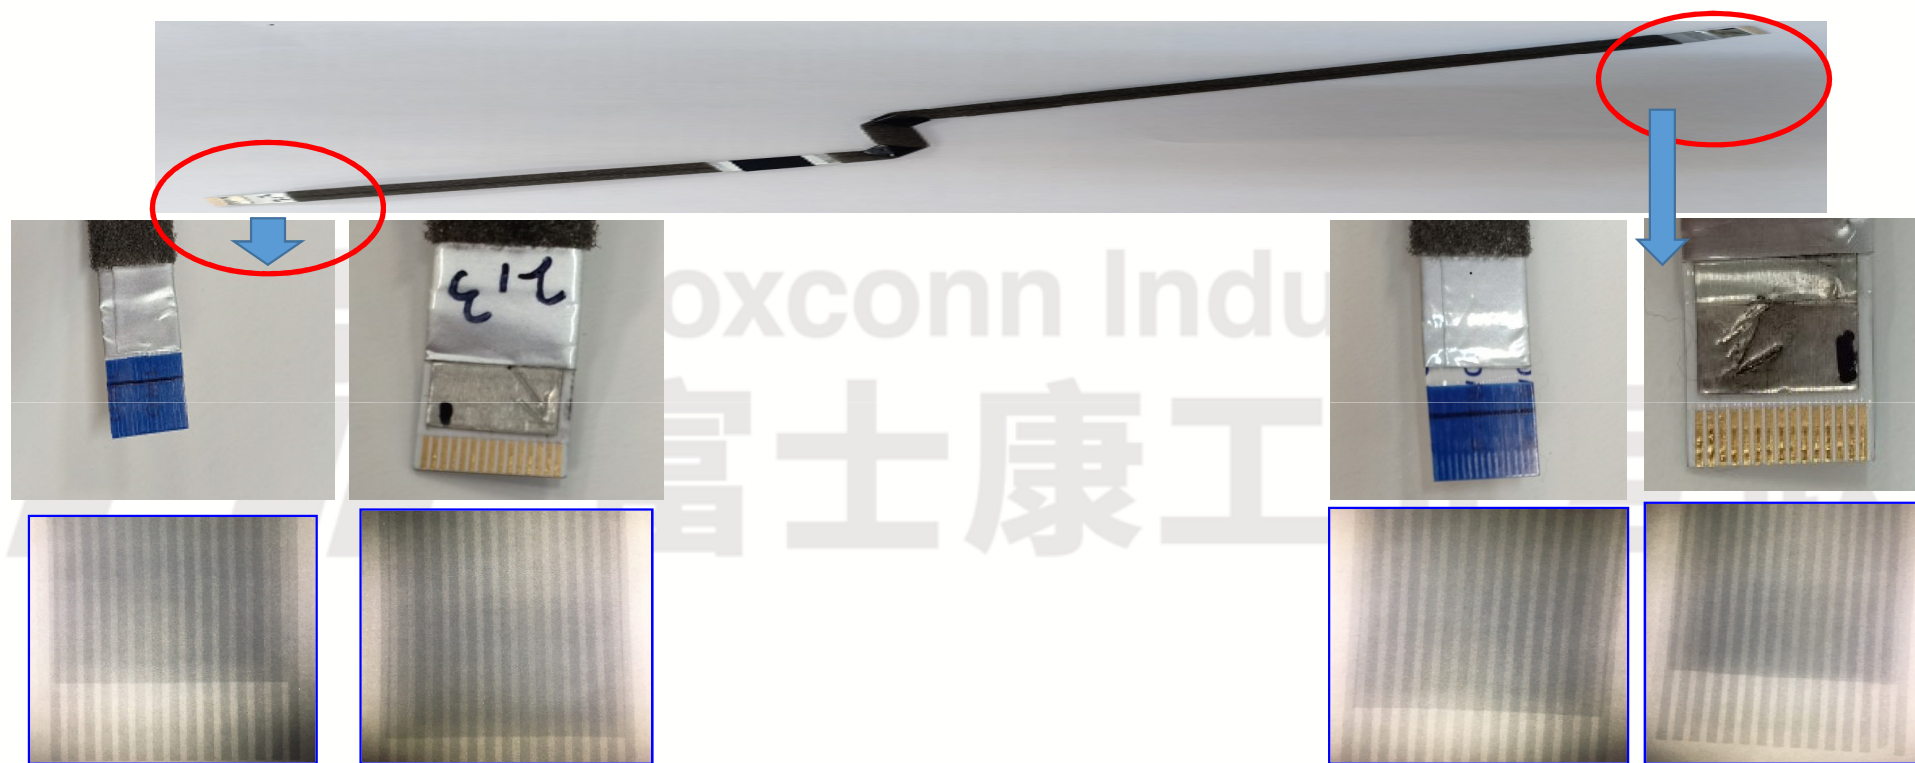
2022-Feb-07, Fii received 01 pcs FFC cable NG ( From customer feedback in 2 units FPC\_LED\_BOARD defect )

**Summary :** Check visual inspection defect FFC cable had damage before Fii received ( as picture )  
Checking X-Ray connect zone of FPC\_LED\_BOARD Jack LED => **Not found out open.**

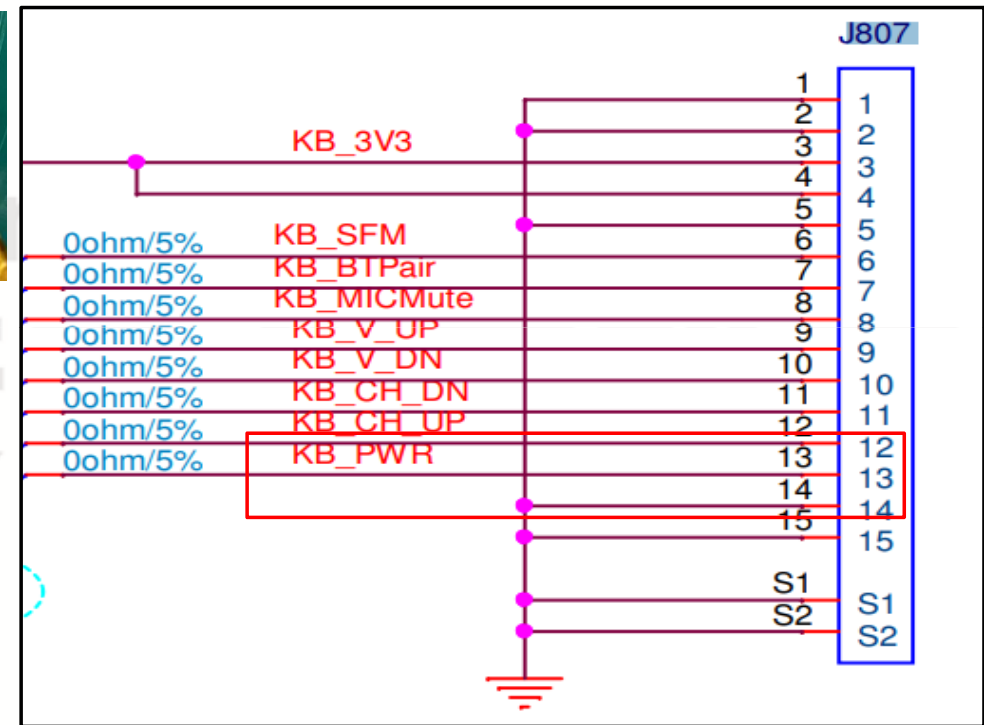
→ Find out Pin 13( KB\_ PWR), Pin14( GND) of NG sample not connection( as Picture 2).

**Summary:** NG FFC cable has Pin13, Pin14 not connection.

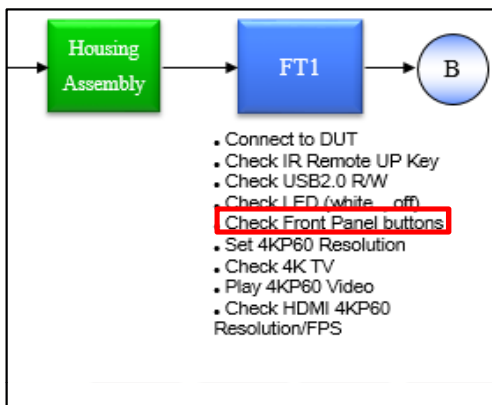
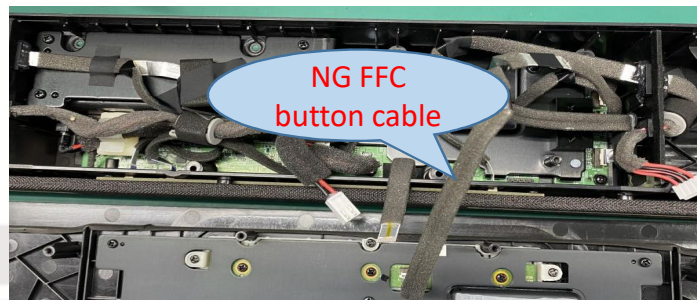
Assemble to verify NG FFC button cable

| No # | Station | Log Test | Result | Remark |
|---|---|---|---|---|
| 1 | FT1 | <br>NG FFC cable _FT1_BUTTON1 | Fail | Fail Button 0 (Power button) |

**Summary:** NG FFC button has Pin 13, Pin 14 not connection → test Power button fail at FT1 station.

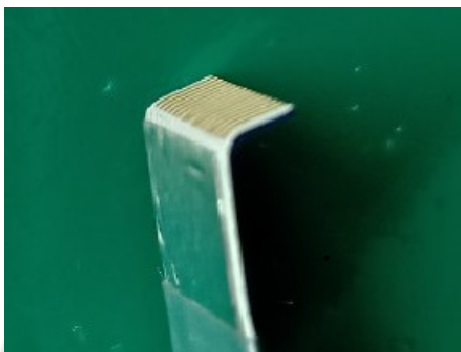
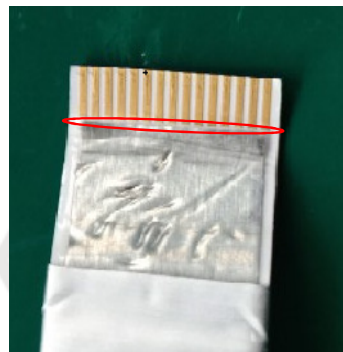
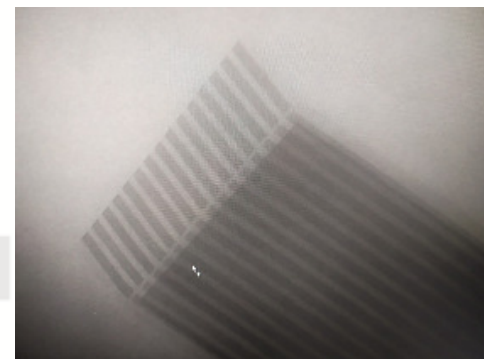
Fii verify 1 units – FFC cable will folded 3 times ( hand gold location ) . Check visual , X-Ray defect all gold finger had broken.

**Summary:** Base check NG FFC cable and Fii had verify folded FFC cable result all pin will open when we folded 2 times. **2 units failure at customer defect not by FFC folded issue**, cause if FFC cable folded will fail all pin open ( NG FFC cable has Pin13, Pin14 not connection ). Maybe cause fii rework **open housing take out FFC cable more 2 times, OP doing online make FFC cable head damage, but function test pass normal that time. So can not cover in production line.**

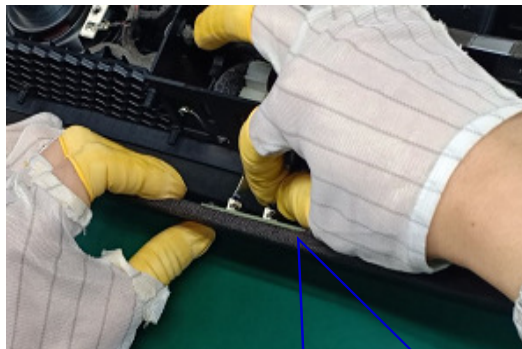
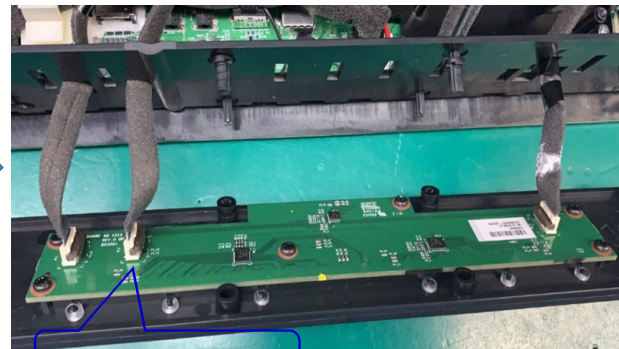
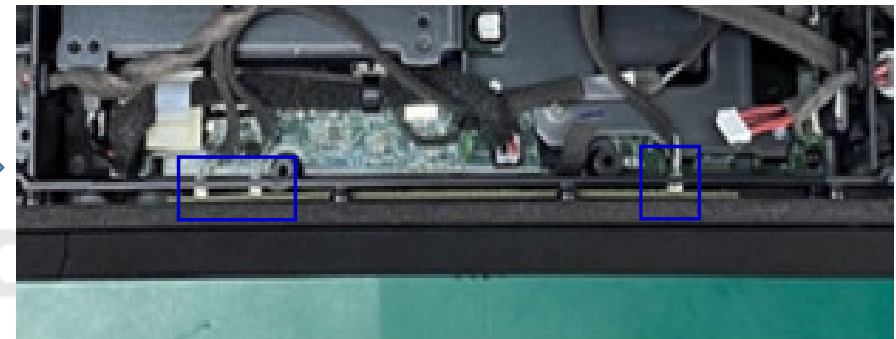
Risk assessment when OP put  
FFC cable into LED main

The product doing to Assy4, We defect housing Top cover button can not press, We rework back Assy2 for open and repair housing Button issue. Due we re-assembly open housing maybe OP input FFC cable head in to LED main board make FFC cable head damage.

Notice OP doing and re-check after doing when assembly FFC cable on each station, use hand put FFC cable into connector. Done: 2022-March-10

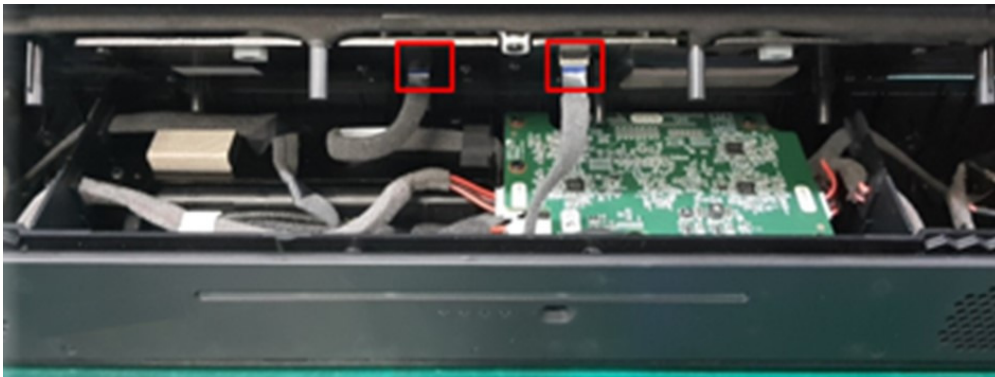
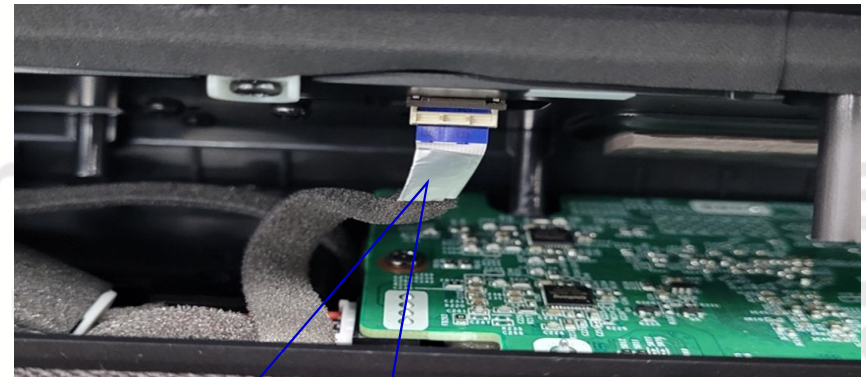
Risk assessment when OP re-put in and put out FFC cable into Button main, make FFC damage.

The product doing to final testing station, If want to rework or repair must be re-open housing and take out all main board and FFC cable out of housing. When we re-assembly housing maybe OP input FFC cable head in to LED main board make FFC cable head damage.
