# **BFX\_UA300 FFC cable 8D report**

**FOXCONN CPEG JBD\_VN**  
**2022-Apr-04**  
**Version 03**

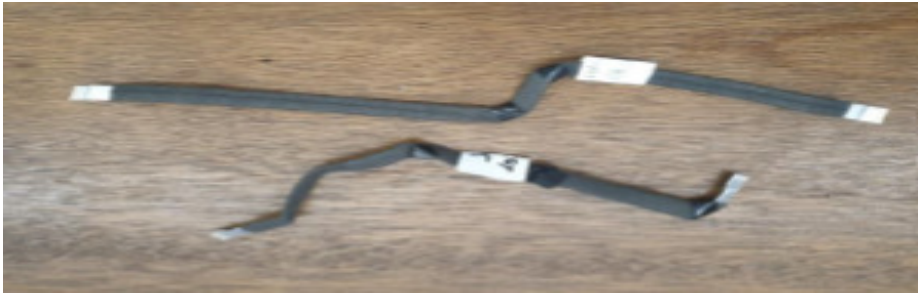
- 2021-Oct-21, ALT customer complain [BFX-UA300] defect 2 units BFX-AU300  
Symptom : No turn on the LED, No button operation.

| No. | MAC ID | Shipping SN | Production date | Failure Description Feedback from Customer | ALT Checked connections FFC cable |
|---|---|---|---|---|---|
| 1 | A8934AFE796F | 2149695001202199000013 | 2021-Sep-27 | Not turn on the LED | LED FFC : 14 Pin open |
| 2 | A8934AFE797E | 2149695001202199000010 | 2021-Sep-27 | Not operation the Button | Button FFC : 14, 15 Pin open |

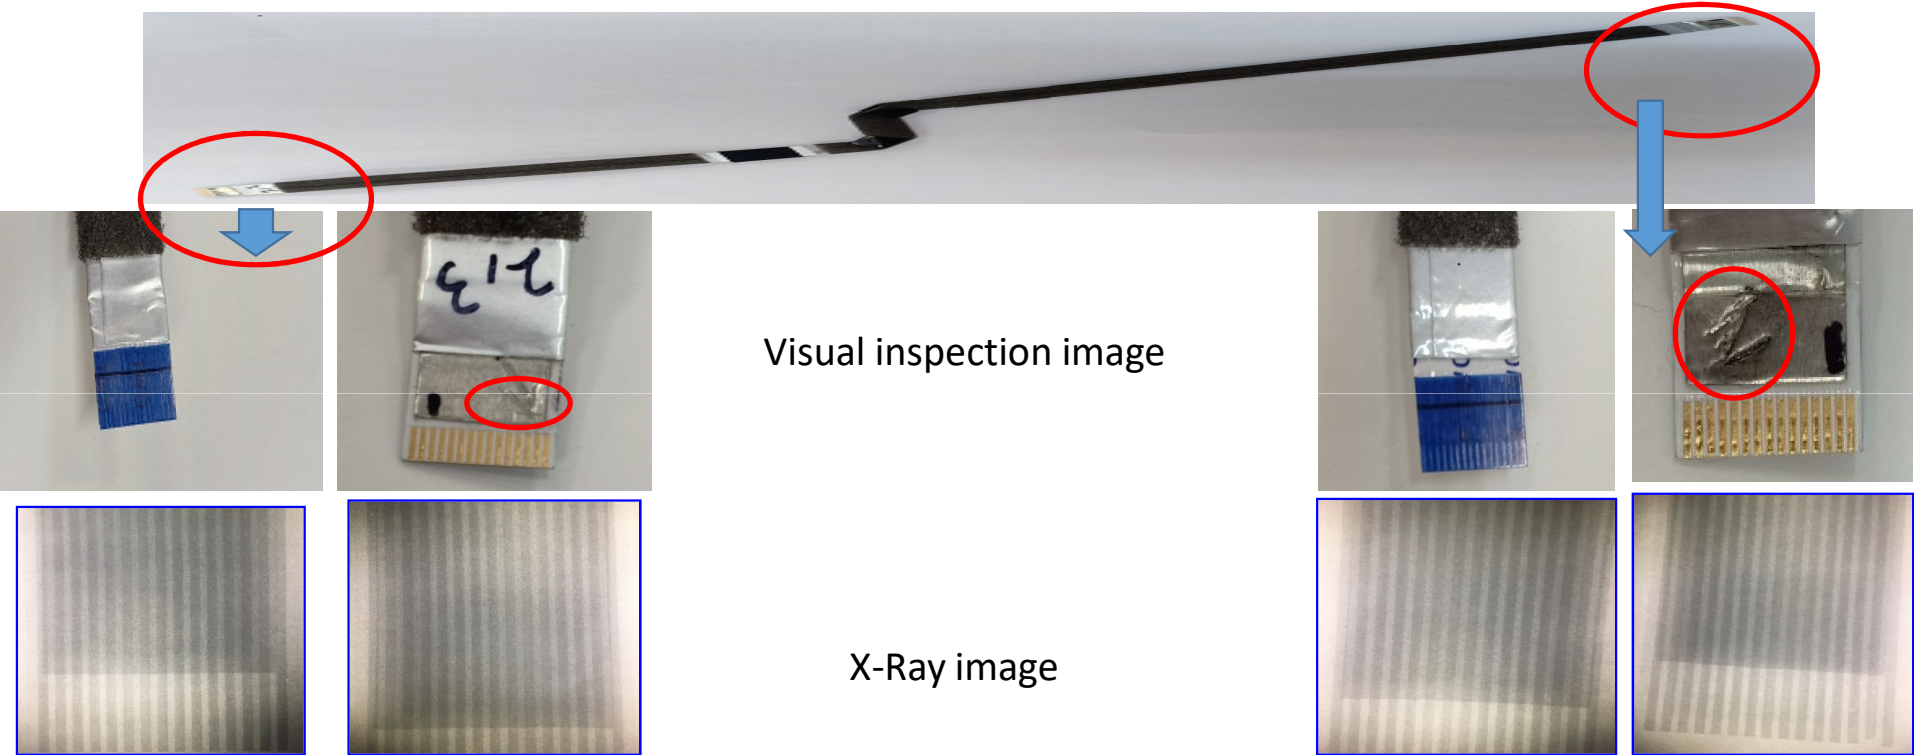
2022-Feb-07, Fii received 01 pcs FFC cable NG from P-TW vendor .

Summary : Check visual inspection defect FFC cable had damage before Fii received ( as picture )  
Checking X\_Ray connect zone of FPC\_LED\_BOARD Jack LED => Not found out open.

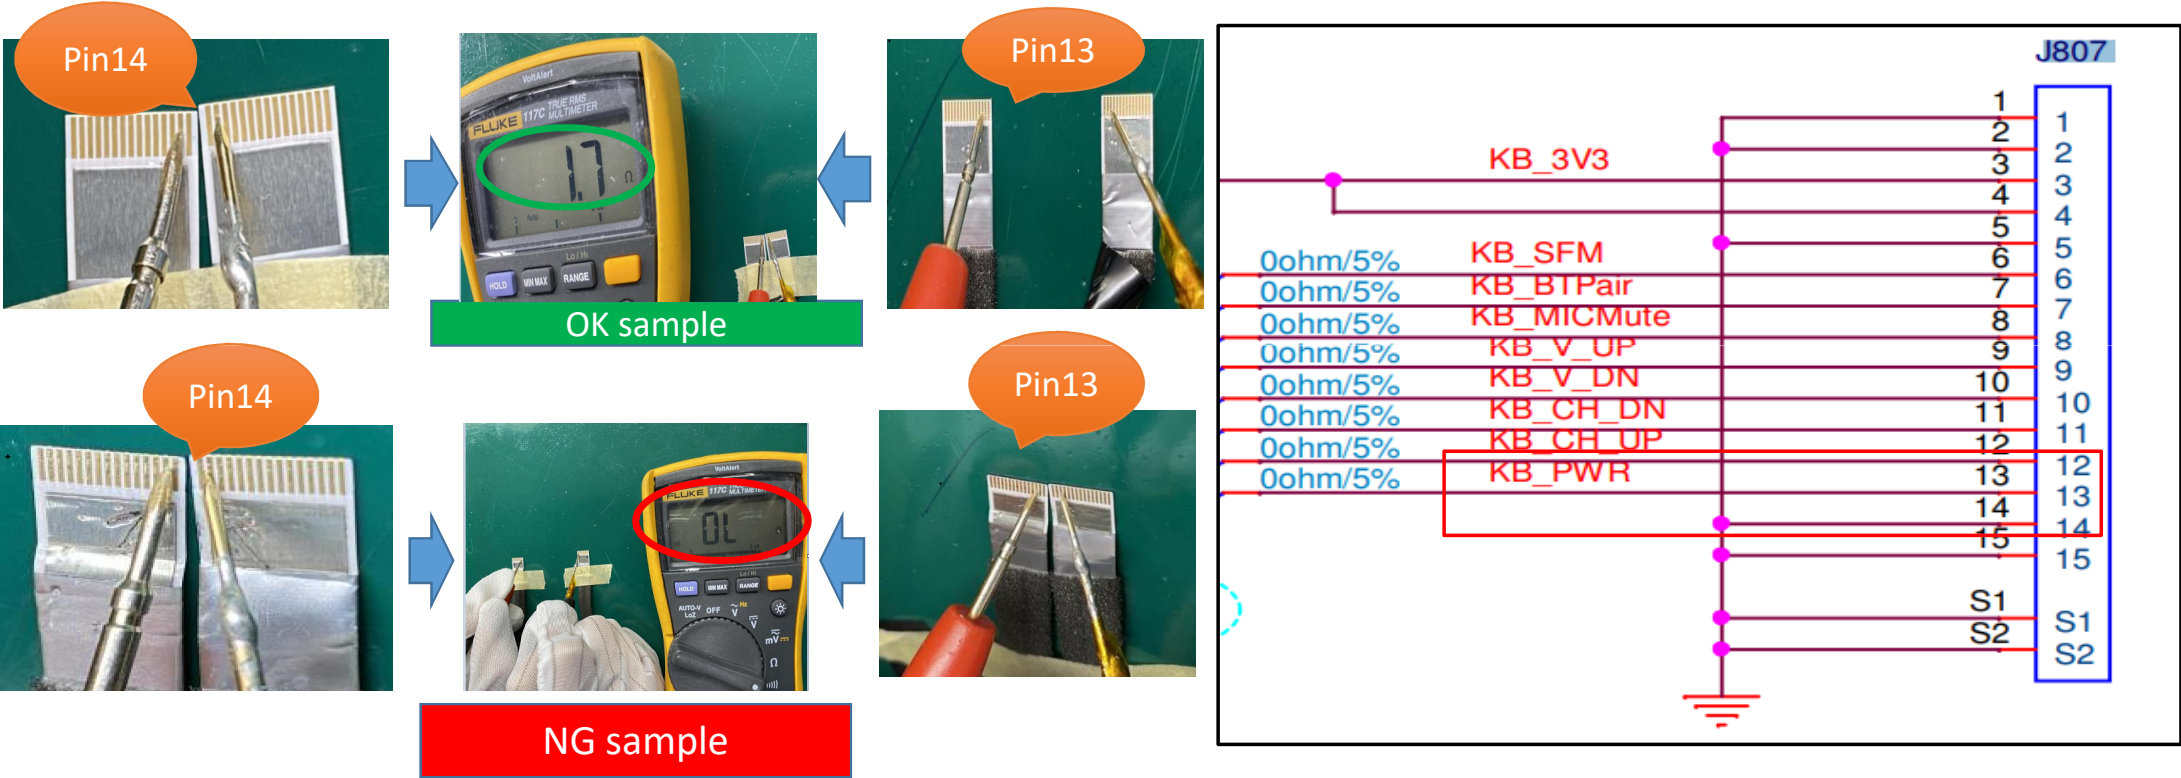
- Measure connection of 2 points of Button FFC NG cable, (compared with button FFC OK cable).

➔ Find out Pin 13( KB\_ PWR), Pin14( GND) of NG sample Open ( as Picture 2).

Summary: NG FFC cable has Pin13, Pin14 open.

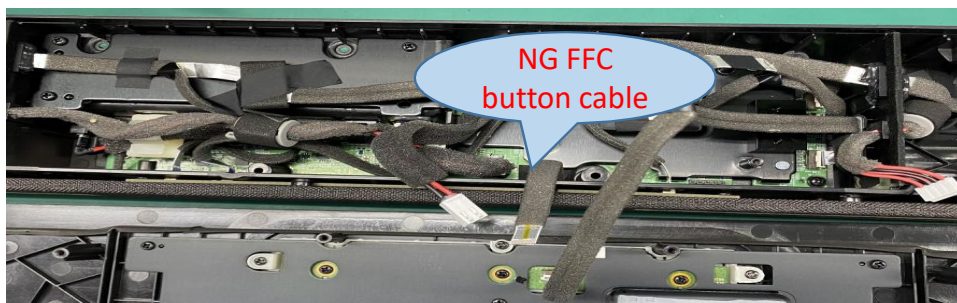
Assemble to verify NG  
button FFC cable

1. Use NG button FFC cable assemble into OK product to test at FT1 station ( Check Button function). => Result Fail button test.

| No # | Station | Test Log | Result | Remark |
|---|---|---|---|---|
| 1 | FT1 | <br>NG FFC cable<br>_FT1_BUTT01 | Fail | Fail Button 0 (Power button) |

**Summary:** NG FFC button has Pin 13, Pin 14 open → test Power button fail at FT1 station.

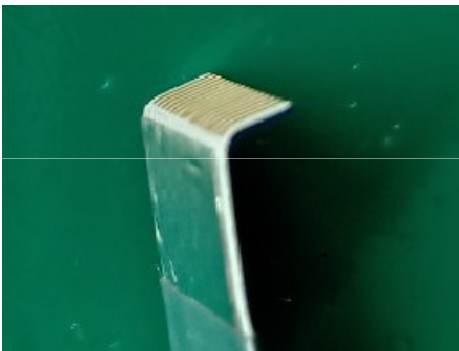
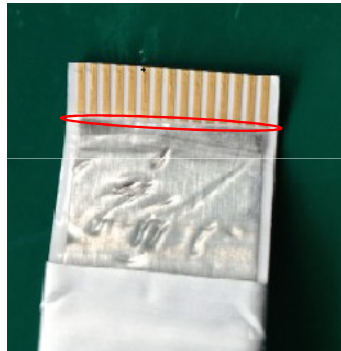
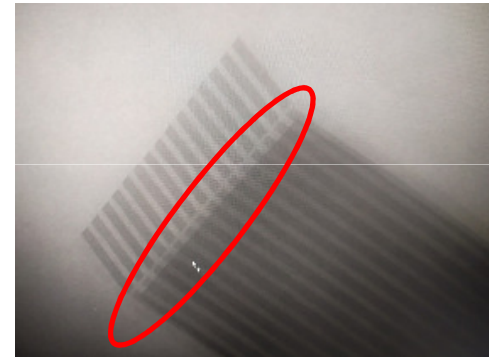
1. Fii verify 1 units – FFC cable folded 3 times ( Golden finger location ). Check visual , X-Ray defect all golden finger had broken.
2. 2 units failure at customer defect not by FFC folded issue, cause if FFC cable folded will fail all pin open ( NG FFC cable has Pin13, Pin14 open).

Check visual , X-Ray defect all gold finger had broken.

**Summary:** Maybe cause production line rework disassembly housing take out FFC cable more 2 times, OP doing make FFC cable damage, but function test pass normal that time. So can not cover in by function test.

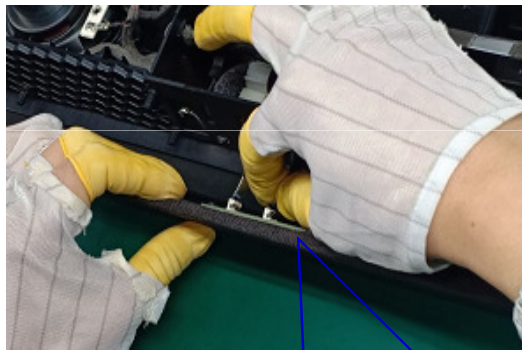
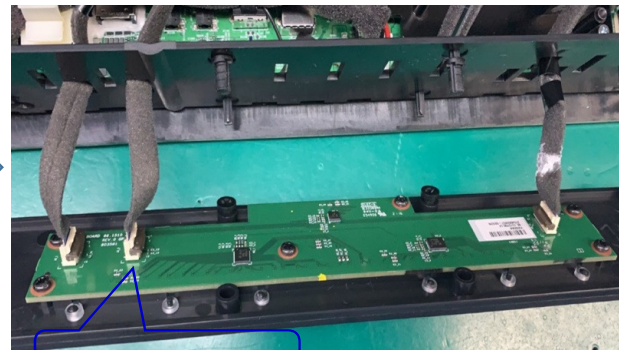
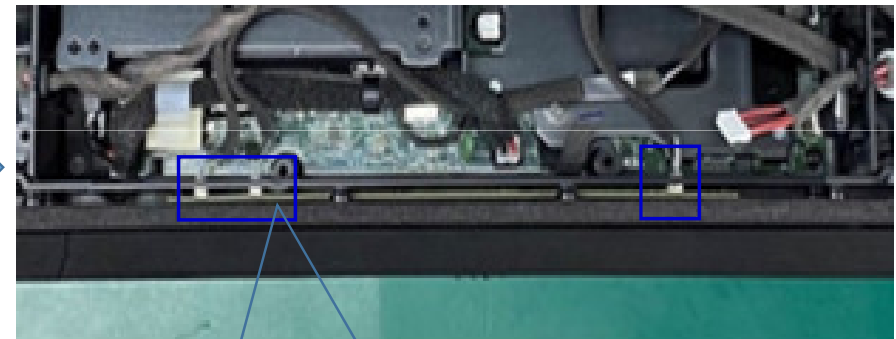
1. The product test FT1 defected housing button top cover can not press ( stuck button ), We rework back Assy2 station for repair housing button issue and disassembly housing.
2. Due we disassembly housing maybe OP input FFC cable in to connecter LED main board make FFC cable pin damage.

Risk assessment when OP put FFC cable into LED main

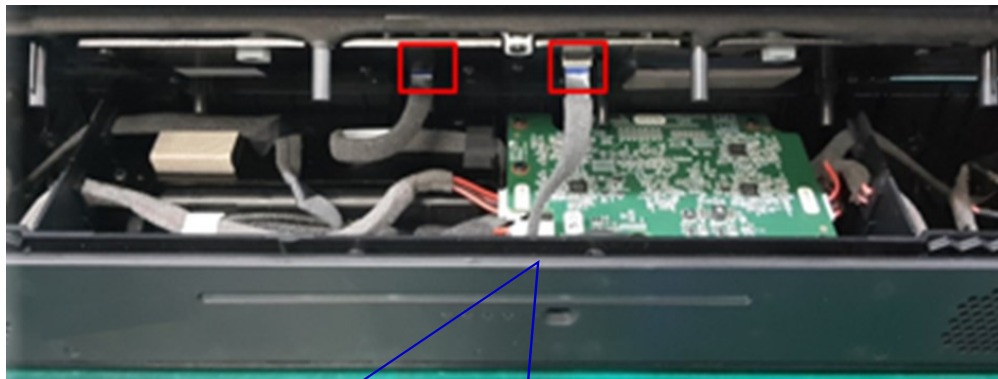
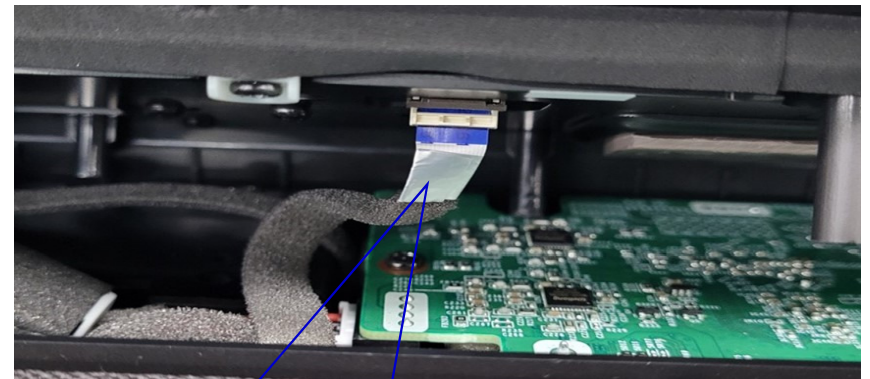
Risk assessment when OP re-put in and put out FFC cable into Button main, make FFC damage.

Risk assessment when OP re-put in and put out FFC cable into Button main, make FFC pin damage.

When we disassembly housing maybe OP input FFC cable into connector button main board make FFC cable pin damage.
