# **BFX-UA300 FFC cable 8D report**

**FOXCONN CPEG JBD\_VN**  
**2022-May-24**  
**Version 06**

# D2. Description of Problems

- 2021-Oct-21, ALT customer complain [BFX-UA300] defect 2 units BFX-AU300  
Symptom : No turn on the LED, No button operation.

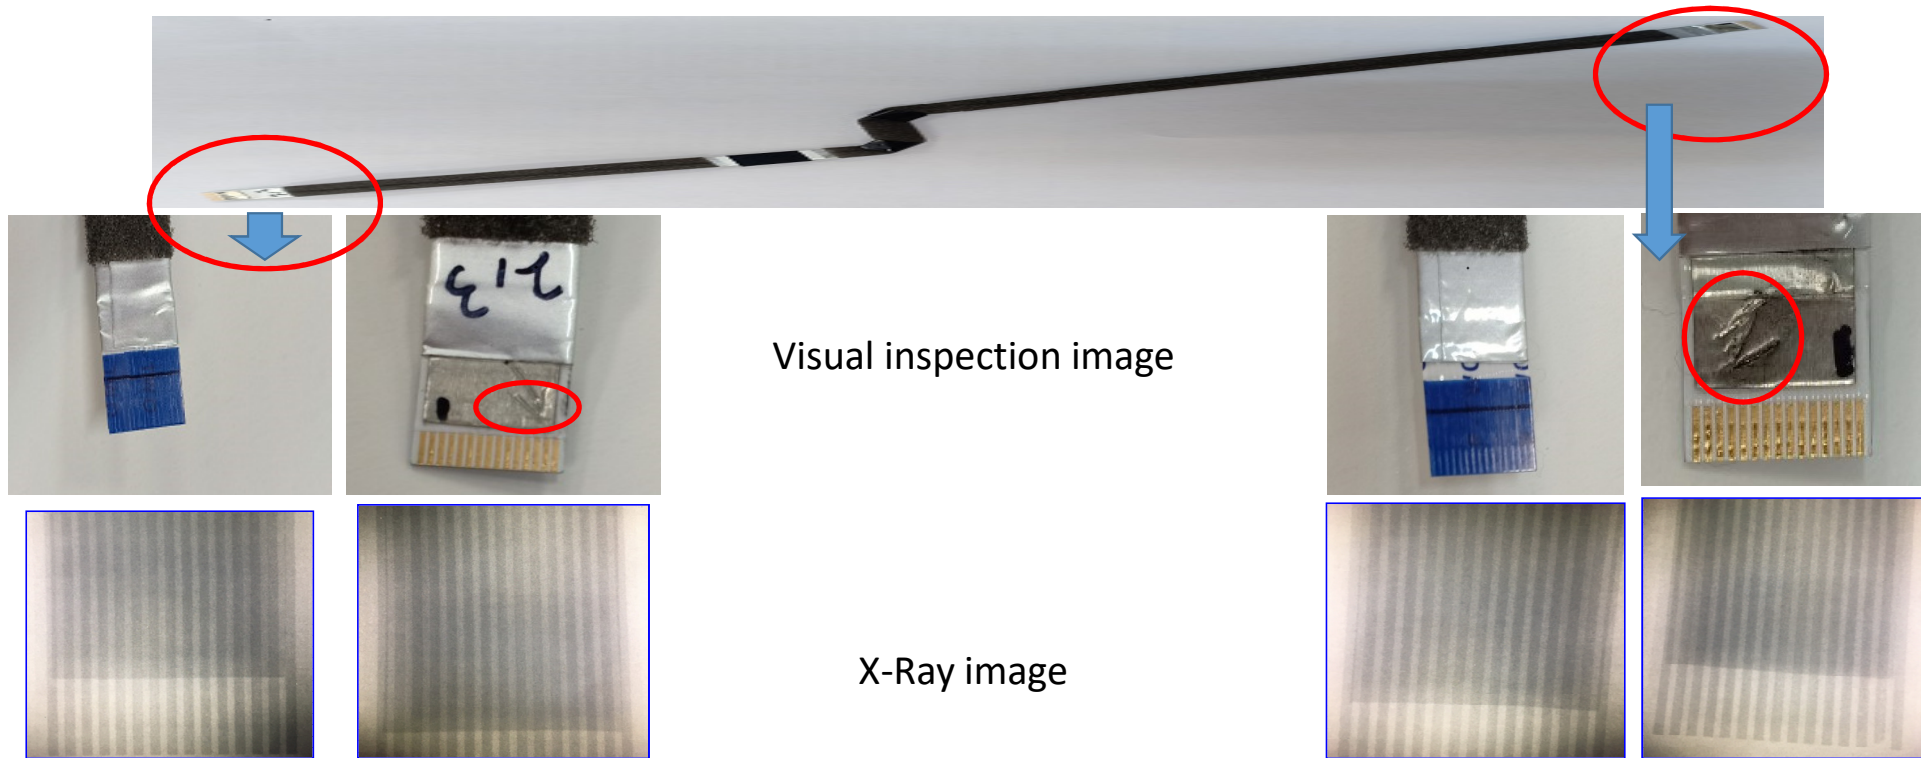
2022-Feb-07, Fii received 01 pcs FFC cable NG from P-TW vendor .

**Summary :** Check visual inspection defect FFC cable had damage before Fii received ( as picture )  
Checking X\_Ray connect zone of FPC\_LED\_BOARD Jack LED => **Not found out open.**

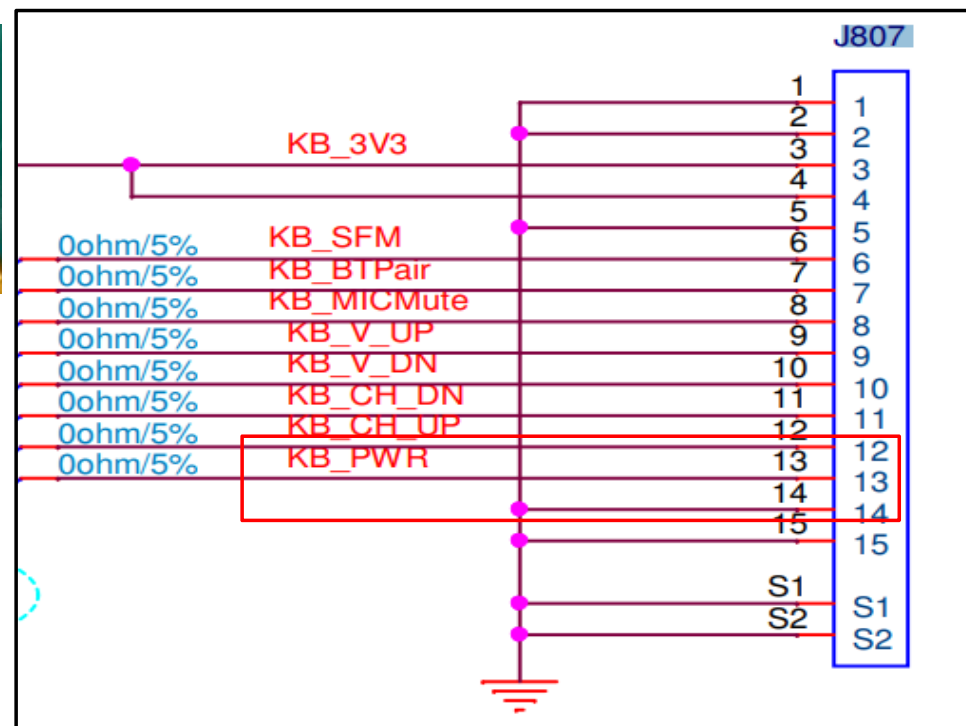
- Measure connection of 2 points of Button FFC NG cable, (compared with button FFC OK cable).

→ Find out Pin 13( KB\_ PWR), Pin14( GND) of NG sample Open ( as Picture 2).

Summary: NG FFC cable has Pin13, Pin14 open.

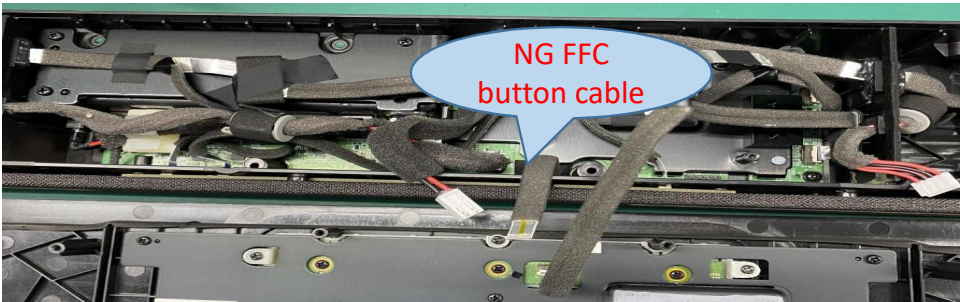
1. Use NG button FFC cable assemble into OK product to test at FT1 station ( Check Button function). => Result Fail button test.

Summary: NG FFC button has Pin 13, Pin 14 open ➔ test Power button fail at FT1 station.

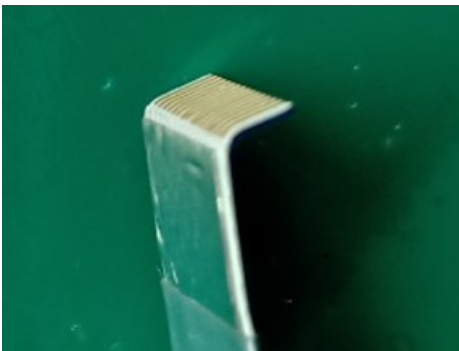
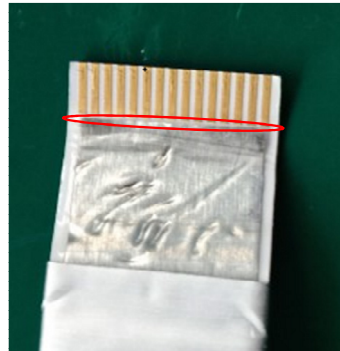
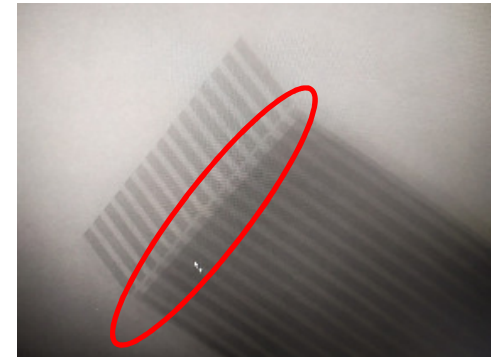
1. Fii verify 1 units – FFC cable folded 3 times ( Golden finger location ). Check visual , X-Ray defect all golden finger had broken.
2. 2 units failure at customer defect not by FFC folded issue, cause if FFC cable folded will fail all pin open ( NG FFC cable has Pin13, Pin14 open).

Check visual , X-Ray defect all gold finger had broken.

**Summary:** Maybe cause production line rework disassembly housing take out FFC cable more 2 times, OP doing make FFC cable damage, but function test pass normal that time. So can not cover in by function test.

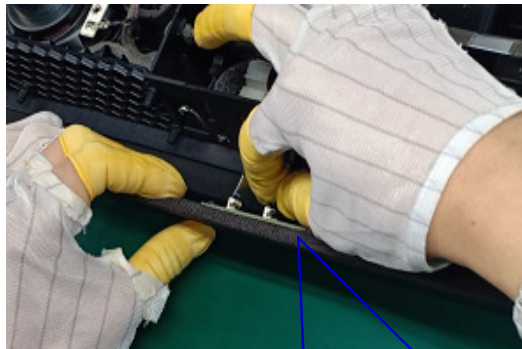
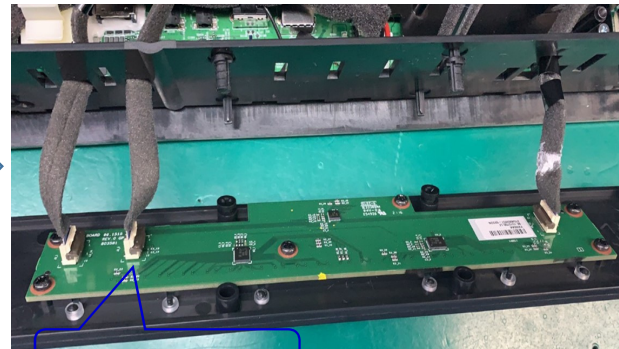
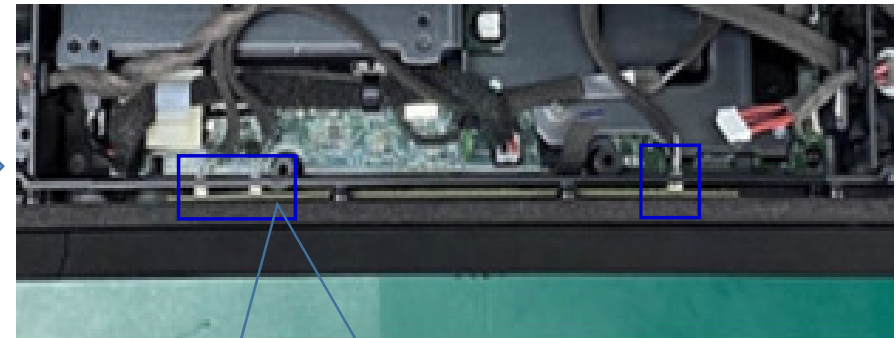
1. The product test FT1 defected housing button top cover can not press ( stuck button ), We rework back Assy2 station for repair housing button issue and disassembly housing.
2. Due we disassembly housing maybe OP input FFC cable in to connecter LED main board make FFC cable pin damage.

Risk assessment when OP put FFC cable into LED main

Notice to SOP, OP doing and re-check after doing when assembly FFC cable on each station, use hand put FFC cable into connector. Done: 2022-Apr-15

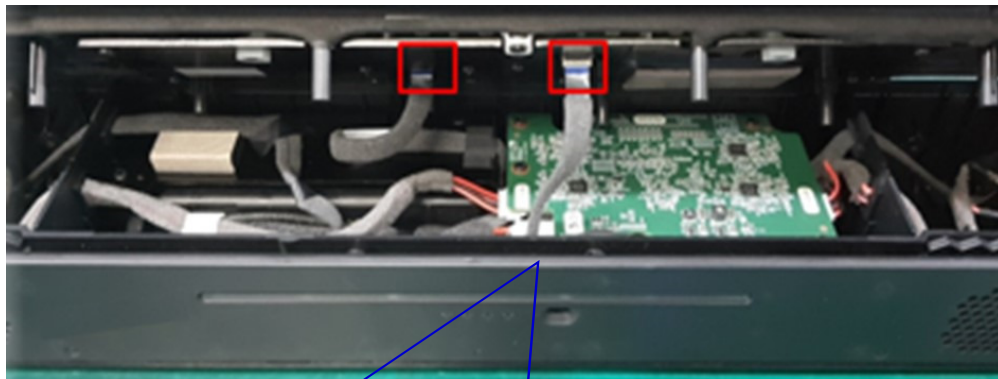
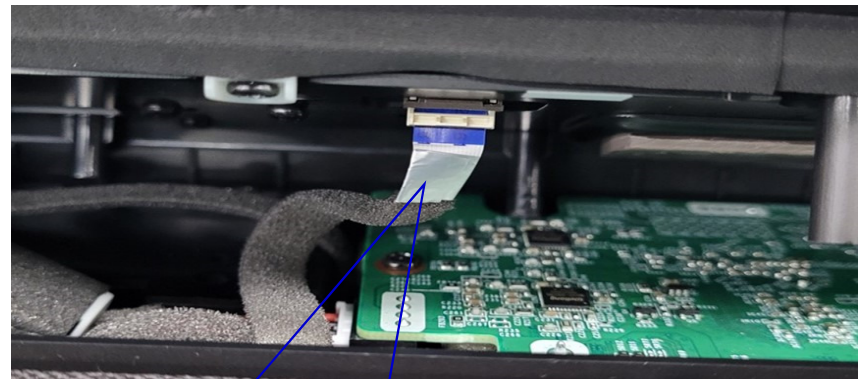
Risk assessment when OP re-put in and put out FFC cable into Button main, make FFC damage.

Risk assessment when OP re-put in and put out FFC cable into Button main, make FFC pin damage.

When we disassembly housing maybe OP input FFC cable into connector button main board make FFC cable pin damage.
