# **Final FA report of SY8824CAIC**

**Prepared by Silergy Corp.**

**CSIM-202209015**

**2022/10/13**

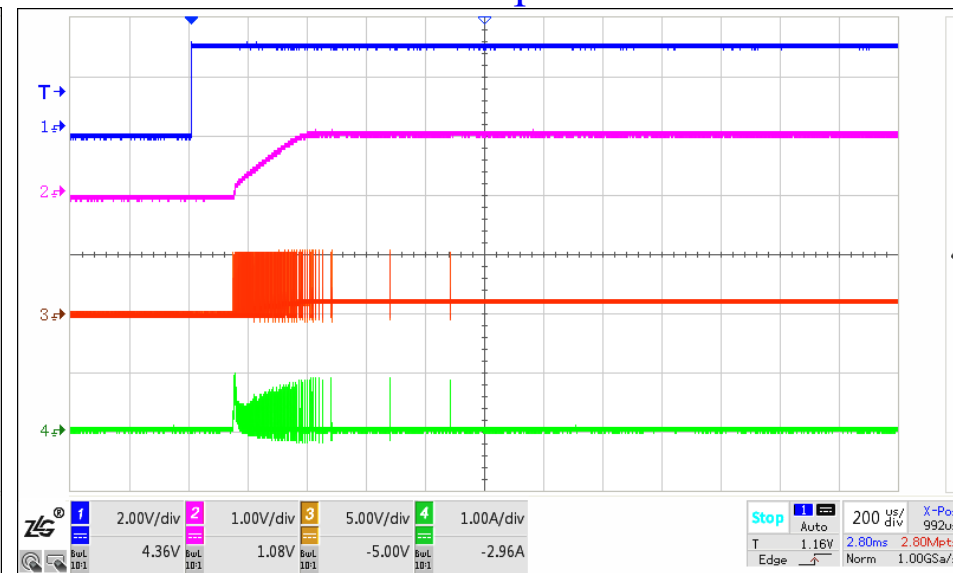
**FA Chip#1**

**OK**

**$I_{OUT}=0A$**

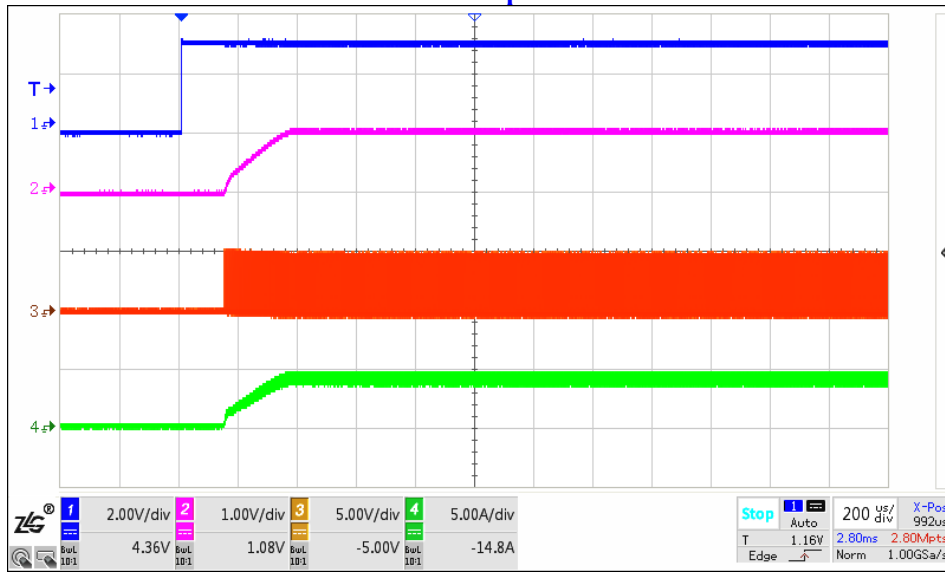
FA Chip#1

OK

$I_{OUT}=4A$

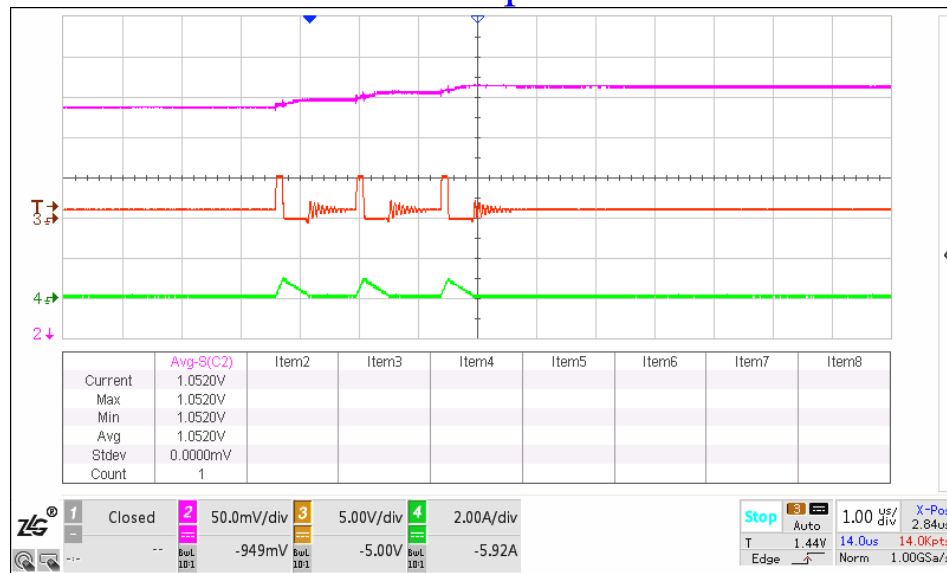
## FA Chip#1

OK

$I_{OUT}=0A$

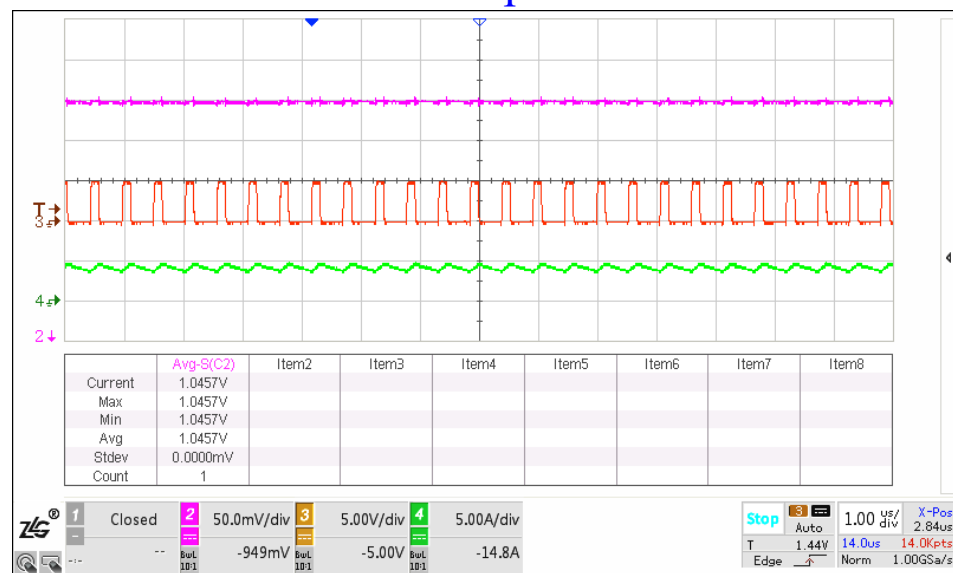
## FA Chip#1

OK

$I_{OUT}=4A$

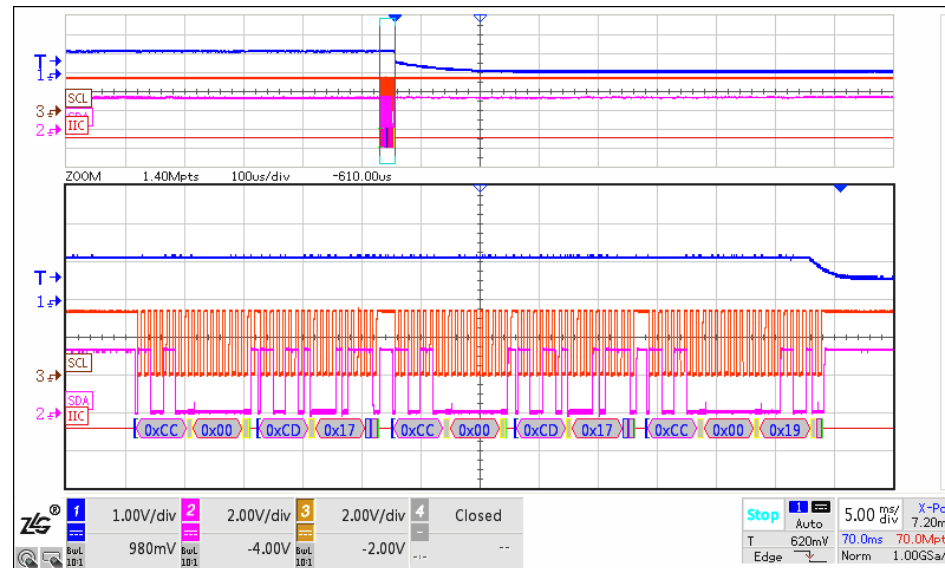
FA Chip#1

Read Data: 0x17, wrong;  
Write Data: 0x19, Buck\_EN OFF, IC shutdown.

For FA chip #1, I2C master wrote a data 0x19, which makes IC soft-ware shutdown.

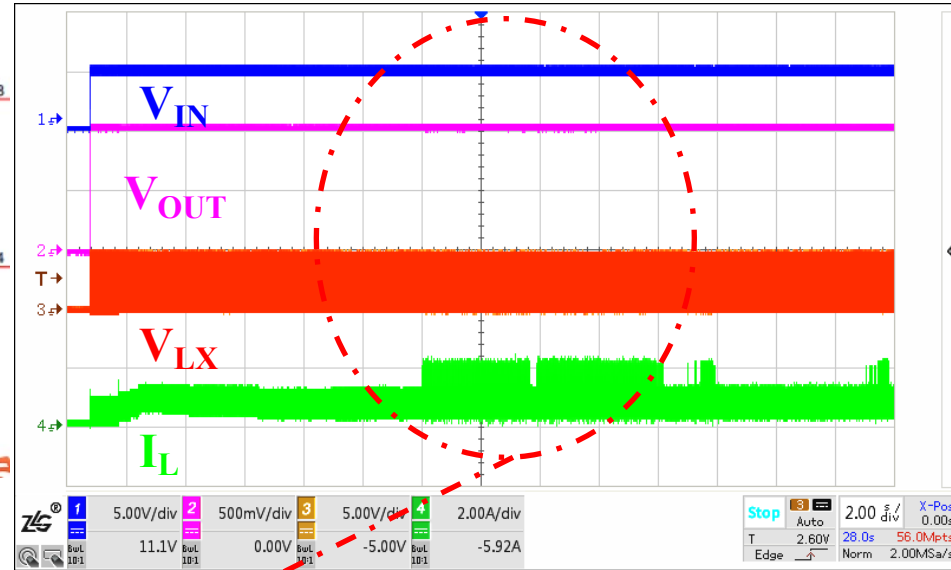
Cut the wire of SDA to prevent transfer path from I2C master to SY8824C.

If cutting off the wire of SAD, SY8824C will not shutdown.
