# **Final FA report of SY8824CAIC**

**Prepared by Silergy Corp.**

**CSIM-202209015**

**2022/10/13**

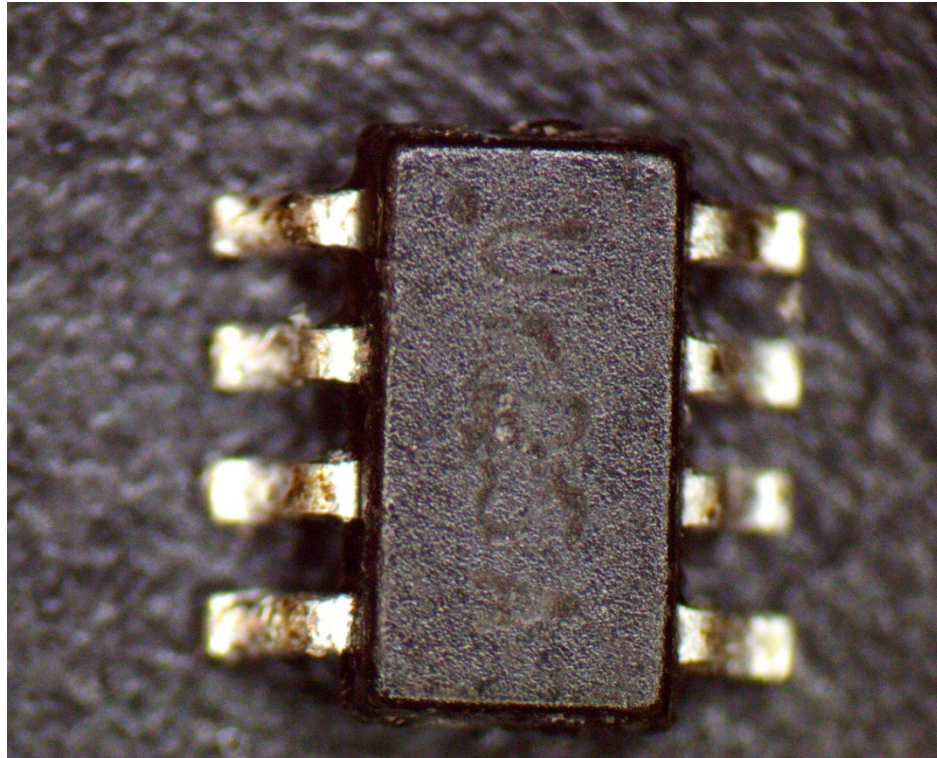
➤ No abnormal was found at the top surface of package.

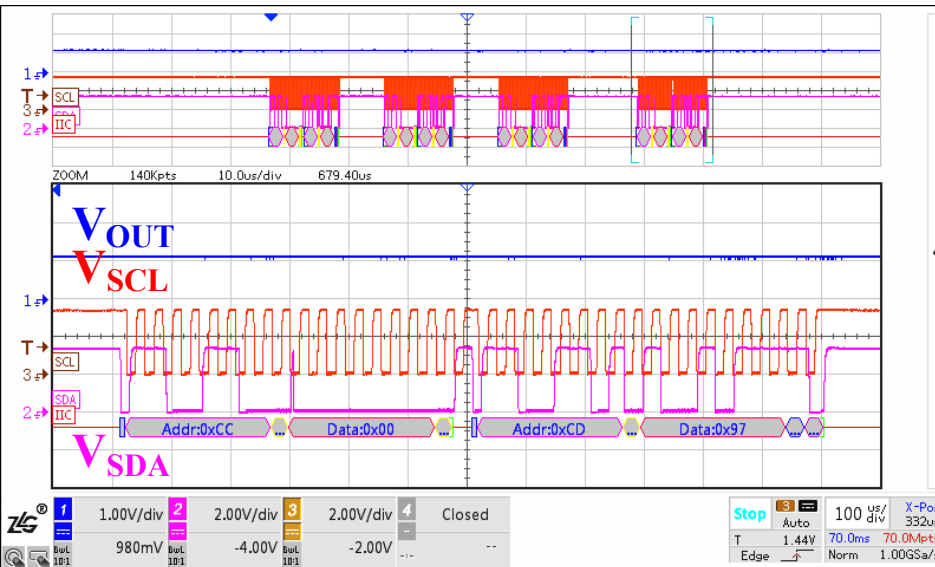
Ref Chip

Read Data: 0x97, OK.

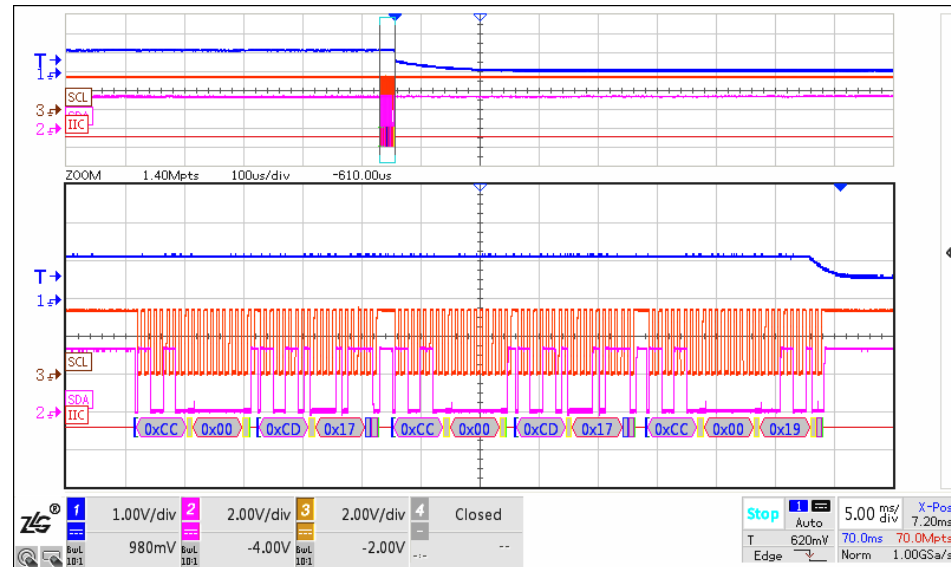
FA Chip#1

Read Data: 0x17, wrong;  
Write Data:0x19, Buck\_EN OFF, IC shutdown.

For FA chip #1, I2C master wrote a data 0x19, which makes IC soft-ware shutdown.

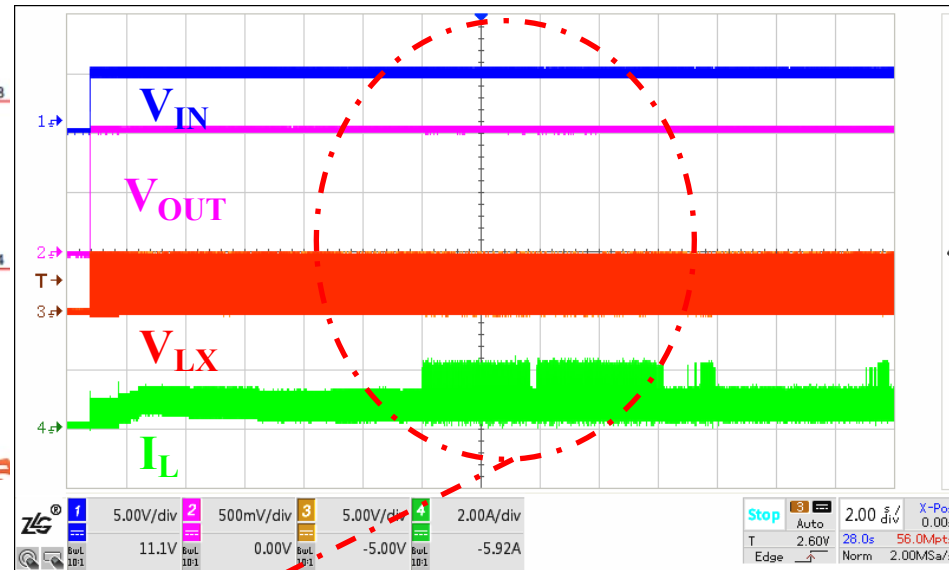
Cut the wire of SDA to prevent transfer path from I2C master to SY8824C.

If cutting off the wire of SAD, SY8824C will not shutdown.

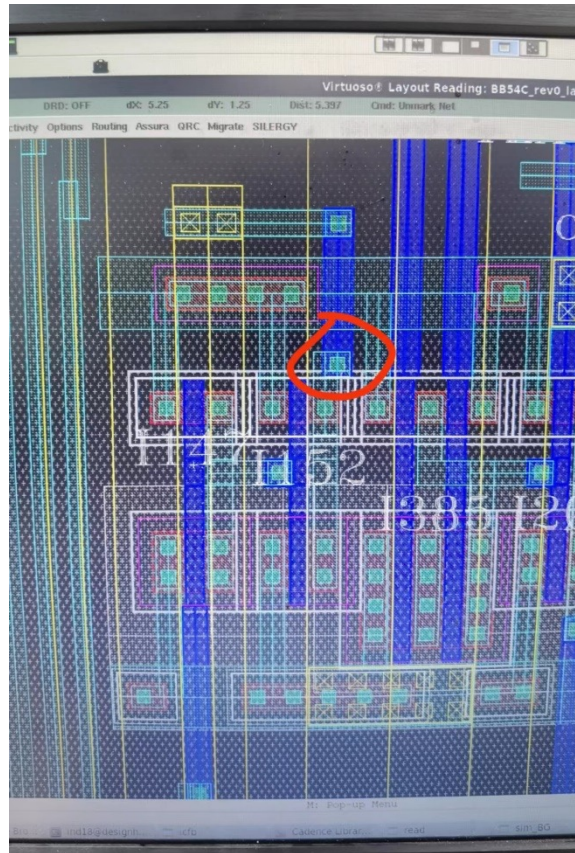
➤Returned #1 I<sub>152</sub> 下拉增大, delay增强, 导致 read function 错误。

From above analysis, returned #1 was damaged by EOS event, but the damage was too small to be observed directly by Delayer .

- EOS let IC internal circuit (I152) get damage and 12C read function abnormal (base on page 12~16's analysis).
- Silergy also add the test program to verify read/write function to filter the suspect product which may damage in our production line.  
(material with date-code 2236 been tested by new program)

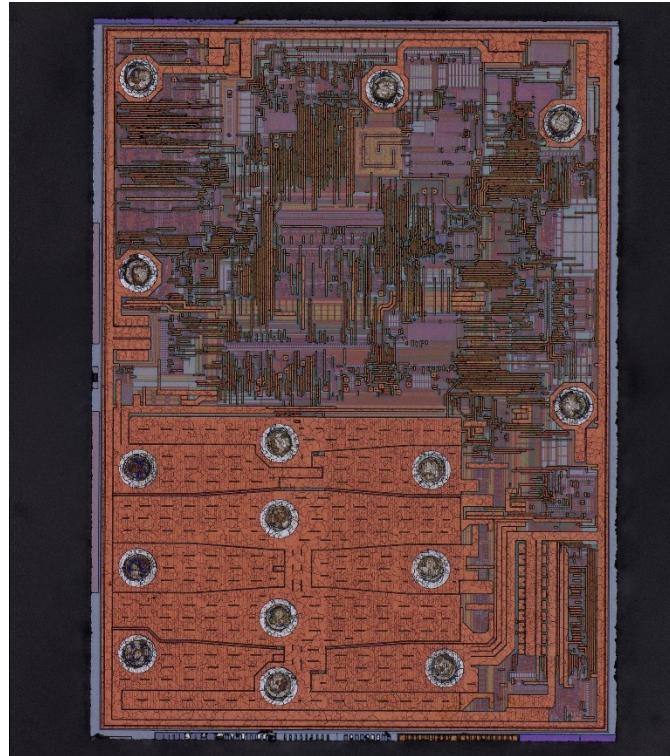
# Decap

➤ No abnormal were found on die surface after Decap.

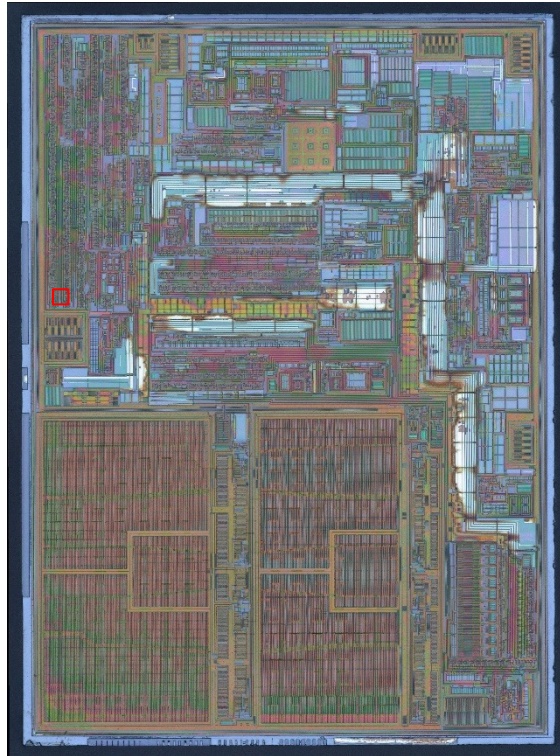
# Delayer-M1

➤ No abnormal were found on die surface after Delayer.

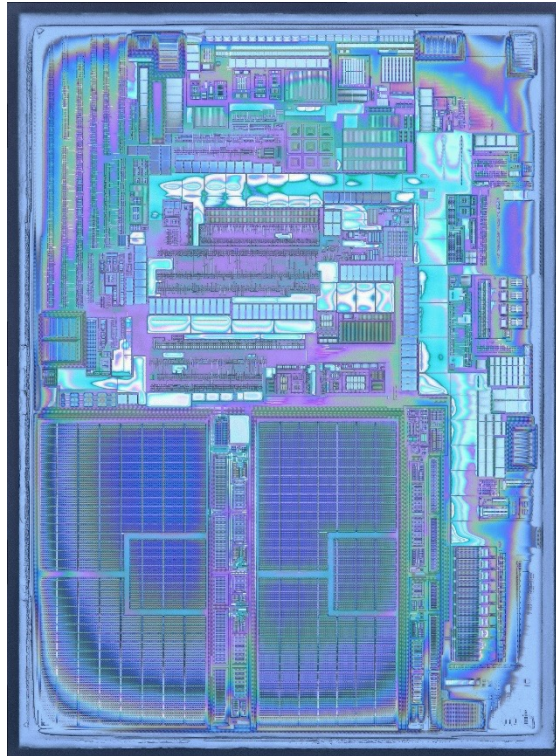
# Delayer-CT

- No abnormal were found on die surface after Delayer.

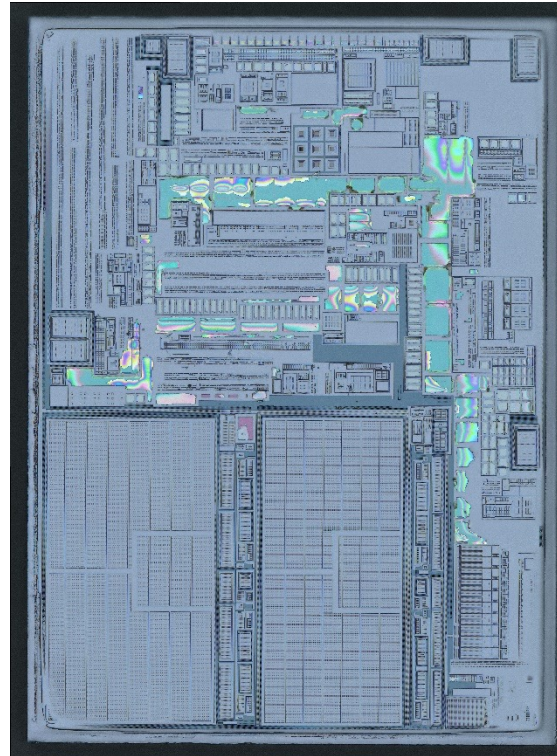
# Delayer-SUB

➤ No abnormal were found on die surface after Delayer.
