# **K18X001.00 FT2 Station Test Fail Report**

**Prepare by: PE- Loc**

**Date: Nov 12<sup>th</sup> 2021**

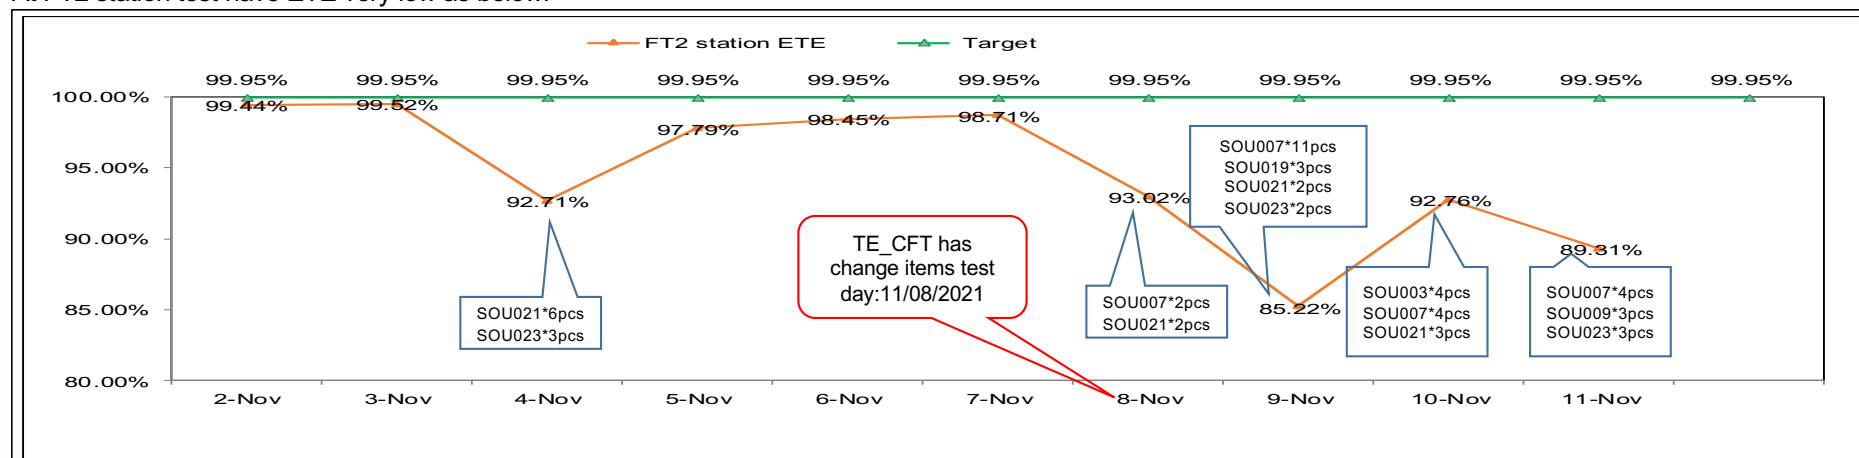
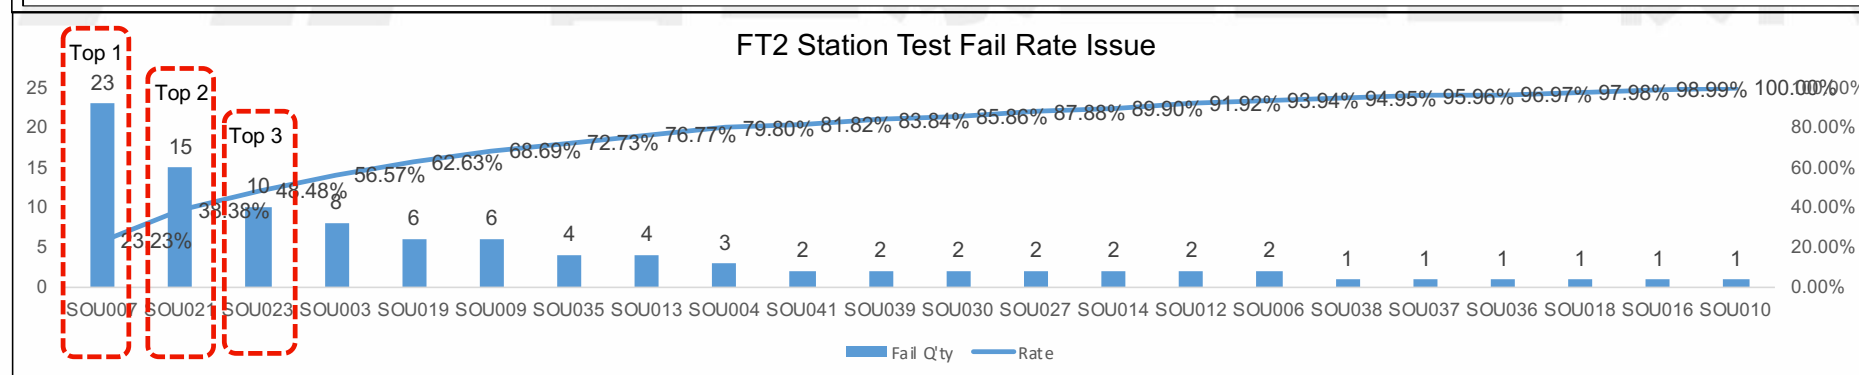
# FT2 Station ETE Yield Rate

K18X001.00 MP production 2K form 11/02/2021 to 11/13/2021. with 2 MO: 2639001581\*1297pcs, 2639001826\*499, 2639001868\*196pcs.

At FT2 station test have ETE very low as below:

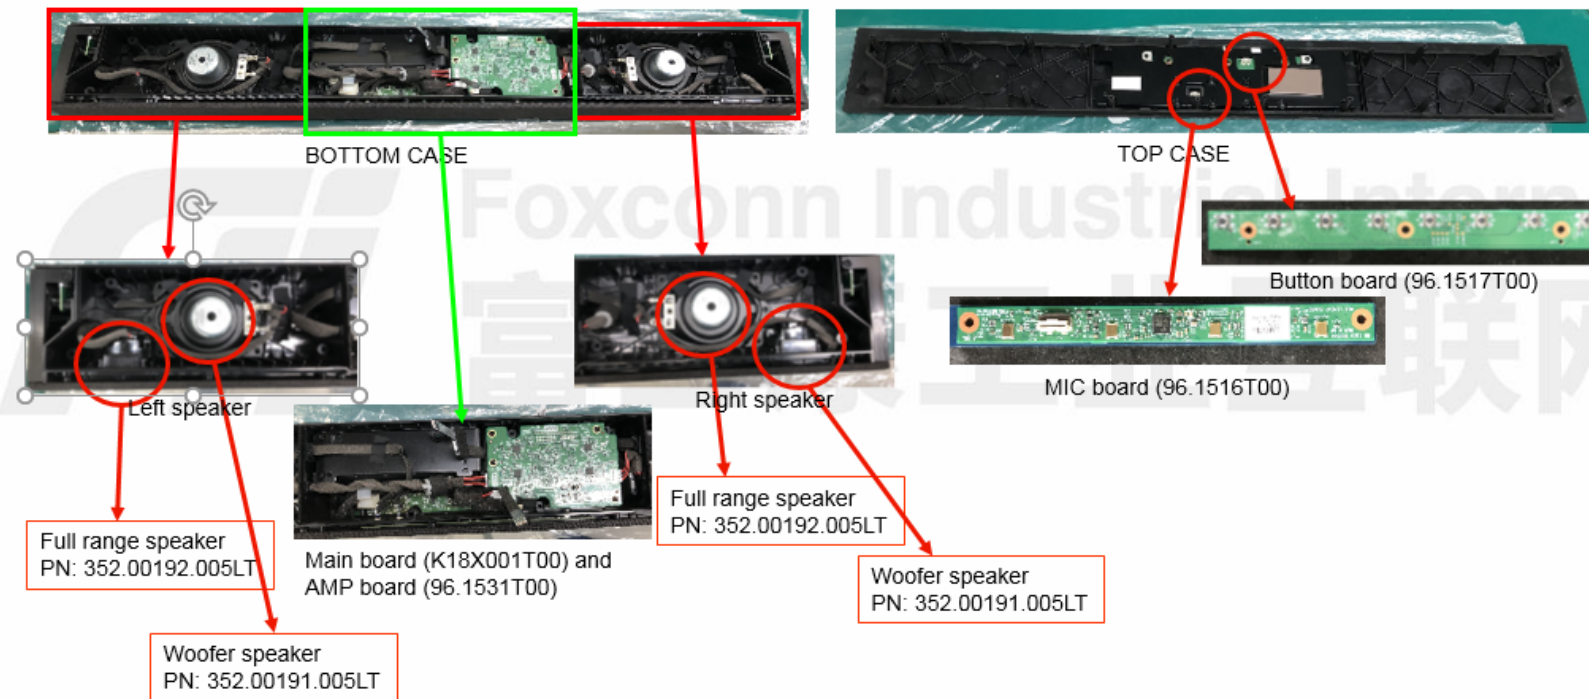
- Check visual inspection for NG boards at FT2 station as below :

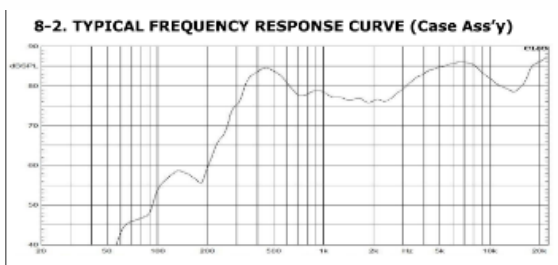
4. Check datasheet of full range speaker, PN: 352.00192.005LT, Des: SPEAKER 4+-0.6ohm 79+-3dB 8~15W GP

→ Check datasheet of full range: when case assembly have power = 85dB at frequency 8K Hz

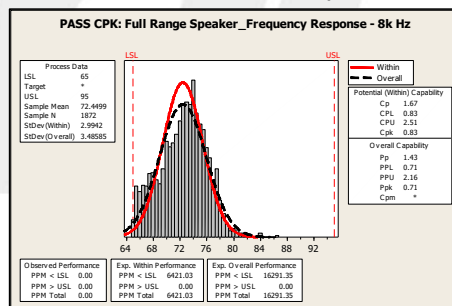
- Check CPK PASS and Fail report of Full Range Speaker\_Frequency Response – 8k Hz:

For Pass CPK , CPK = 0.83. level C. Need RD/ TE/ PE/ ME/ Sound bar vendor improvement, average pass value : 72db is less 13 db than datasheet = 85db

- Change other full range speaker (PN: 352.00192.005LT) can solve this issue but we can not confirm material issue or not
- Suggest change spec from (65, 95)dB to (54, 90)dB to improve this issue

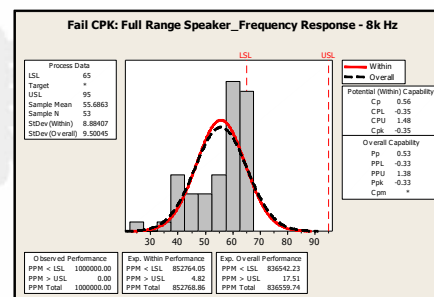
For Fail CPK data , CPK = -0.35 . Fail value from 27 dB to 64.9db

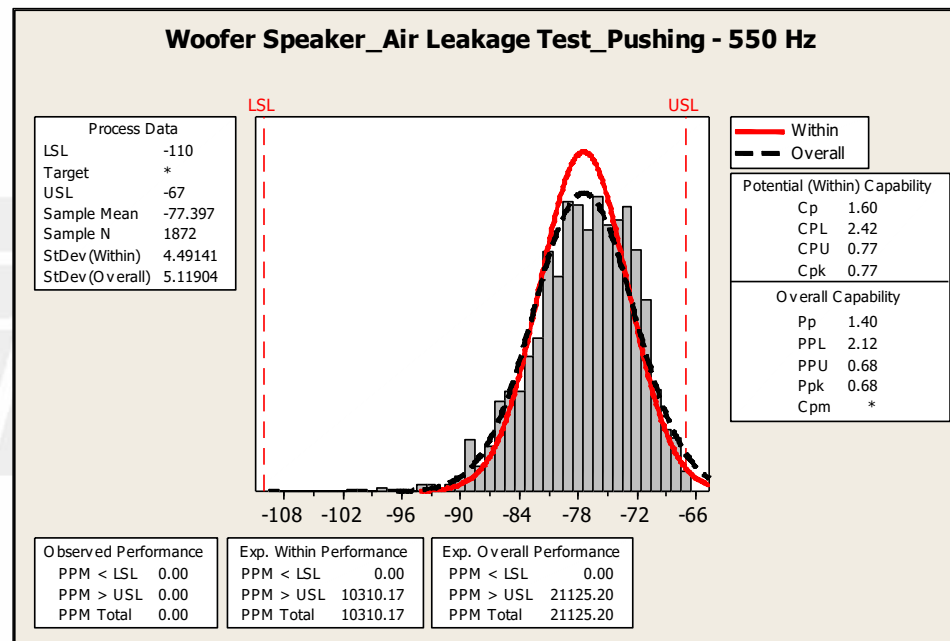
- Check CPK value of Woofer Speaker\_Air Leakage Test\_Pushing - 550 Hz

- CPK value = 0.77. level C. Need RD/ TE/ PE/ ME/ Sound bar vendor improvement, average pass value : -77.34db is higher than average of spec (-110, -67) = 11.16db
- Suggest change spec from (-110, -67 )dB to (-99, -56)dB to improve this issue
