# **Report**

## **for Oct 2021 – 1st MP**

### **BFX – UA300**

### 21-Oct, ALT customer complain [BFX-UA300] Oct 2021 1st Mass production issue.

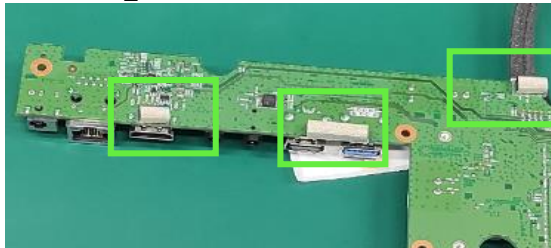
| SN | MAC | Note | 214965001.202199000013 | a893-4a7e-797f | Not turn on the LED | 214965001.202199000010 | a893-4a7e-797e | Not operation the Button | <p>1.Check production data of products detect two product was been rework cause gasket making AMP_SDA &amp; GND short issue.</p>

<p>2. Check Log test , two product pass all test station =&gt; LED and Button function still working normal before shipping.</p> <p><b>Summary:</b></p> <p>- The issue could be happen when FFC cable folding and release when rework and vibrate of product during shipping time cause damage to cable wire.</p> | <p>1.Change gasket paste location to edge of PCBA to avoid AMP_SDA &amp; GND short.</p>

<p>2. Change gasket marking on heat spreader to prevent AMP_SDA &amp; GND short .</p> | RD: Tom Lee | TBD |

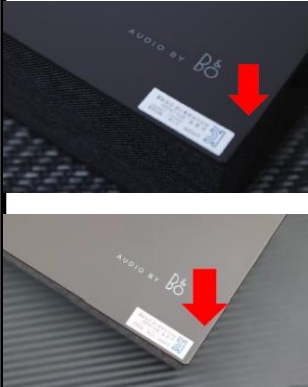
## 4. KC label attachment NG

| Issue Description | Root Cause | Actions | Owner | Due Date | Status |
|---|---|---|---|---|---|
| <p><b>KC label attachment NG</b><br/> <b>Type: Minor</b><br/> <b>Defect unit Q'ty : 2pcs / 756pcs</b><br/> <b>Defect rate : 0.26%</b></p> | <p>1. SOP define KC label adding method by using fixture but in this case, operator paste KC label manually without label fixture.</p> <p>2. VI operator was not detect the defect before put product into foam bag</p> | <p>1. Add NG picture to SOP of PACKING and VI station,</p> <p>2. SOP define KC label adding method must be 100% use label fixture.</p> <p>3. Training all OP by Quality alert customer high light inspection issue with K18 product.</p> <p>KC Label Wrong Training</p> | <p>PQE: Bien<br/> IE: Hang<br/> PD: Van Anh</p> | <p>Done<br/> 22-Aug</p> | |
