# **Final FA report of SY8824CAIC**

**Prepared by Silergy Corp.**

**CSIM-202209015**

**2022/09/14**

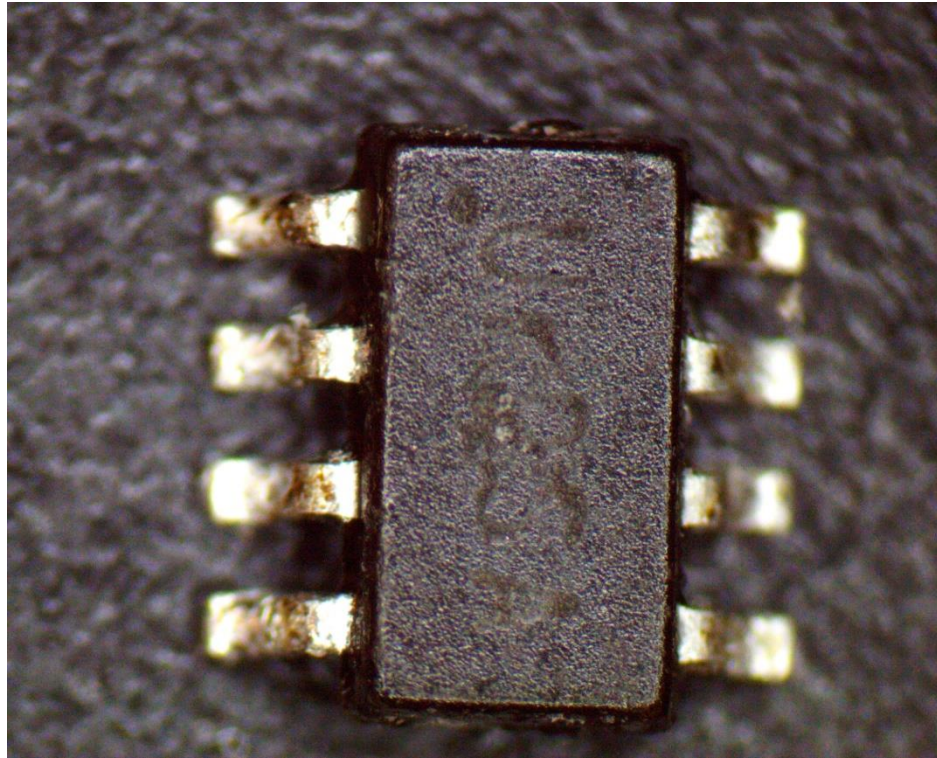
➤ No abnormal was found at the top surface of package.

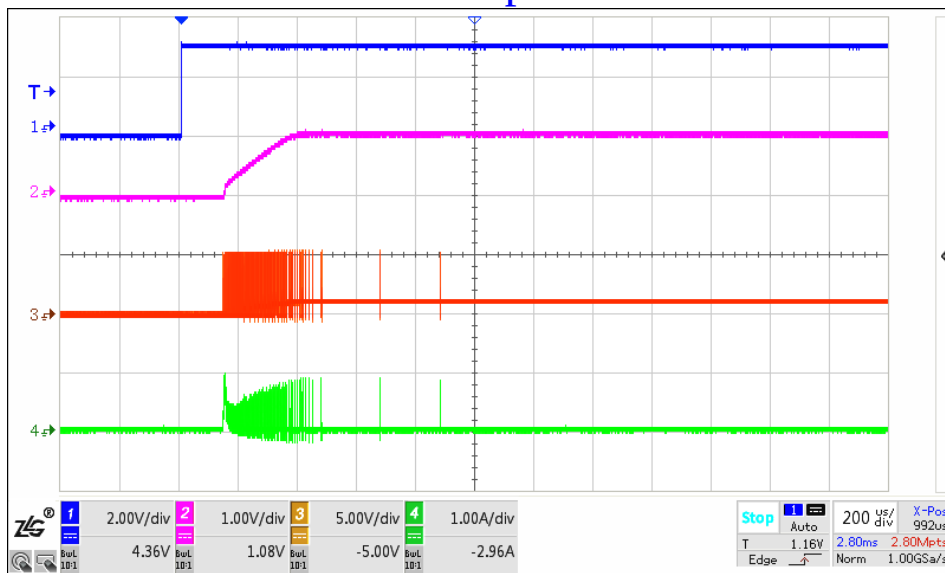
FA Chip#1

OK

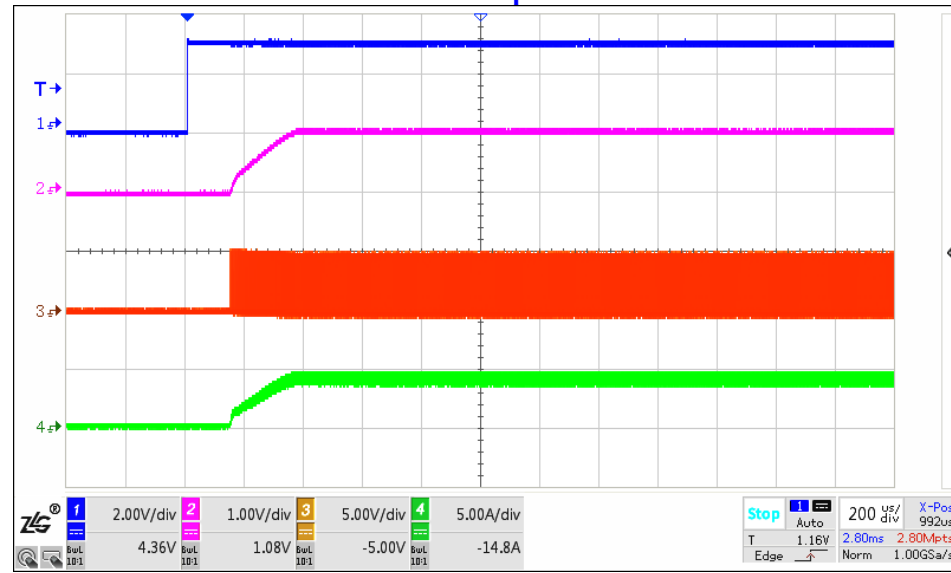
FA Chip#1

OK

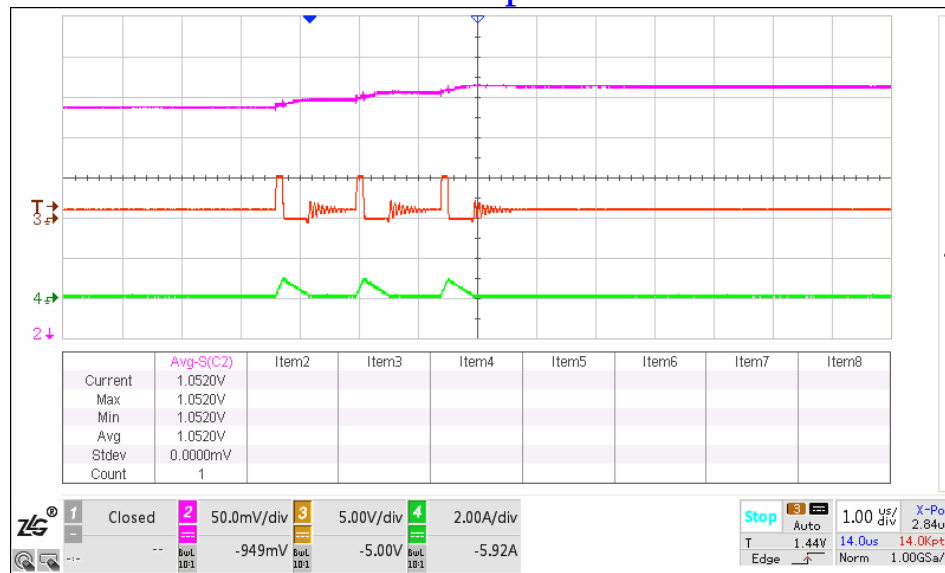
## FA Chip#1

OK

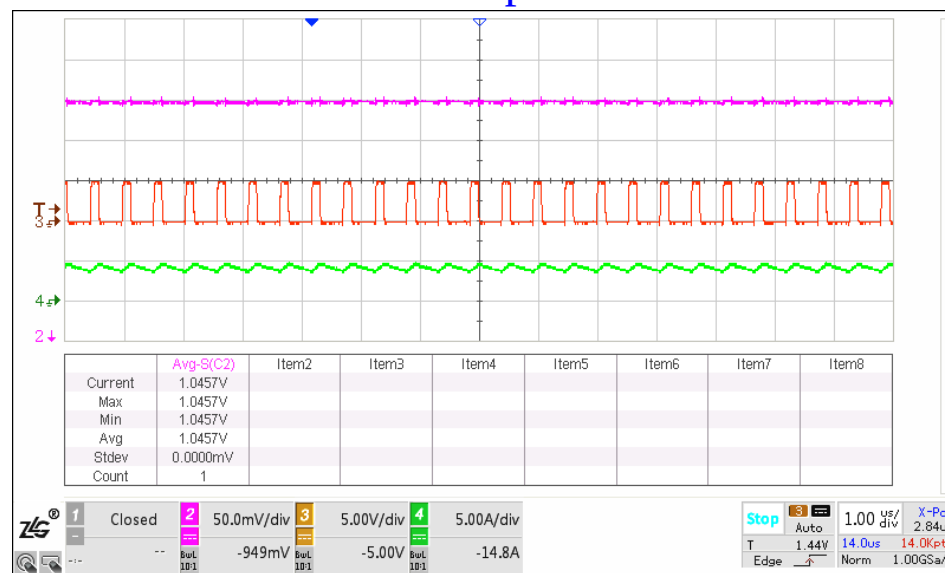
## FA Chip#1

OK

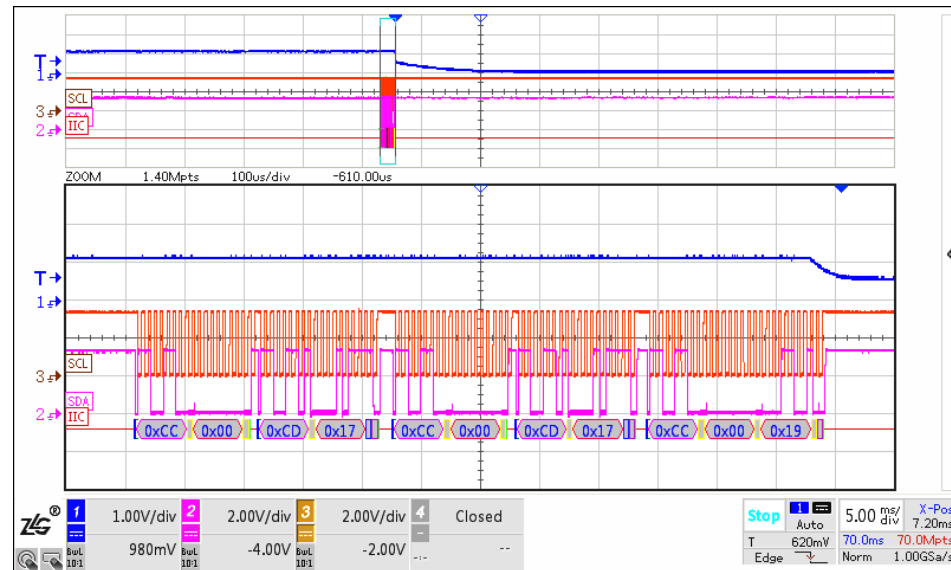
FA Chip#1

#1's I2C read function is fail.

Read Data: 0x17, wrong;  
Write Data:0x19, Buck\_EN OFF, IC shutdown.

For FA chip #1, I2C master wrote a data 0x19, which makes IC soft-ware shutdown.

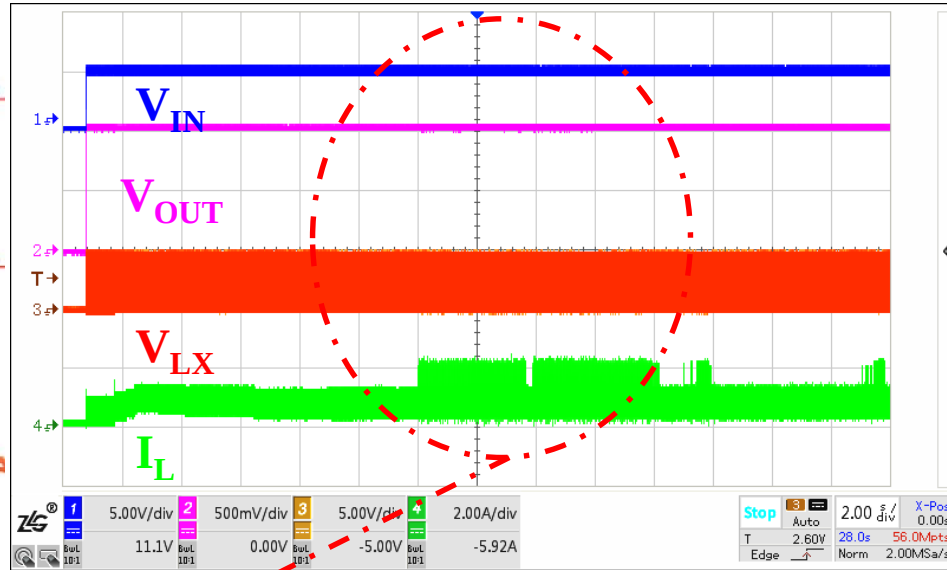
Cut the wire of SDA to prevent transfer path from I2C master to SY8824C.

If cutting off the wire of SAD, SY8824C will not shutdown.

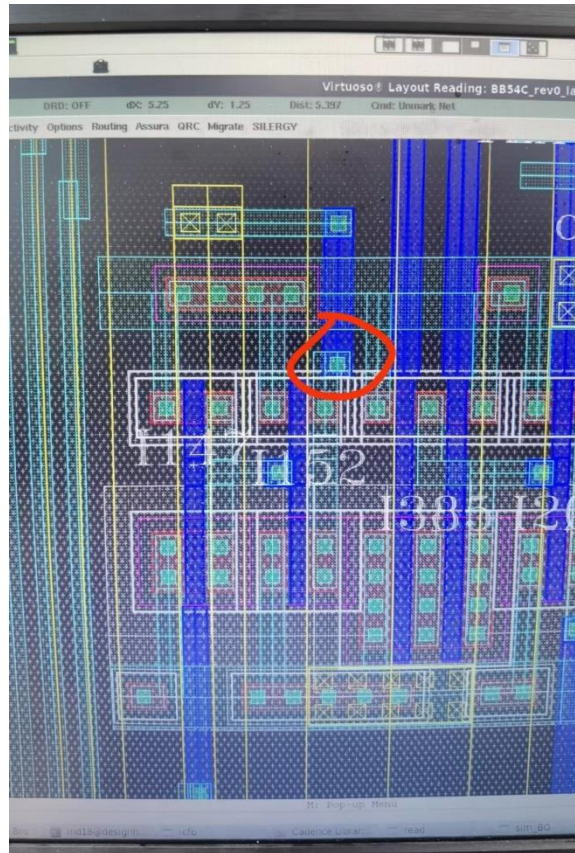
➤Returned #1  $I_{152}$  下拉增大, delay增强, 导致 read function 错误。

➤ From above analysis, returned #1 was damaged by EOS event .
