# Swan\_soundbar DVT3 soldering review

ALT Co., Ltd.

Issued Date 2021.08.30

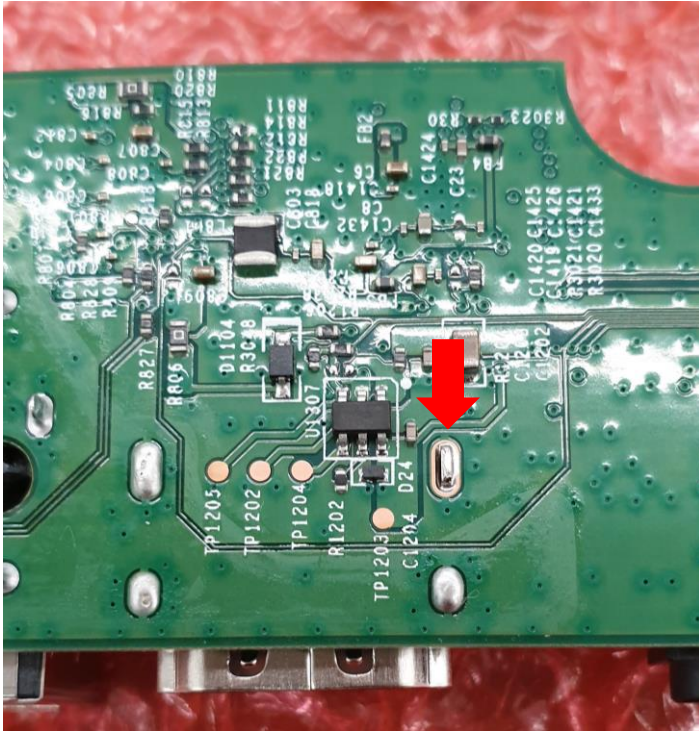
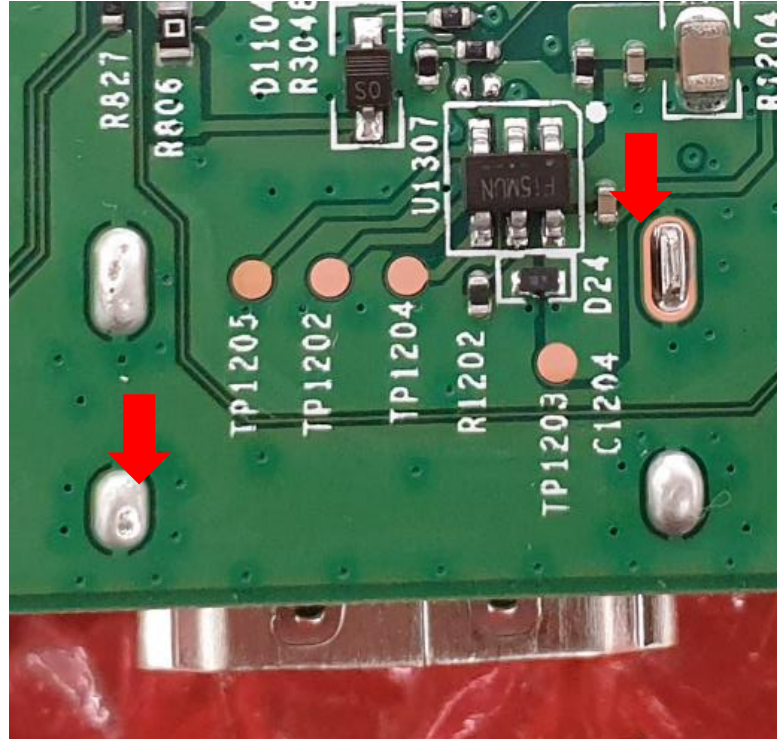
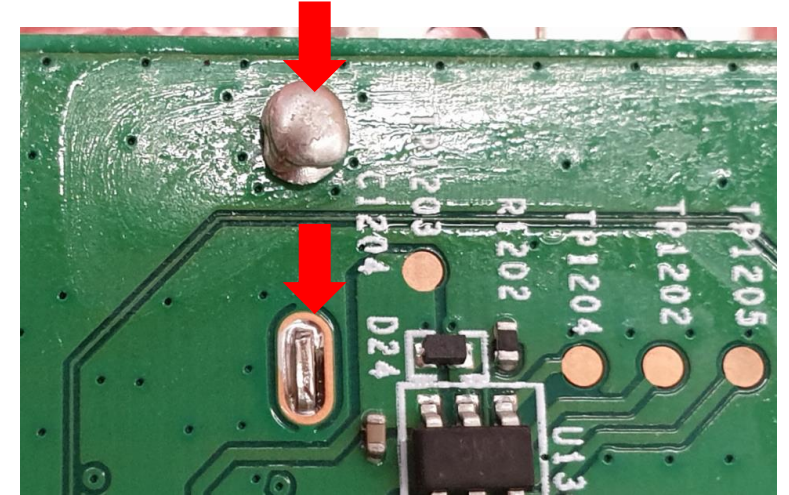
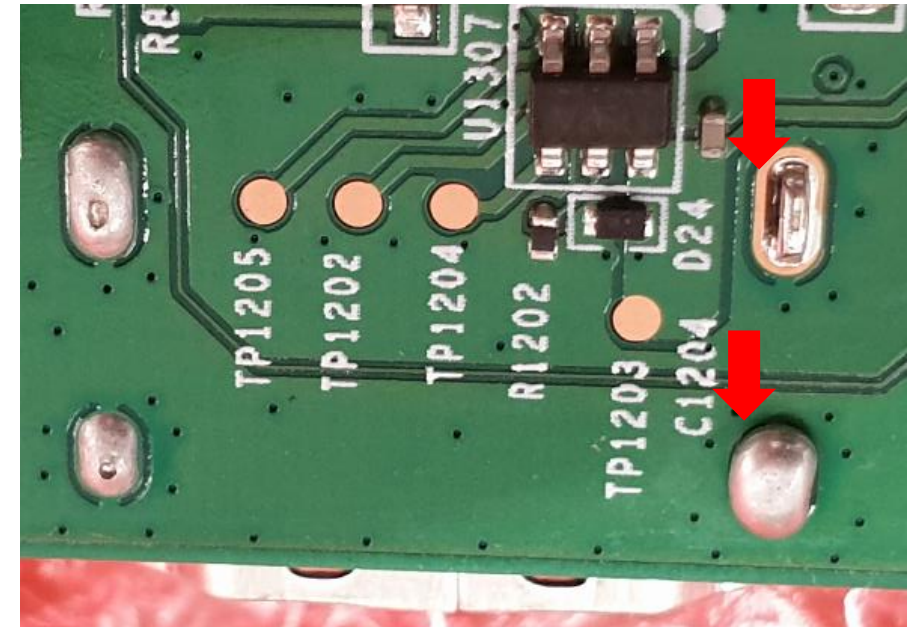
# • SoC PCBA - Defect

- GND PIN not fully fill up - Defect.
  - 100%
- GND PIN soldering defect - lump of solder
  - 80%

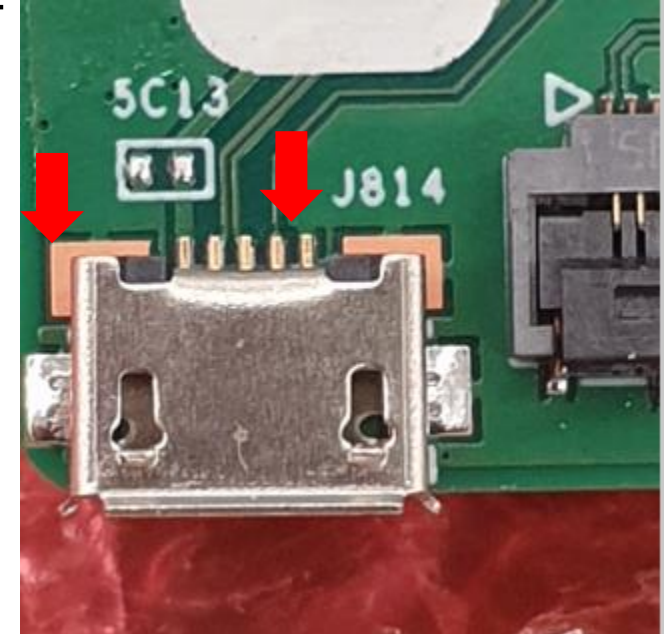
# • AMP PCBA - Defect

- GND PIN not soldered.
  - 100%
- GND signal pin lack of solder
- Metal mask design must be updated
  - Report the before / after metal mask design for J814

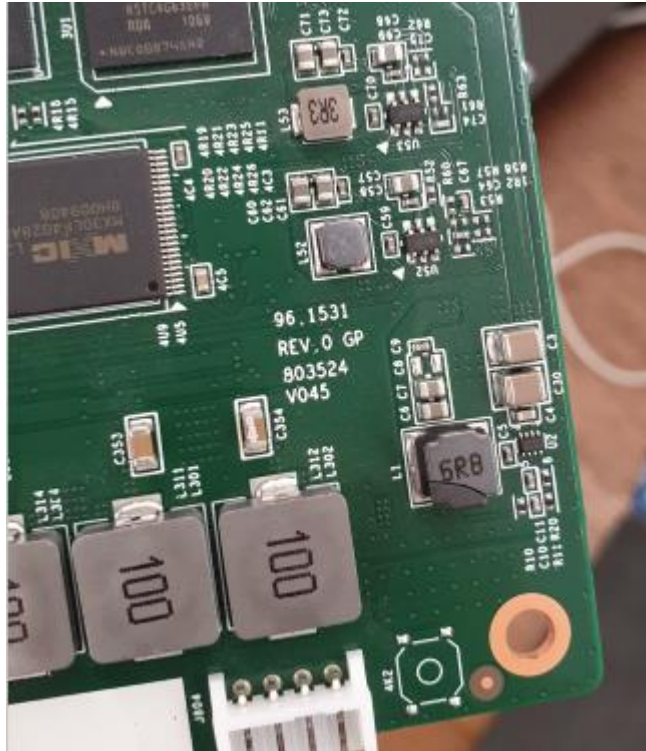
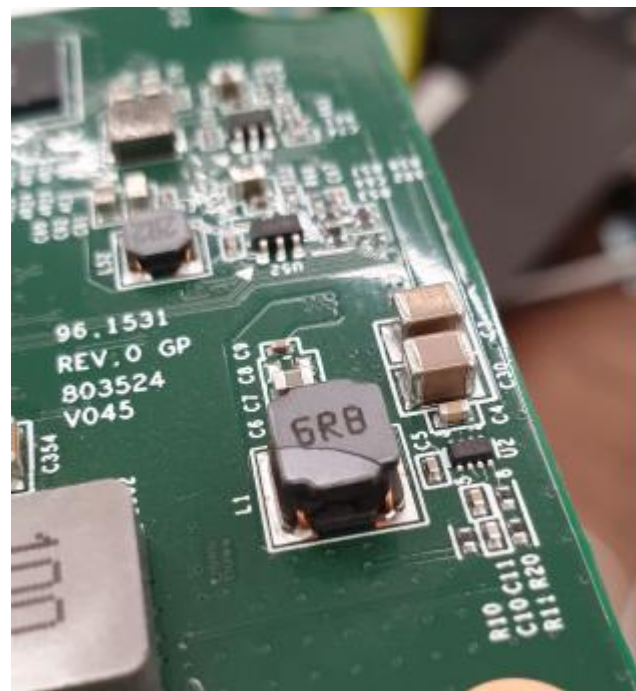
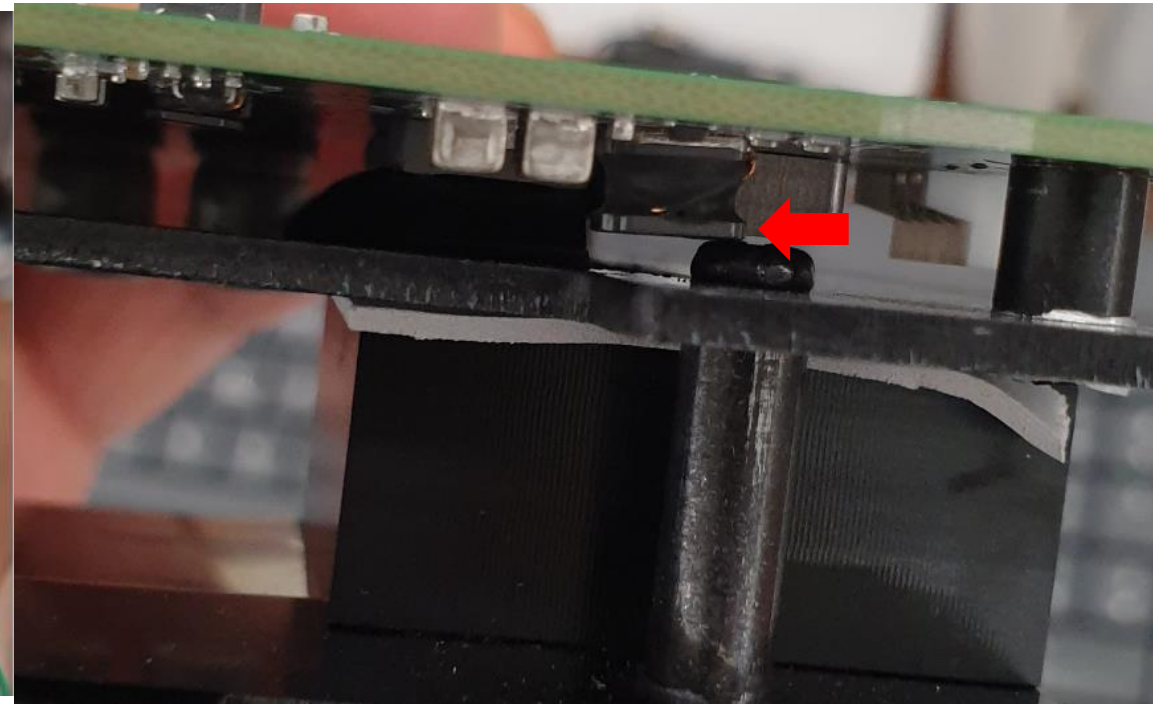
- AMP PCBA - Defect

- Inductor L1 broken
  - 100%
  - Touched with heat spreader
