# Swan\_soundbar

## DVT3\_Assembly review

Issued Date 2021.08.30

Ver.1.0

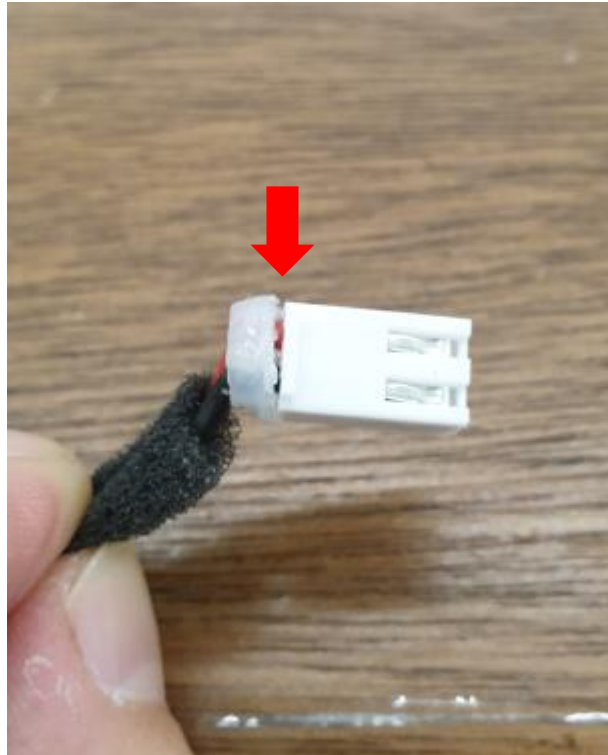
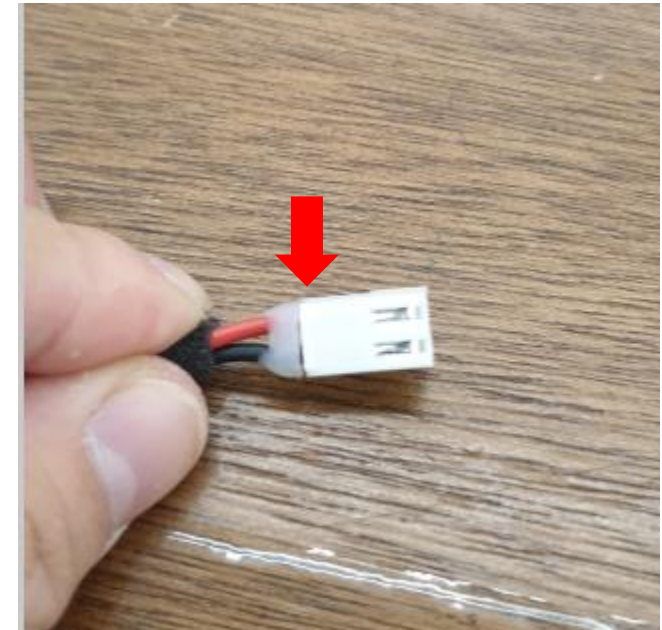
- The glue of amp power cable / power cable
  - DVT3 is applied hot melt type. But it is cracked after assembly.
  - Recommend to use "DOWSIL\_7091"

Minor

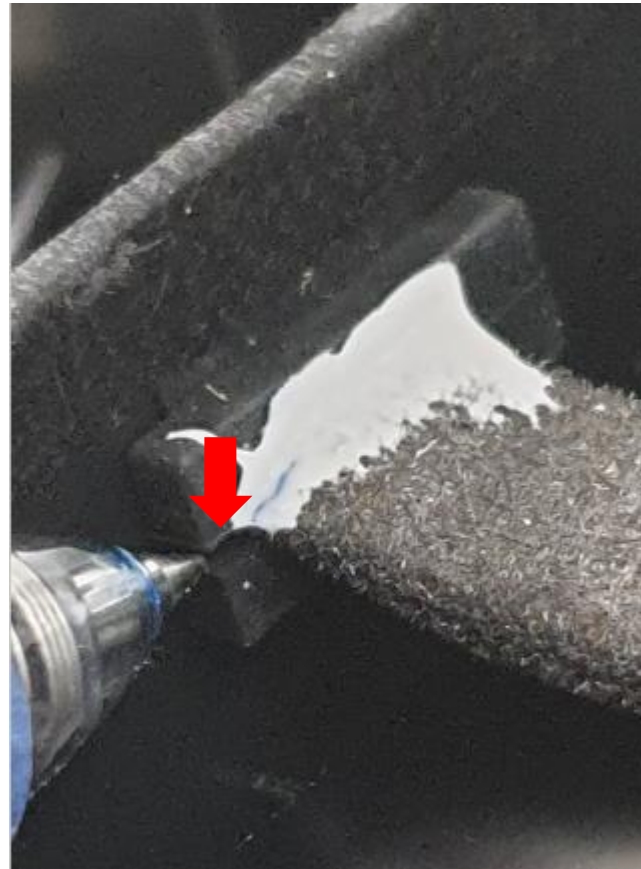
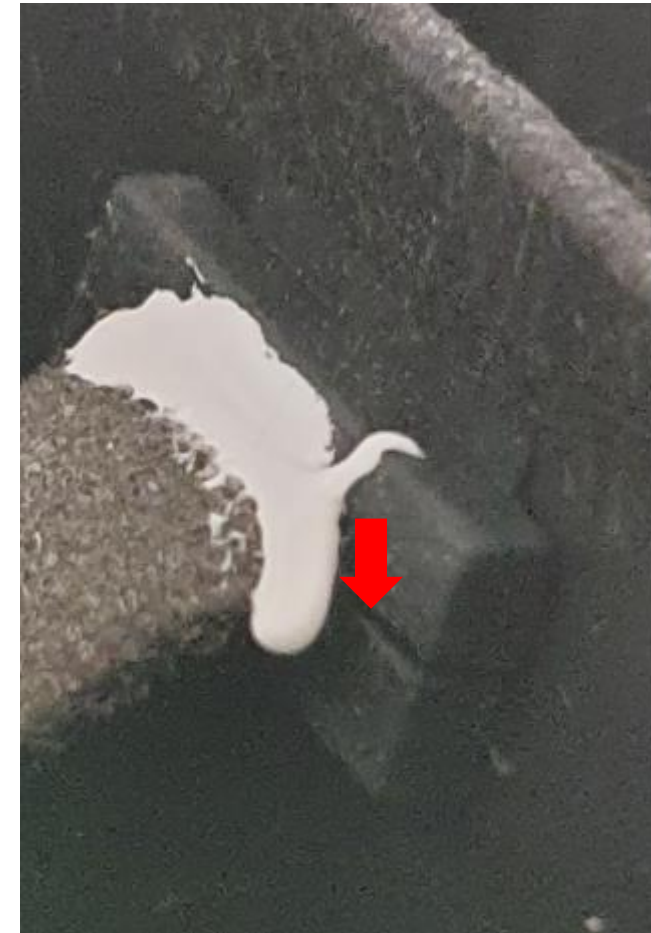
- Glue apply defect

Critical

- Recommend the Change glue materials : DOWSIL\_7091

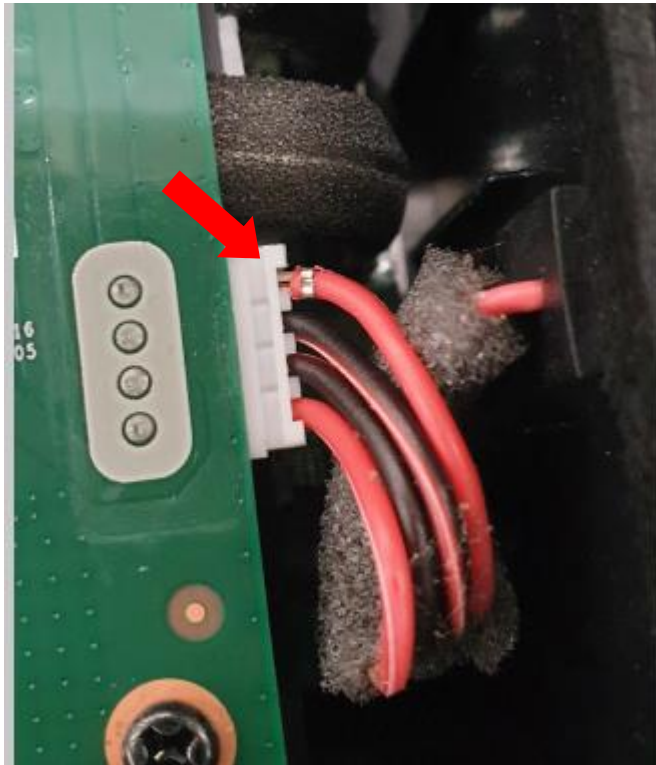
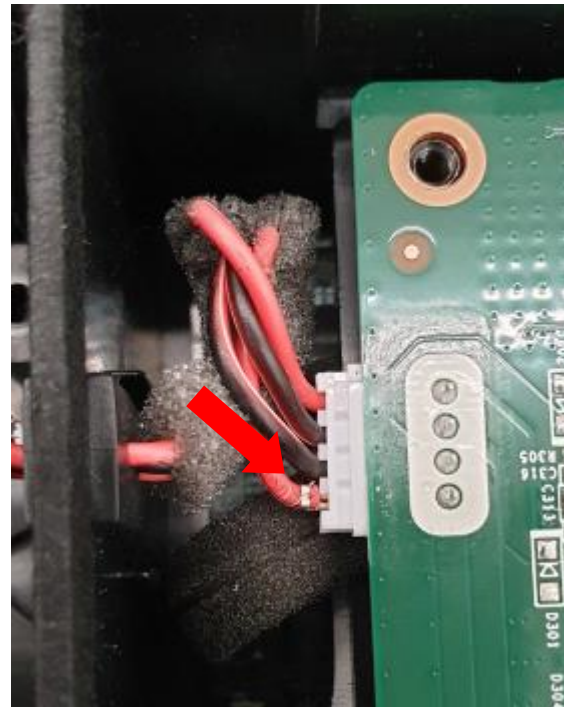
- Please tug test on IQC
  - From 1<sup>st</sup> MP to 15K production
  - Due to cable pin reworked.

Critical

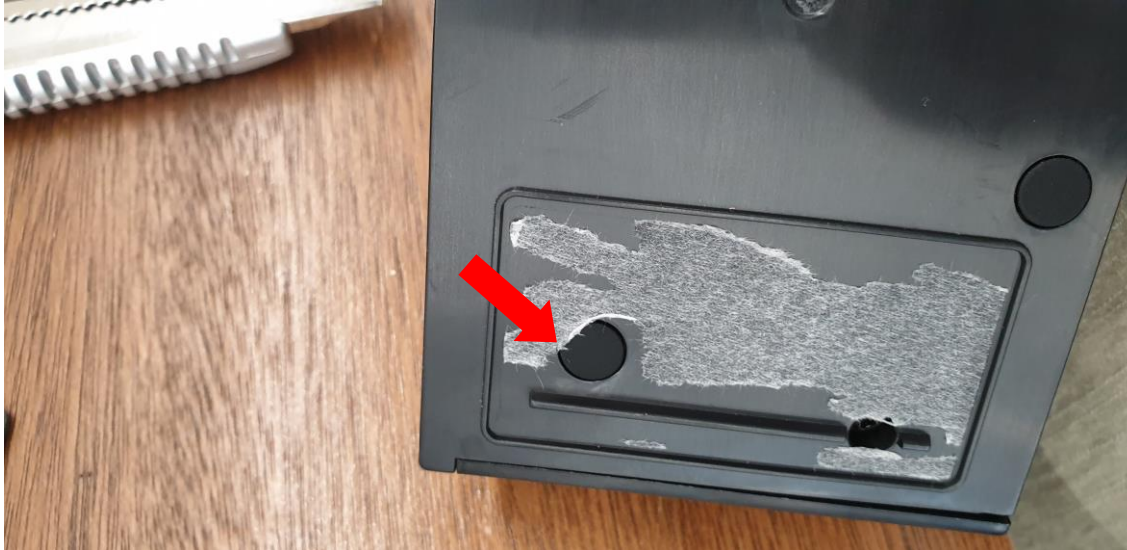
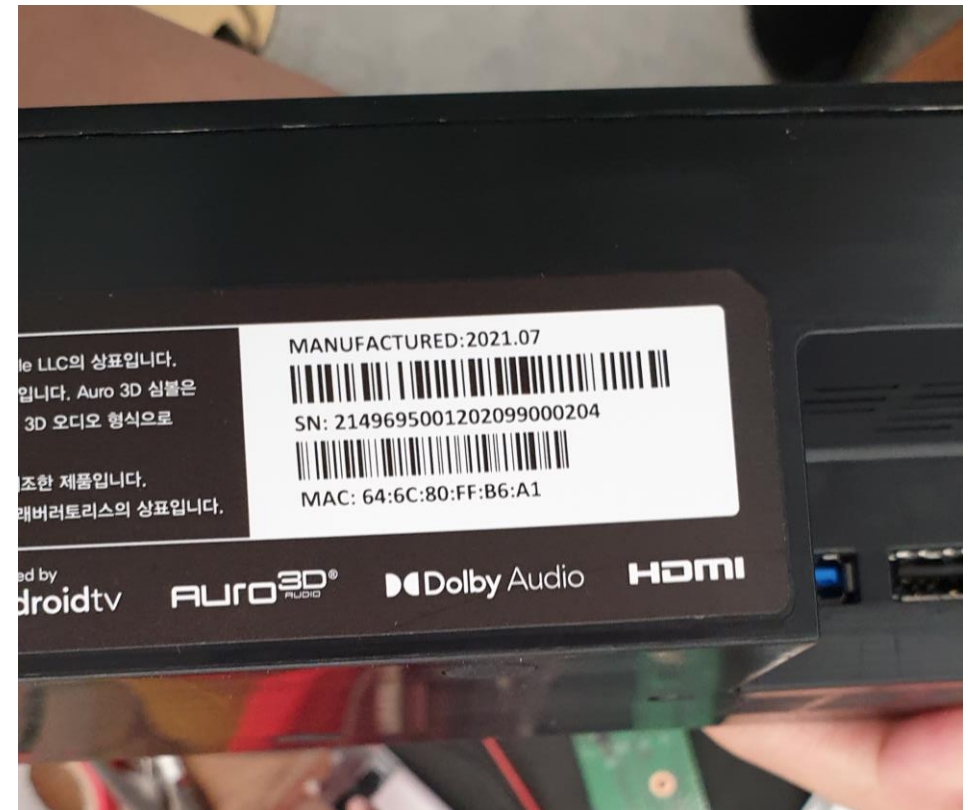
- Screw cover assembled under foot

Minor

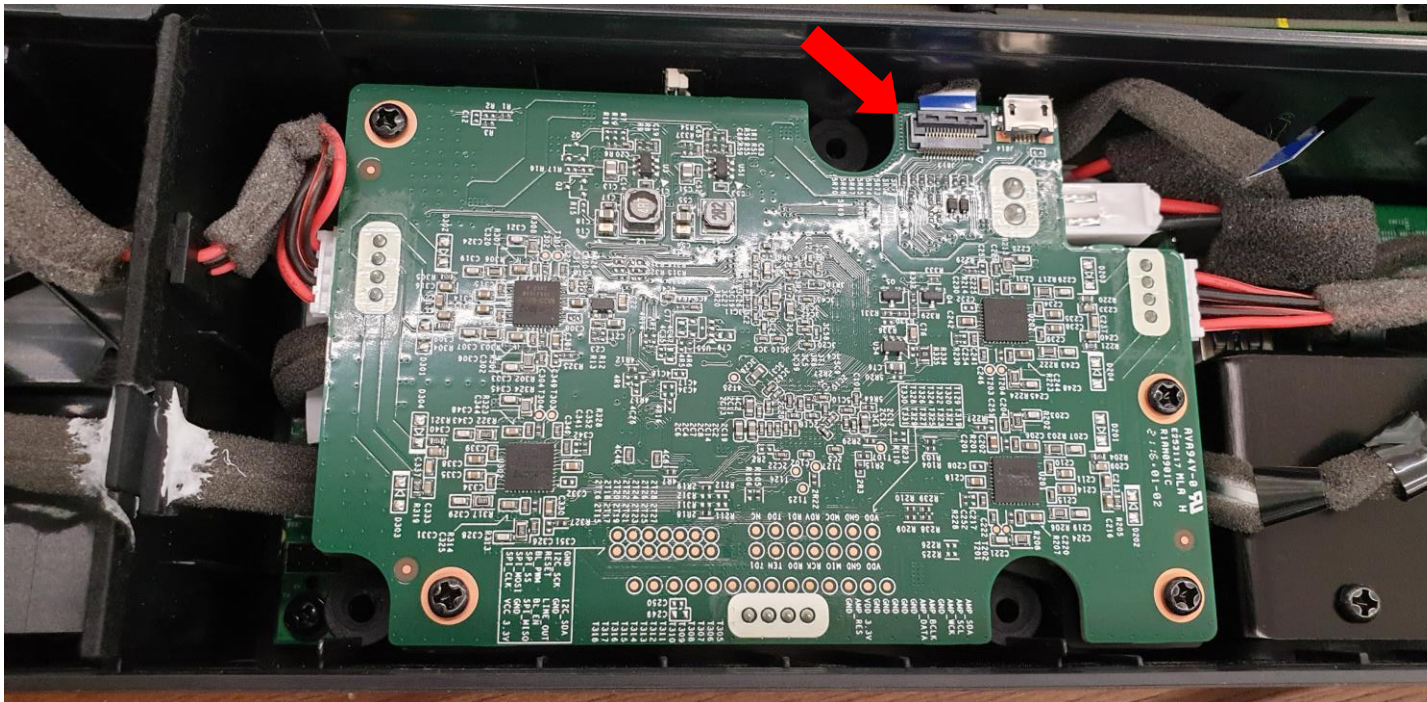
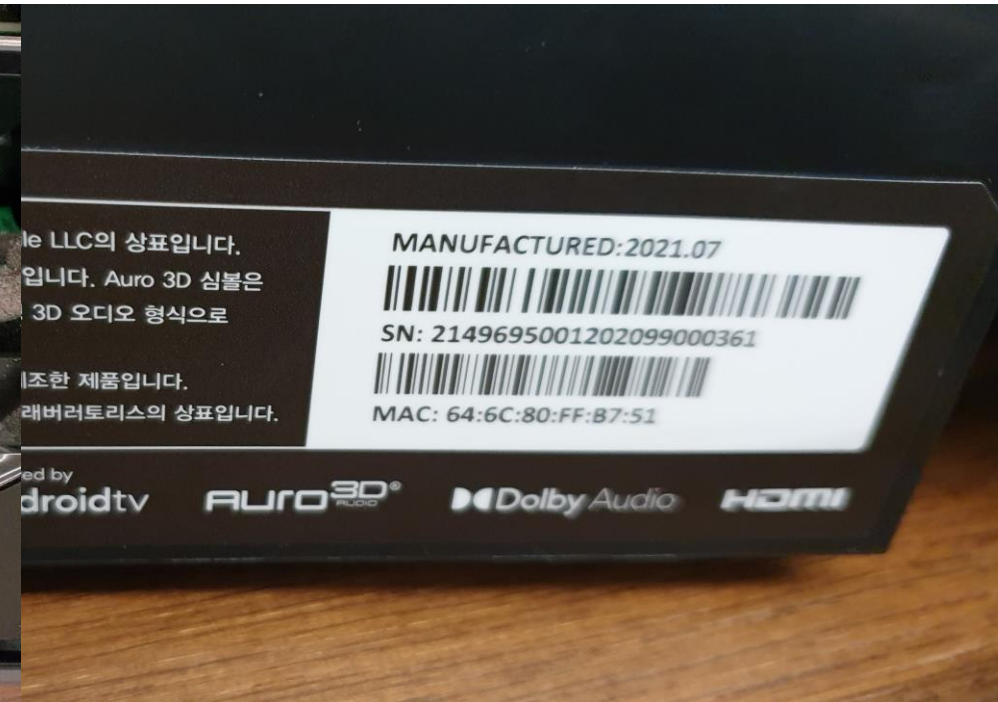
- Tape missing on the FFC connector

Major

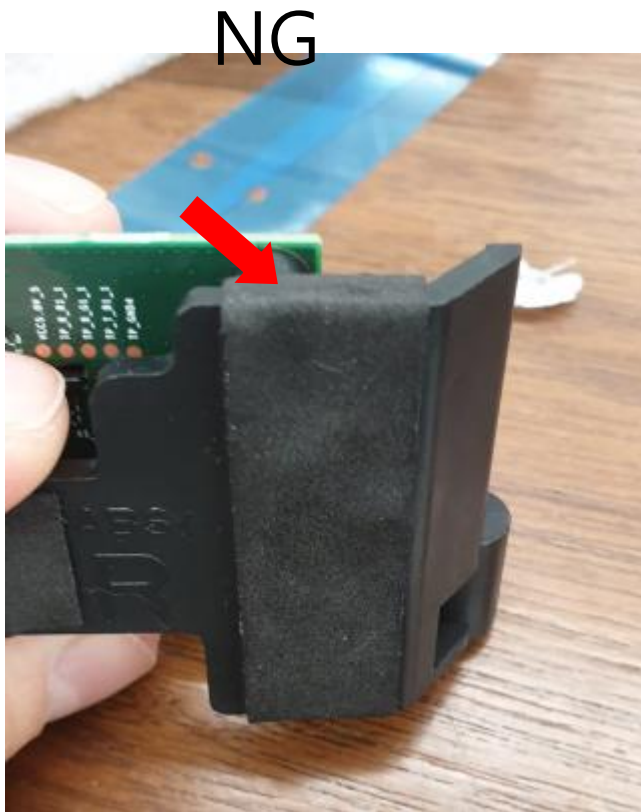
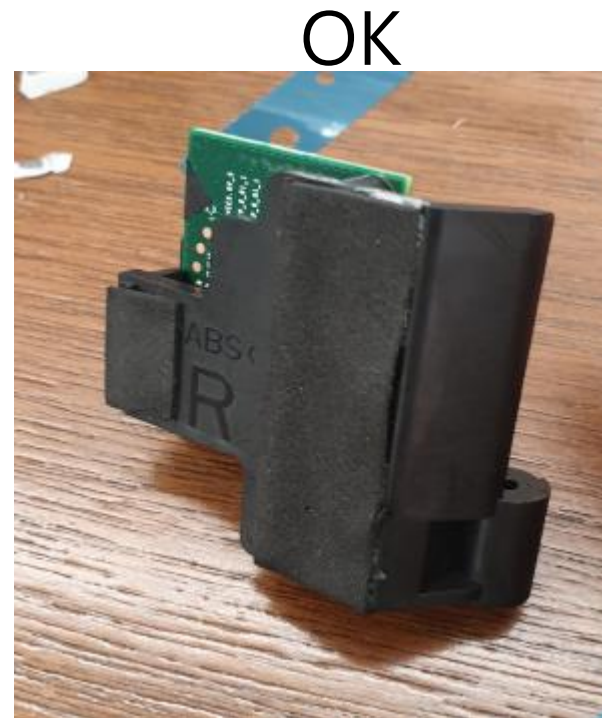
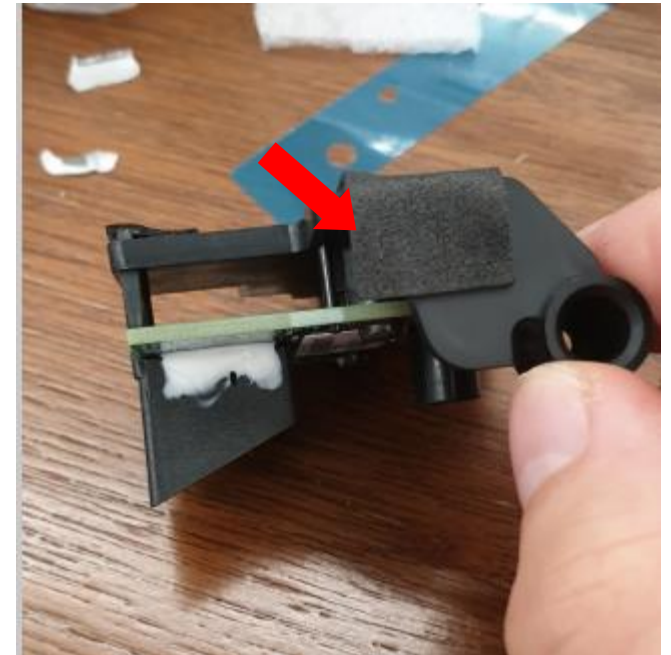
- Gasket attachment NG
  - Gasket should be cover bottom side

Major

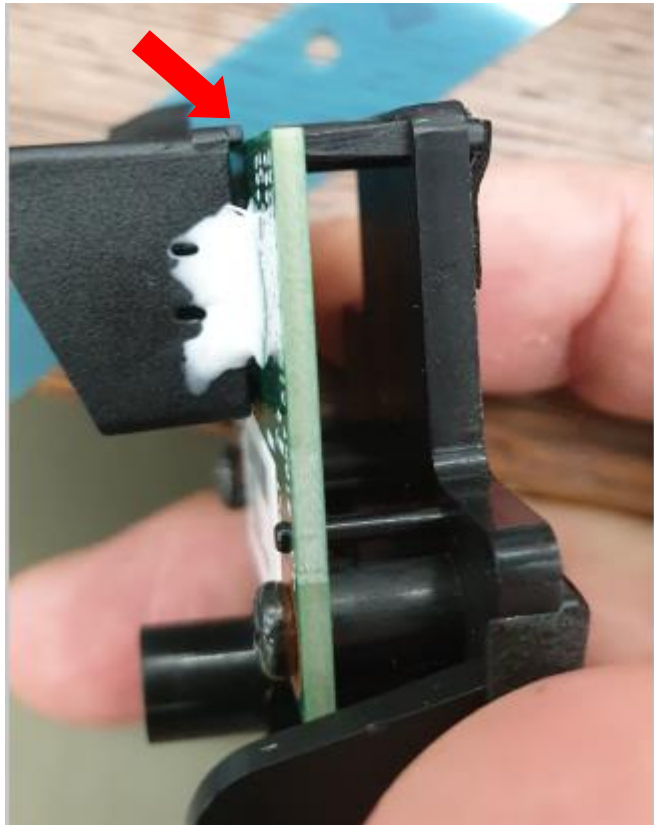
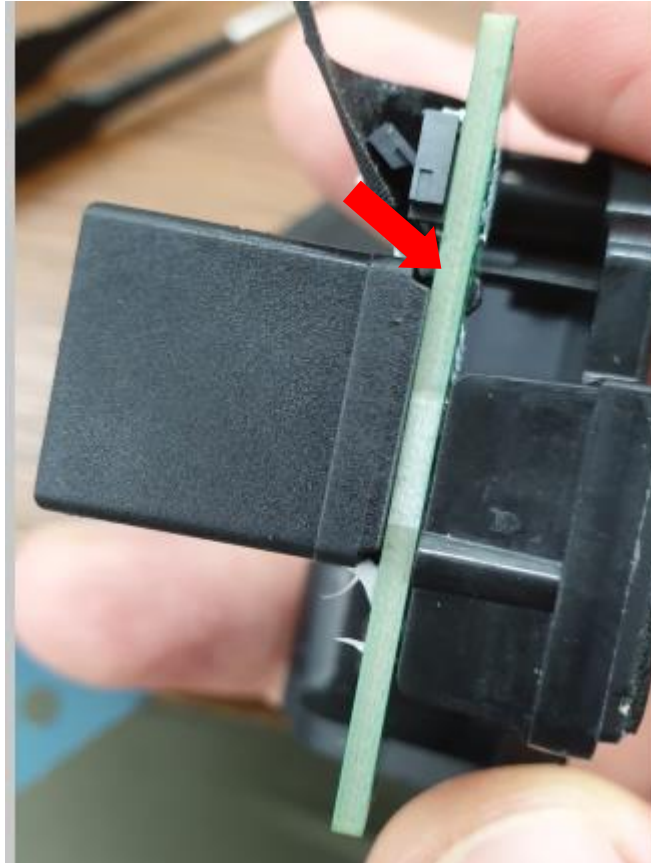
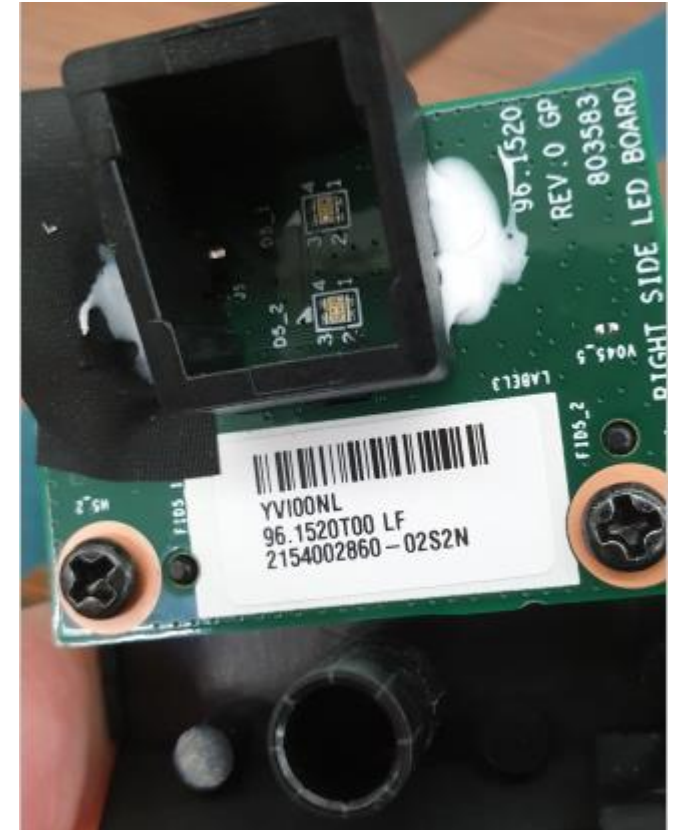
- Light pipe assembly NG
  - Light pipe is not fully inserted.
  - Not detected next operation – apply glue

Minor

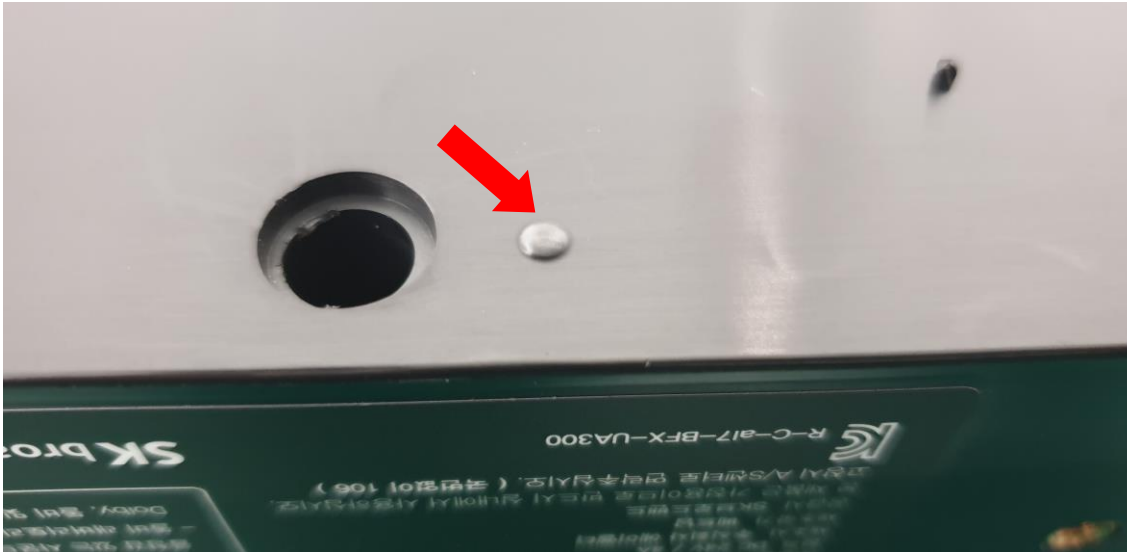
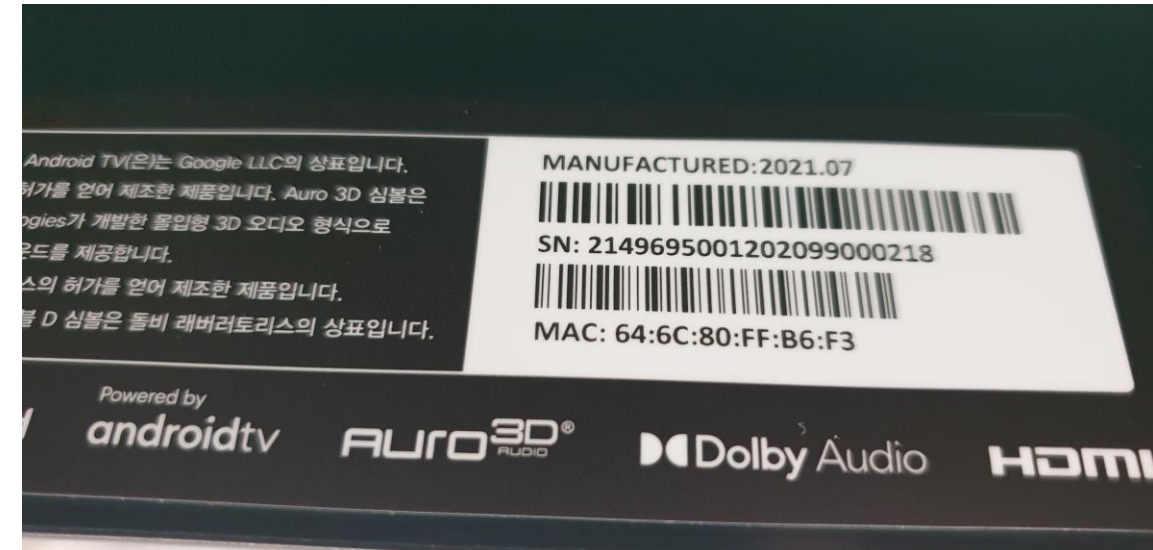
- Wrong screw assembly
  - Damage the bottom housing
  - The screw should be apply M3\*7
  - But assembled M3\*10 screw

Major

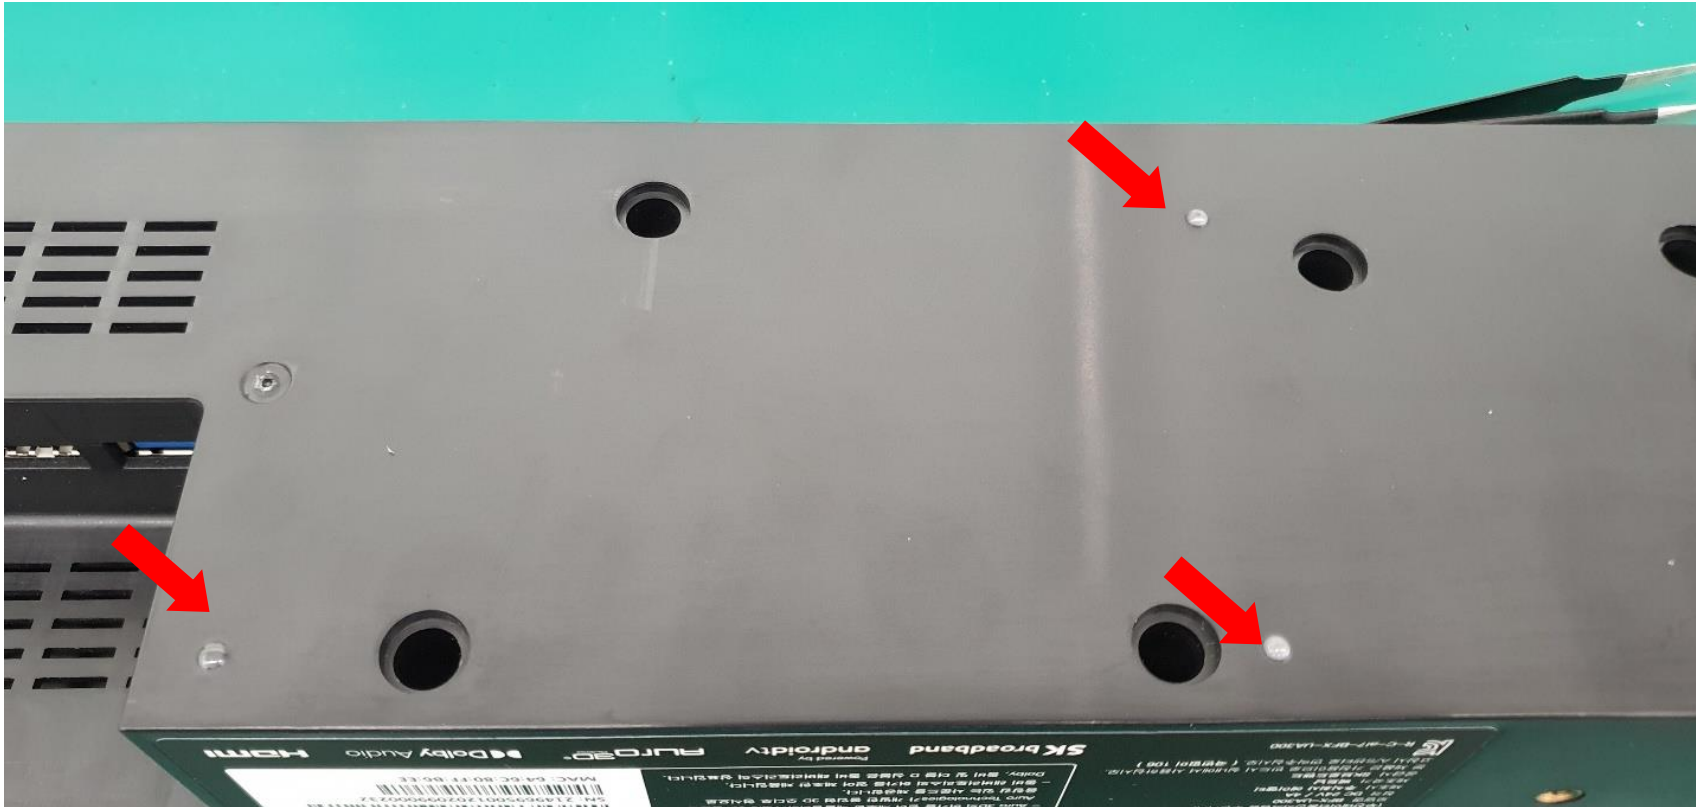
- Wrong screw assembly
  - Damage the bottom housing
  - The screw should be apply M3\*7
  - But assembled M3\*10 screw

Major

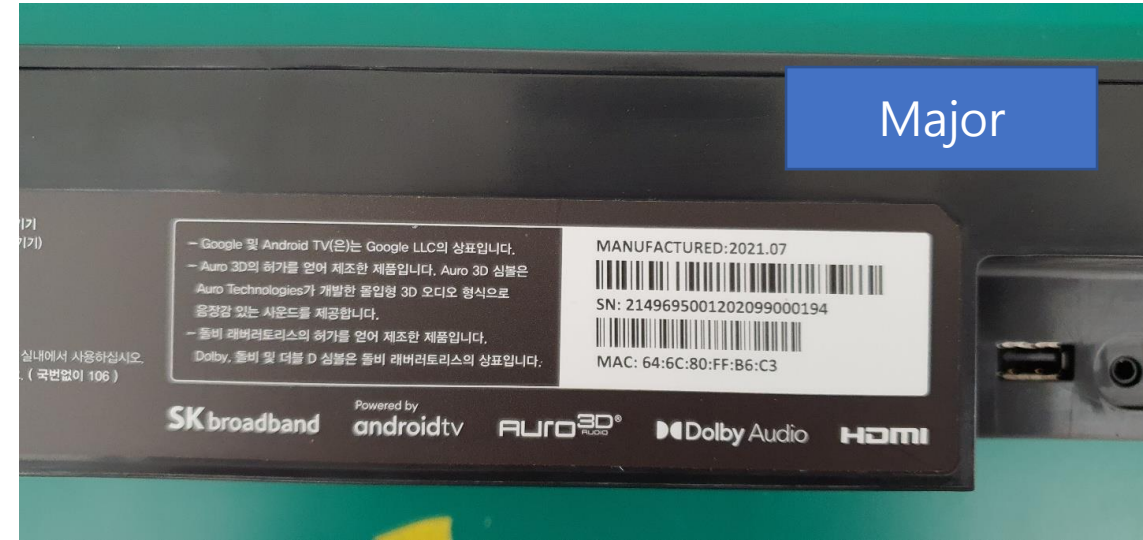
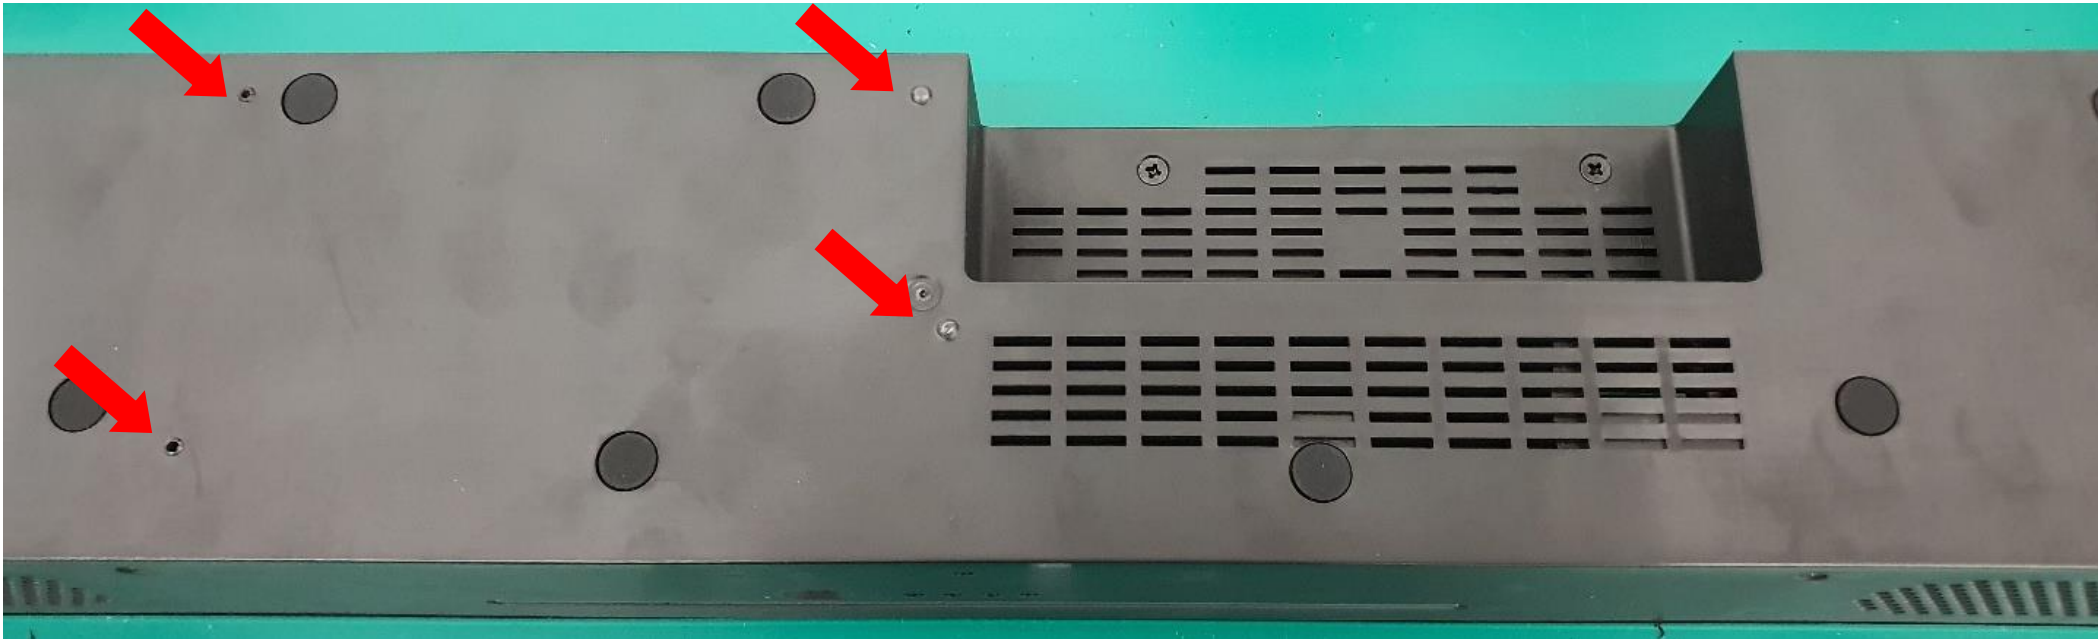
- Wrong screw assembly
  - Damage the bottom housing
  - The screw should be apply M3\*7
  - But assembled M3\*10 screw

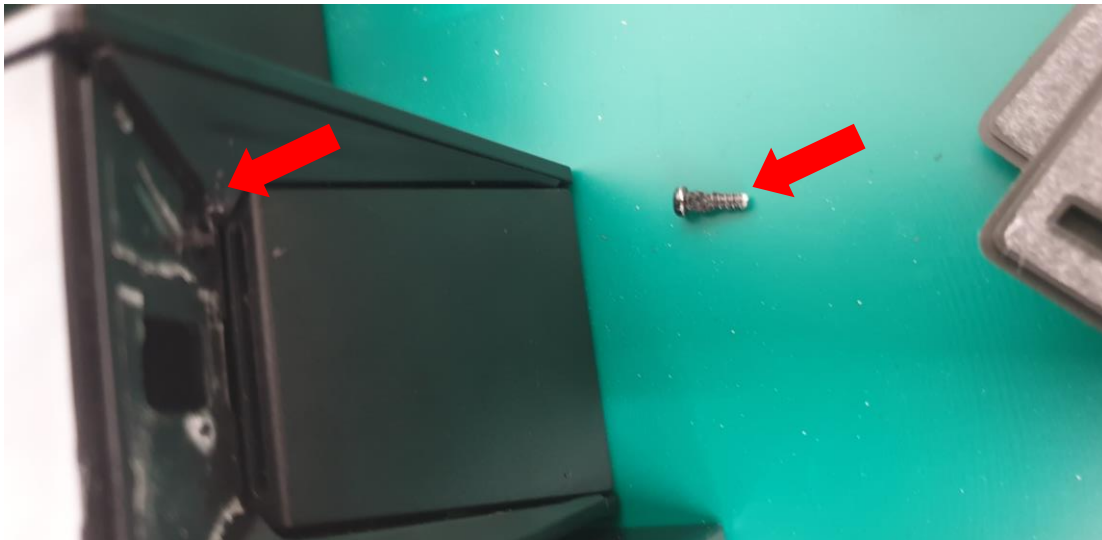
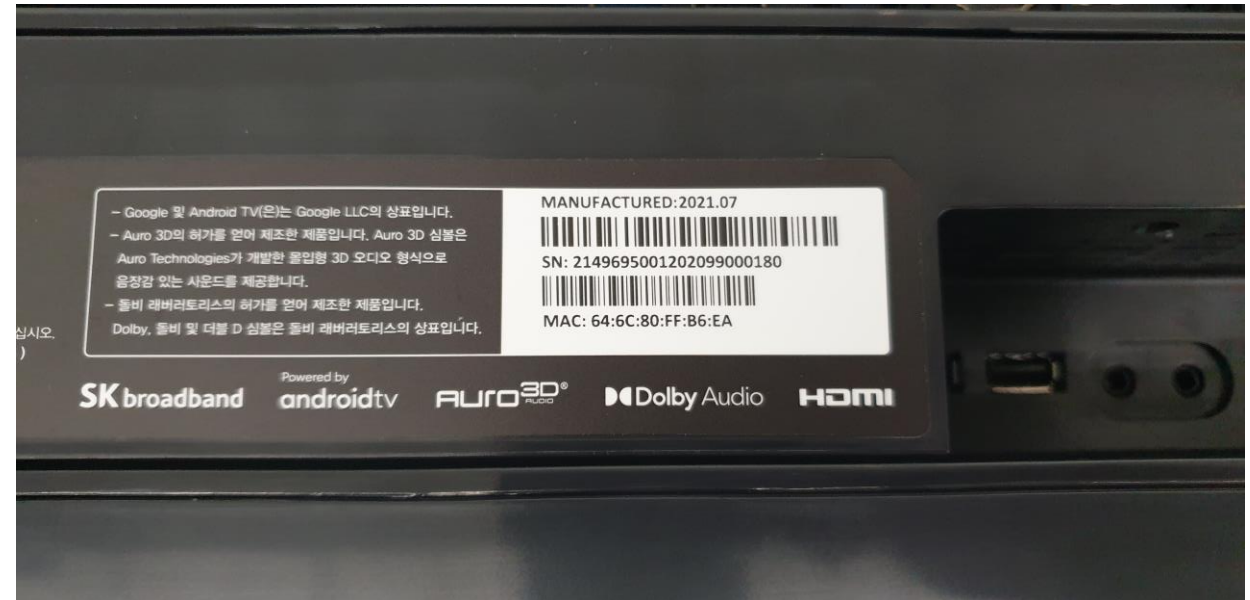
- Wrong screw assembly
  - The screw should be apply M3\*7
  - But assembled M3\*10 screw

Major

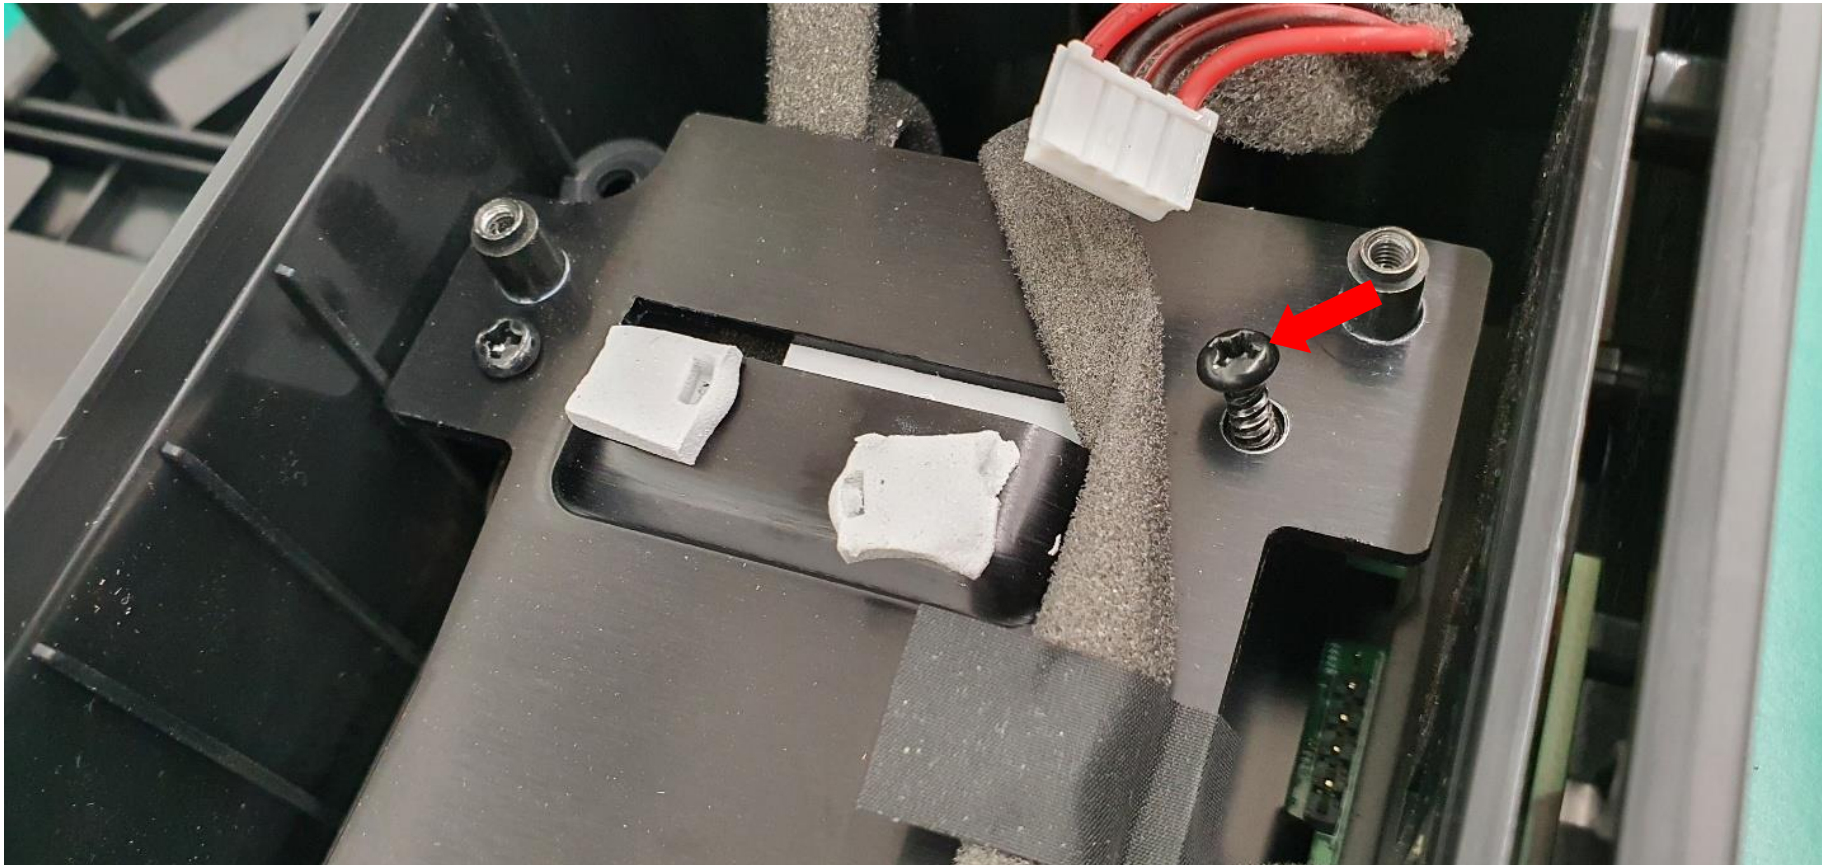
- Wrong screw assembly
  - assembled with the wrong type screw

Major

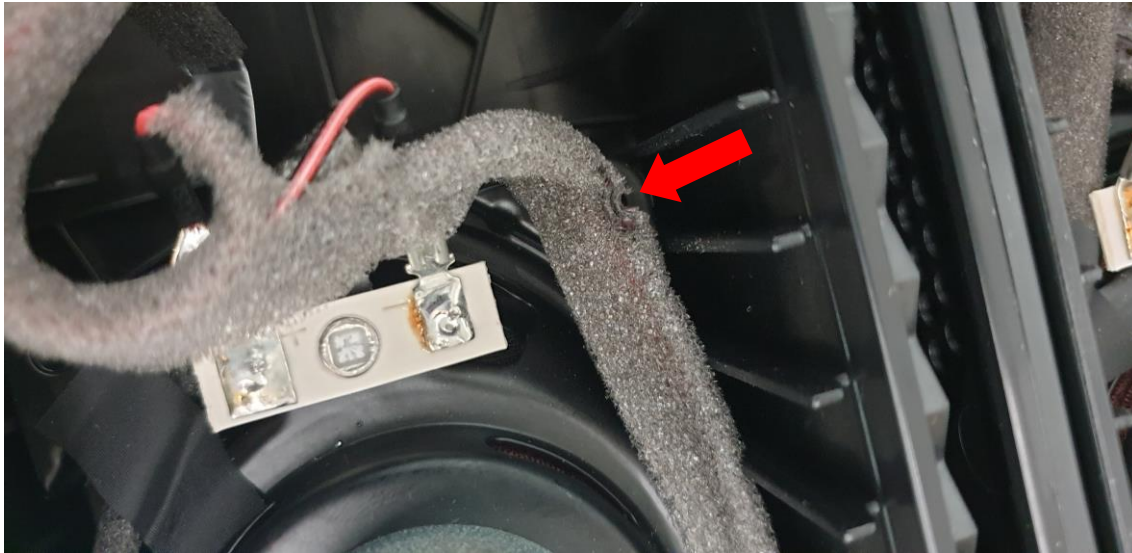
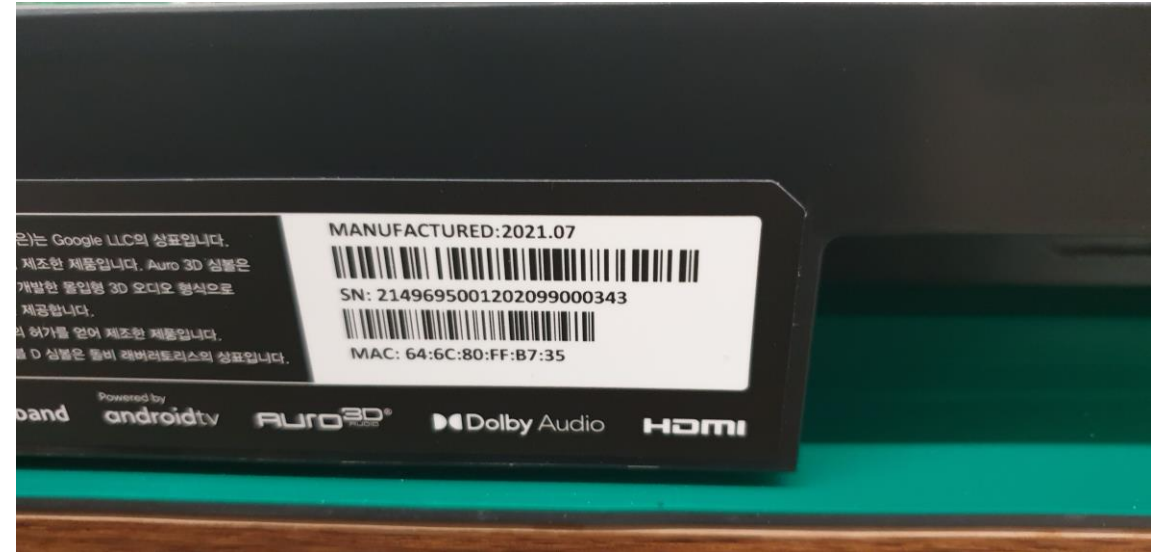
- Cable routing defect

- The cable is damaged due to screw lock up

Critical

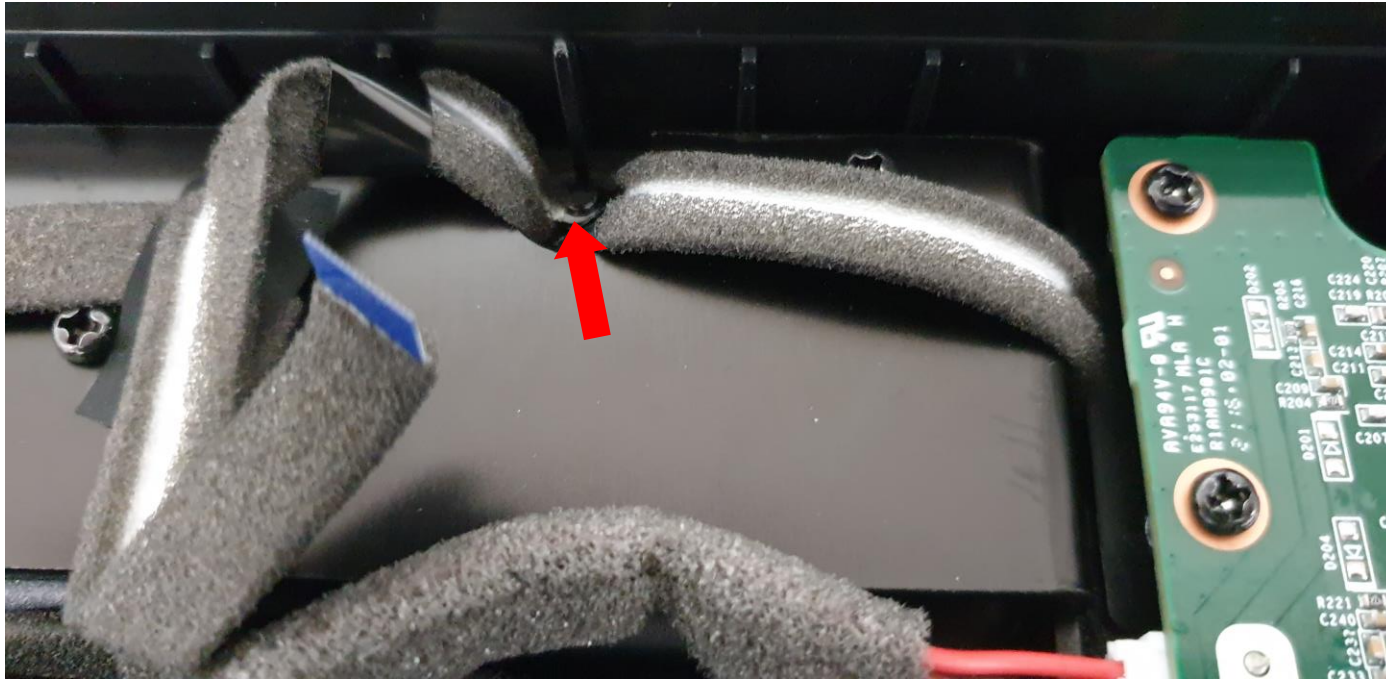
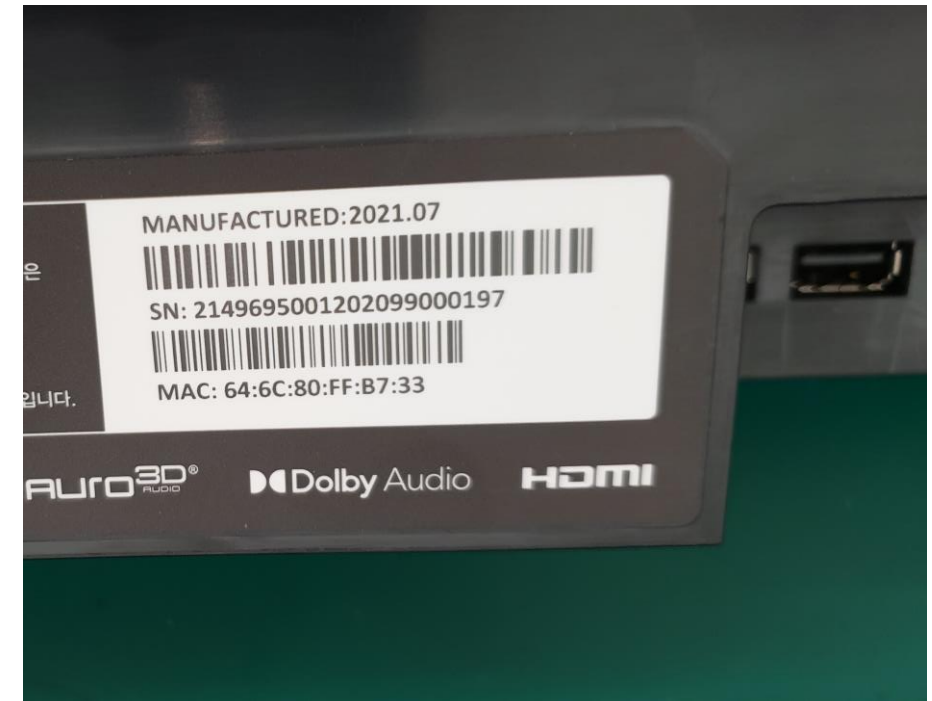
- Cable routing defect

- The FFC cable is damaged due to screw lock up

Critical

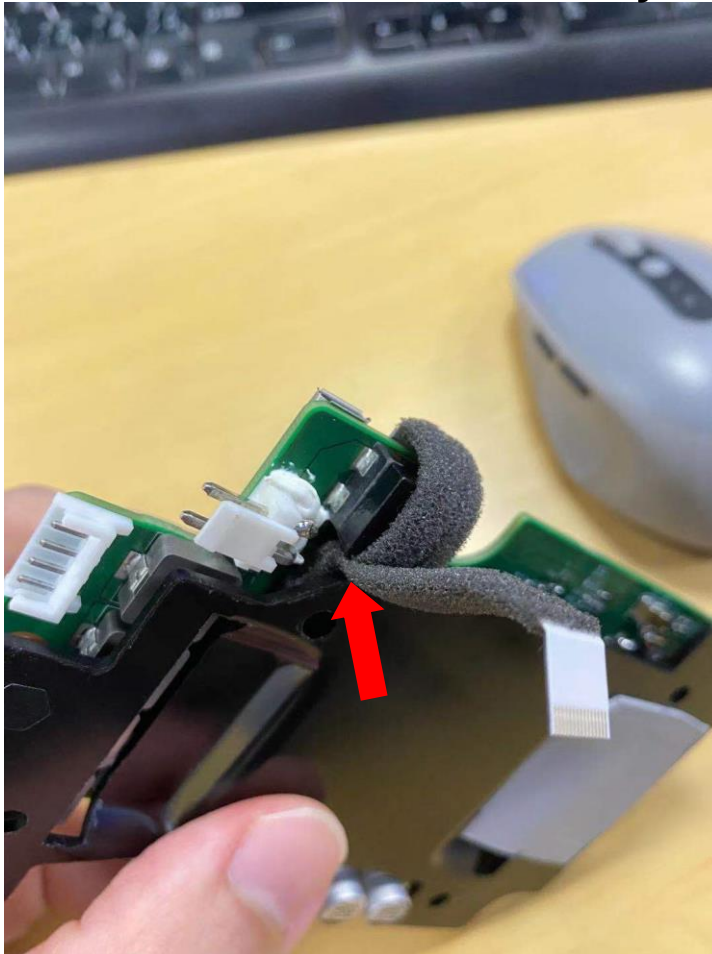
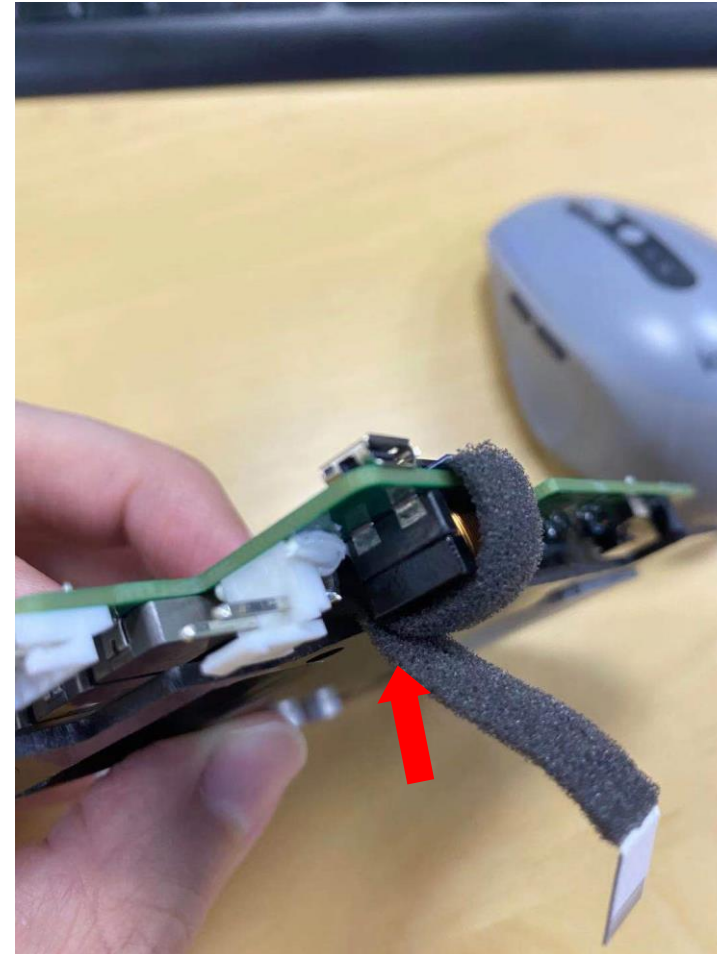
- Cable routing defect

- The AMP FFC cable is damaged due to bad assembly
- I2C short defect caused by this issue

Major

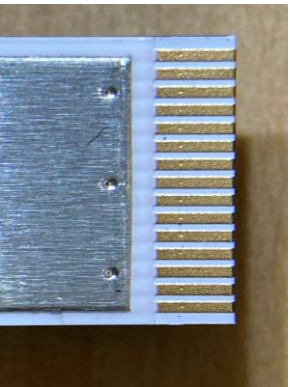
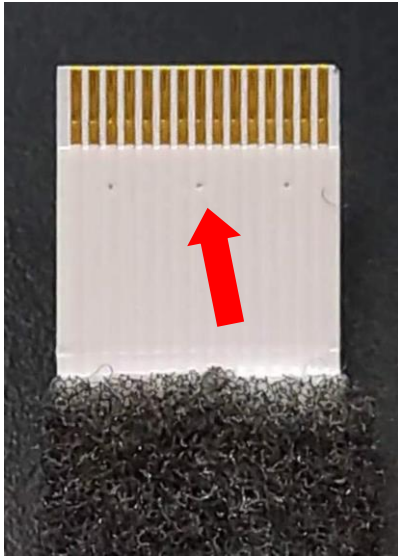
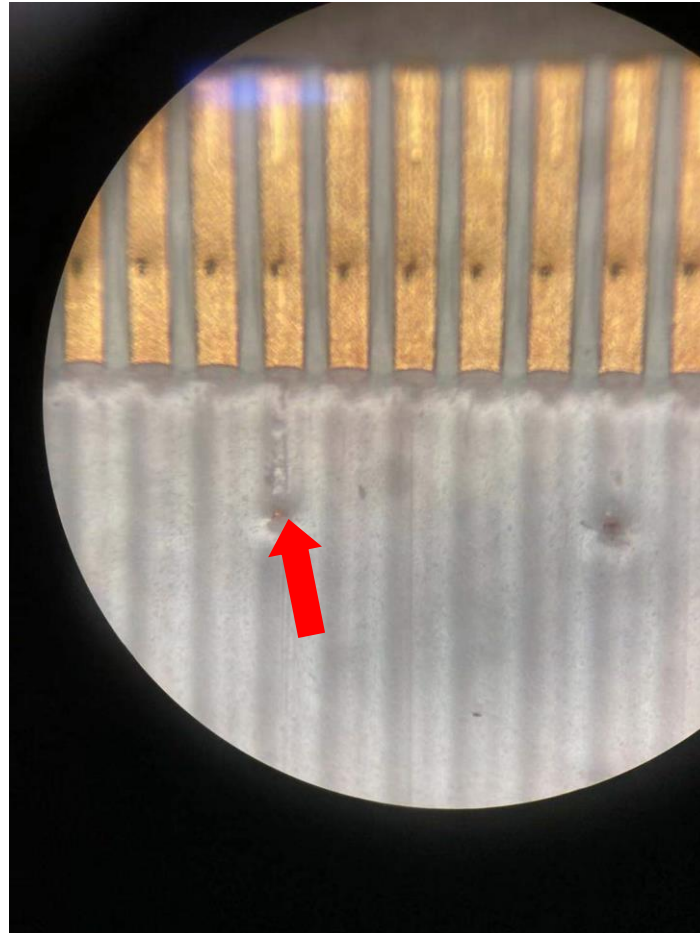
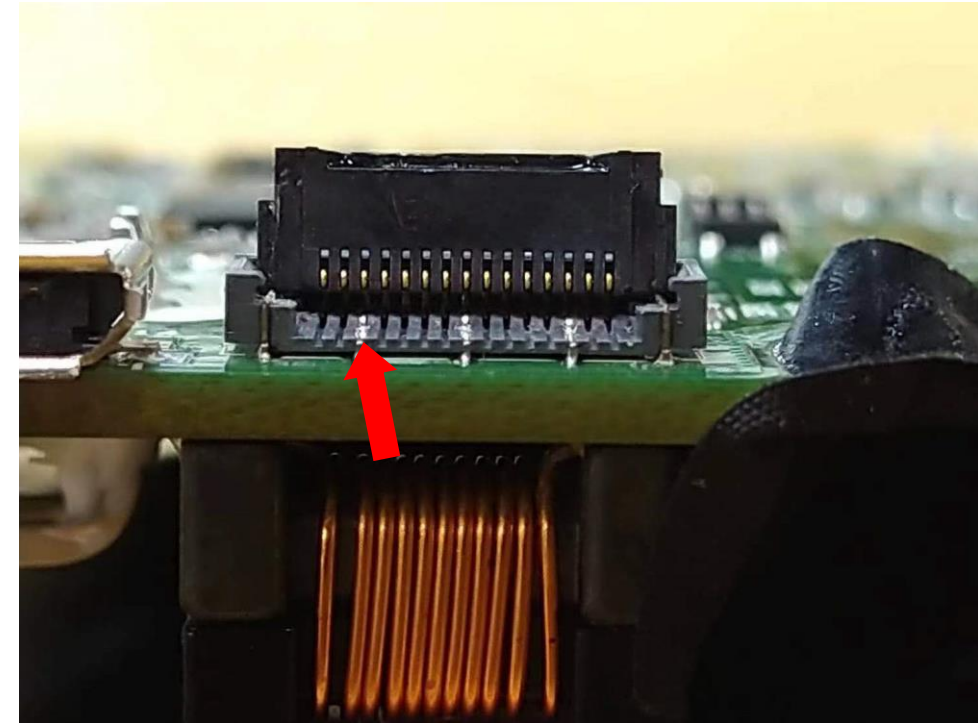
## • FFC Cable damage

- The AMP FFC cable is damaged due to FFC Connector
- I2C short defect caused by this issue

Critical
