# Swan\_soundbar

## DVT3\_Assembly review

Issued Date 2021.08.30

Ver.1.0

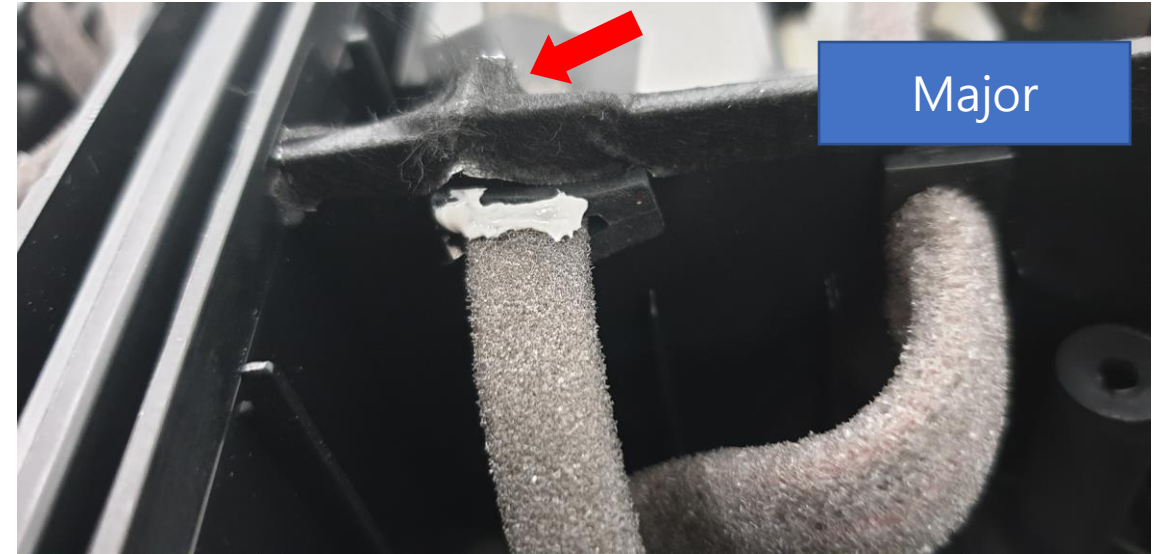
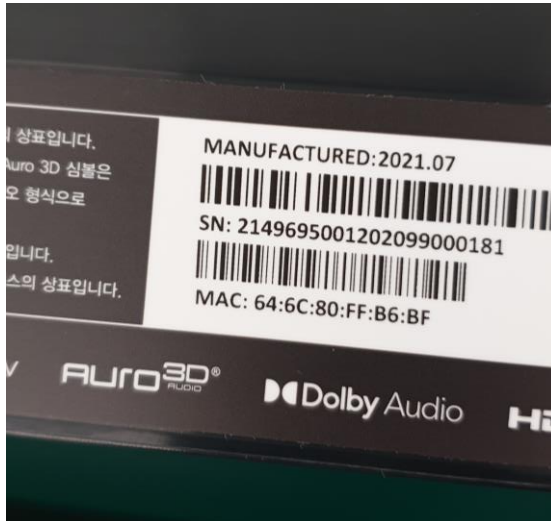
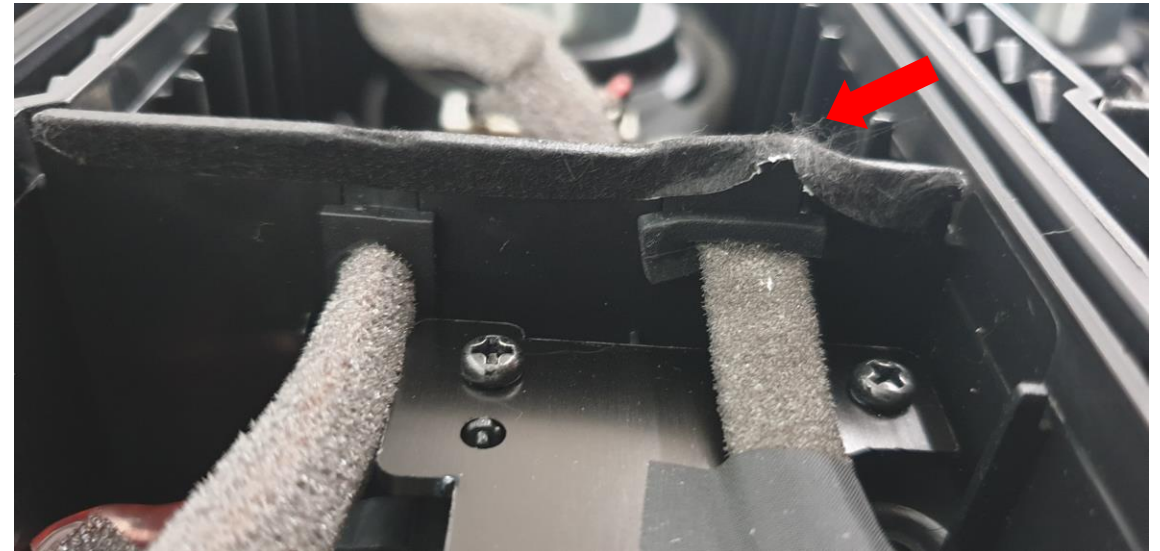
- Inner bushing assembly NG
  - The bushing is incorrectly assembled.

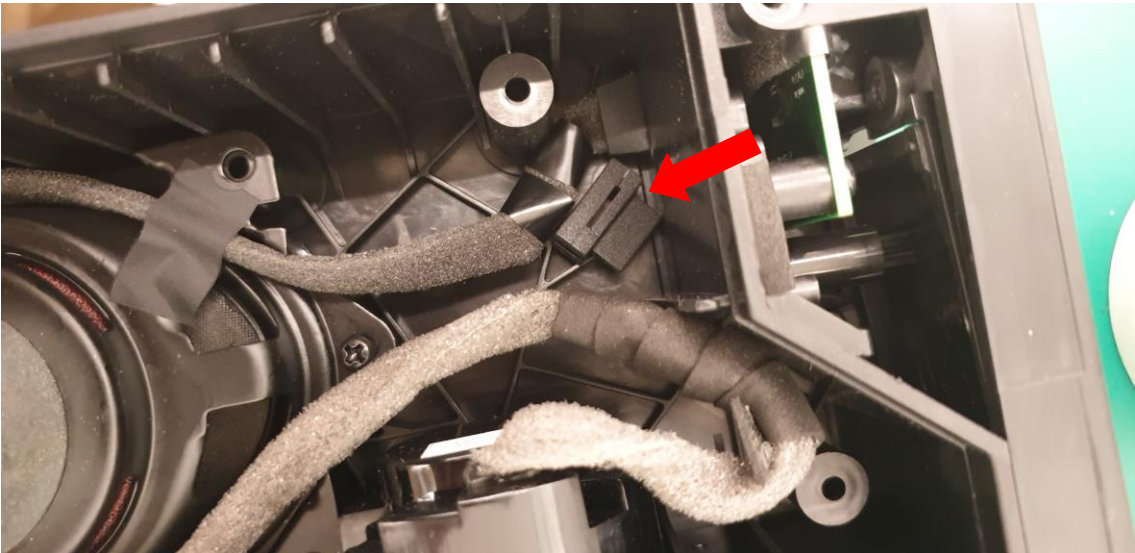
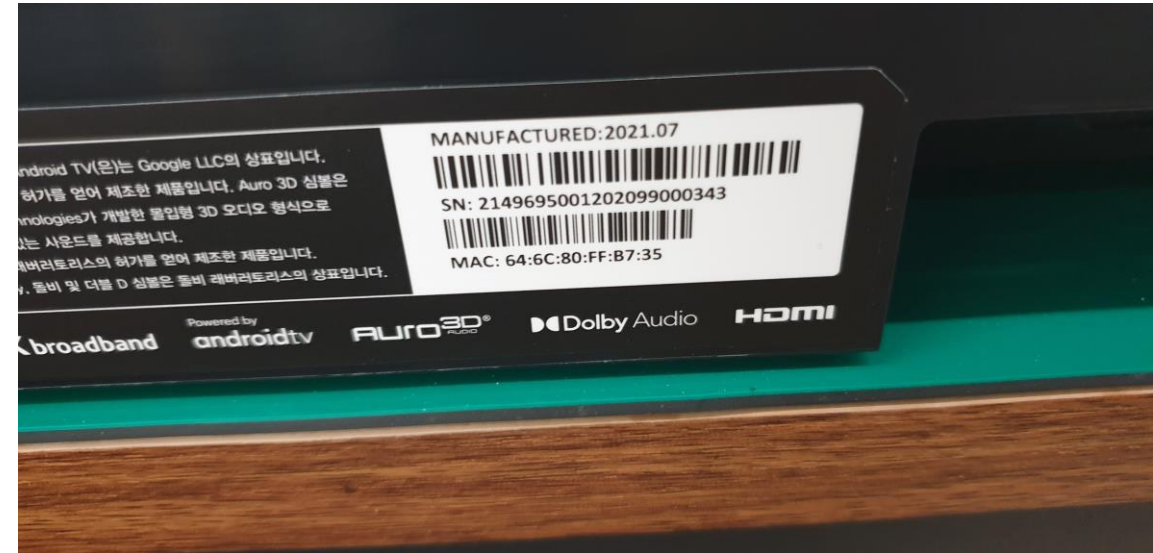
- The bushing is inside the sound area.
- Stuff inside is not allowed in the sound area.

Minor

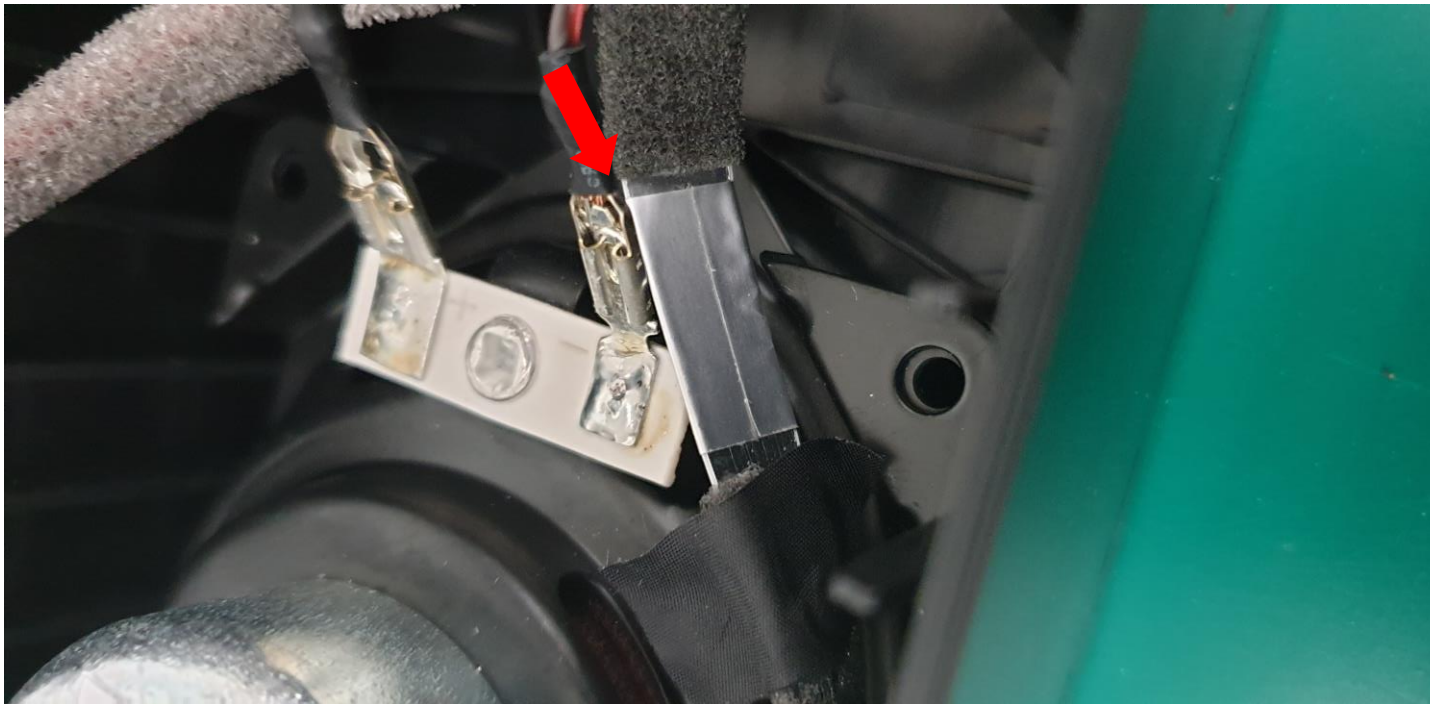
- Cable routing caution

- It may can touch side FFC GND with Speaker signal connector

Major

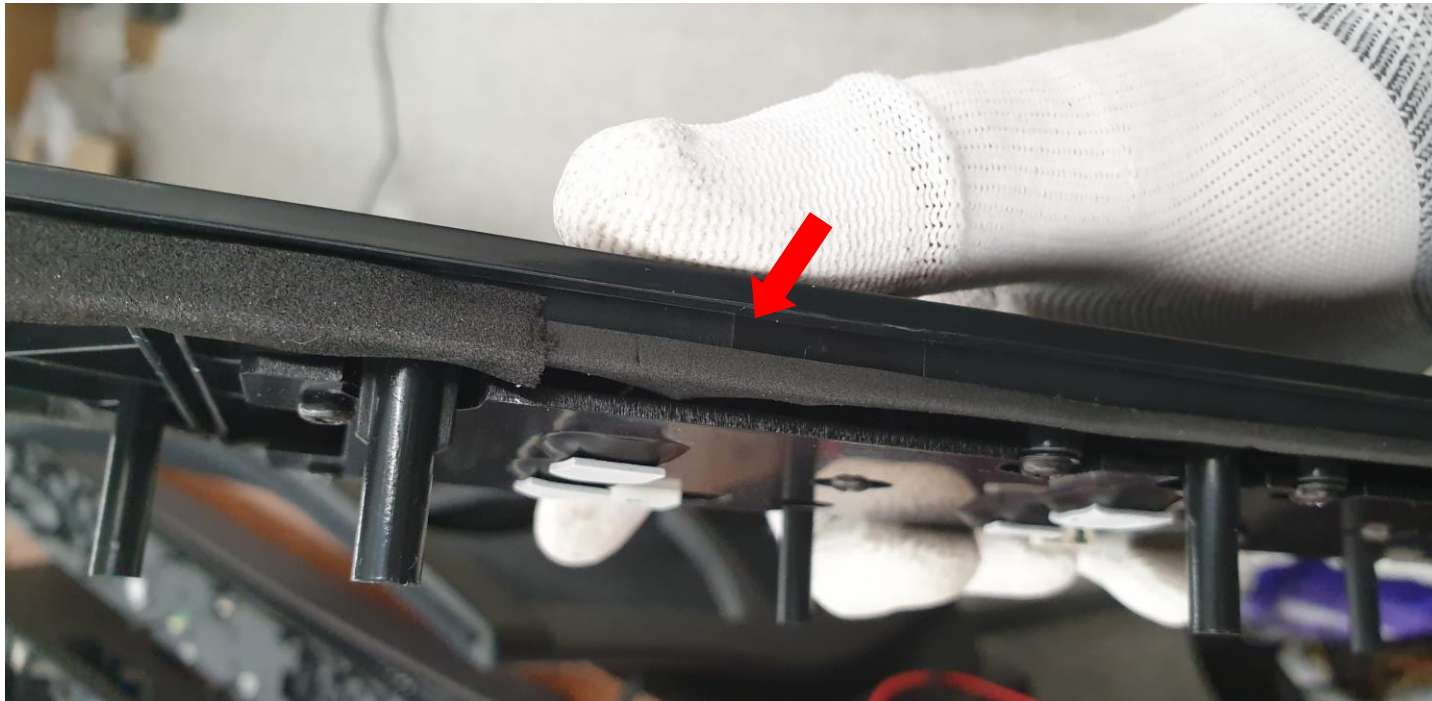
Critical

- Top gasket adhesion NG
  - It's about 20% NG.
  - The air leakage is occurs through this point.

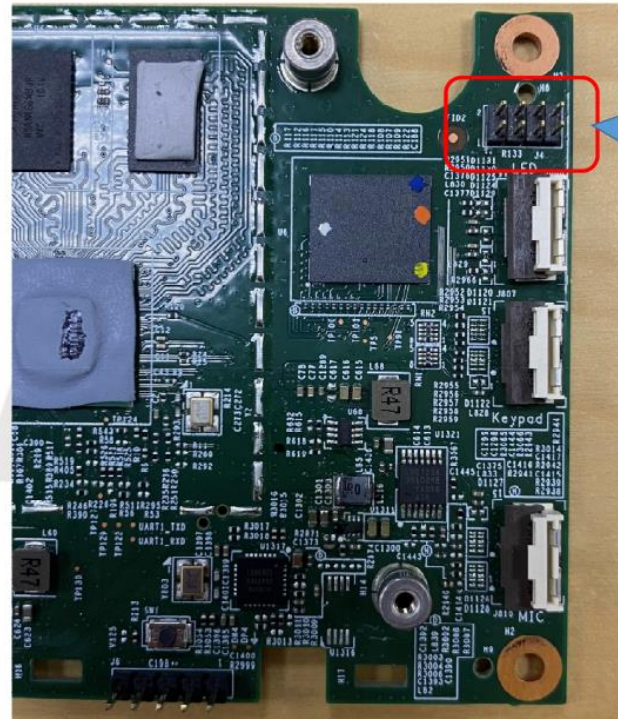
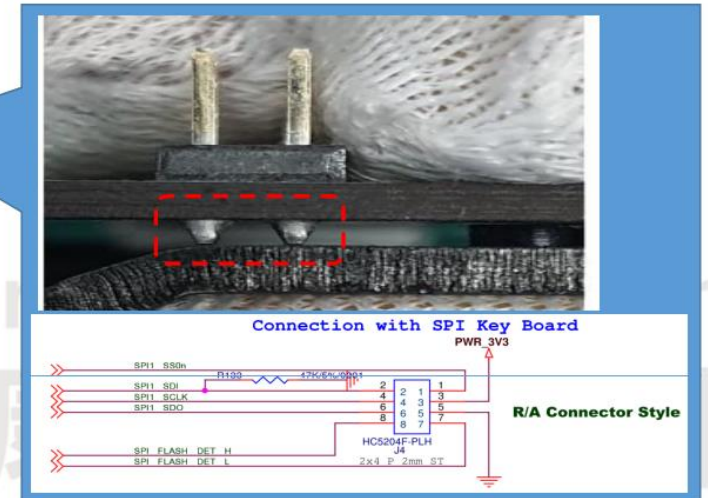
## No booting issue\_J4 contact issue

- The J4 is touch with bottom spreader
- DFM ISSUE :

Critical

1. The J4 is used for debug port of VS550
2. The J4 pin header is very close to the bottom heat spreader of main board. If J4 is in contact with the heat spreader, the main board may not bootup properly because the 3.3V power short-circuited to ground
3. The leg of pin header changed to normal type in DVT3 build in order to solve the soldering issue on ground pin of pin header. And we will change the pin header to short leg type in MP to prevent the risk of short issue after assembly.
