# Swan\_soundbar\_sound\_leackage Defect

ALT Co., Ltd.

Issued Date 2021.05.11

Ver.1.0

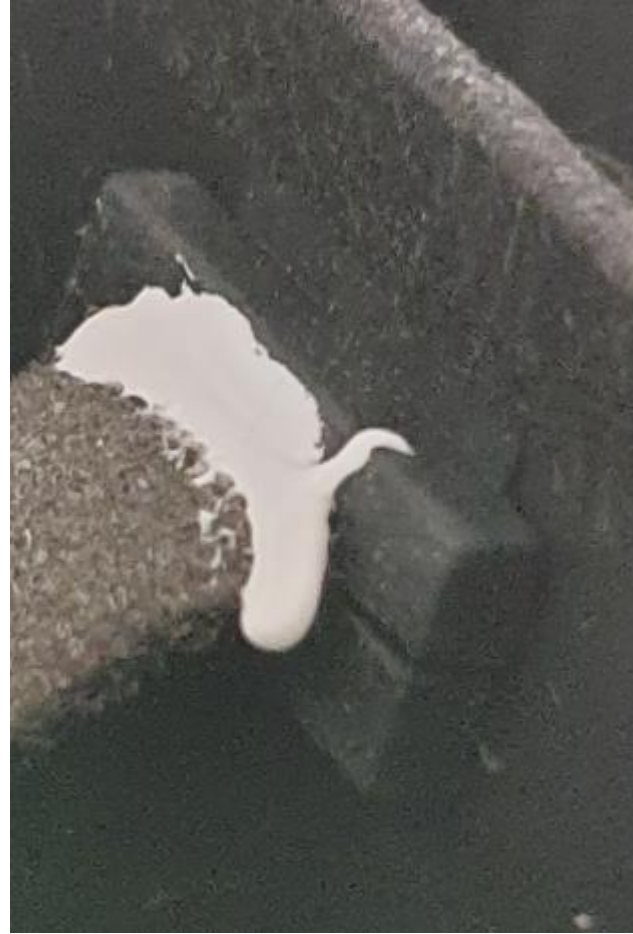
- Inner bushing glue apply defect

- Recommend Glue apply method.
  - Apply glue : DOWSIL\_7091
  - How to apply glue
    1. Fill the inside on the bushing with glue
    2. Assembly with FFC cable
    3. Add the glue open area

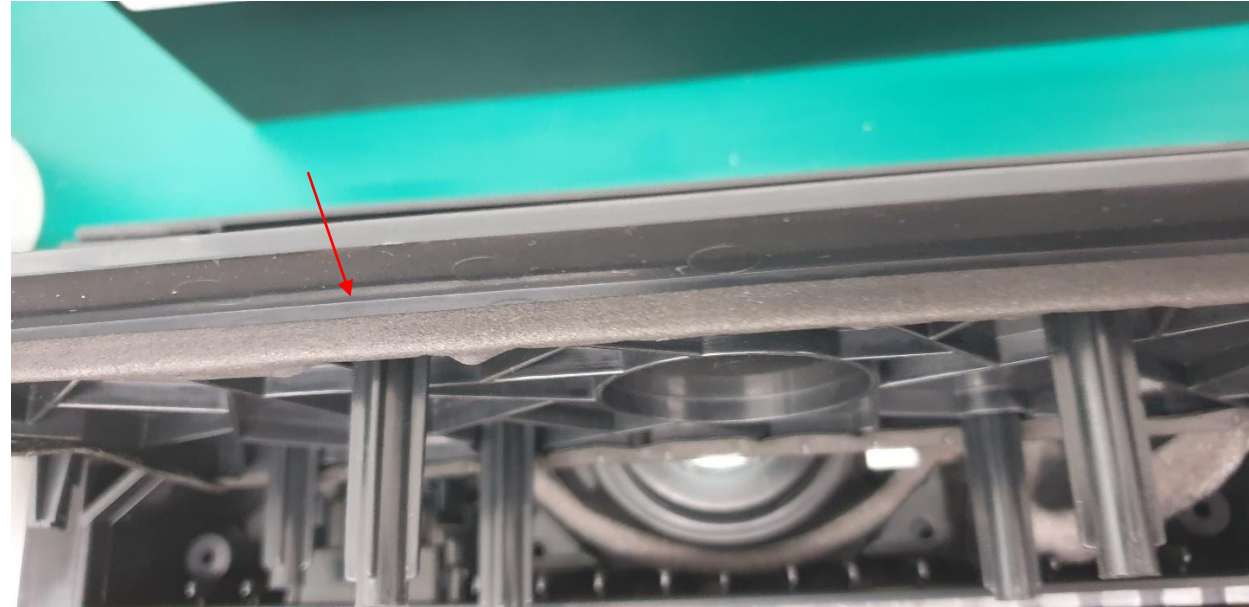
- Gasket attachment defect

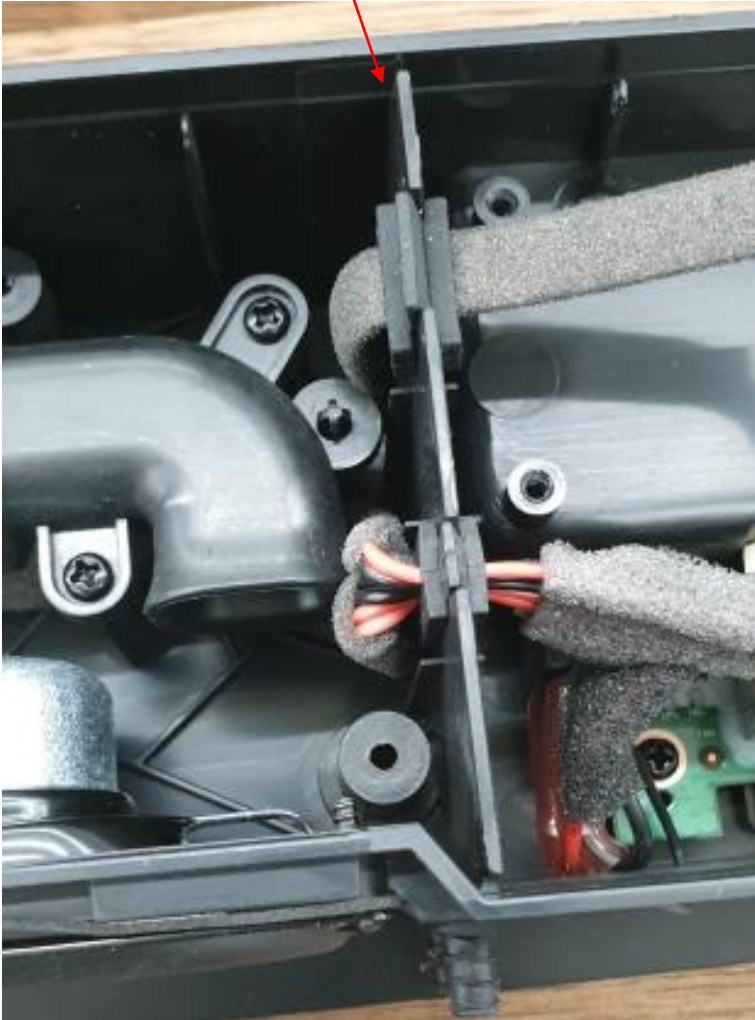
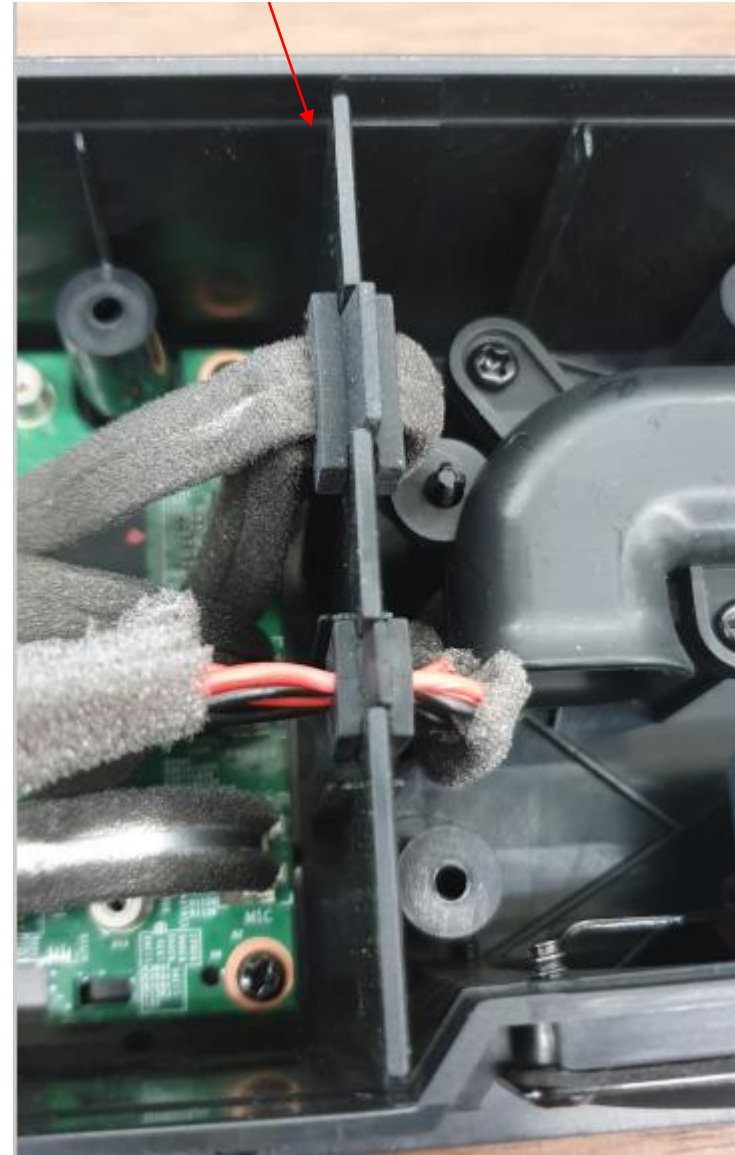
Missing inner gasket
