# Swan\_soundbar\_sound\_leackage Defect

ALT Co., Ltd.

Issued Date 2021.05.11

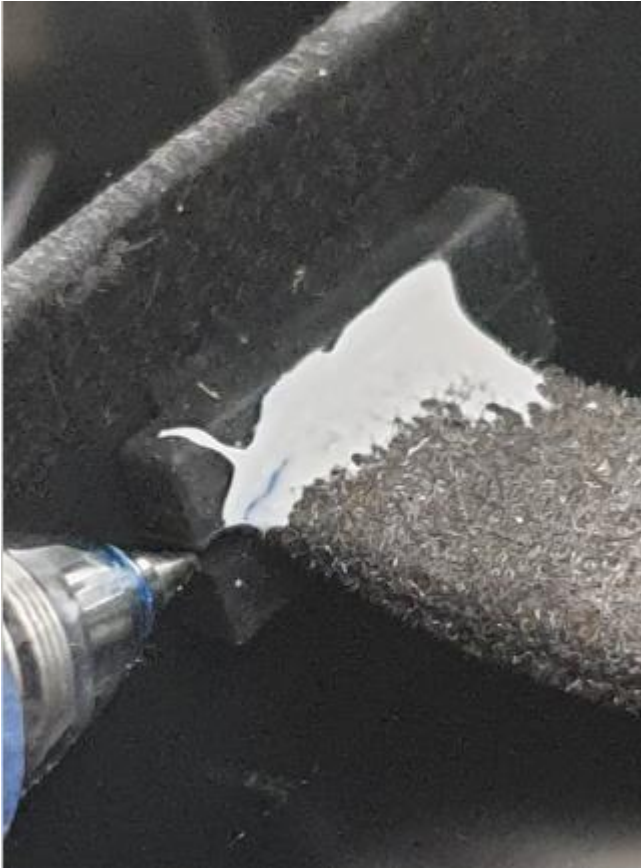
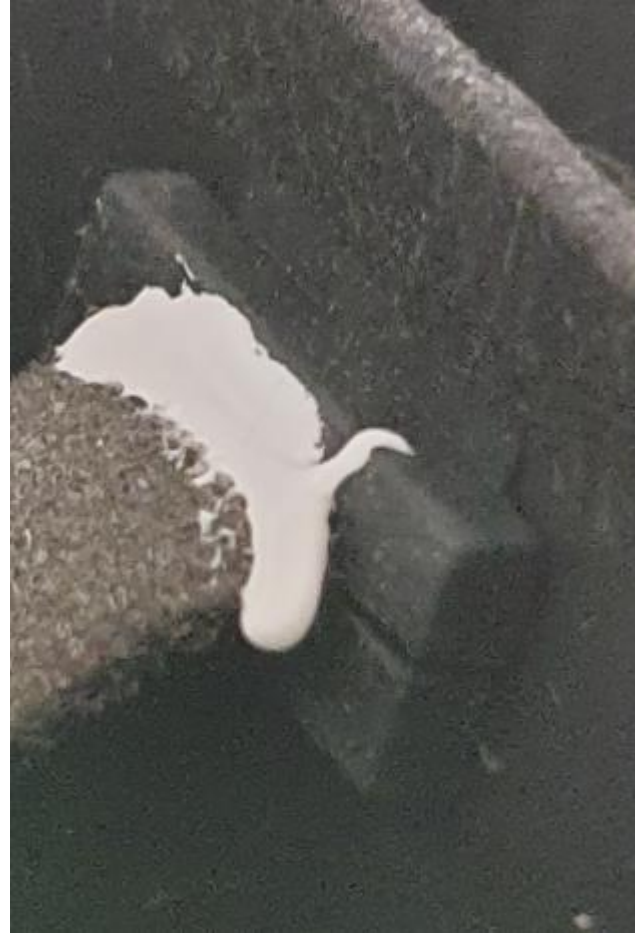
- Inner bushing glue apply defect

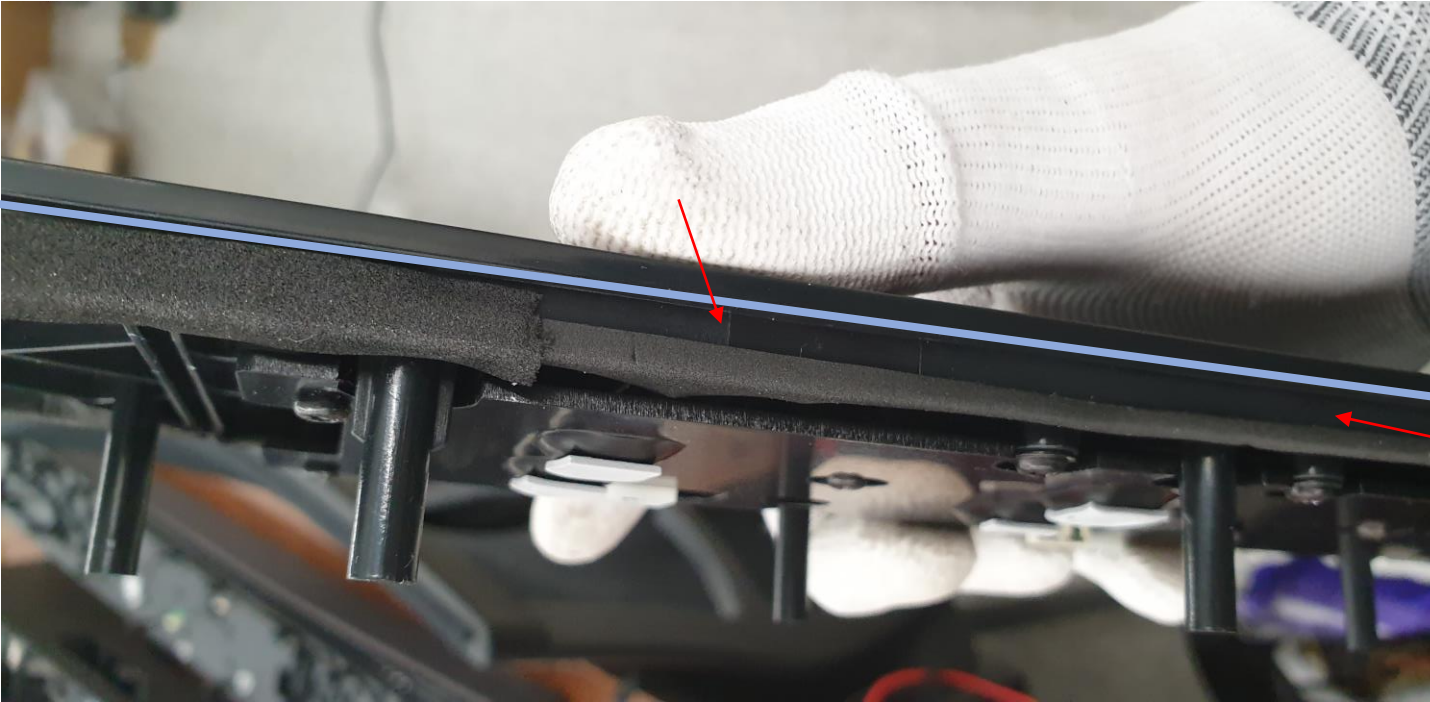
- Gasket attachment defect

Gasket attachment line  
The air leakage in this area

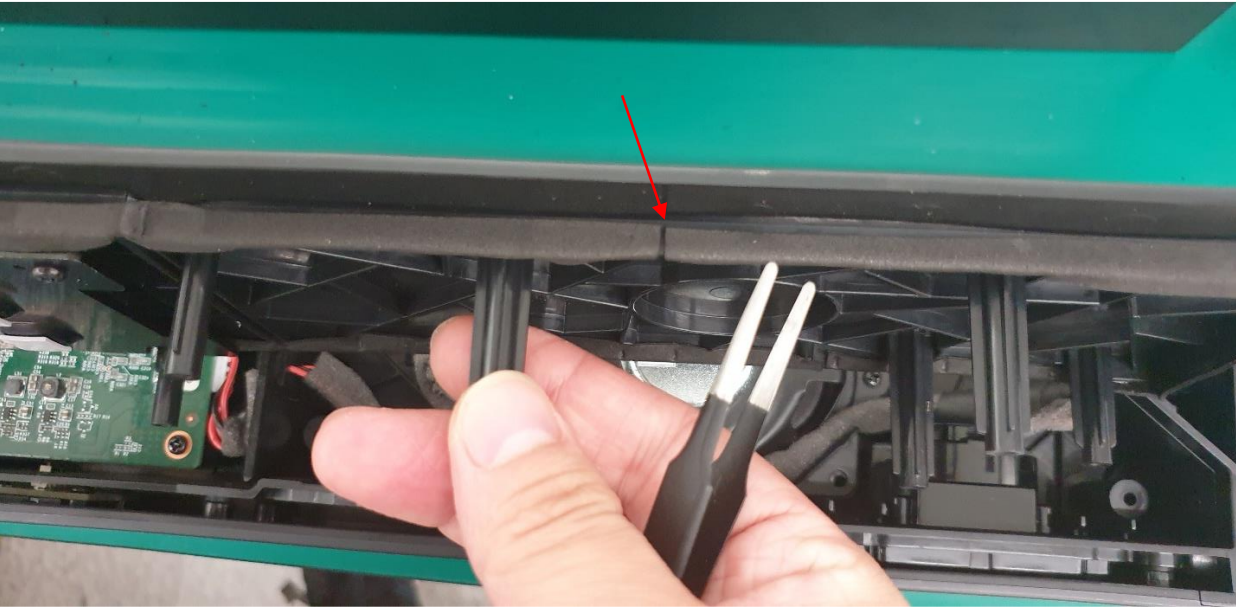
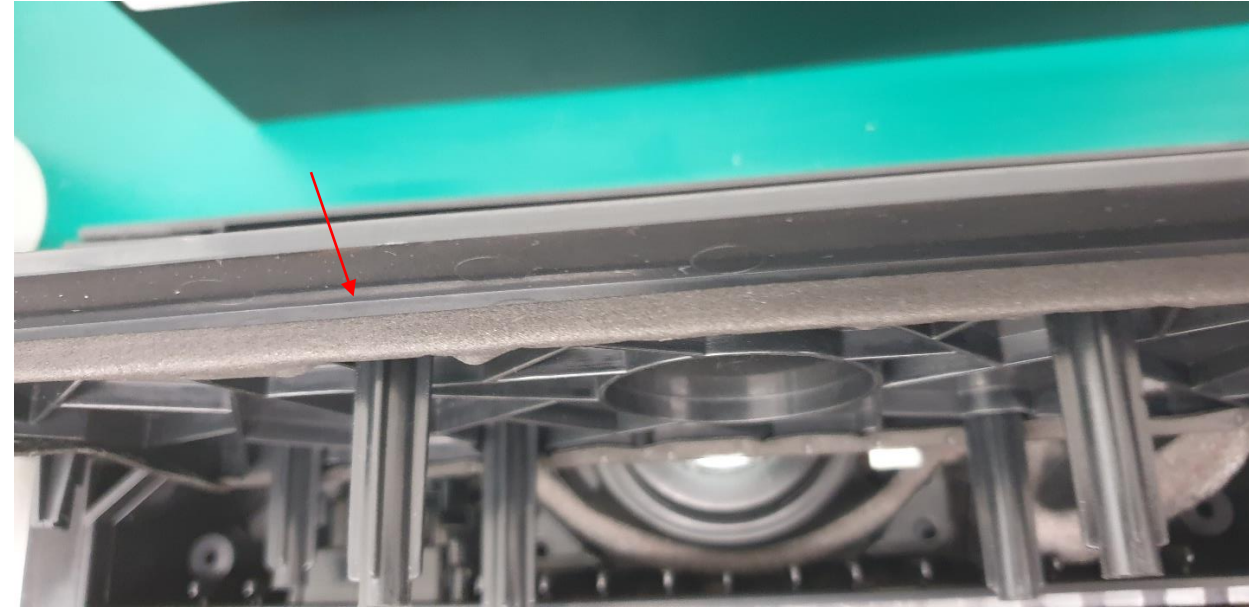
- Gasket attachment defect

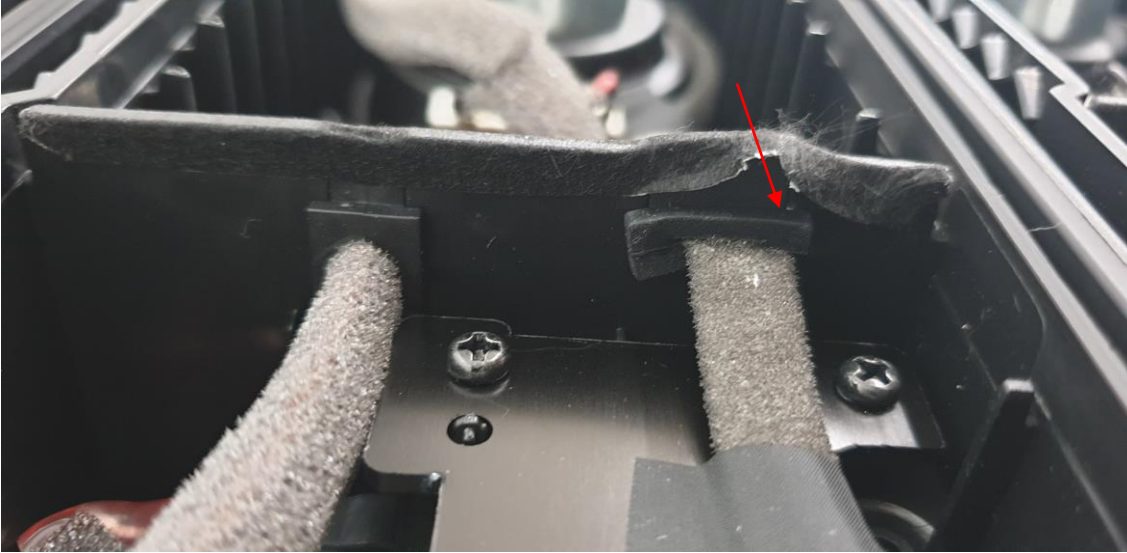
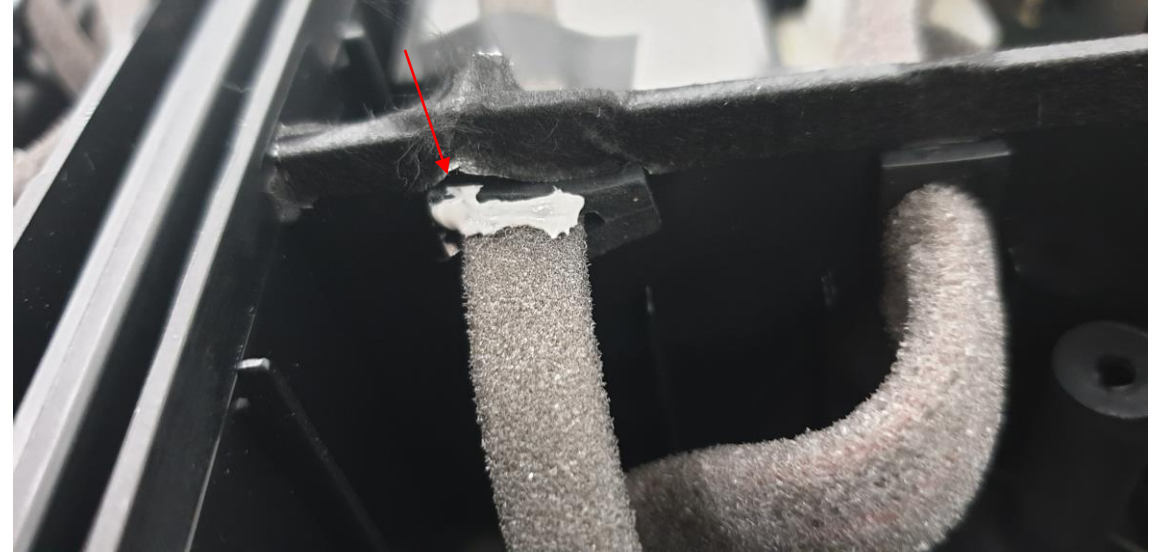
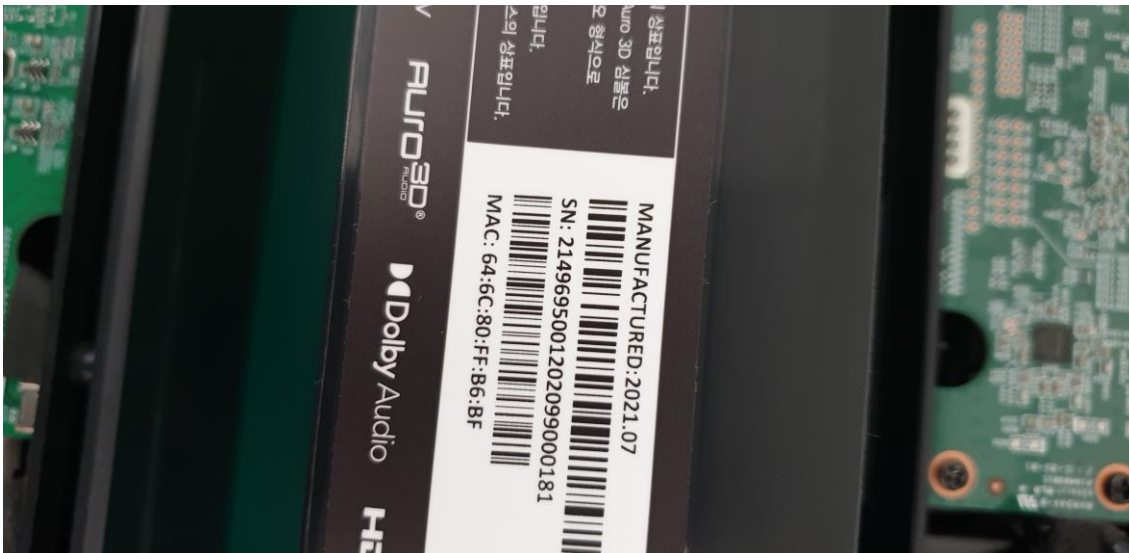
## Bushing defect – assembly or material

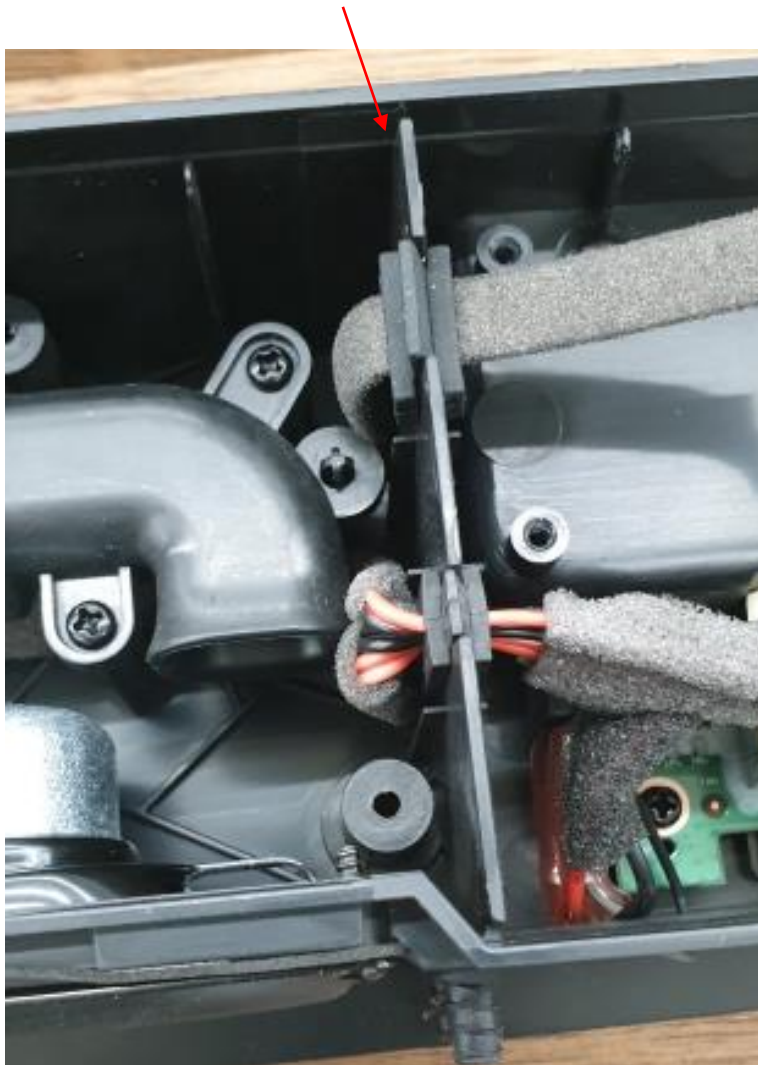
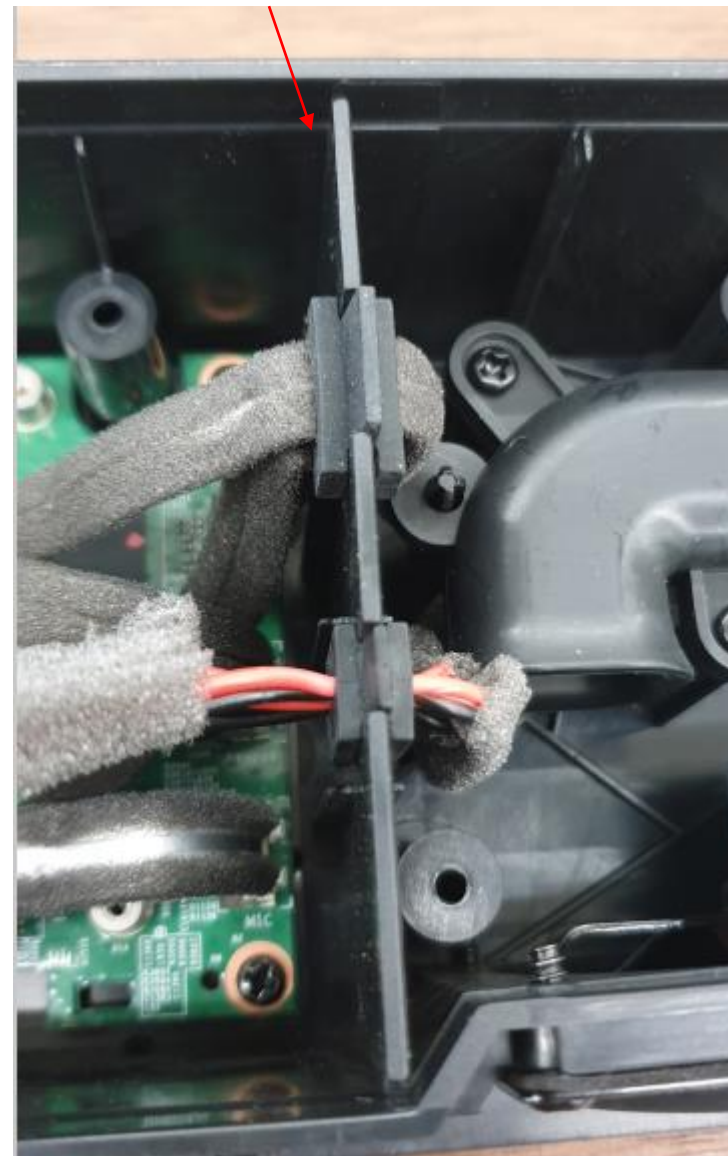
Missing inner gasket
