## 2021.10 First Mass production inspection

Model Name: BFX-UA300

Document Version: ALT\_STB\_MP\_CSMTINS\_001

Issued Date: 2021.10.20

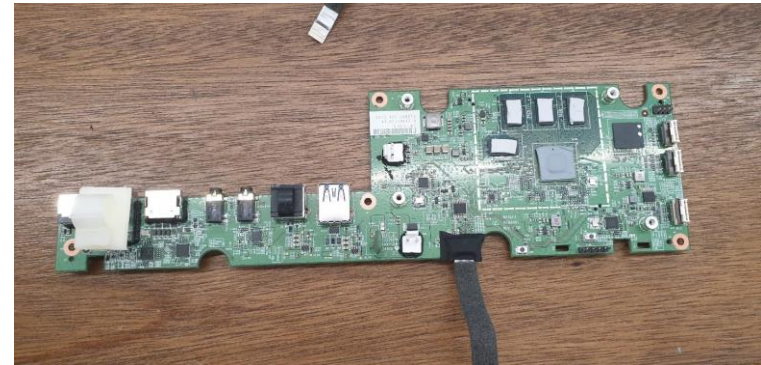
- Booting fail
  - Issue grade : Critical
  - Symptom : no boot after usb upgrade
    - Defect unit Q'ty : 1pcs / 756pcs
    - Defect rate : 0.13%

- ALT initial review
  - Booting is fail It may HW defect
  - No boot after SPI booting and eMMC update directly.
  - Booting log : [Link](#)
    - init cpupll 800MHz
    - init mempll 2400MHz
    - init 3GB DDR, lib version r63074
    - hw\_init done
    - custom table done
    - asking BCM to load miniloader.
    - bcm\_load\_next\_img error! init cpupll 800MHz
  - Also, this SET is no screw fastening inside
- Action item
  - FXN should be submit 8D report
    - Find the root cause.
    - Provide the preventive action

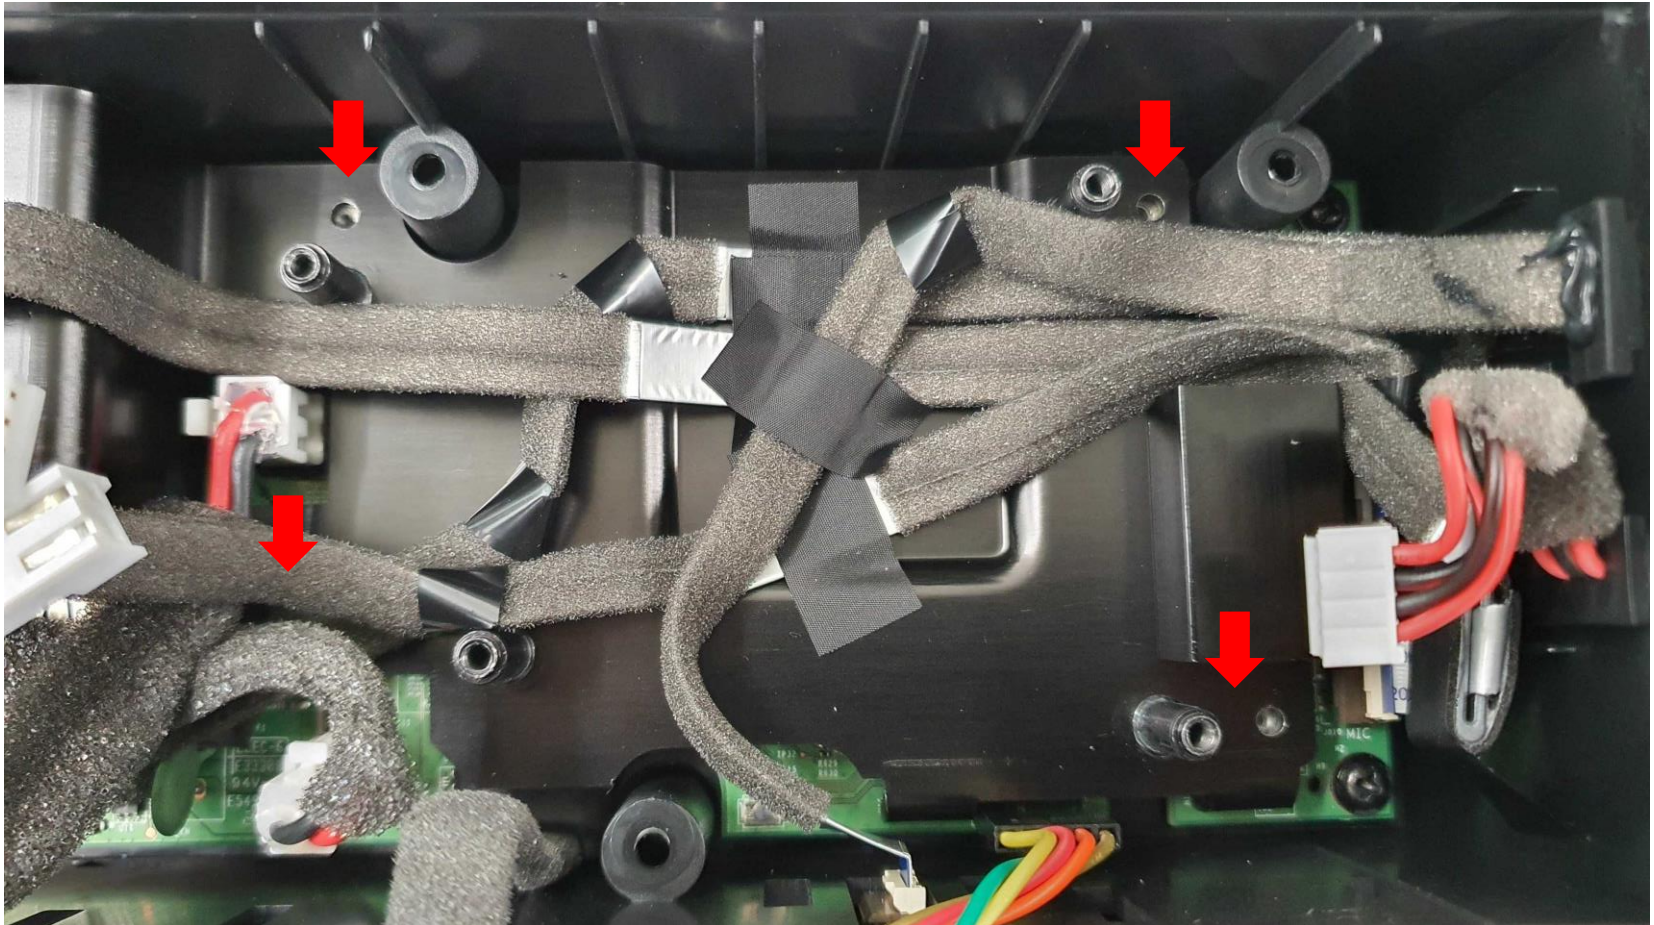
- Booting fail

- ALT initial review
  - Also, this SET is no screw fastening inside

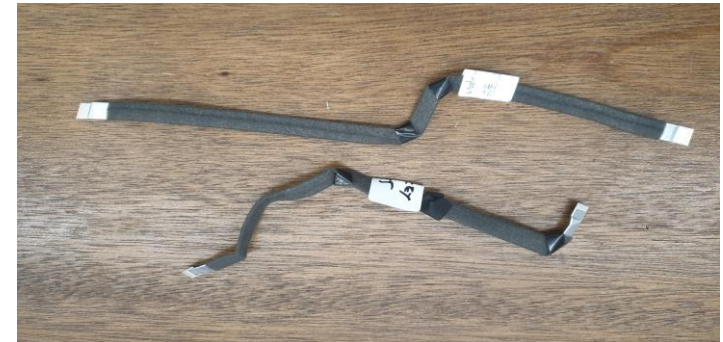
- FFC defect
  - Issue grade : Critical
  - Symptom : No turn on the LED, No button operation
    - Defect unit Q'ty : 2pcs / 756pcs
    - Defect rate : 0.26%

- ALT initial review
  - Checked all of connections -> No abnormalities found.
  - Changed FFC cable : Cleared Issue.
    - LED FFC : 14 Pin open
    - Button : 14, 15 Pin open
- Action item
  - FXN should be submit 8D report
    - Explain why it was not detected in the factory
    - Find the root cause.
    - Provide the preventive action

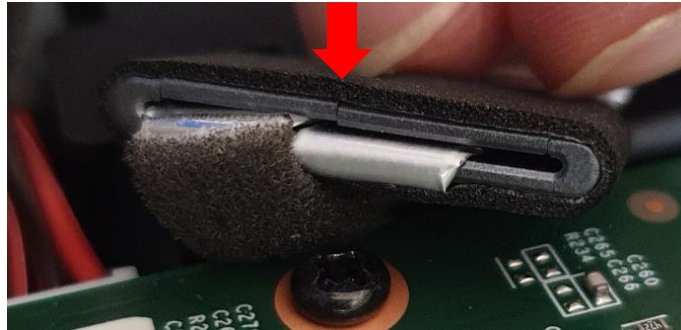
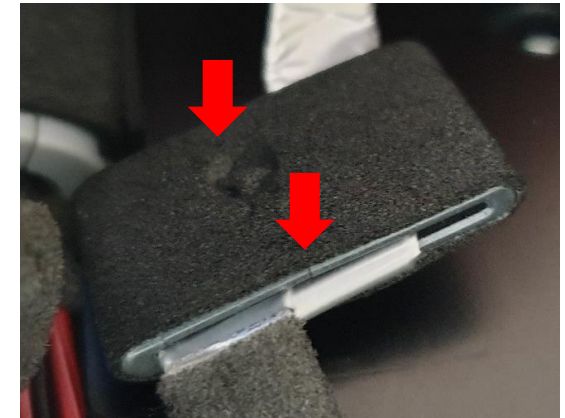
- Ferrite Core broken
  - Issue grade : Critical
  - Symptom : Ferrite Core broken after assembly
    - Defect unit Q'ty : Not counted
    - Defect rate : about 60%

- ALT initial review
  - It is damaged due to interference with the holder mic screw after final assembly
- Action item
  - FXN should be submit 8D report
    - Make short term solution for mass production.
    - Find the root cause and long term solution
    - Provide the preventive action

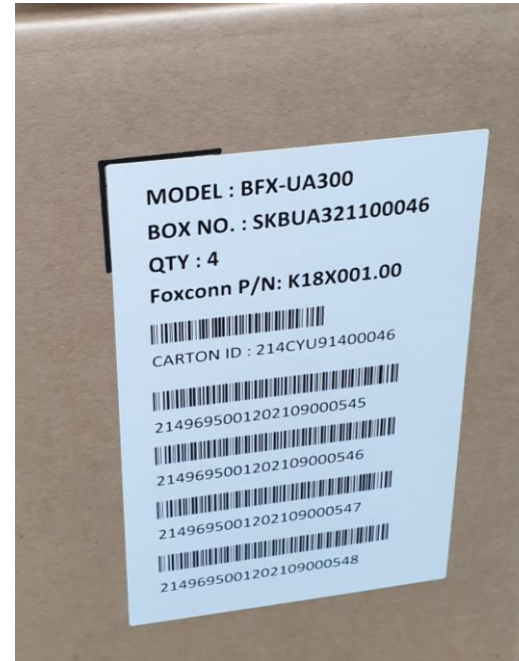
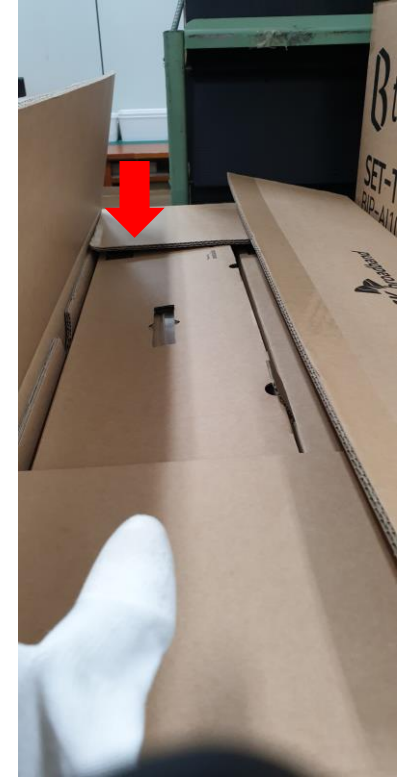
- Inner sheet missing on the carton box

- Issue grade : Minor
- Symptom
  - Missing inner sheet
  - Defect unit Q'ty : 1pcs / 189 carton
  - Defect rate : 0.52%
  - Box No : SKBUA321100046

- ALT initial review
  - temporary replacement the inner sheet
- Action item
  - FXN should be submit 8D report
    - Need to update SOP and WI (Work Instruction)
    - Provide the preventive action

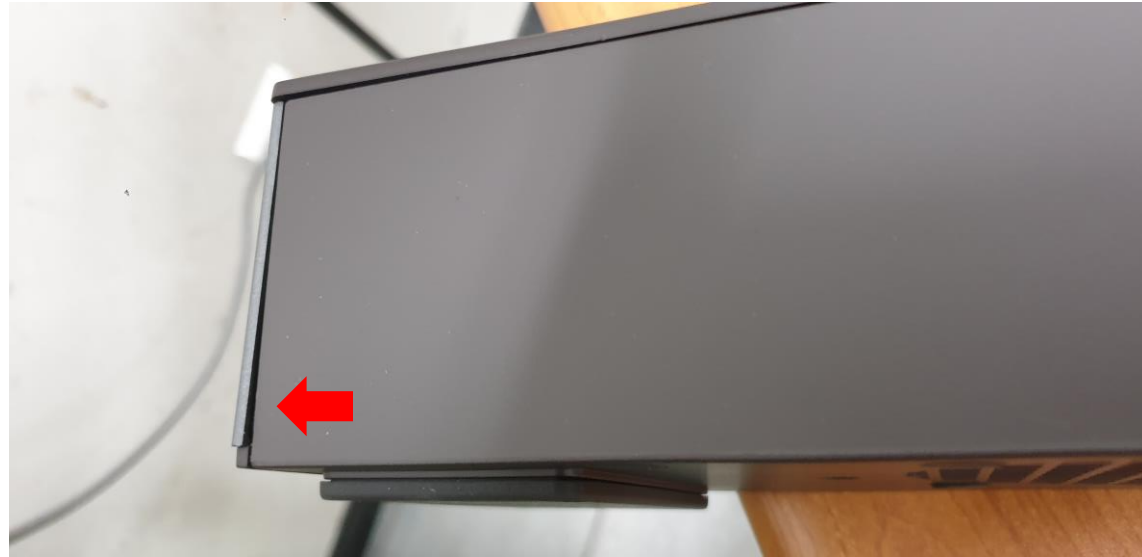
- Side deco plate NG
  - Issue grade : Major
  - Symptom
    - Attachment line NG
    - Defect unit Q'ty : Not counted
    - Defect rate : about 40%
- ALT initial review
  - Attachment line : visual inspection NG
- Action item
  - FXN should be submit 8D report
    - Need to update SOP and WI (Work Instruction)
    - Provide the preventive action

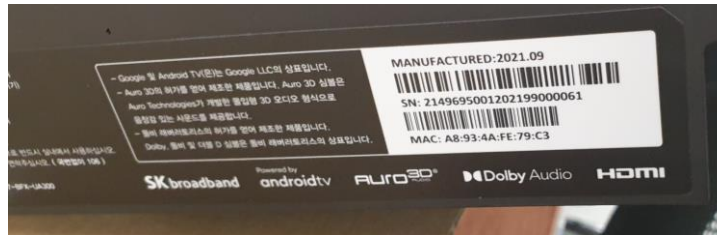
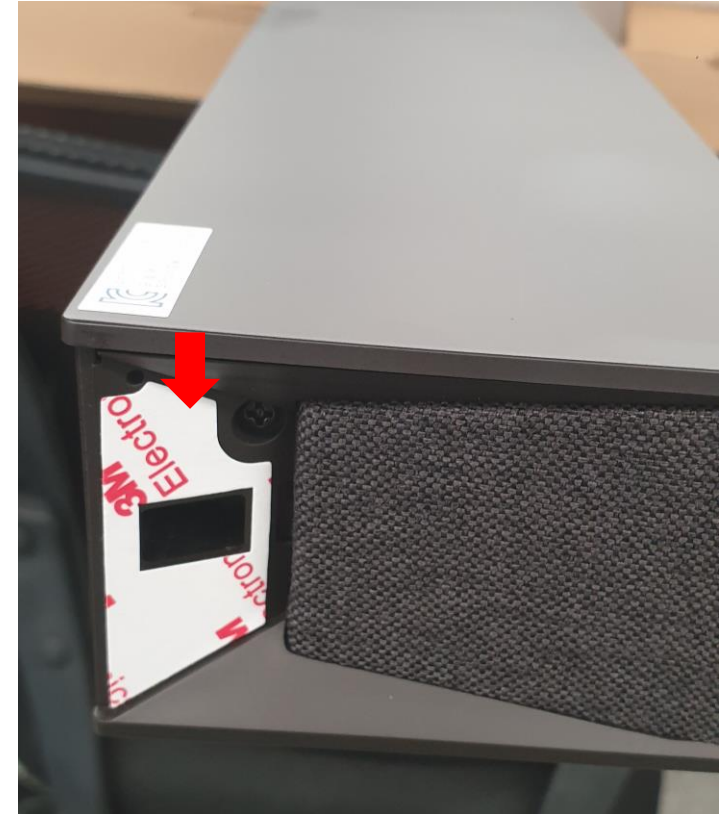
- Side deco plate Missing
  - Issue grade : Major
  - Symptom
    - Side deco plate missing
    - Defect unit Q'ty : 1pcs / 756pcs
    - Defect rate : 0.13%

- ALT initial review
  - Visual inspection NG
- Action item
  - FXN should be submit 8D report
    - Remaining material(deco plate) occurred after assembly, explain why it was not checked.
    - update SOP and WI (Work Instruction)
    - Provide the preventive action

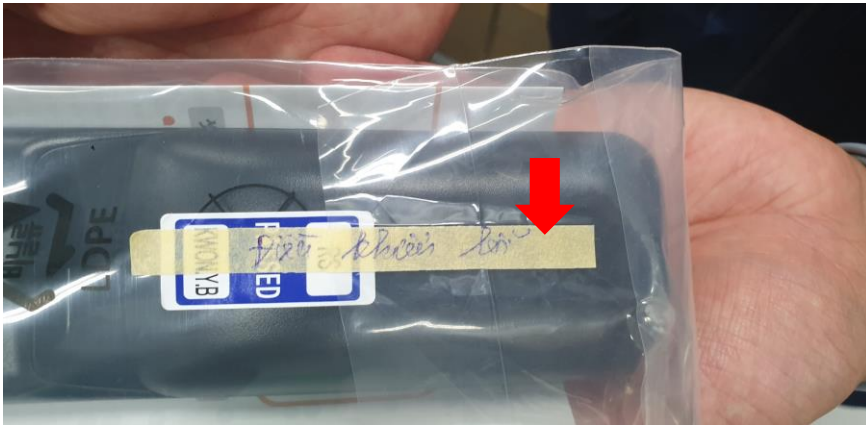
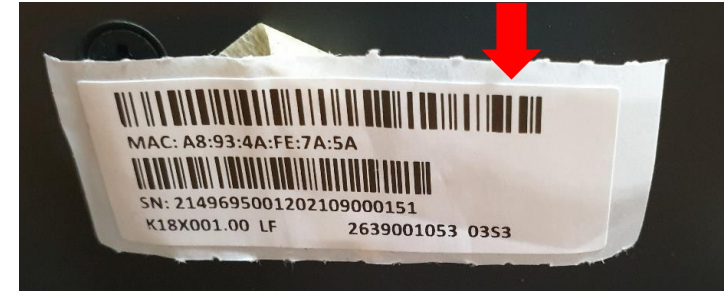
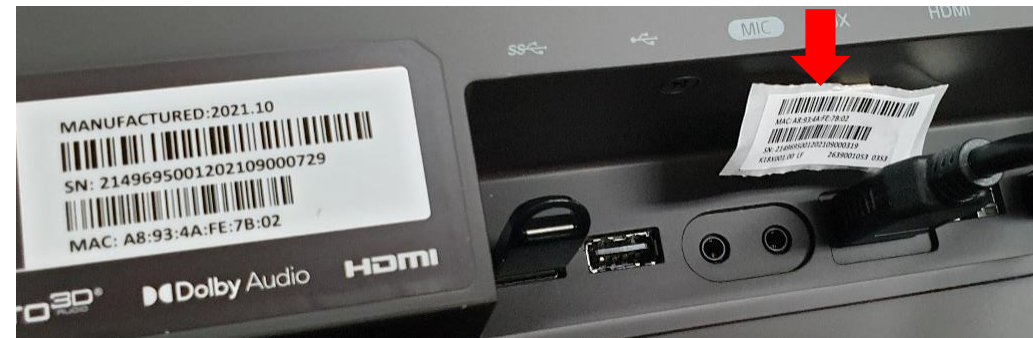
- Factory stuff inside the product
  - Issue grade : Minor
  - Symptom
    - Memo on the RCU 1pcs / 756pcs
    - SET temp label on the rear side 2pcs / 756pcs
    - Defect rate : 0.39%

- Action item
  - FXN should be submit 8D report
    - Need to update SOP and WI (Work Instruction)
    - Provide the preventive action

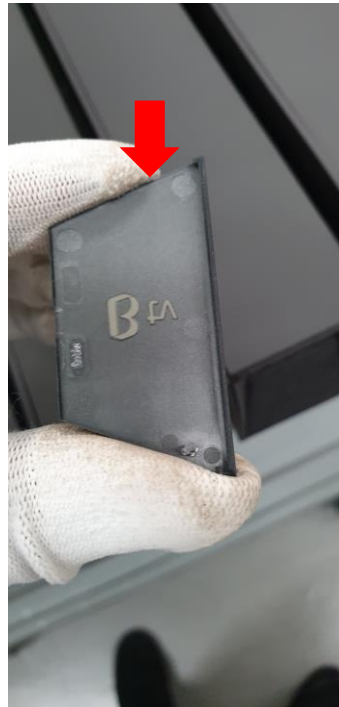
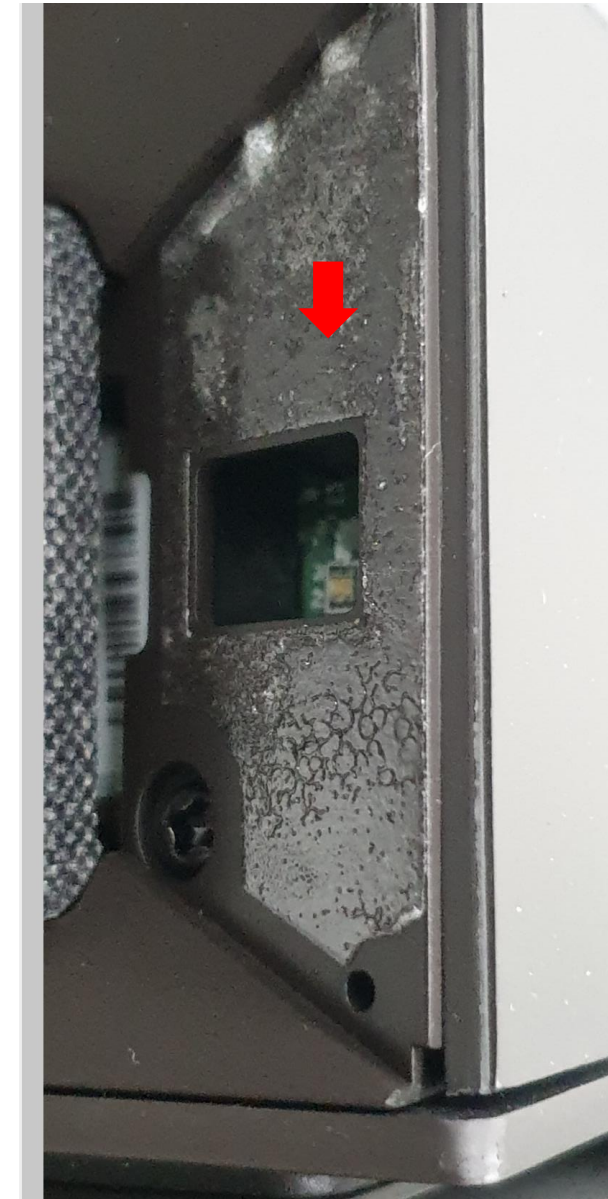
- Side deco plate poor attachment

- Issue grade : Minor
- Symptom
  - poor attachment
  - Defect unit Q'ty : Not counted
  - Defect rate : about 40%

- ALT initial review
  - poor attachment : Falls off easily
  - **Please push deco plate after attachment**
- Action item
  - FXN should be submit 8D report
    - Need to update SOP and WI (Work Instruction)
    - Provide the preventive action

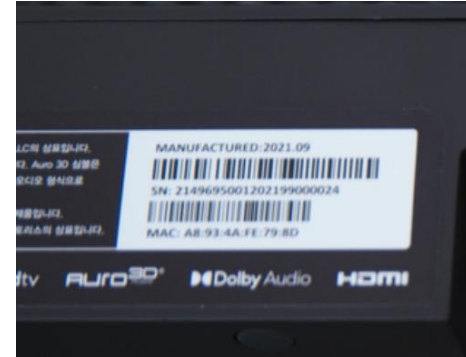
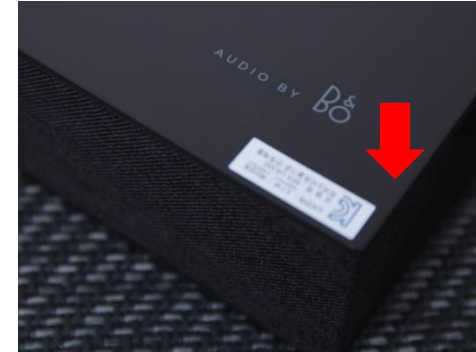
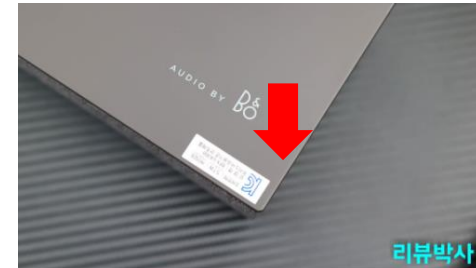
- KC label attachment NG

- Issue grade : Minor
- Symptom
  - Wrong place on the KC label
  - Defect unit Q'ty : 2pcs / 756pcs
  - Defect rate : 0.26%

- ALT initial review
  - These SETs are used in a blogger review
  - <https://blog.naver.com/der68/222541569881>
  - <https://blog.naver.com/hmshms1224/222534856348>
- Action item
  - FXN should be submit 8D report
    - Need to update SOP and WI (Work Instruction)
    - Provide the preventive action
