## 2021.11 Mass production inspection

Model Name: BFX-UA300

Document Version: ALT\_STB\_MP\_CSMTINS\_001

All Life Technology Co., Ltd

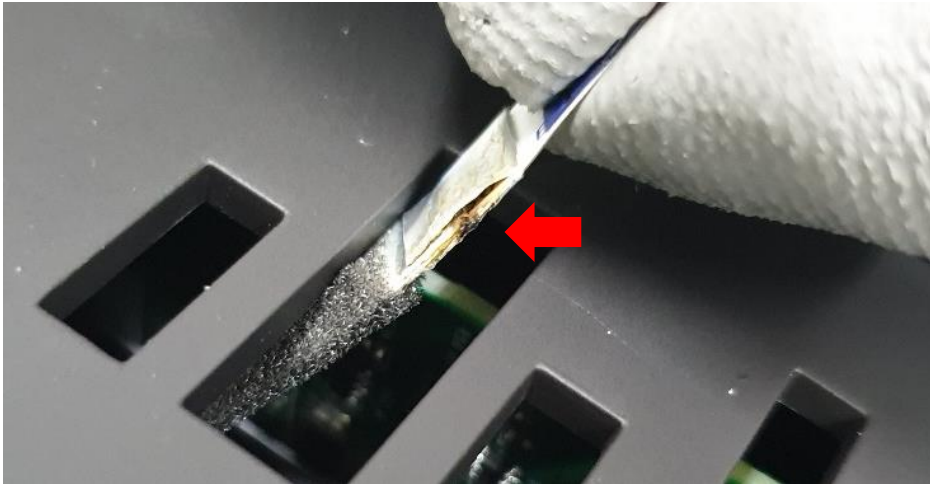
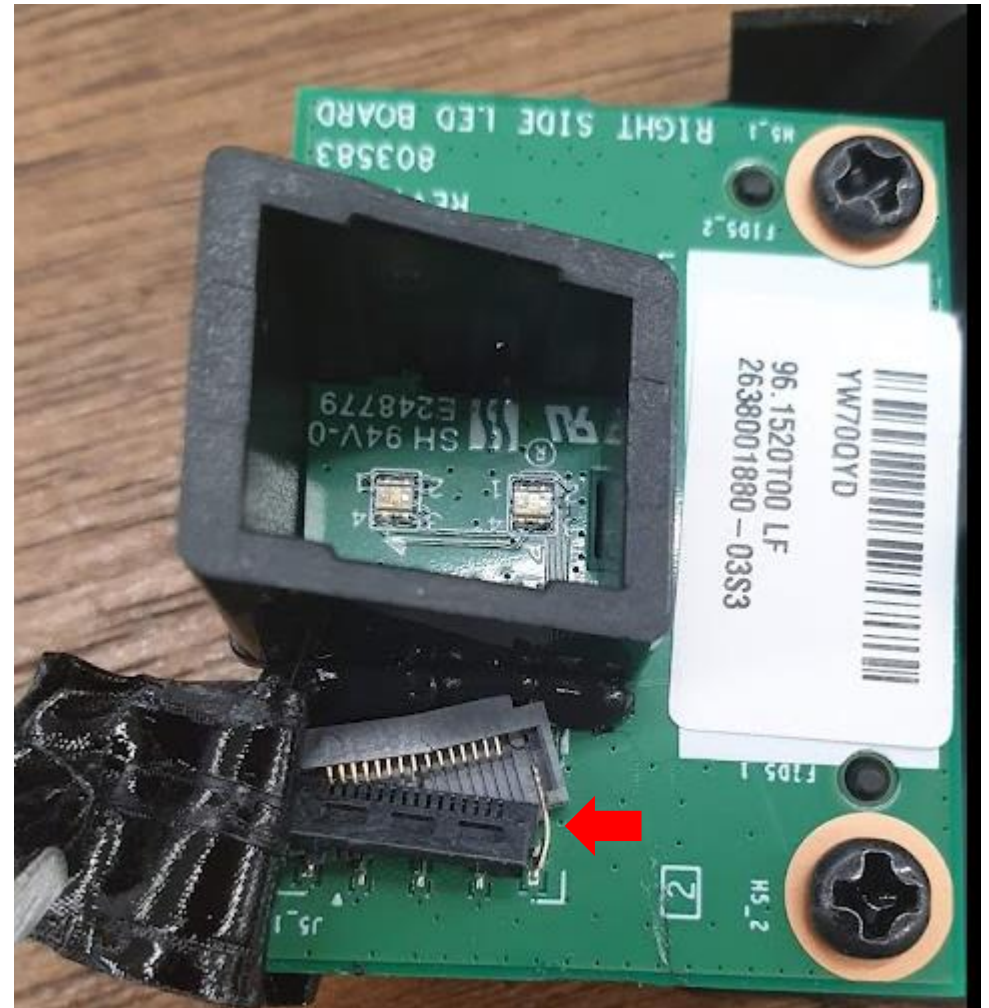
- Side LED not working
  - Issue grade : Critical
  - Symptom : R-Ch Side LED is not turn on
    - Defect unit Q'ty : 1pcs / 756pcs
    - Defect rate : 0.13%

- ALT initial review
  - Disassembly Front grill, the FFC was damaged.
  - Disassembly side LED ass'y, the FFC connector broken due to top cover rib
- ALT Action
  - Replace the Side LED PCBA, FFC cable
- Factory Action item
  - FXN should be submit 8D report
    - Check and verify rib cutting result at the factory

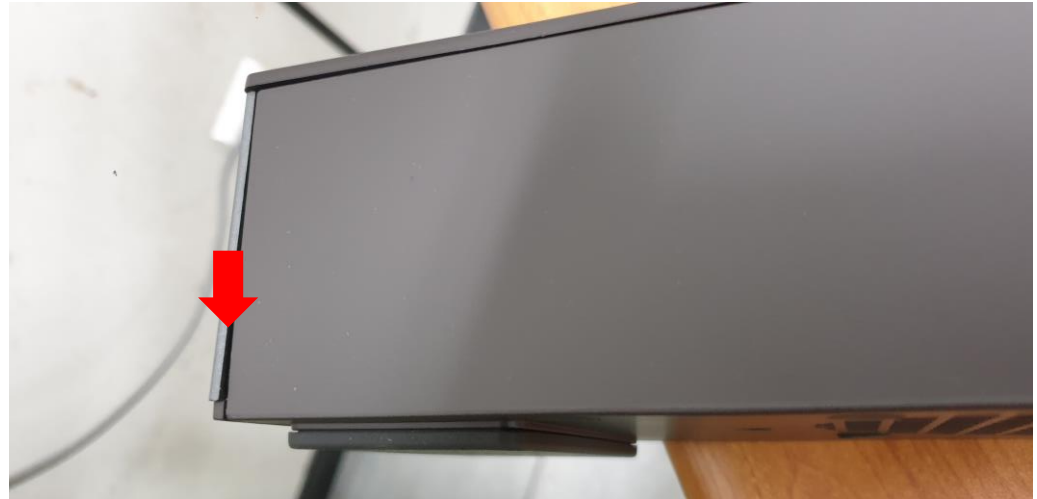
- Side deco plate poor attachment

- Issue grade : Minor
- Symptom
  - poor attachment
  - Defect unit Q'ty : Not counted
  - Defect rate : about 10%

- ALT initial review
  - Attachment line : visual inspection NG
  - **It's still need improvement**
- Action item
  - FXN should be submit 8D report
    - Need to update SOP and WI (Work Instruction)
    - Provide the preventive action
