## 2021.11 Mass production inspection

Model Name: BFX-UA300

Document Version: ALT\_STB\_MP\_CSMTINS\_001

- SKB incoming inspection
  - Inspection lot : BFX-UA300 MP delivered on Oct~Nov
    - Sampling size : AQL 0.15
    - Date : 2021.10.12 ~ 2021.11.16
  - Location : [SK networks warehouse](#), Anseong, Korea.
- Overall inspection result
  - Fail (Waived, due to product launch schedule)
- Defect Total
  - Critical\*
    - Side LED not working \* 1pcs
  - Major
    - BTV deco plate broken \* 1pcs
    - BTV deco plate cosmetic NG \* 3pcs
    - Missing accessory \* 4pcs
    - Grill attachment NG \* 1pcs
  - Minor
    - Side deco plate poor attachment \* 10%

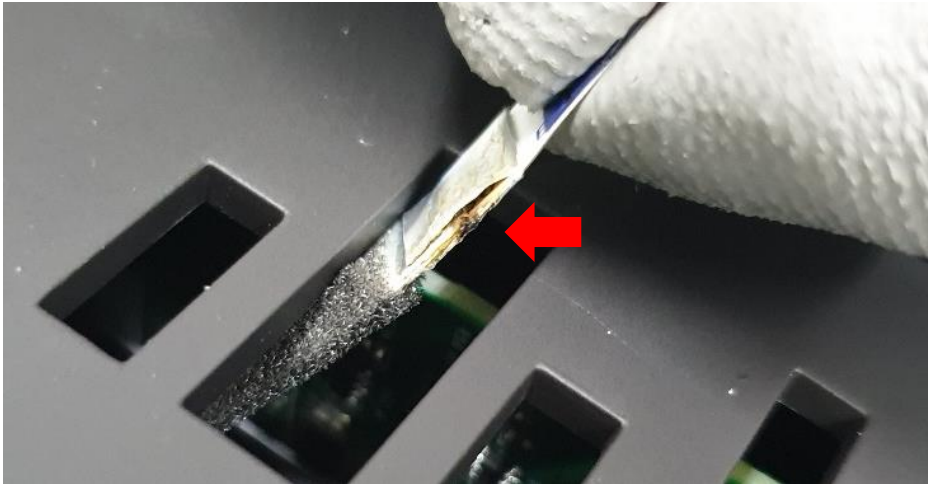
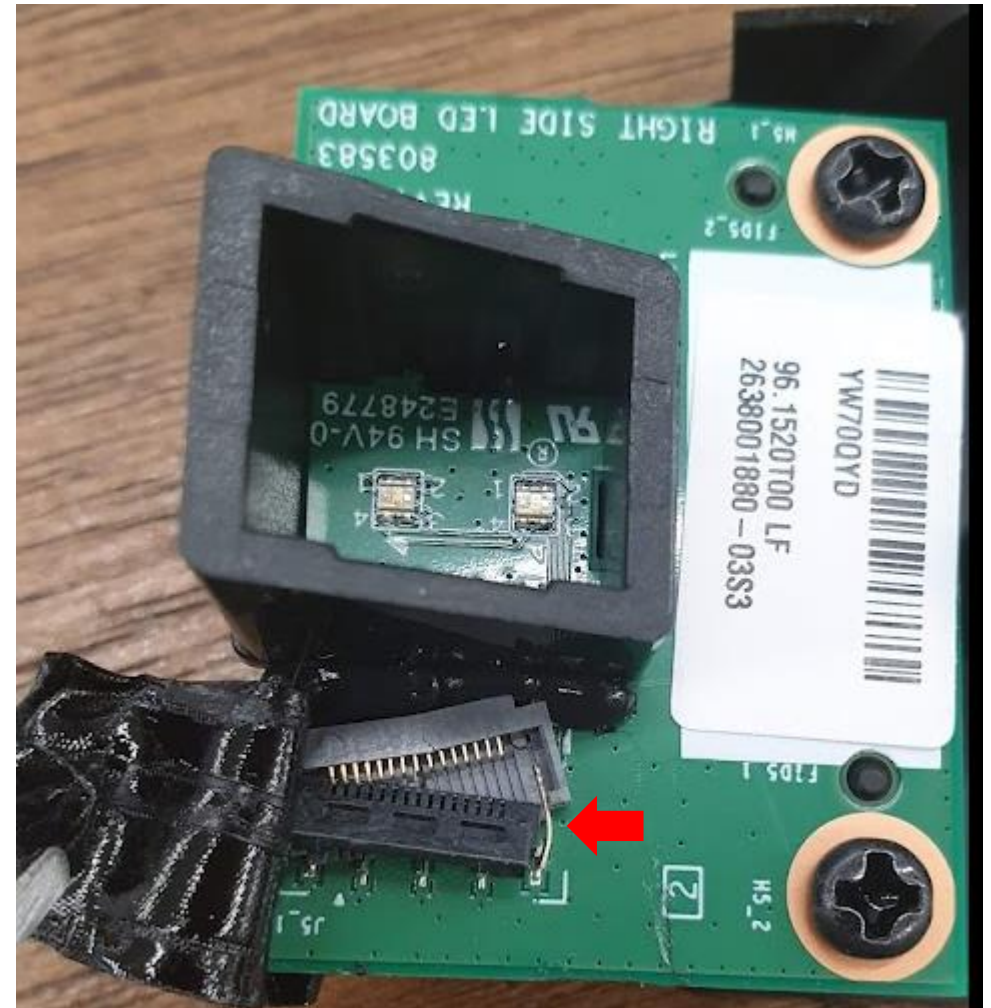
- Side LED not working
  - Issue grade : Critical
  - Symptom : R-Ch Side LED is not turn on
    - Defect unit Q'ty : 1pcs / 244pcs
    - Defect rate : 0.4%

- ALT initial review
  - Disassembly Front grill, the FFC was damaged.
  - Disassembly side LED ass'y, the FFC connector broken due to top cover rib
- ALT Action
  - Replace the Side LED PCBA, FFC cable
- Factory Action item
  - FXN should be submit 8D report
    - Check and verify rib cutting result at the factory

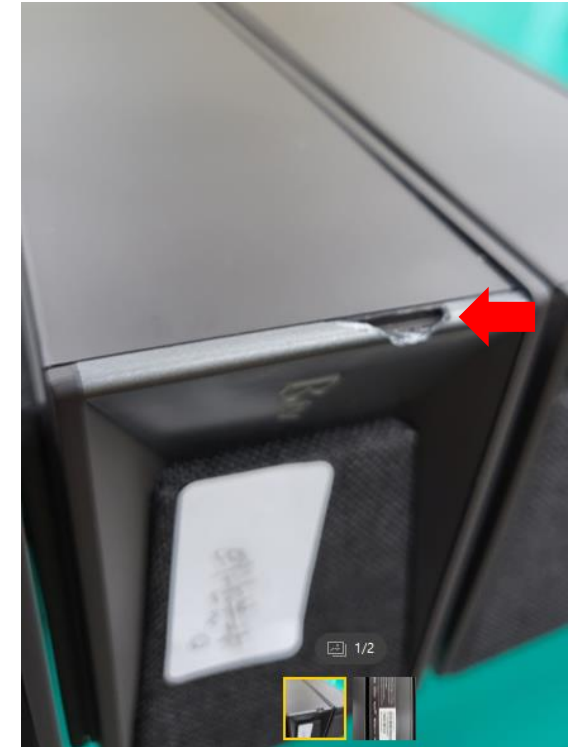
- BTV deco plate broken

- Issue grade : Major
- Symptom
  - Left side BTV deco plate broken
  - Defect unit Q'ty : 1pcs / 244pcs
  - Defect rate : 0.4%

- ALT initial review
  - Before packing, BTV logo plate may broken.
  - There were no fragments inside the packaging.
- Factory Action item
  - ADD visual check point – PQC / OBA
  - FXN should be submit 8D report
    - Need to update SOP and WI (Work Instruction)
    - Provide the preventive action

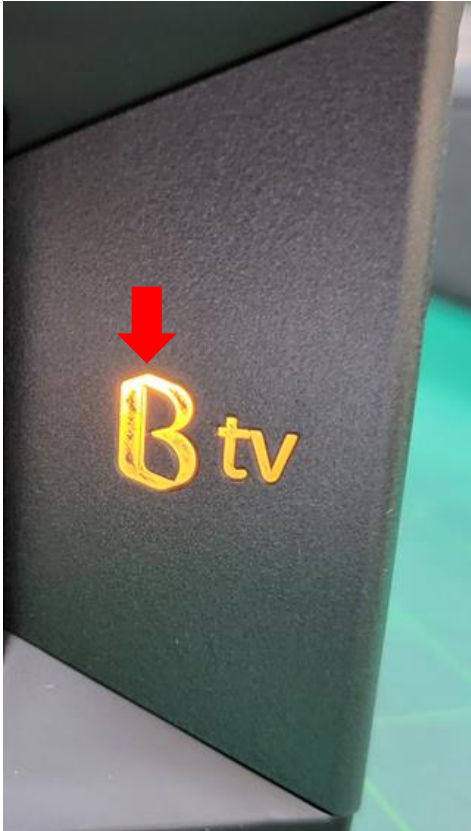
- BTV deco plate NG

- Issue grade : Major
- Symptom
  - Attachment line NG
  - Defect unit Q'ty : 3 pcs / 244 pcs
  - Defect rate : 1.33%

- ALT initial review
  - BTV logo plate quality improvement in progress
    - Poor quality Lasor cutting
  - ALT will send to Vender 8D report to factory
- Factory Action item
  - Please add the CTQ point – IQC, PQC, OBA
  - Please check the cosmetic point, and contact Vender(Inkel) direct.
  - Vender will provide replacement parts.

Poor Lasor cutting

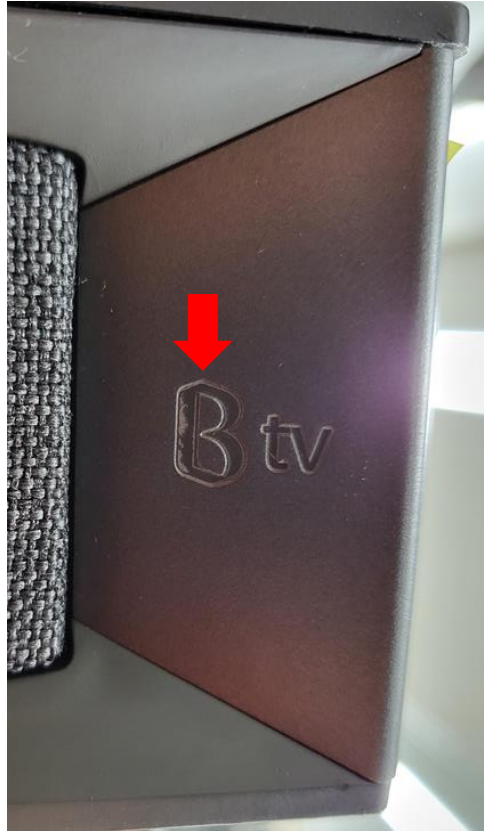
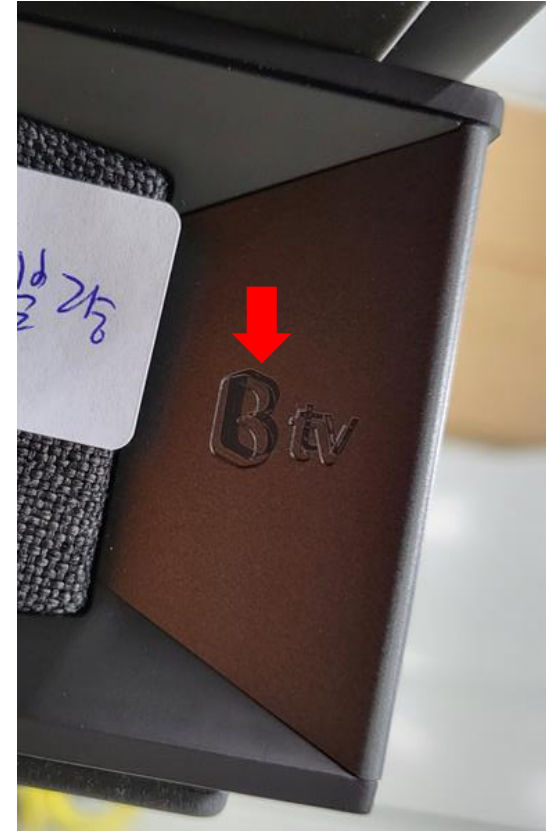
Shifted Lasor cutting

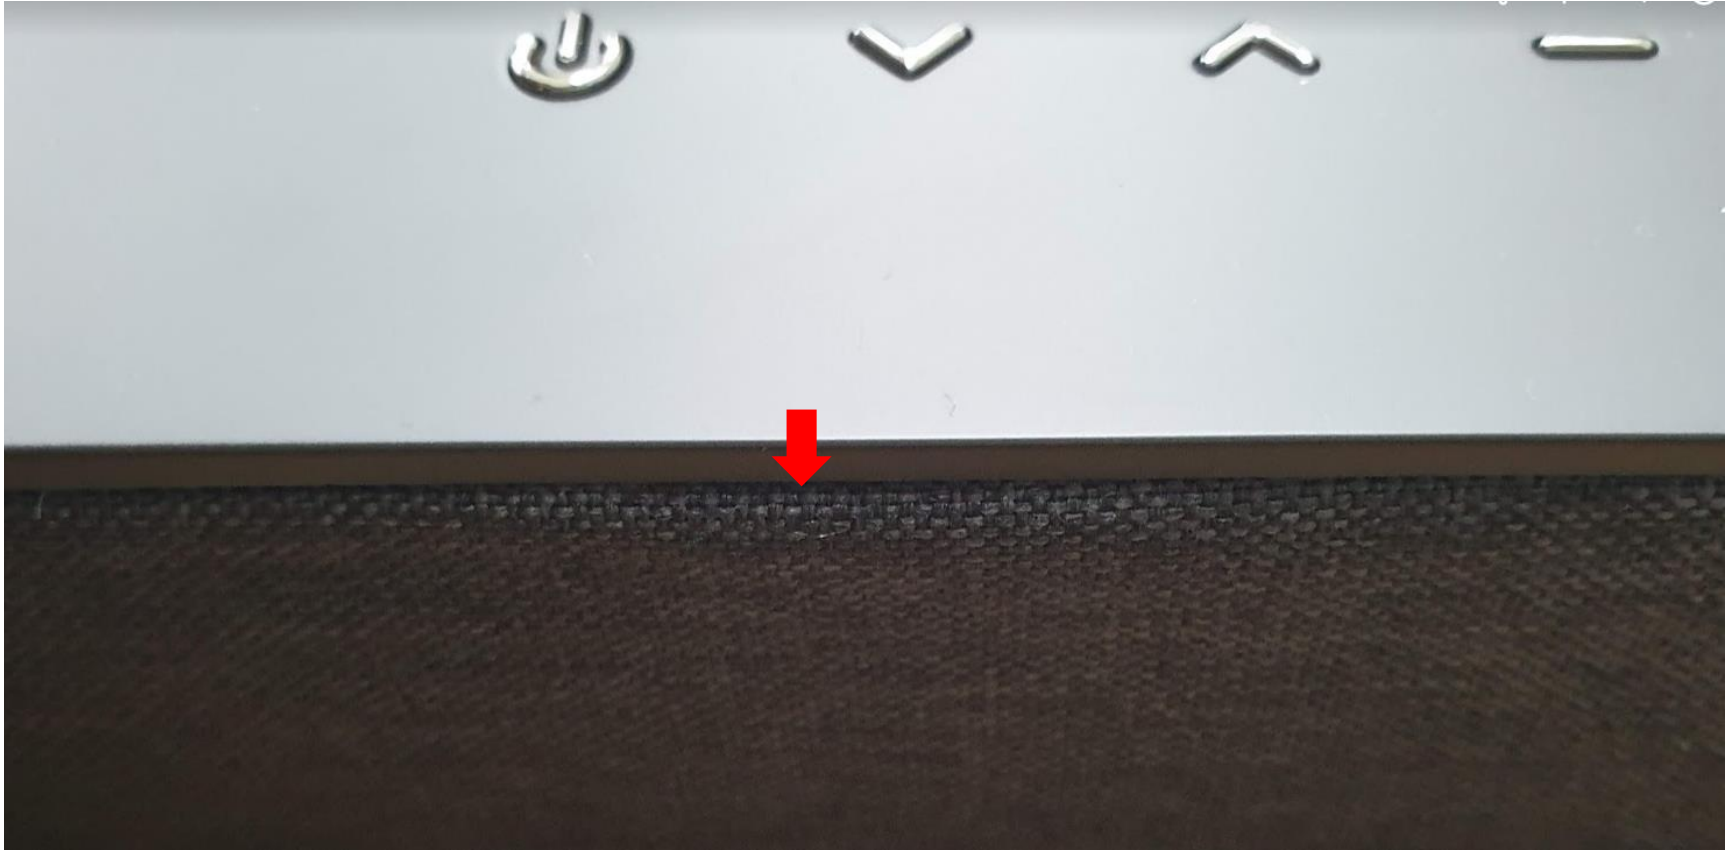
- Grill attachment NG

- Issue grade : Major
- Symptom
  - Attachment line NG
  - Defect unit Q'ty : 1pcs / 244pcs
  - Defect rate : 0.4%

- ALT initial review
  - Grill assembly quality improvement in progress
    - grill fabric adhesive apply NG
    - If the fabric does not adhere completely, It can cause vibration noise.
  - ALT will send to Vender 8D report to factory
- Factory Action item
  - Please add the CTQ point – IQC, PQC, OBA
  - Please check the cosmetic point, and contact Vender(Inkel) direct.
  - Vender will provide replacement parts.

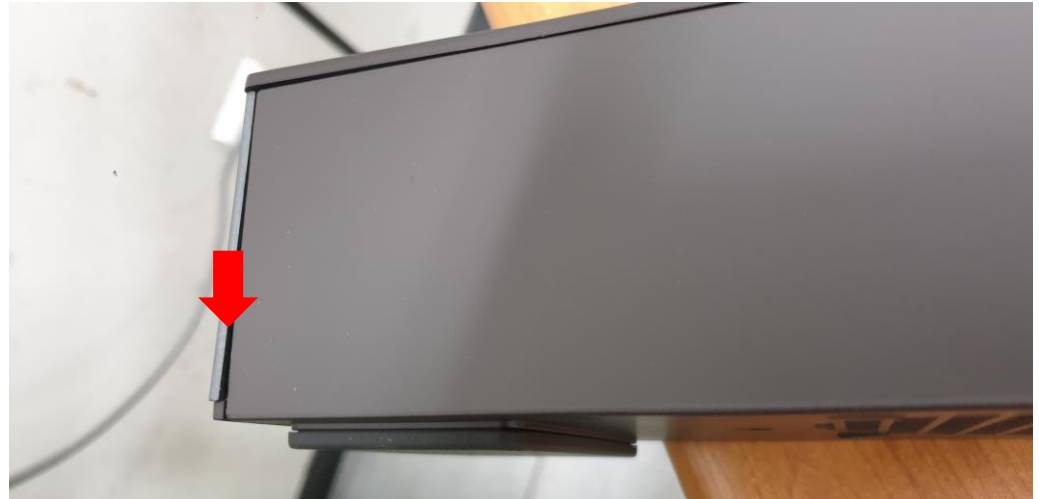
- Side deco plate poor attachment

- Issue grade : Minor
- Symptom
  - poor attachment
  - Defect unit Q'ty : Not counted
  - Defect rate : about 10%

- ALT initial review
  - Attachment line : visual inspection NG
  - **It's still need improvement**
- Action item
  - FXN should be submit 8D report
    - Need to update SOP and WI (Work Instruction)
    - Provide the preventive action
