## 2022.01 ~03 Mass production inspection

Model Name: BFX-UA300

Document Version: ALT\_STB\_MP\_CSMTINS\_001

Issued Date: 2022.04.08

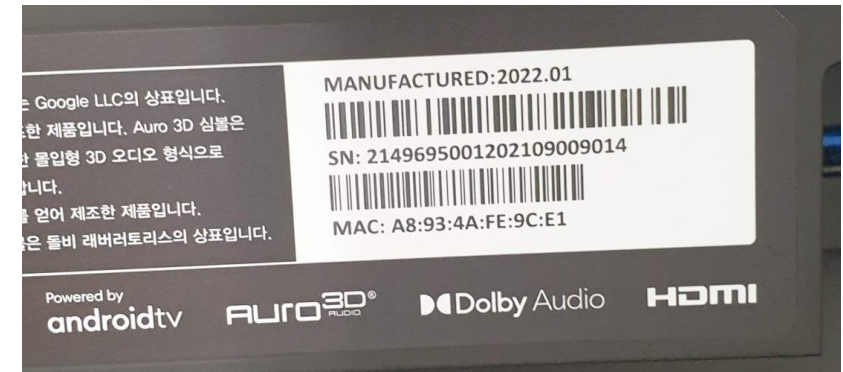
- No boot
  - Issue grade : Critical
  - Symptom : No boot
    - Defect unit Q'ty : 1pcs / 315 pcs
    - SN : 2149695001202109009014
- ALT initial review
  - Same issue : Mantis ID 1373 ([link](#))
- ALT Action
  - Replace the main PCBA
- Factory Action item
  - FXN should be submit 8D report
    - Need to update SOP and WI (Work Instruction)
    - Provide the preventive action

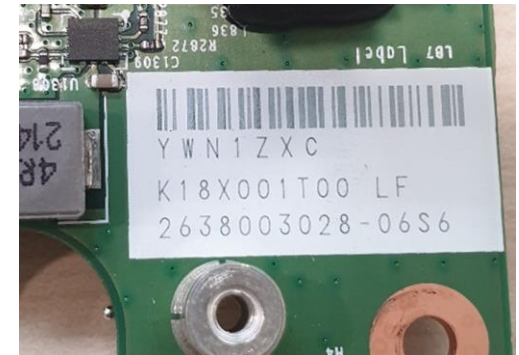
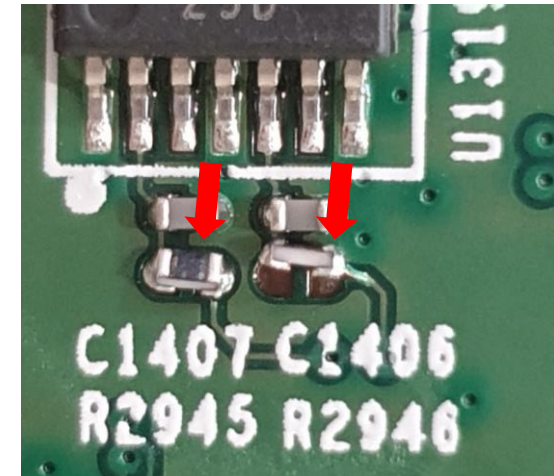
- Aux is not working
  - Issue grade : Critical
  - Symptom : Aux is not working
    - Defect unit Q'ty : 1pcs / 315 pcs
    - PCBA SN : YWN1ZXC
- ALT initial review
  - Aux is not working, R2945 and R2946 PCB pattern was broken
  - SW engineer review history  
<https://mantis.cnsbg.foxconn.com/vas/view.php?id=1460>
- ALT Action
  - Replace the main PCBA
- Factory Action item
  - FXN should be submit 8D report
    - Need to update SOP and WI (Work Instruction)
    - Provide the preventive action

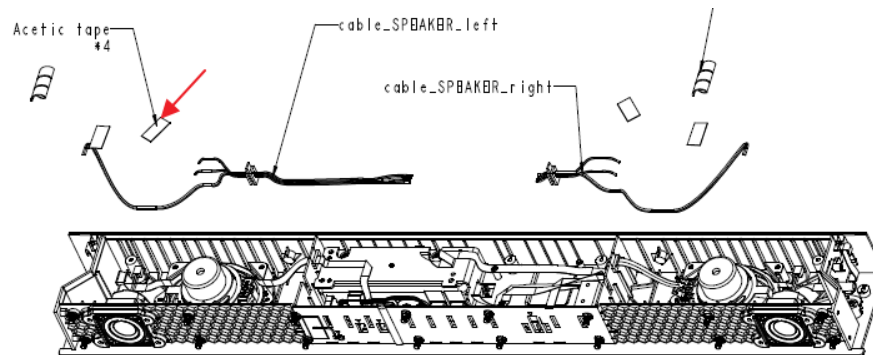
- Acetic tape missing
  - Issue grade : Minor
  - Symptom
    - Missing acetic tape
    - Defect unit Q'ty : 1 / 315pcs
    - SN : 2149695001202109009014
- ALT initial review
  - This tape missing may make some noise during STB operation

- Action item
  - FXN should be submit 8D report
    - Need to update SOP and WI (Work Instruction)
    - Provide the preventive action

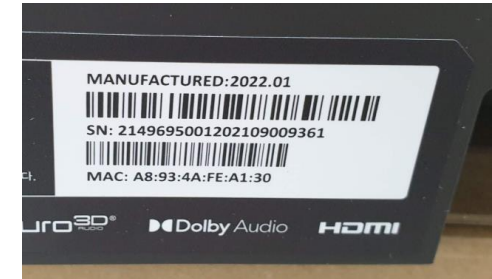
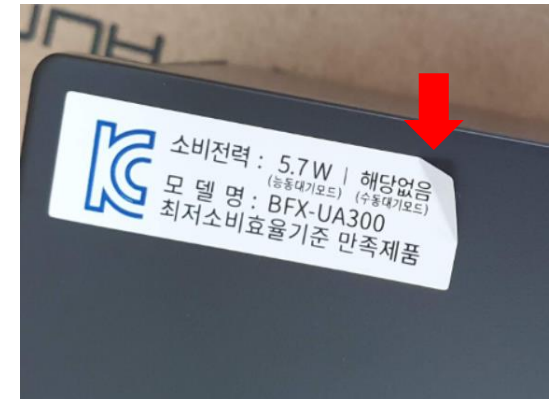
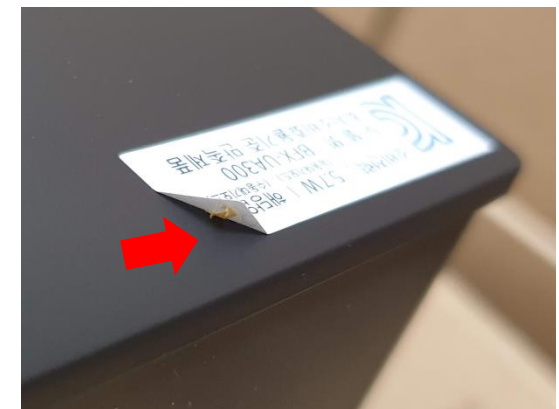
- KC label attachment NG

- Issue grade : Major
- Symptom
  - KC label is NG
  - Defect unit Q'ty : 1 / 315pcs
  - SN : 2149695001202109009361

- KC label NG

- FXN should be provided spear KC label
- FXN should be submit 8D report
  - Need to update SOP and WI (Work Instruction)
  - Provide the preventive action

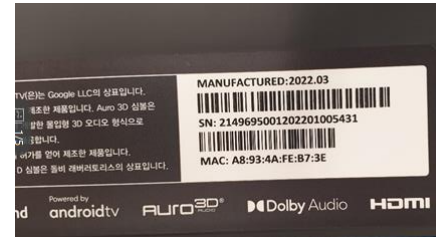
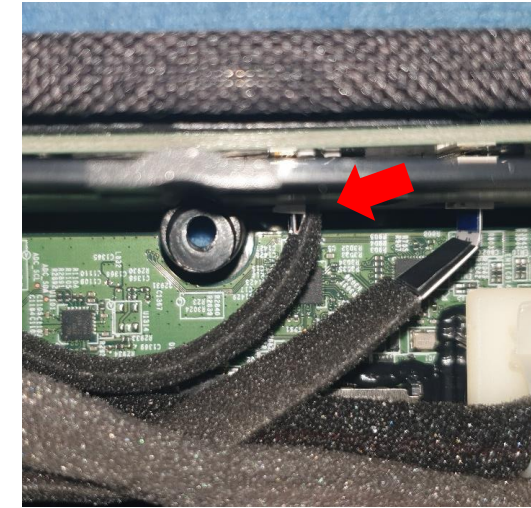
- LED FFC bad assembly

- The LED FFC cable was assembled with a bent
- Defect unit Q'ty : 1 / 315pcs
- SN : 214969500120202201005431

- LED FFC change

- FXN should be submit 8D report
  - Need to update SOP and WI (Work Instruction)
  - Provide the preventive action

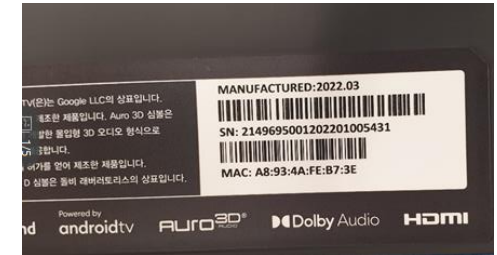
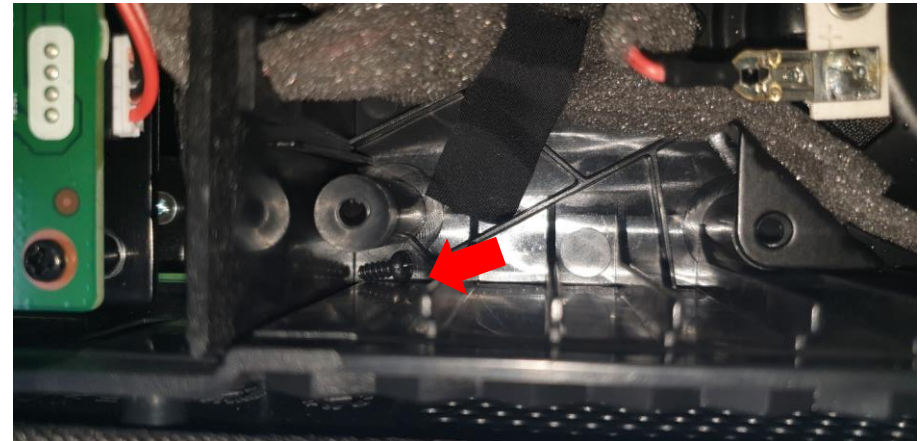
- Inside the screw

- A noise is heard when the product is shaken (Link)
- Defect unit Q'ty : 1 / 315pcs
- SN : 214969500120202201005431

- Remove the screw

- FXN should be submit 8D report
  - Need to update SOP and WI (Work Instruction)
  - Provide the preventive action – Add product shake test after final assembly

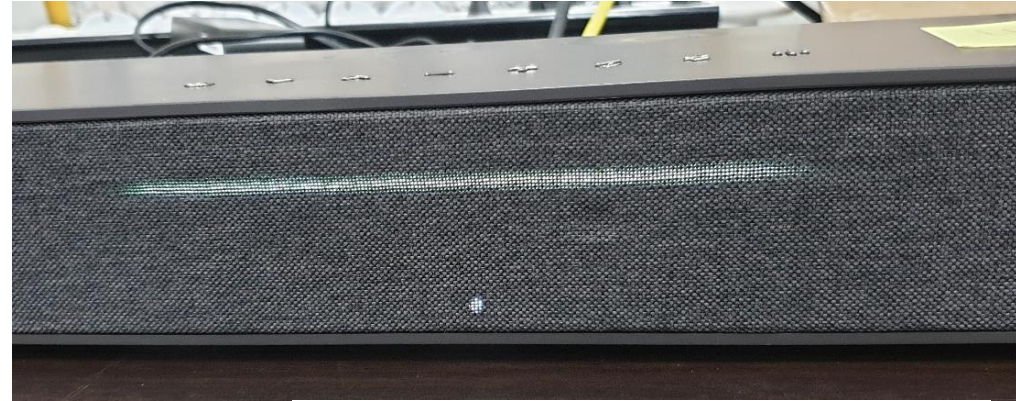
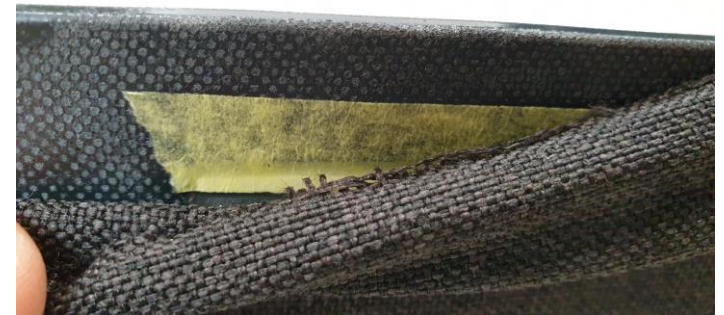
- NUGU LED slightly different color

- Nugu LED looks yellowish
    - Defect unit Q'ty : 1 / 315pcs
    - SN : 2149695001202201005410

- Housing vender is not removed masking tape.
    - Request 8D report about this

- FXN should check LED Color
      - Need to update SOP and WI (Work Instruction)

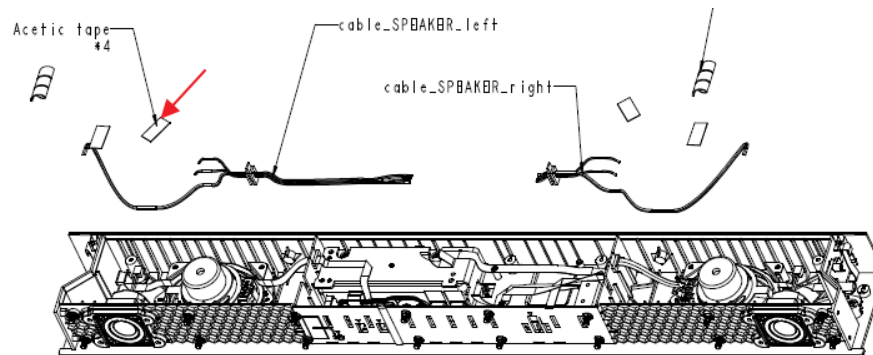
- Acetic tape miss align
  - Issue grade : Minor
  - Symptom
    - acetic tape miss align
    - Defect unit Q'ty : 1 / 315pcs
    - SN : 2149695001202109007608

- ALT initial review
  - This miss align is make more rear side gap. (+ 0.1mm)

- Action item
  - FXN should be submit 8D report
    - Need to update SOP and WI (Work Instruction)
    - Provide the preventive action

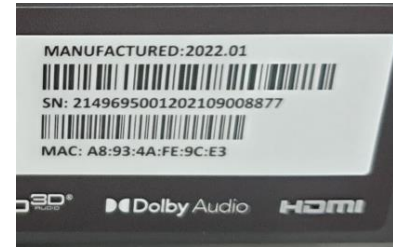
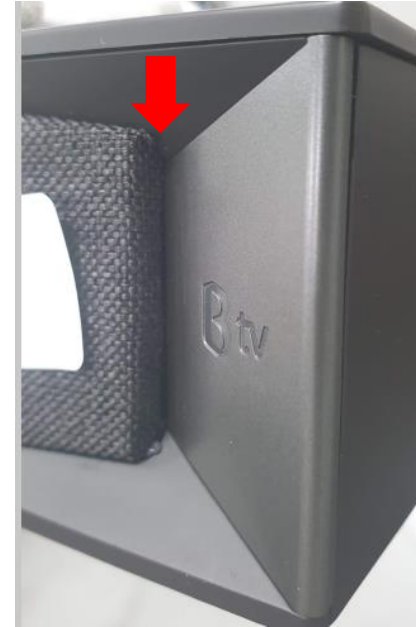
- Grill assembly NG

- Issue grade : Minor
- Symptom
  - Grill ass'y is not fully assembled
  - Defect unit Q'ty : 1 / 315pcs
  - SN : 2149695001202109008877

- ALT initial review
  - Grill ass'y was not fully push.
  - Re assembly the front Grill assy
- Action item
  - FXN should be submit 8D report
    - Need to update SOP and WI (Work Instruction)
    - Provide the preventive action

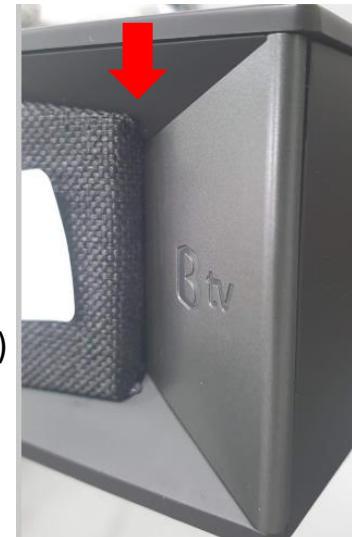
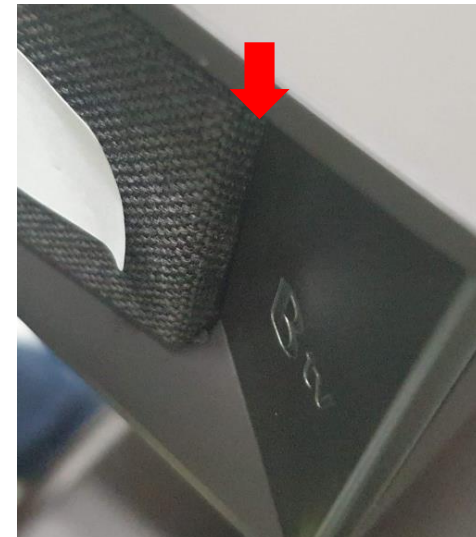
- Issue grade : Major
  - Top scratch
    - Defect unit Q'ty : 8pcs / 1260pcs
    - Defect rate : 0.63%
  - Bottom scratch
    - Defect unit Q'ty : 2pcs / 1260pcs
    - Defect rate : 0.15%
- ALT initial review
  - Replace the housing : Top / Bottom / Grill ass'y
- Factory Action item
  - ADD visual check point – PQC / OBA
  - Need to update SOP and WI (Work Instruction)

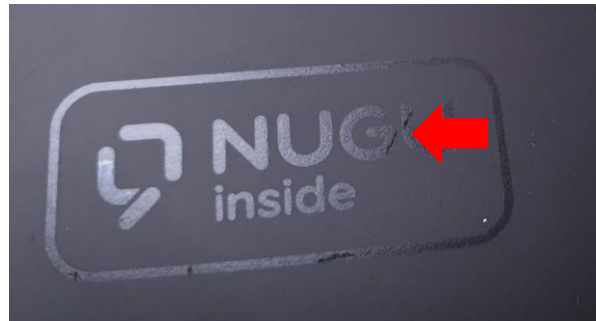
- Issue grade : Major
  - Symptom
    - NUGU logo painting NG
    - SN : 2149695001202109007608
- ALT initial review
  - Replace the Top housing

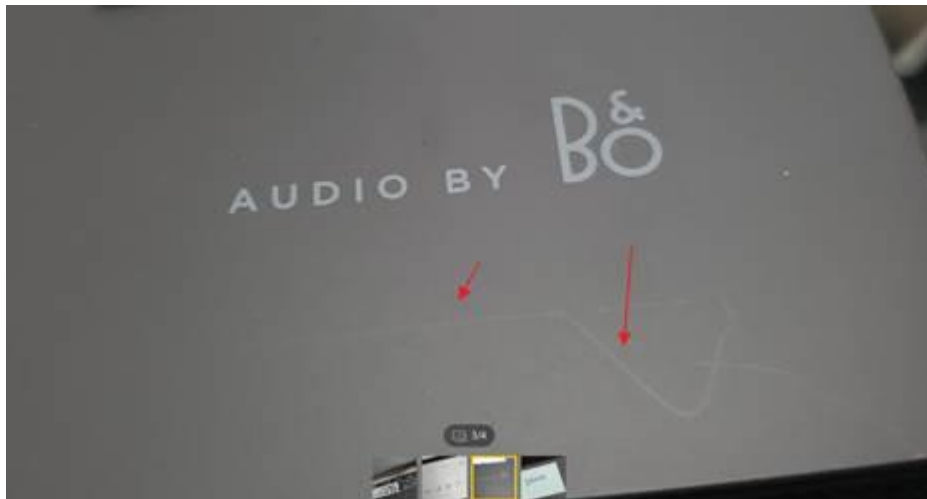
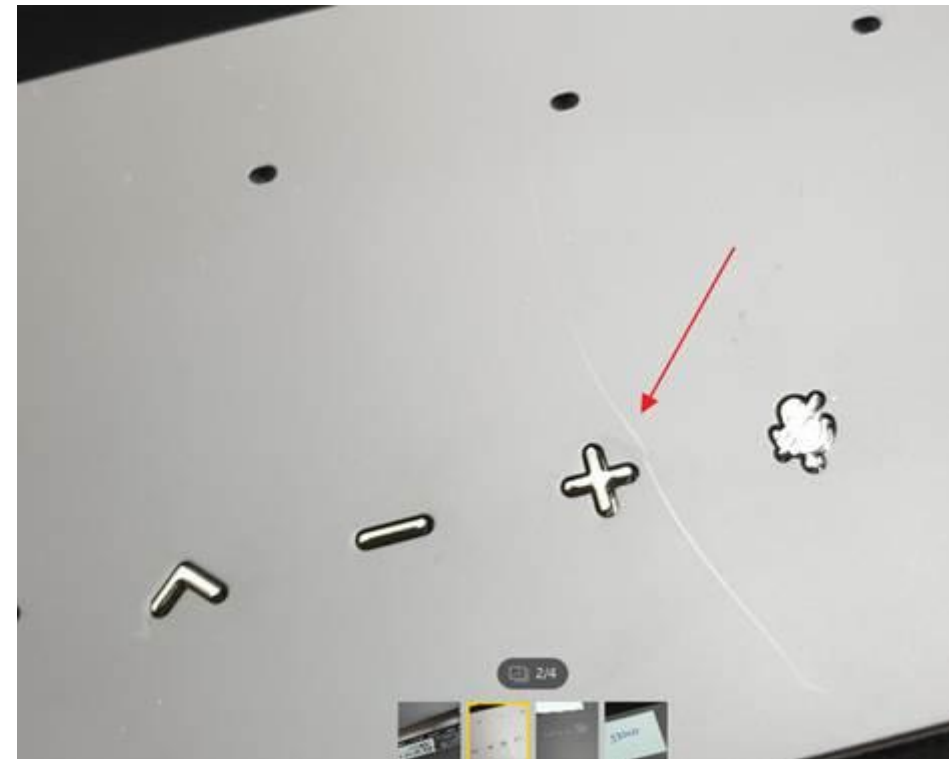
- Issue grade : Major
  - Symptom
    - Top case
    - SN : 2149695001202201005009

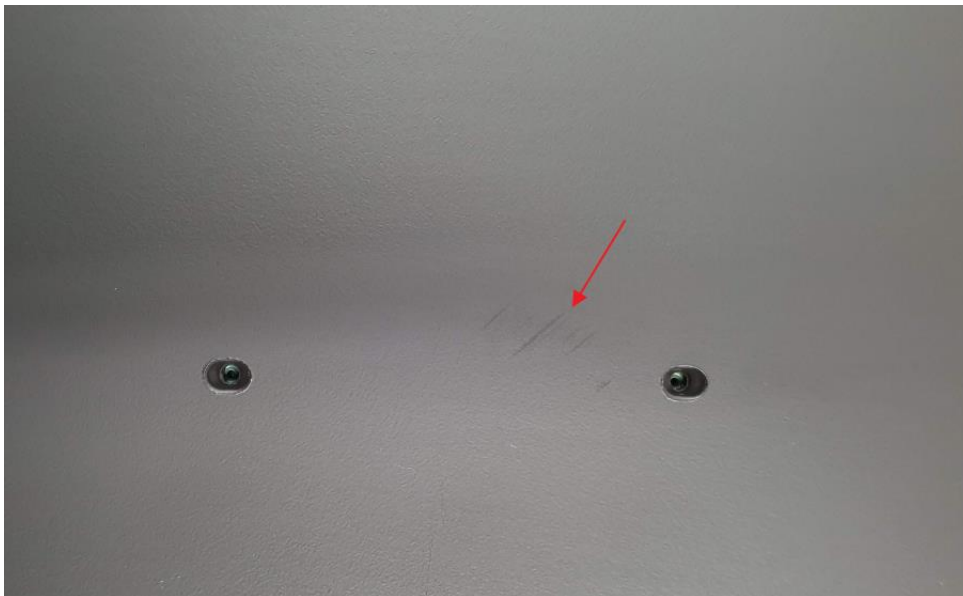
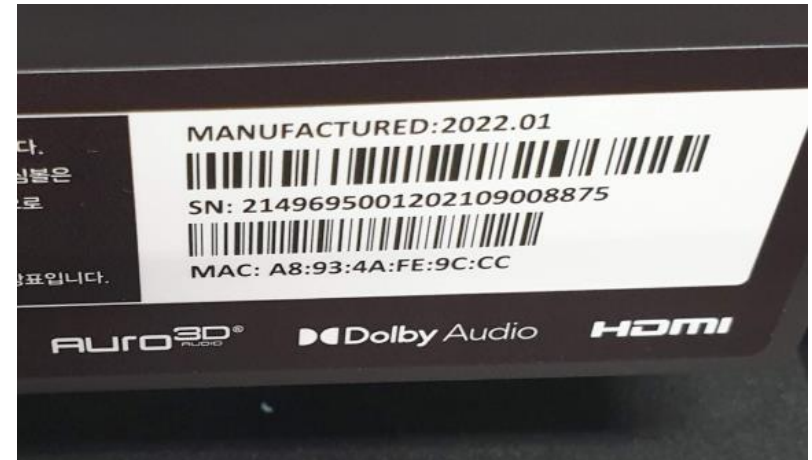
- Issue grade : Major
  - Symptom
    - Top case
    - SN : 2149695001202109008875

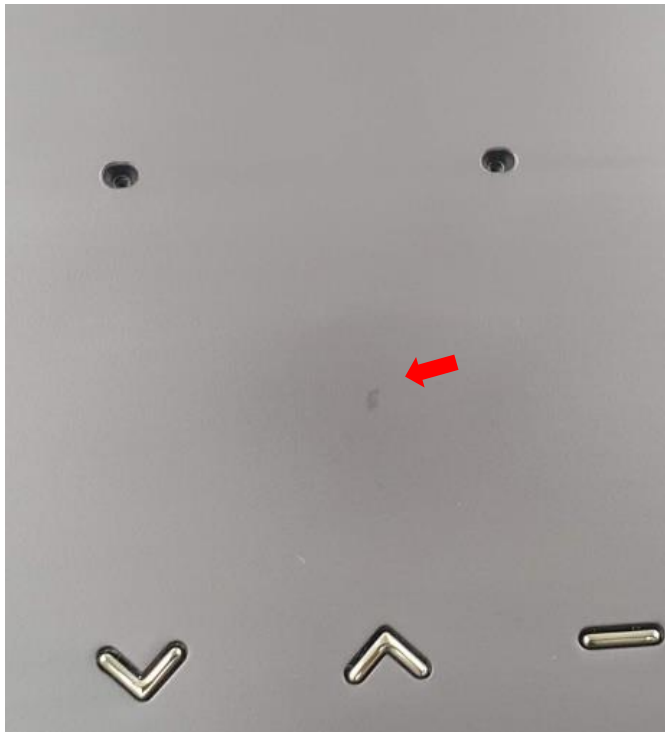
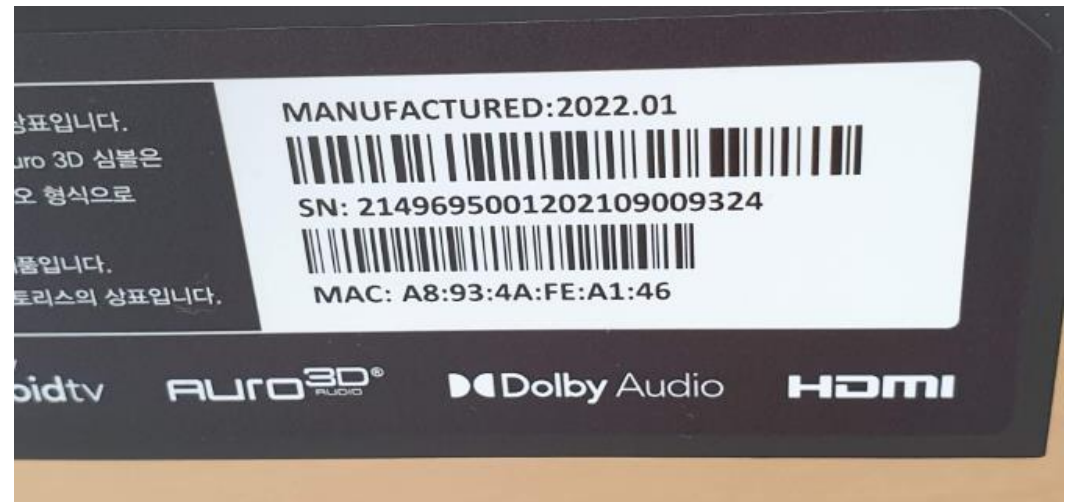
- Issue grade : Major
  - Symptom
    - Top case
    - SN : 2149695001202109009324

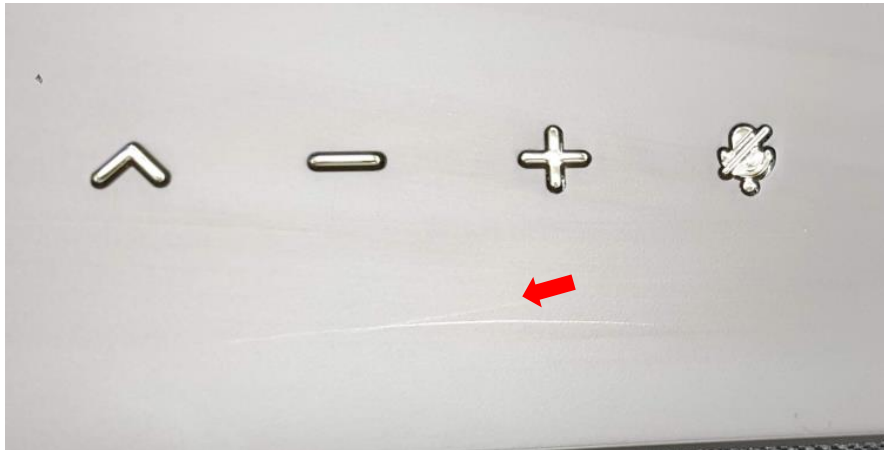
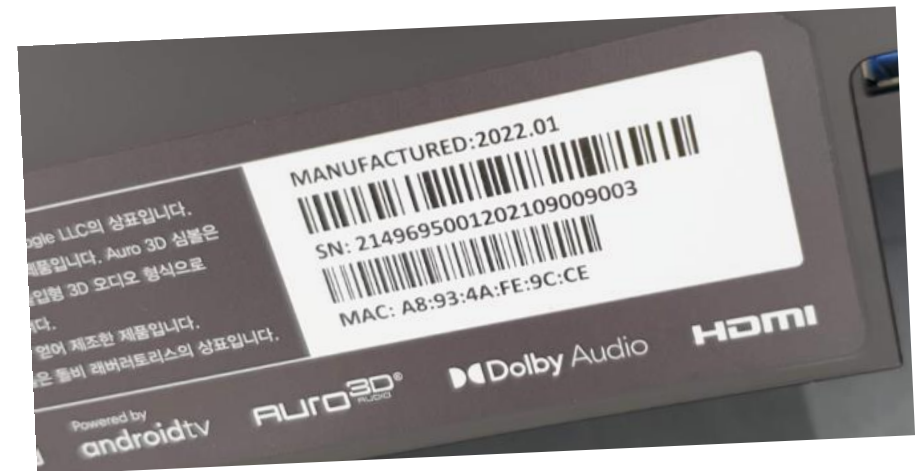
- Issue grade : Major
  - Symptom
    - Top case
    - SN : 2149695001202109009003

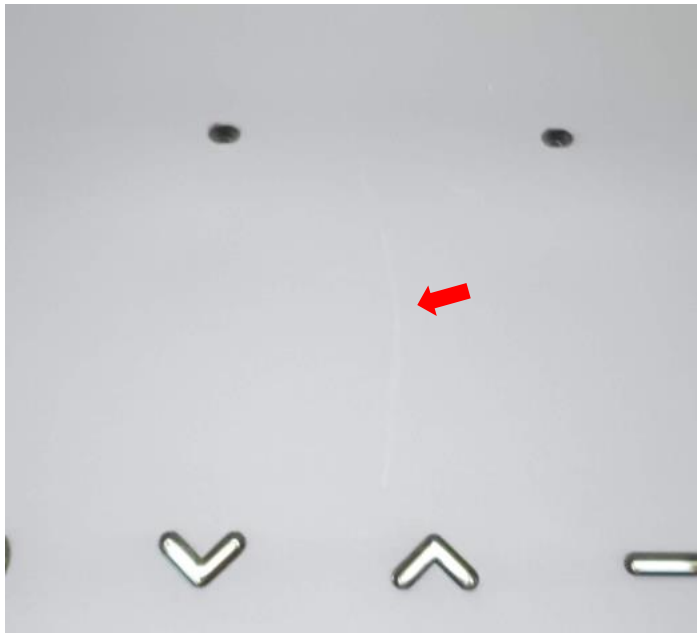
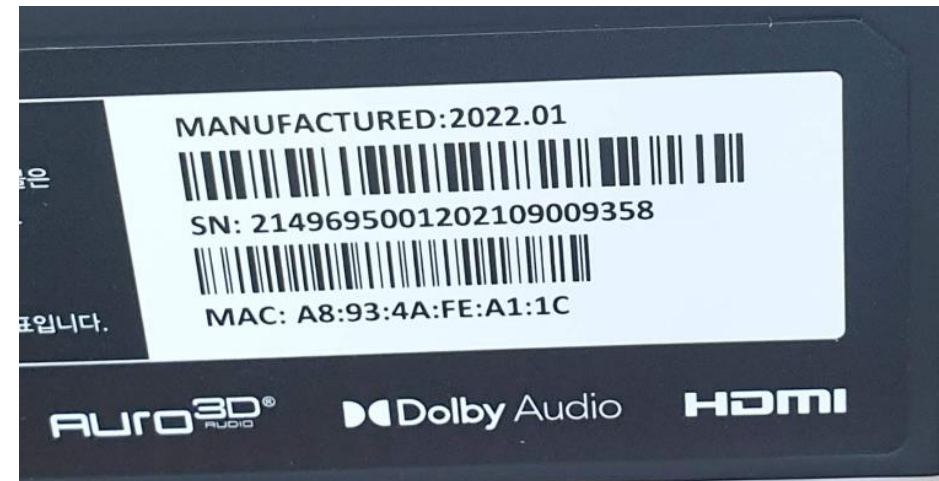
- Issue grade : Major
  - Symptom
    - Top case
    - SN : 2149695001202109009358

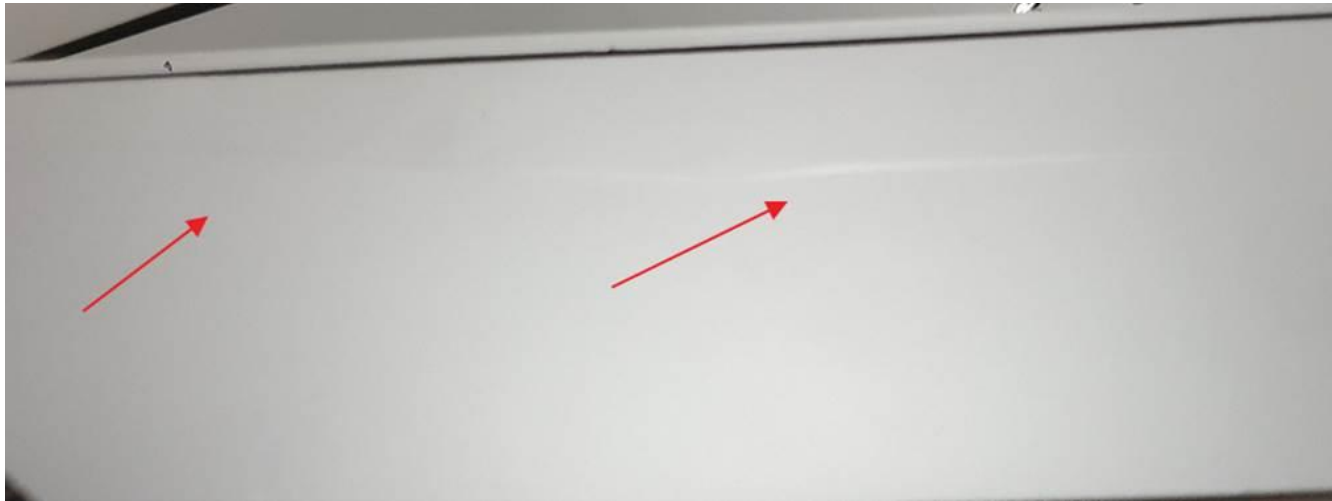
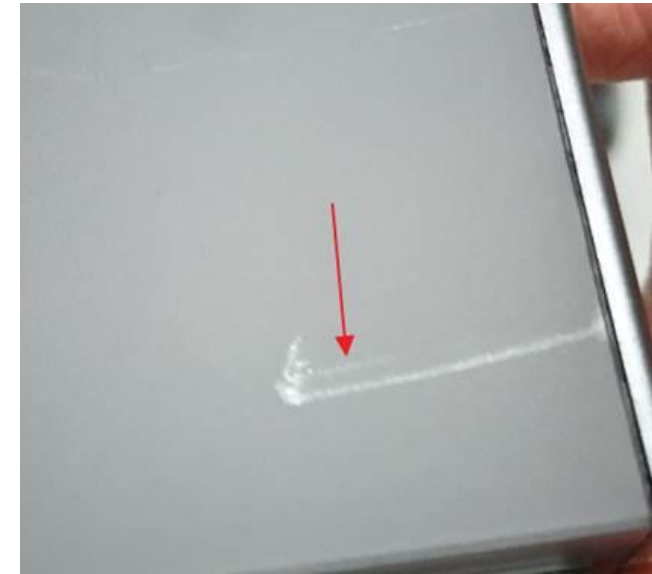
- Issue grade : Major
  - Symptom
    - Bottom case
    - SN : 2149695001202201005442

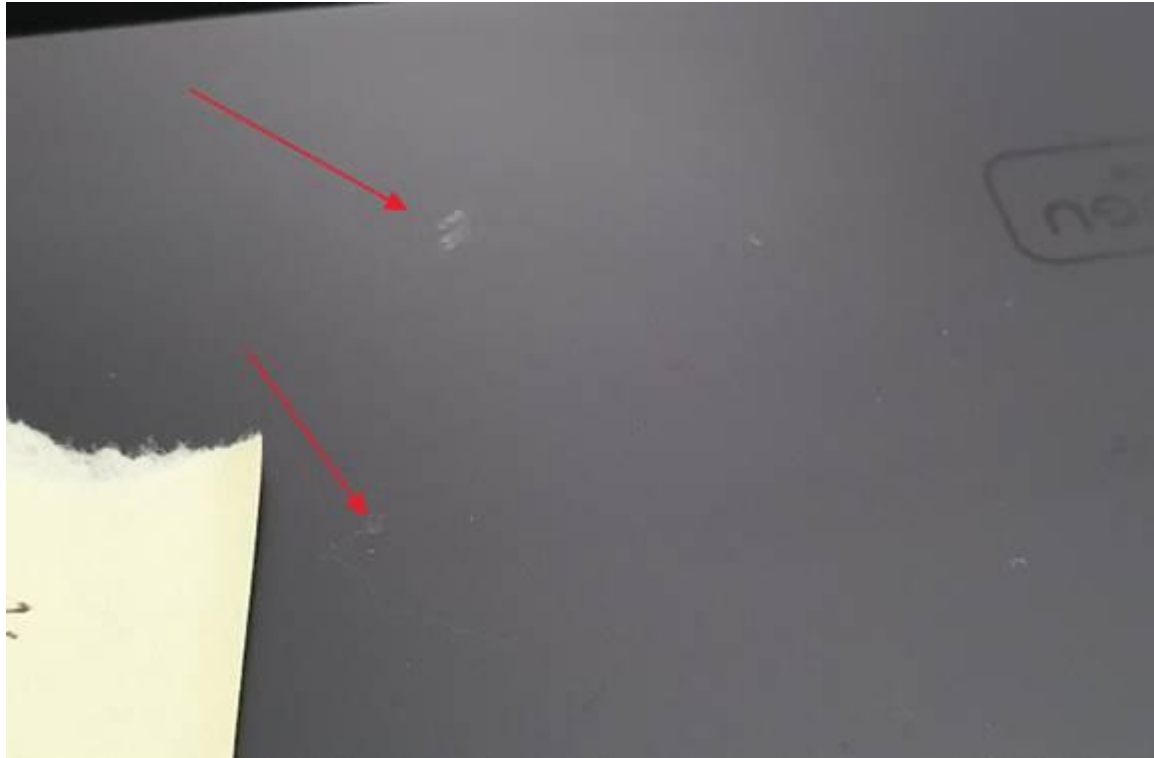
- Issue grade : Major
  - Symptom
    - Bottom case
    - SN : 2149695001202201005431

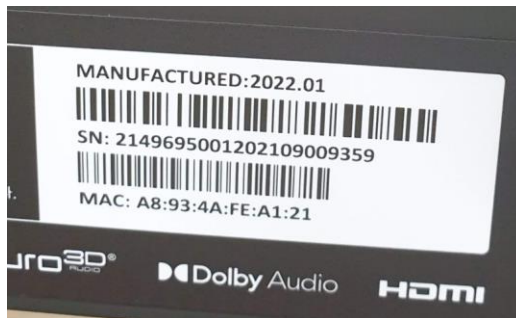
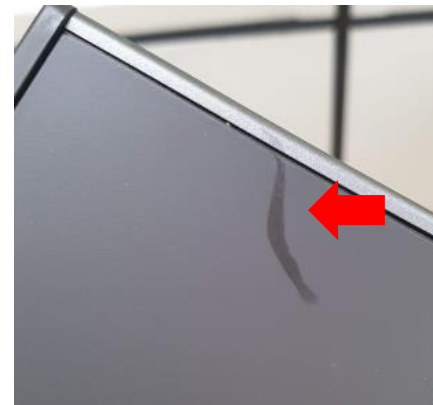
- Issue grade : Major
  - Symptom
    - Rear scratch
    - SN : 2149695001202109009359
- ALT initial review
  - Replace the bottom case

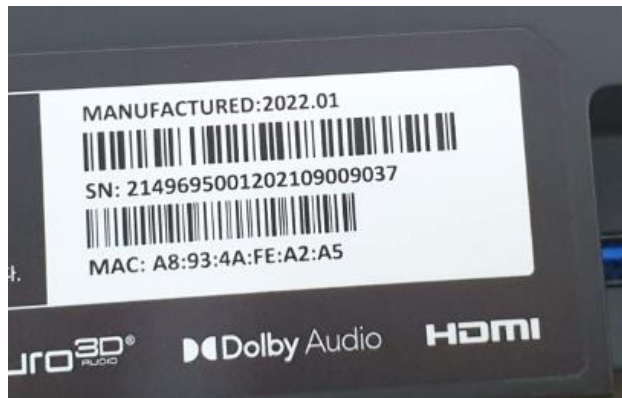
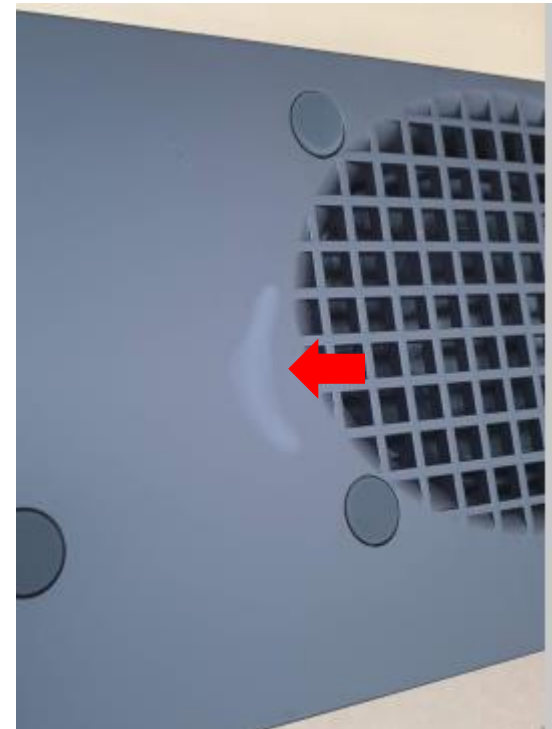
- Issue grade : Major
  - Symptom
    - Rear scratch
    - SN : 21496950012021090099037
- ALT initial review
  - Replace the bottom case
