## 2023.05 Mass production inspection

Model Name: BFX-UA300

Document Version: ALT\_STB\_MP\_CSMTINS\_001

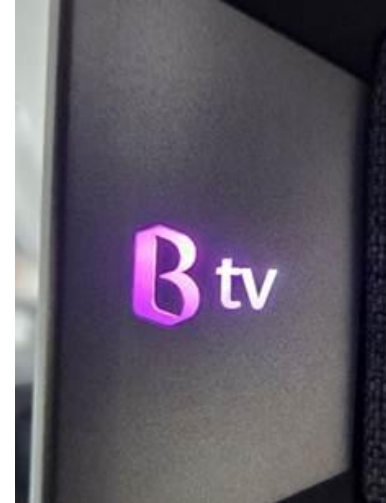
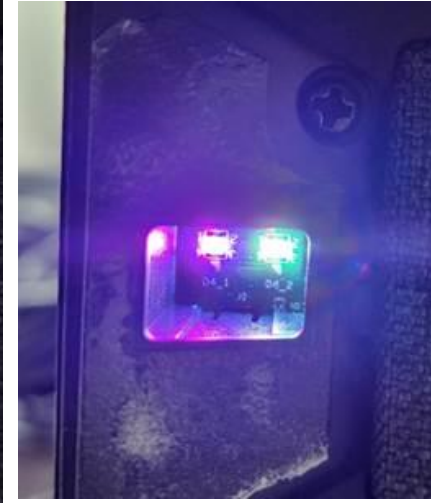
- Side LED – R is different color
  - Issue grade : Major
  - Symptom : turn on different color
    - Defect unit Q'ty : 1 / 315pcs
    - S/N : 2149688001202303001179
- ALT initial review
  - Visual check : found abnormal.
  - R side FFC cable was not fully inserted.
- ALT Action
  - Replace assembly LED – R FFC cable
- Action item
  - FXN should be submit 8D report
    - Request the enhanced the PQC at factory.
      - Add each side LED check process
    - Provide the preventive action

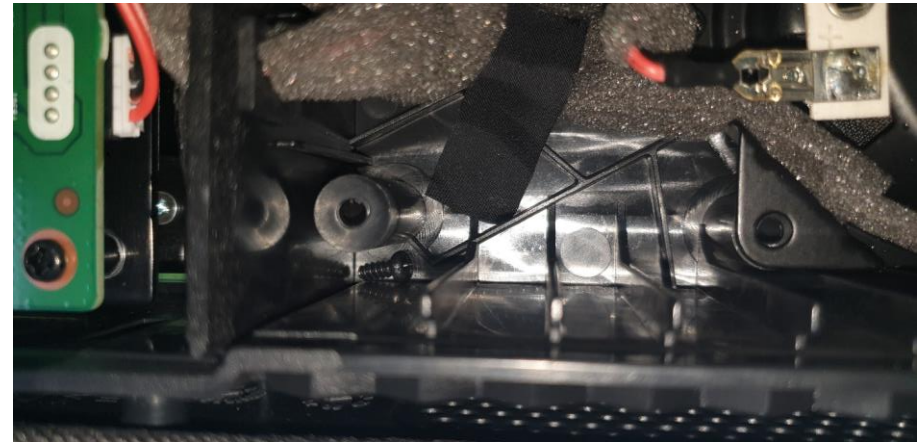
- Screw inside
  - Issue grade : Major
  - Symptom : screw is inside the housing
    - Defect unit Q'ty : 1 / 315pcs
    - S/N : 2149688001202303002967
- ALT initial review
  - Visual check : No found abnormal.
- ALT Action
  - Remove the screw
- Action item
  - FXN should be submit 8D report
    - Check this unit speaker test result.
    - Provide the preventive action
