## 2023.09 Mass production inspection

Model Name: BFX-UA300

Document Version: ALT\_STB\_MP\_CSMTINS\_001

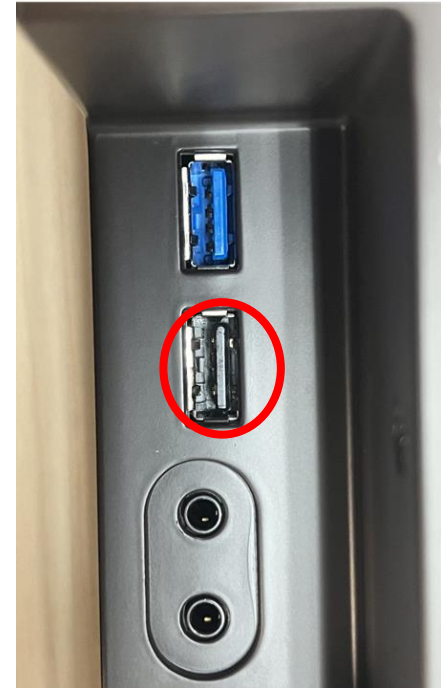
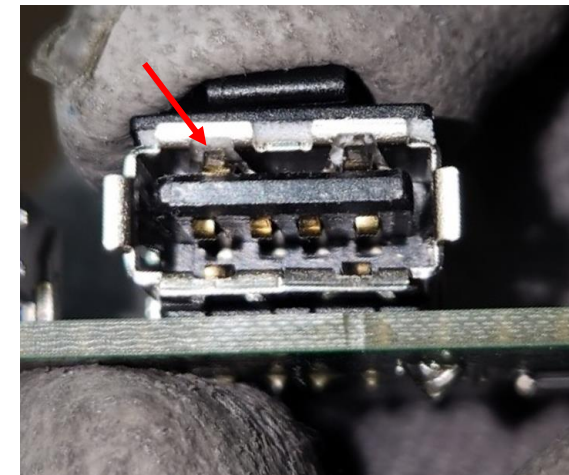
- USB 2.0 port issue
- Issue grade : Major
  - Symptom : Issue not inserting into USB 2.0 port
    - Defect unit Q'ty : 1 / 200pcs
    - S/N : 2149695001202303011195
  - ALT initial review
    - Visual check : ~~damaged~~ deformed hook pin on USB 2.0 port .
      - Set level : not insert USB
      - PCBA level : hard to insert USB, insertion force was increased.
      - Upper side hook deformed
    - it might be pressured on the USB connector after assembling the surrounding cables and housing.
  - ALT Action
    - Replace Main B/D
  - Action item
    - FXN should be submit 8D report
      - Need to find out why it wasn't detected in factory tests
      - Provide the preventive action
