## 2023.12 Mass production inspection

Model Name: BFX-UA300

Document Version: ALT\_STB\_MP\_CSMTINS\_001

Issued Date: 2024.01.18

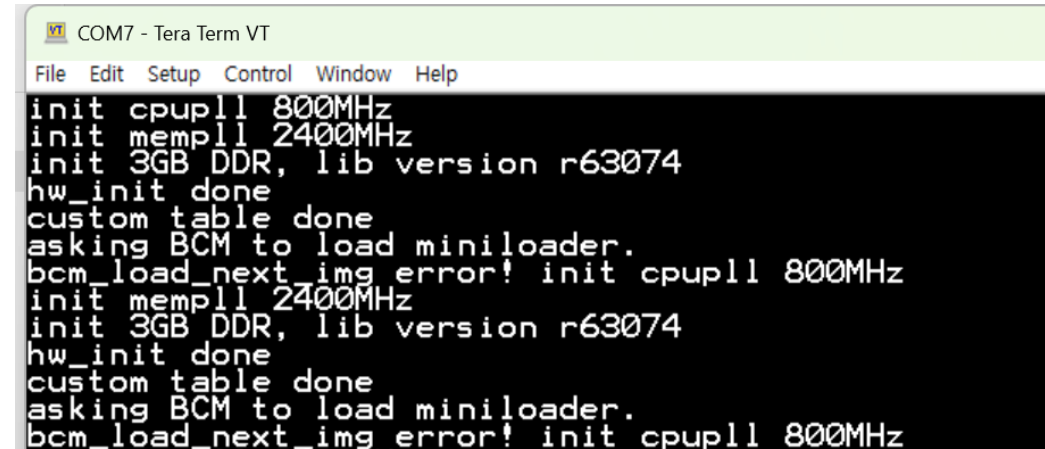
- No boot

- Issue grade : Critical
- Symptom : No boot
  - Defect unit Q'ty : 1 / 316pcs
  - S/N : 2149695001202303021988

- Visual check : No found abnormal.
- Console log : Abnormal - **bcm\_load\_next\_img error!**

```
COM7 - Tera Term VT
File Edit Setup Control Window Help
init cpupll 800MHz
init mempll 2400MHz
init 3GB DDR, lib version r63074
hw_init done
custom table done
asking BCM to load miniloader.
bcm_load_next_img error! init cpupll 800MHz
init mempll 2400MHz
init 3GB DDR, lib version r63074
hw_init done
custom table done
asking BCM to load miniloader.
bcm_load_next_img error! init cpupll 800MHz
```

- Replace the Main PCBA

- FXN should be submit 8D report
  - Check all of factory test log.
  - Need to find out why it wasn't detected in factory tests
  - Provide the preventive action

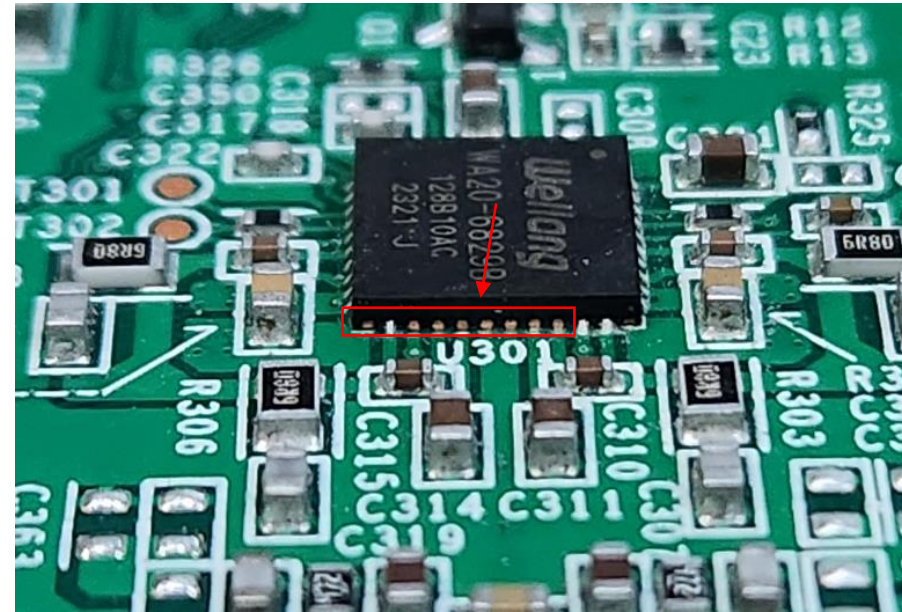
- Noise sound – R channel
  - Issue grade : Critical
  - Symptom : noise sound output
    - Defect unit Q'ty : 1 / 316pcs
    - S/N : 2149695001202303021730
  - ALT initial review
    - Visual check : found abnormal -> Amp IC is not soldered.
    - Defect PCBA SN : YZ60RJM
  - ALT Action
    - Replace the Amp PCBA
  - Action item
    - FXN should be submit 8D report
      - Check this unit speaker test result.
      - Provide the preventive action including SMT inspection process of QFN IC

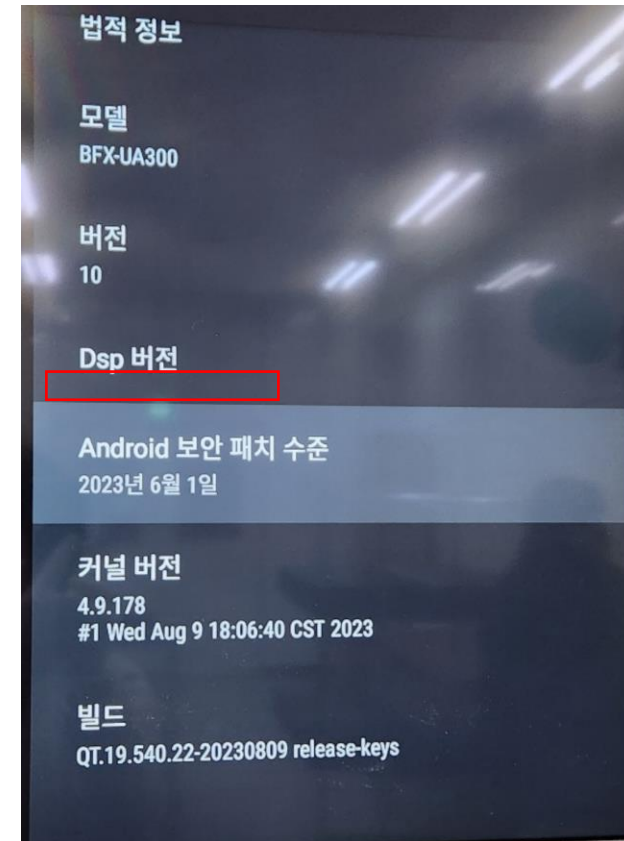
- No sound
  - Issue grade : Major
  - Symptom : No sound after 10 min of booting
    - Defect unit Q'ty : 1 / 316pcs
    - S/N : 2149695001202303021211
- ALT initial review
  - DSP version N/A
  - Visual check : found abnormal
    - FFC is shorted to GND
    - Kepton tape on the FFC, is not aligned.
- ALT Action
  - Replace the Amp FFC
- Action item
  - FXN should be submit 8D report
    - Need to find out why it wasn't detected in factory tests
    - Provide the preventive action

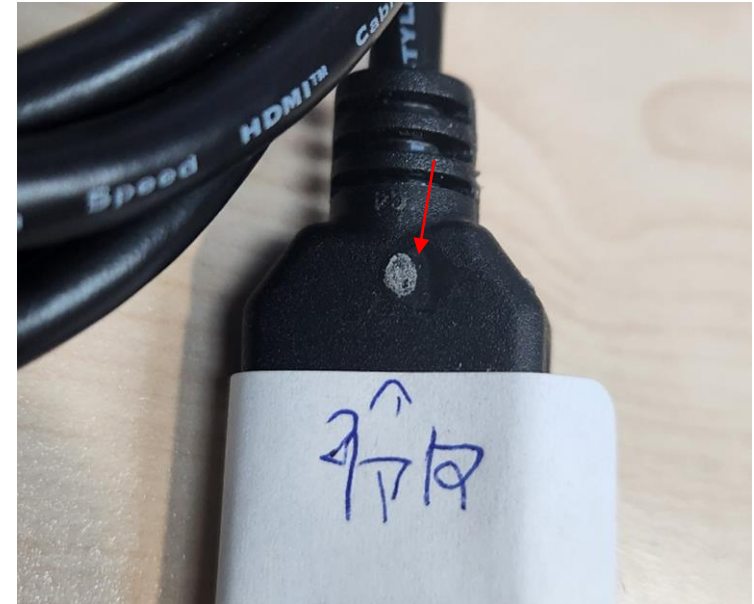
- HDMI Cable NG

- Issue grade : Minor

- HDMI Cable – cosmetic NG

- Visual check : found abnormal.

- Replace the HDMI Cable

- FXN should be submit FA report and vender FA report
      - Provide the preventive action
