# **8D Report for ALT STB BFX-UA300 Choke Burned and FFC Cable Melted Issue**

Date : 2022-March-26  
Version: 01

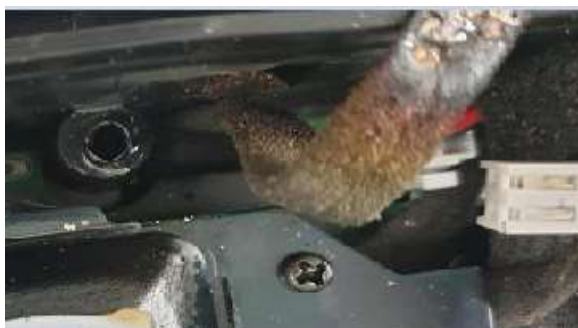
FFC cable melted

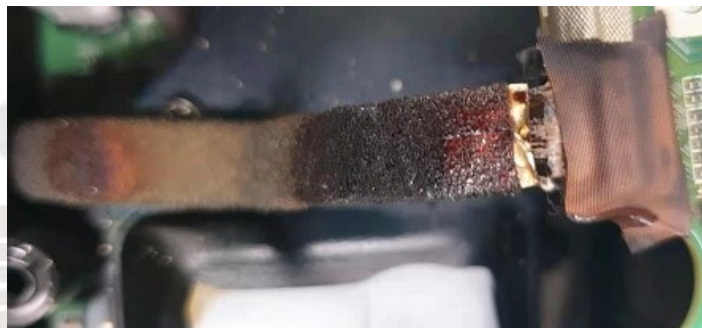
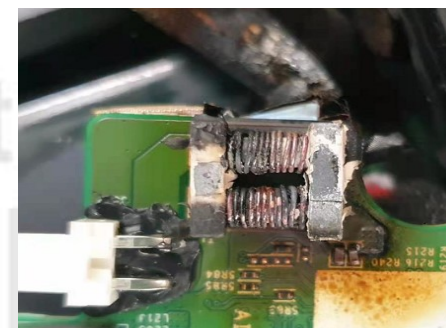
T1 component (choke) burned

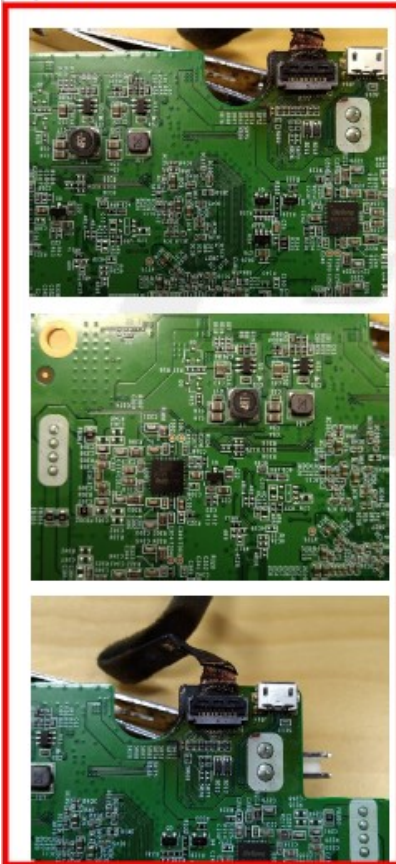
Top side

- At top side:
  1. 24V trace had charred and FFC connector was burned out.
  2. The other circuits look ok and are not affected.
- At bottom side:
  1. SOC, eMMC, and other circuit are ok.
  2. 24V power choke and capacitors were burned out at 24V frond end.

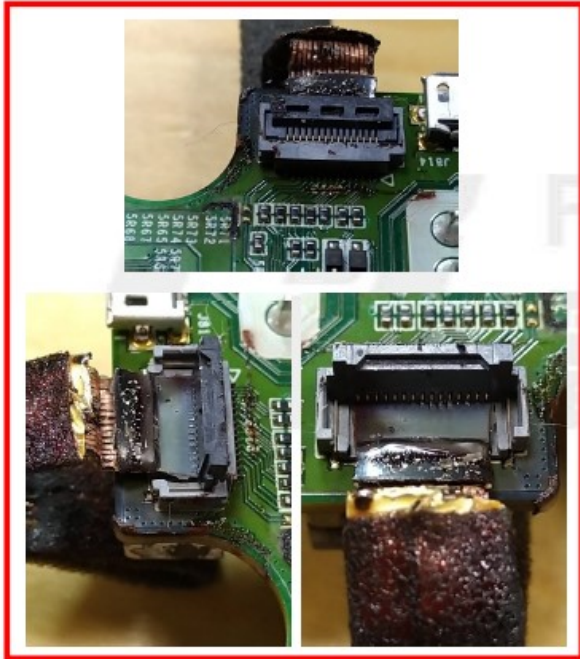
- Top side of FFC cable and foam seriously burned out.
- FFC cable trace is exposed.

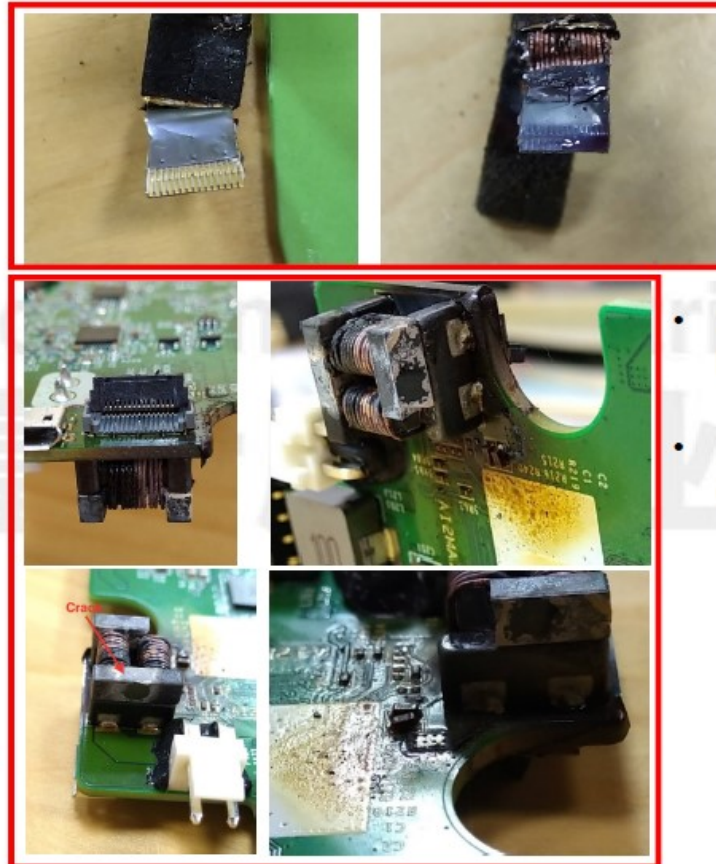
- FFC cable:  
Bottom: golden fingers are ok.  
Top: Burned out mark.

- 24V trace of PCB is going to peel off by burned out.
- The core of choke has crack and damaged.

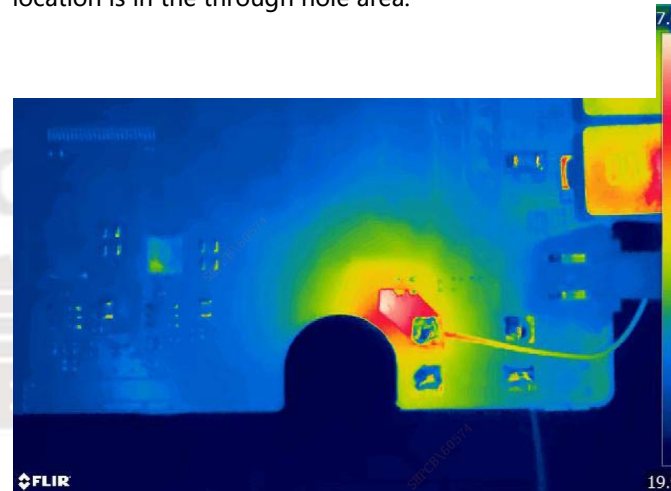
2) Thermal imaging device to view the top side : the hot location is in the through hole area.

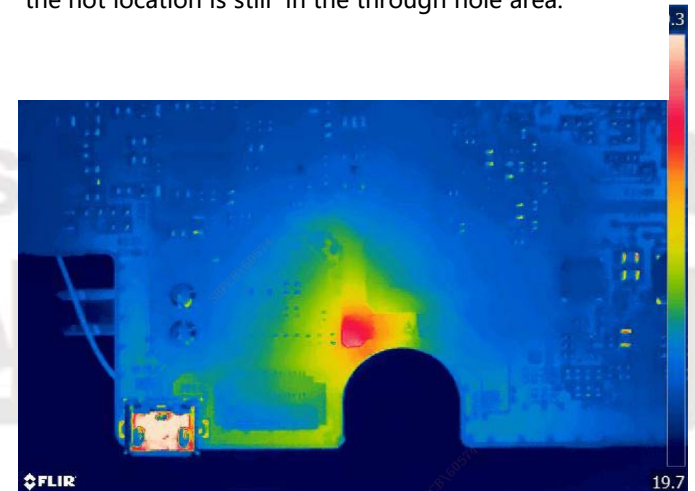
3) Thermal imaging device to view the bottom side : the hot location is still in the through hole area.

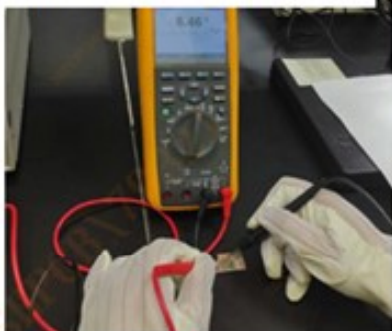
1) Grind off the Top side(L1), the short still exists.

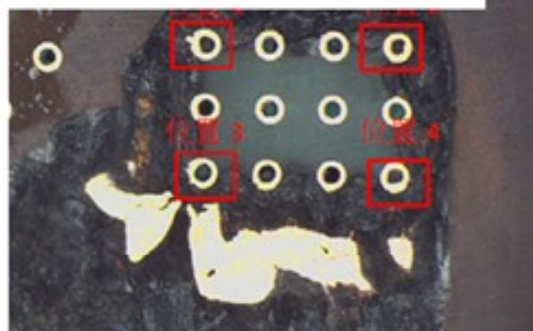
2.1) Observe L2 layer, some melted copper is found around the through hole.

Summary : confirmed that the short point exists in the layer 2

- **VGT PCB L2 layer short - residual copper [Possible Occur Reason]**
  - PCB Layer 2 **Etching process** maybe cause residual copper.
  - PCB **Lamination pressing process** maybe cause residual copper.
  - **VRS station** after AOI - Only visual inspection the repaired PCB.
- **VGT PCB L2 layer short - residual copper [Possible Escape Reason]**
  - PCB Layer 2 **Inner layer AOI station** can cover the short defect, but it maybe bypass by AOI operator.
  - **E-test station** can cover the open/short defect.

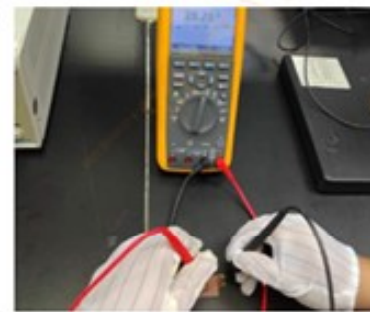
3) Grind off the bottom side(L4 layer), test the A,B network, the short still exists:

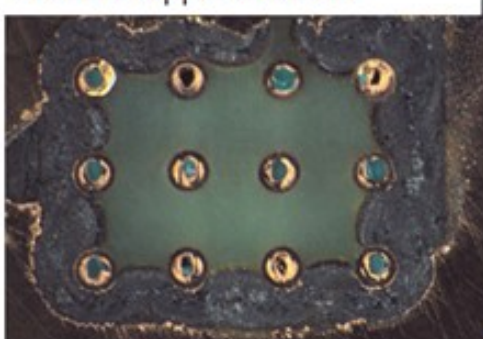
4.1) Observe the L3 layer, no residual copper is found.

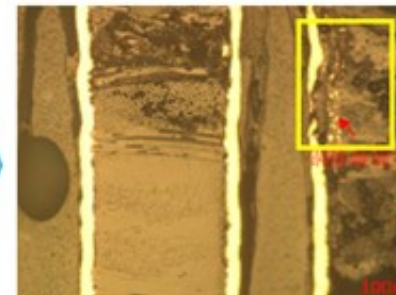
100X, melted copper could be found c.

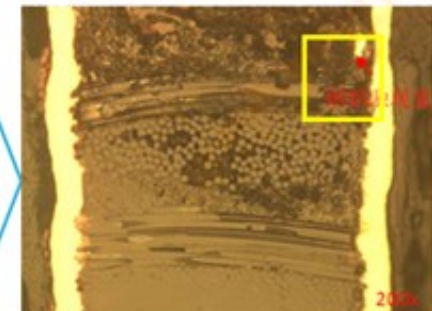
200X, melted copper could be found in the lamination

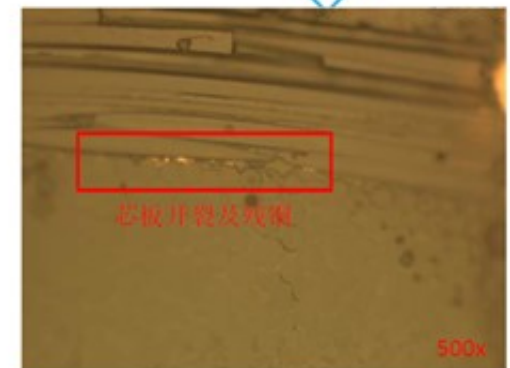
500x

SEM observation summary:  
500X, the lamination is cracked and melted copper could be found in the crack of the lamination

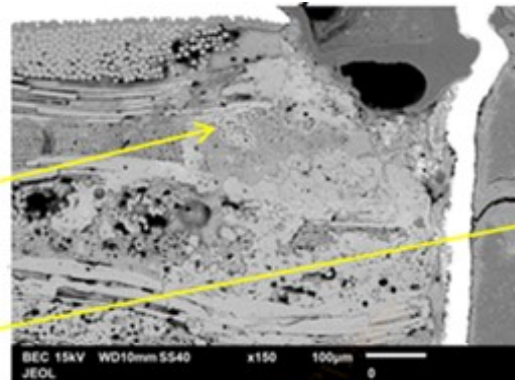
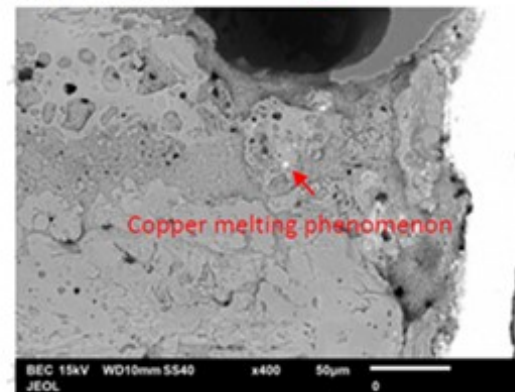
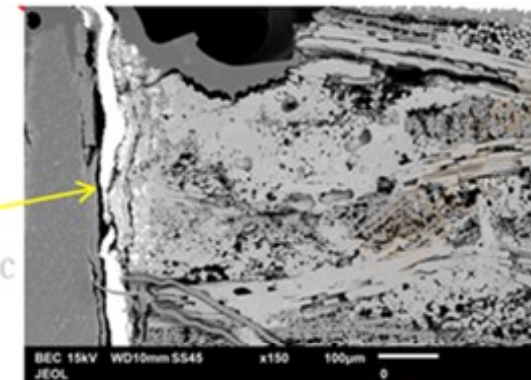
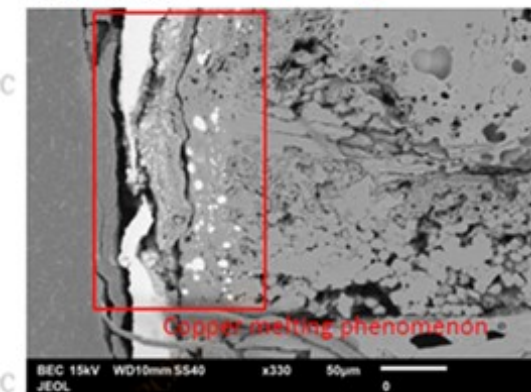
SEM observation summary:  
the lamination is cracked and  
melted copper could be  
found in the crack of the  
lamination.

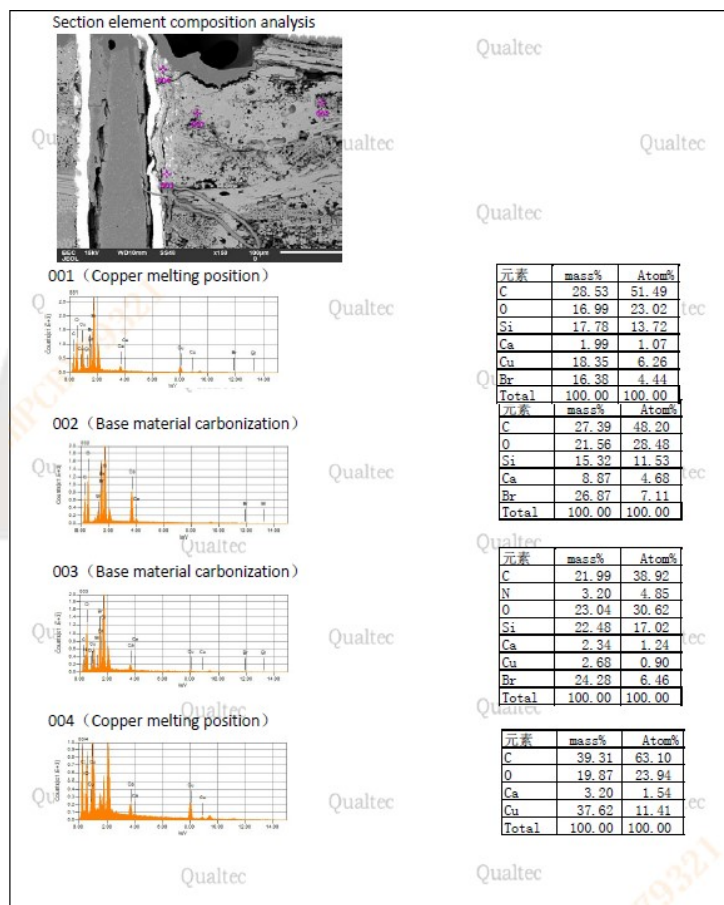
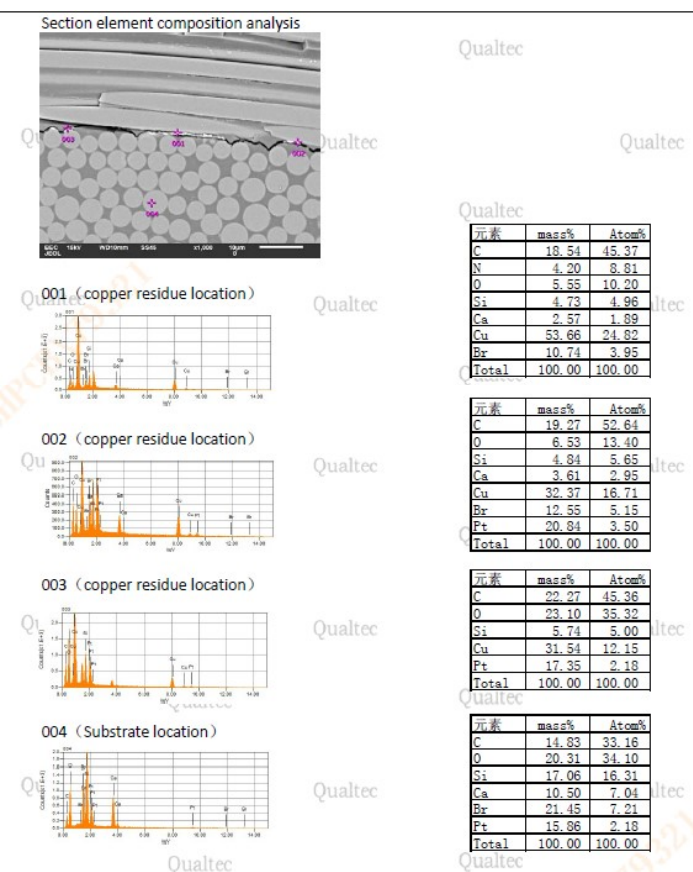
3.5 EDX analysis – Confirmed the material in the crack of lamination is melted copper.
