# **SWAN- 96.1531T00**

## **AMP board burnout FA report**

# 96.1531T00(AMP board)-FA report

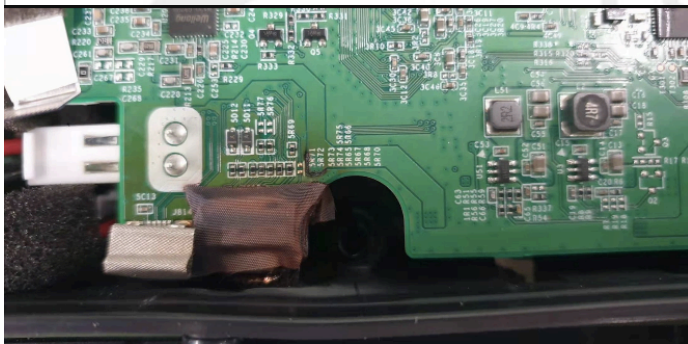
The housing was burned and PCB 24V trace had charred.  
No water vapor mark was found at top cover and LED panel.

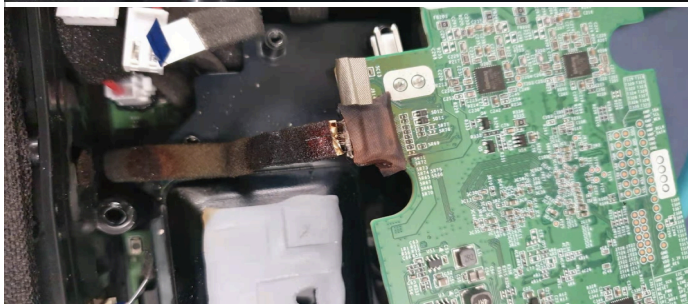
The FFC cable was burned out and charred seriously.  
The heat spreader also has burned out mark.

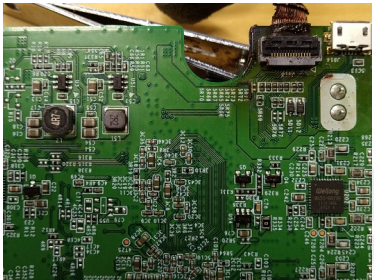
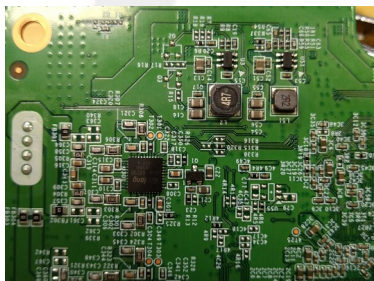
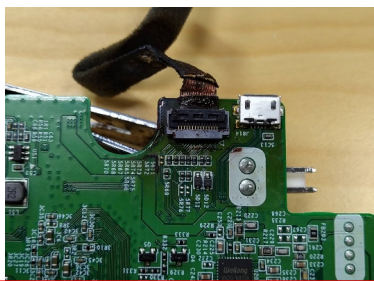
Top side

- At top side:
  1. 24V trace had charred and FFC connector was burned out.
  2. The other circuits look ok and are not affected.
- At bottom side:
  1. SOC, EMMC, and other circuit are ok.
  2. 24V power choke and capacitors were burned out at 24V frond end.
- Simulated FFC cable folding on the top of power choke, the burned out area are as well as position of choke. See next page(page 4) detail pictures.

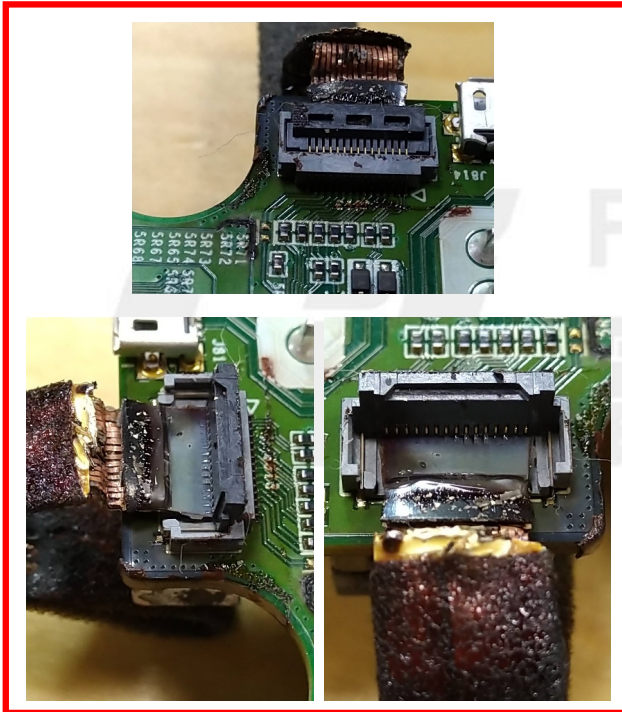
- Top side of FFC cable and foam seriously burned out.
- FFC cable trace is exposed.

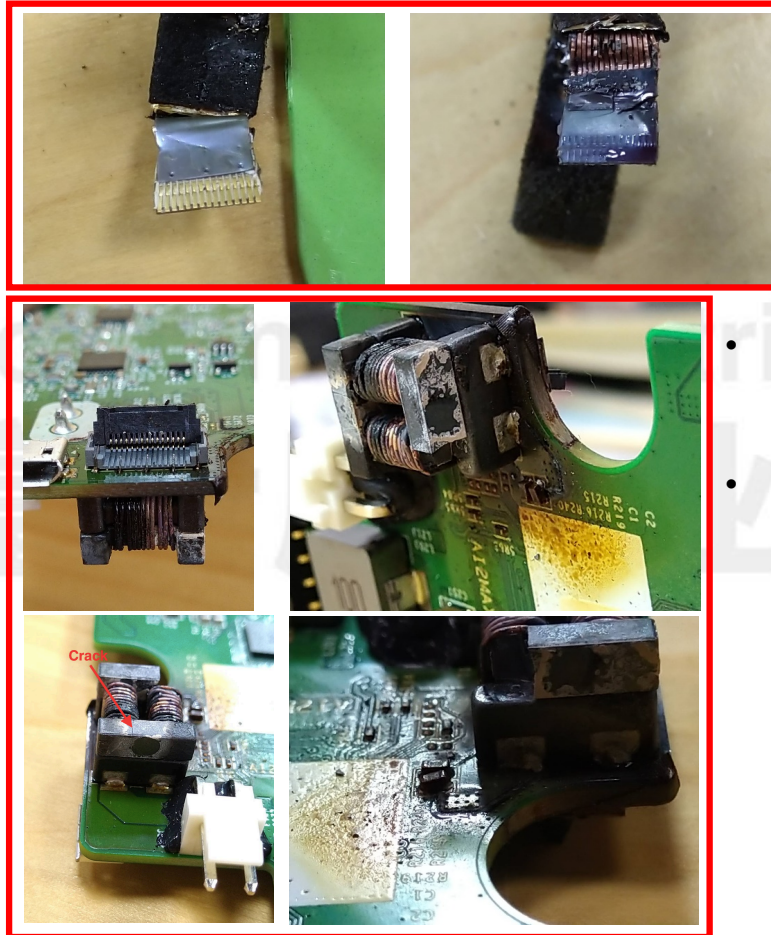
- FFC cable:  
Bottom: golden fingers are ok.  
Top: Burned out mark.

- 24V trace of PCB is going to peel off by burned out.
- The core of choke has crack and damaged.

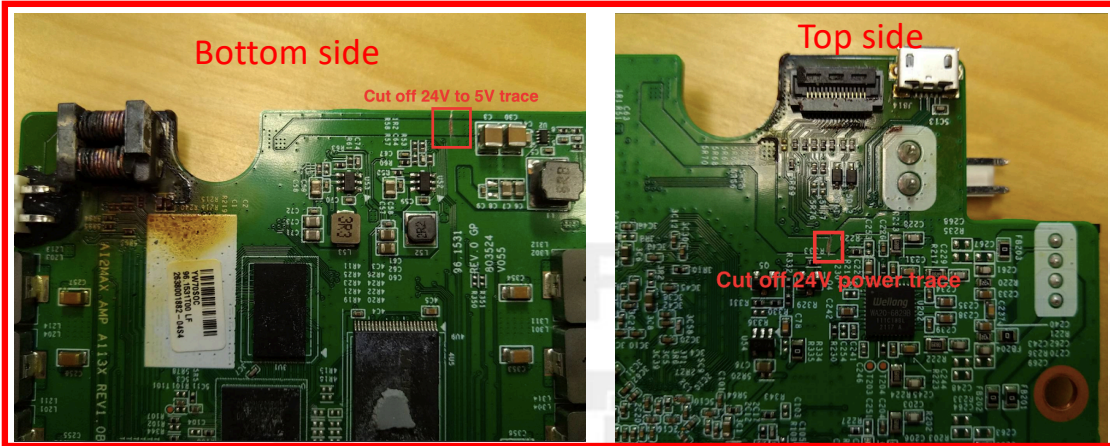
- Cut off 24V power trace:
  1. Bottom side: 24V to 5V DCDC(U2)
  2. Top side: AMP ICs and E-Caps

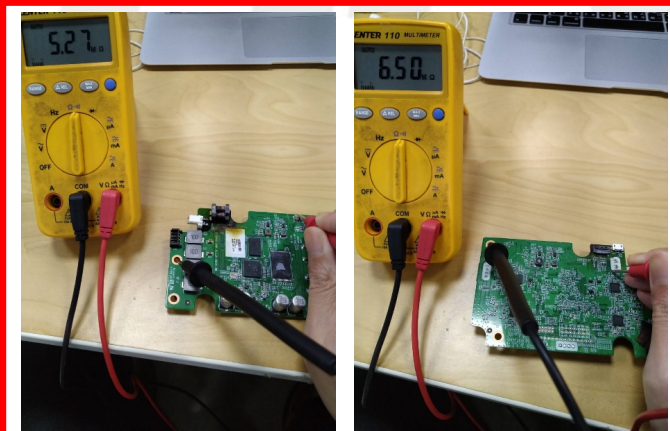
- After cutting off 24V power trace, the short is in choke circuit.
  1. The other circuits are normal.
  2. 24V to 5V DCDC(U2) and AMP ICs and E-caps are ok.

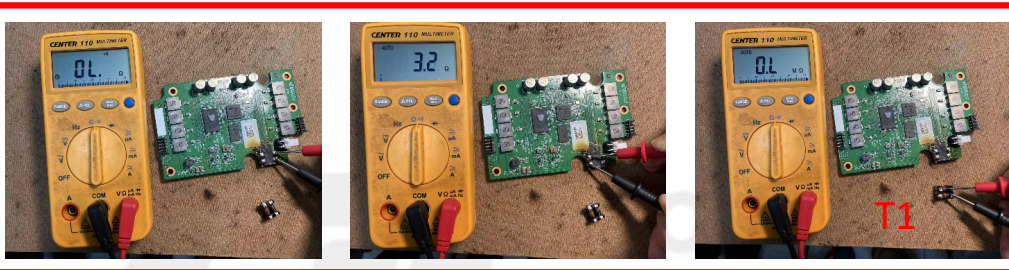
1. Remove T1 choke, then check PCB and component.

1. Remove T1 choke, the choke is ok.  
Check the PCB, it is still short to GND.
2. Remove C2, C2 is ok.  
Check PCB, it is still short to GND.
3. Remove C1, C1 is ok.  
Check PCB, it is still short to GND.

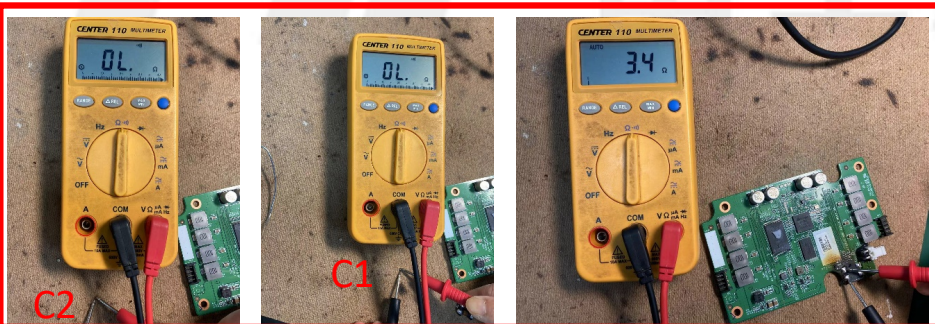
2. Remove C1 and C2, then check PCB and component.

1. Cut off 24V power trace to DCDC(U2) and E-caps loop, the short phenomenon is exist.
2. Remove components as choke and C1/C2 capacitor, PCB is still short to GND,
3. Suspect PCB power trace on 24V at choke circuit is short to GND.

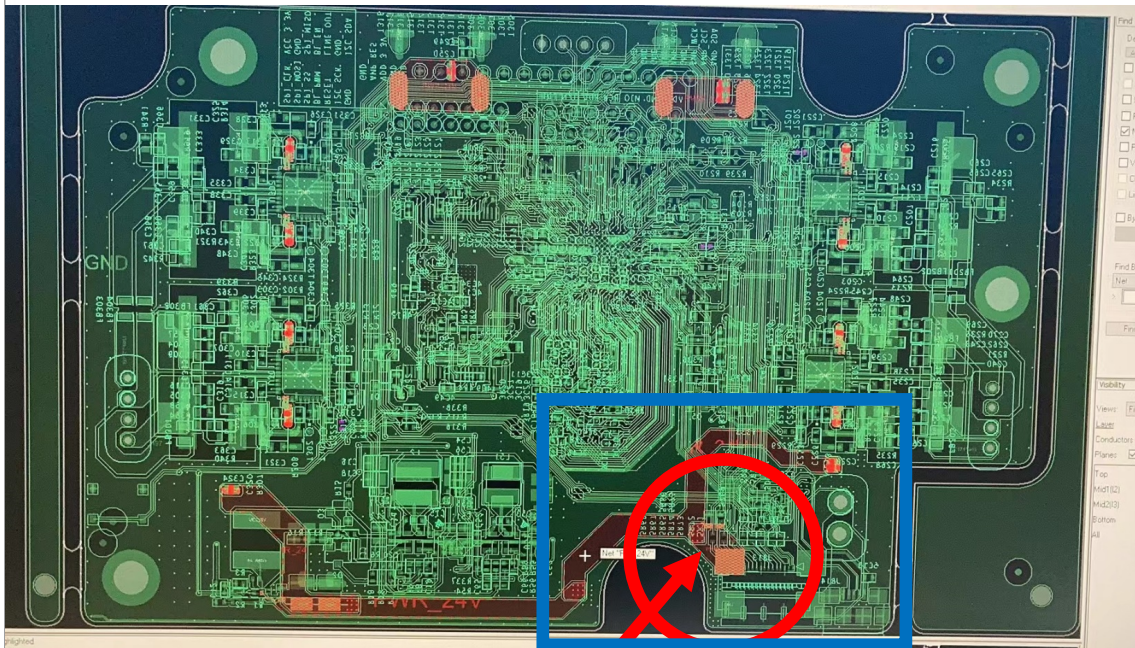
Suspect short area

1. Return the defective PCBA to PCB vendor for x-section analysis on 2/18
2. Vietnam QA and RD will work with vendor to analyze the short circuit root cause and prepare the report
