# FA Report for ALT STB BFX-UA300 Choke Burned and FFC Cable Melted Issue

Date : 2022-March-18  
Version: 02

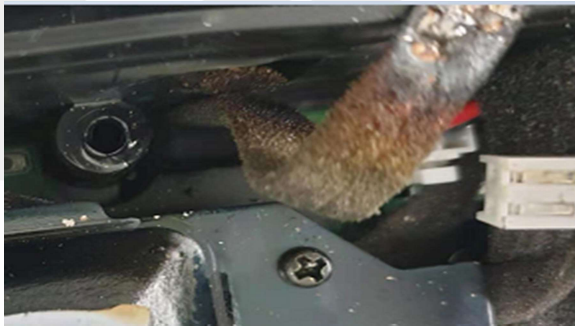
FFC cable melted

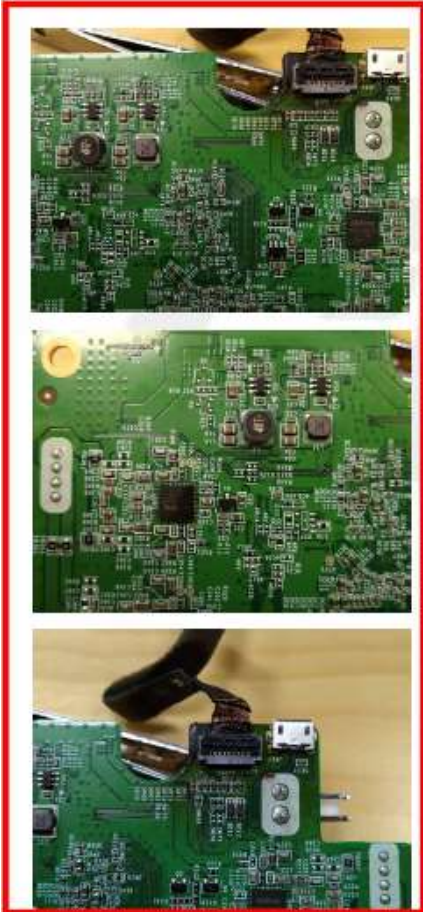
Top side

- At top side:
  1. 24V trace had charred and FFC connector was burned out.
  2. The other circuits look ok and are not affected.
- At bottom side:
  1. SOC, eMMC, and other circuit are ok.
  2. 24V power choke and capacitors were burned out at 24V frond end.
- Simulated FFC cable folding on the top of power choke, the burned out area are as well as position of choke. See next page detail pictures.

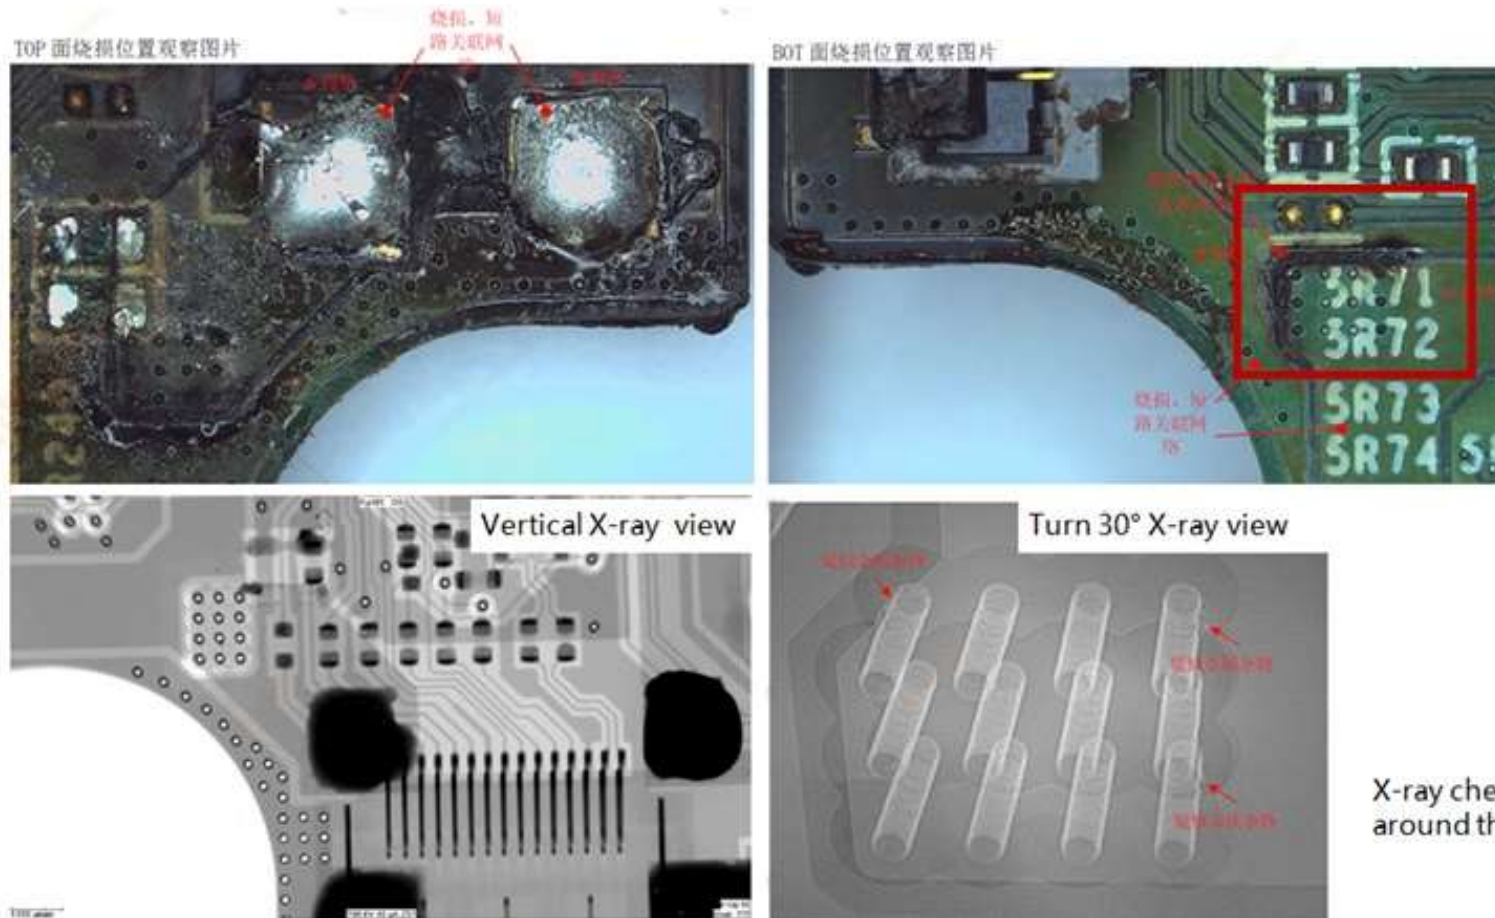
#### 4.3.1 X-Ray inspection – see some material around the through holes.

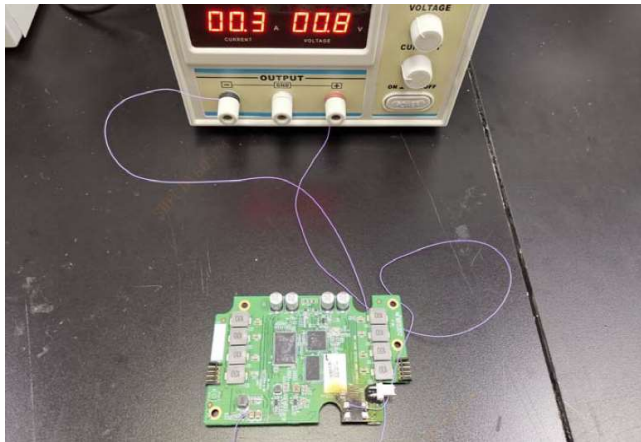
1 ) energized 0.3A current to A/B circuit , to make the short point hot.

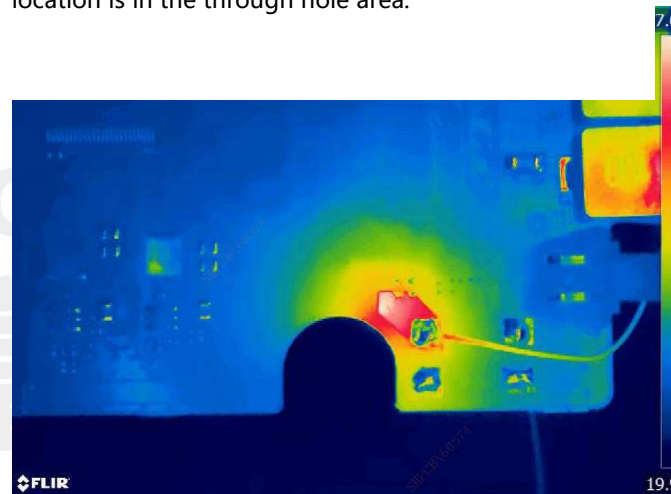
2 ) Thermal imaging device to view the top side : the hot location is in the through hole area.

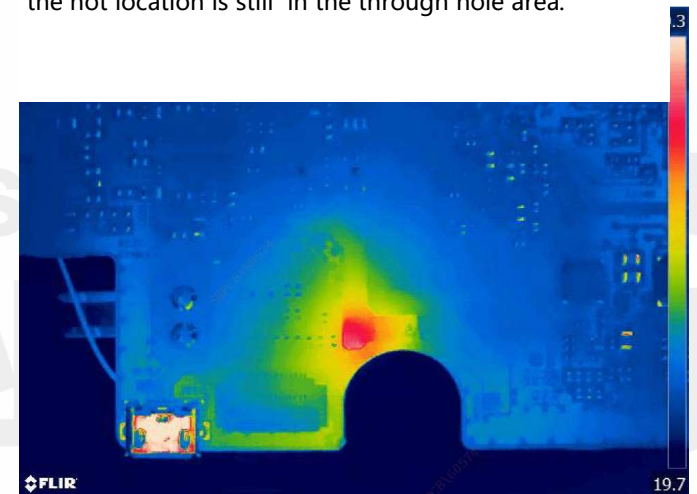
3 ) Thermal imaging device to view the bottom side : the hot location is still in the through hole area.

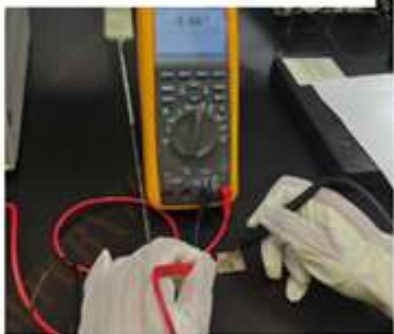
1) Grind off the Top side(L1), the short still exists.

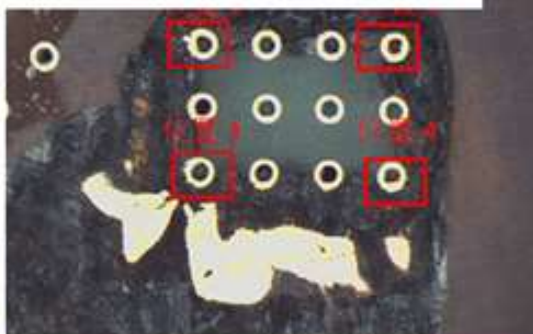
2.1) Observe L2 layer, some melted copper is found around the through hole.

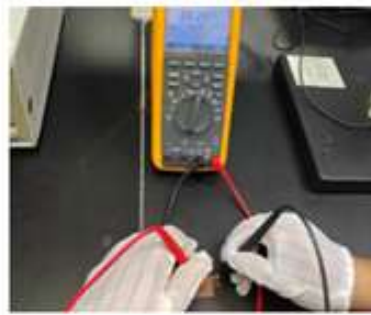
3) Grind off the bottom side(L4 layer), test the A,B network, the short still exists:

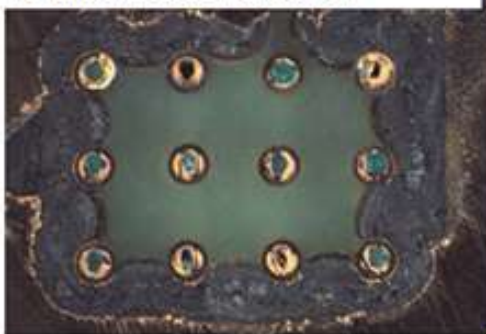
4.1) Observe the L3 layer, no residual copper is found.

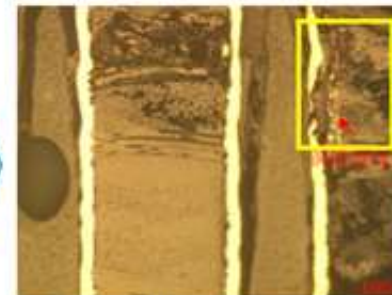
100X, melted copper could be found c.

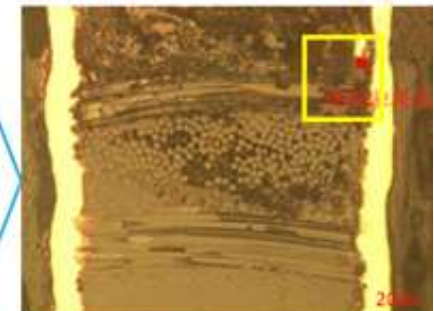
200X, melted copper could be found in the lamination

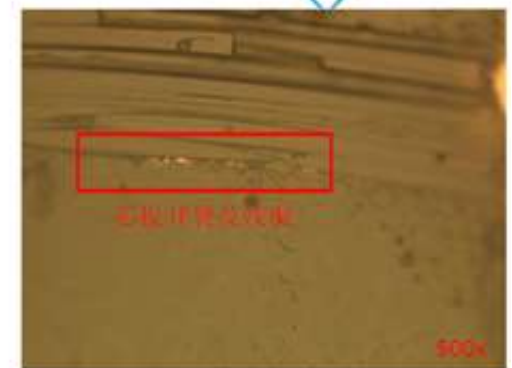
SEM observation summary:  
500X, the lamination is cracked and melted copper could be found in the crack of the lamination

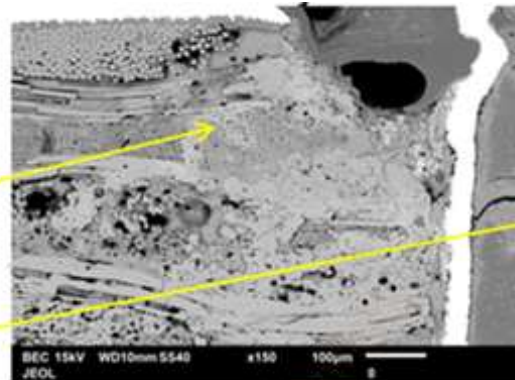
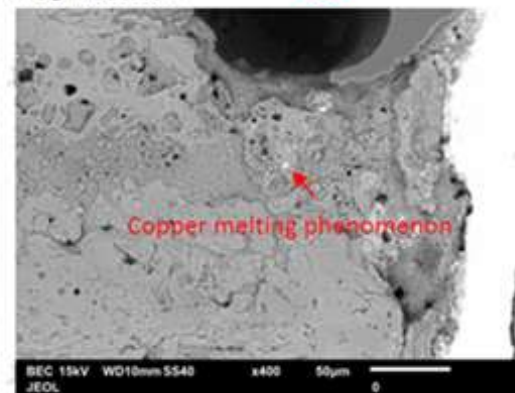
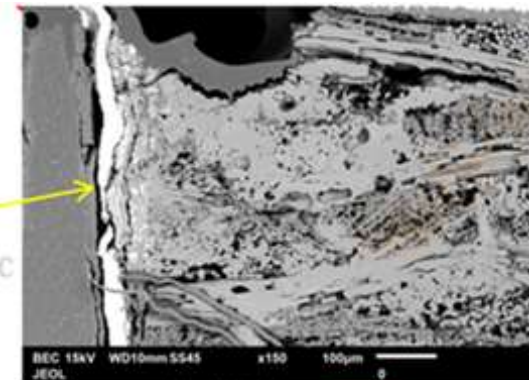
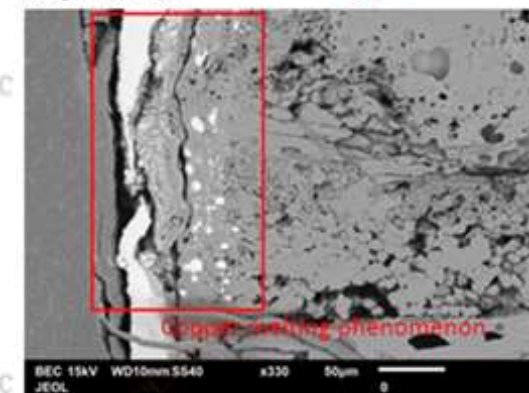
SEM observation summary:  
the lamination is cracked and melted copper could be found in the crack of the lamination.

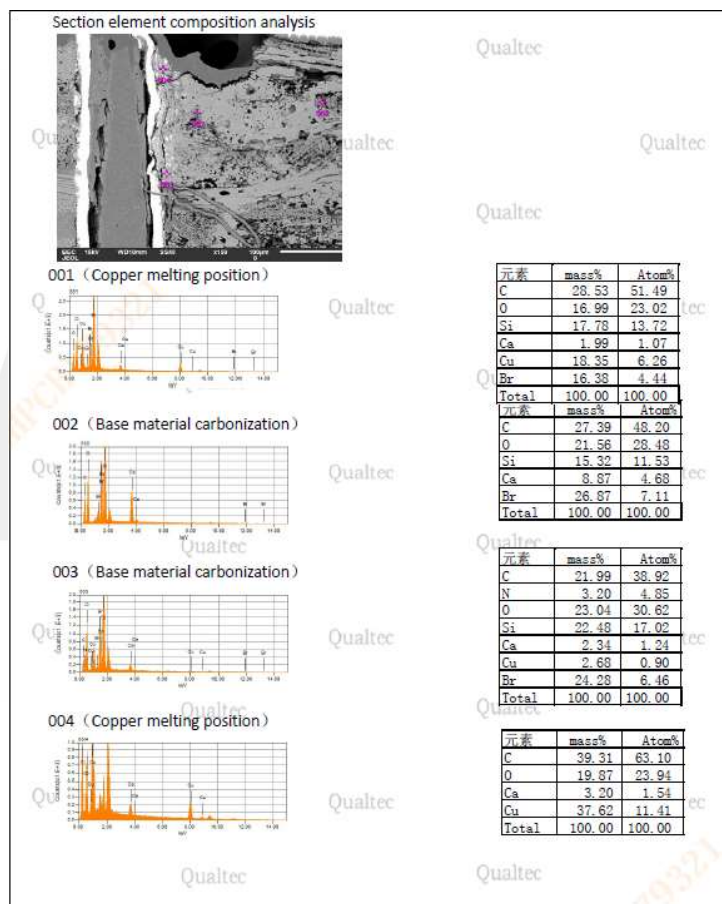
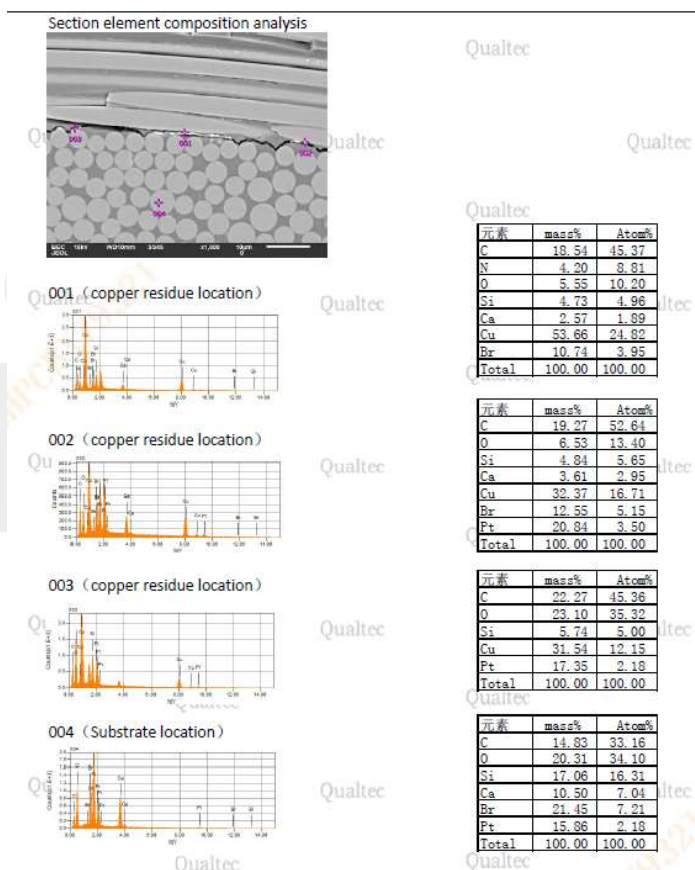
### 4.3.5 EDX analysis – Confirmed the material in the crack of lamination is melted copper.
