# Test Report

Sample Name : PCB

Report NO. : REP220300400038

| 1. Test title: | Burning plate short circuit analysis | | | | |

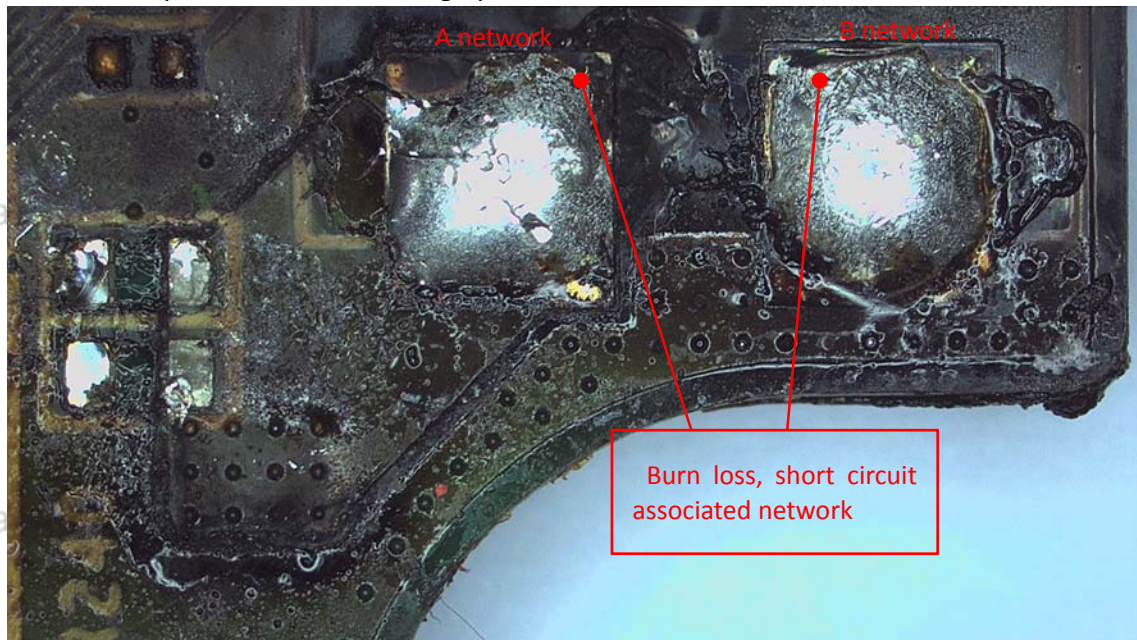
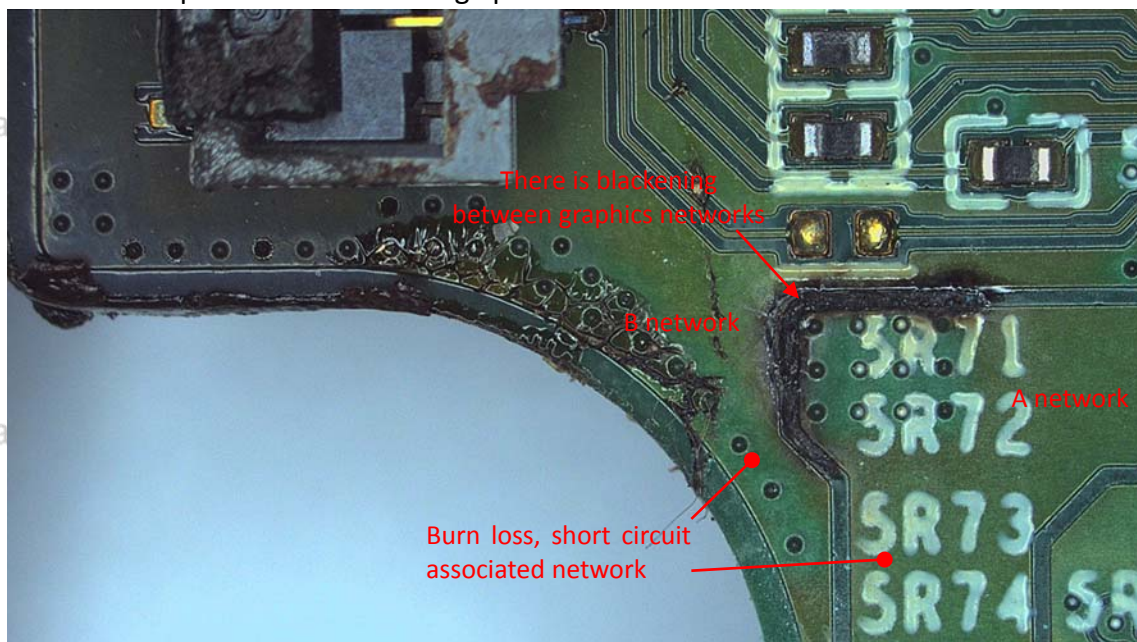
| 8. Test results: | 8.1、Observe the burned positions of the TOP surface and BOTTOM surface of the sample. The burned areas on the top surface have blackened to varying degrees and have no obvious characteristics; There is obvious blackening between the associated networks on the BOTTOM surface (near the via position of network A).<br>8.2、X-ray observation was conducted on the sample burn loss position, and no obvious abnormal phenomenon was found between A/B network. See P8。<br>8.3、Thermal infared imaging observation was carried out on the burned position, With 0.3A current applied to A/B network, the thermal infared imaging | | | | |

Description : Observe the burned positions of the TOP surface and BOTTOM surface of the sample. The burned areas on the top surface have blackened to varying degrees and have no obvious characteristics; There is obvious blackening between the associated networks on the BOTTOM surface (near the via position of network A).

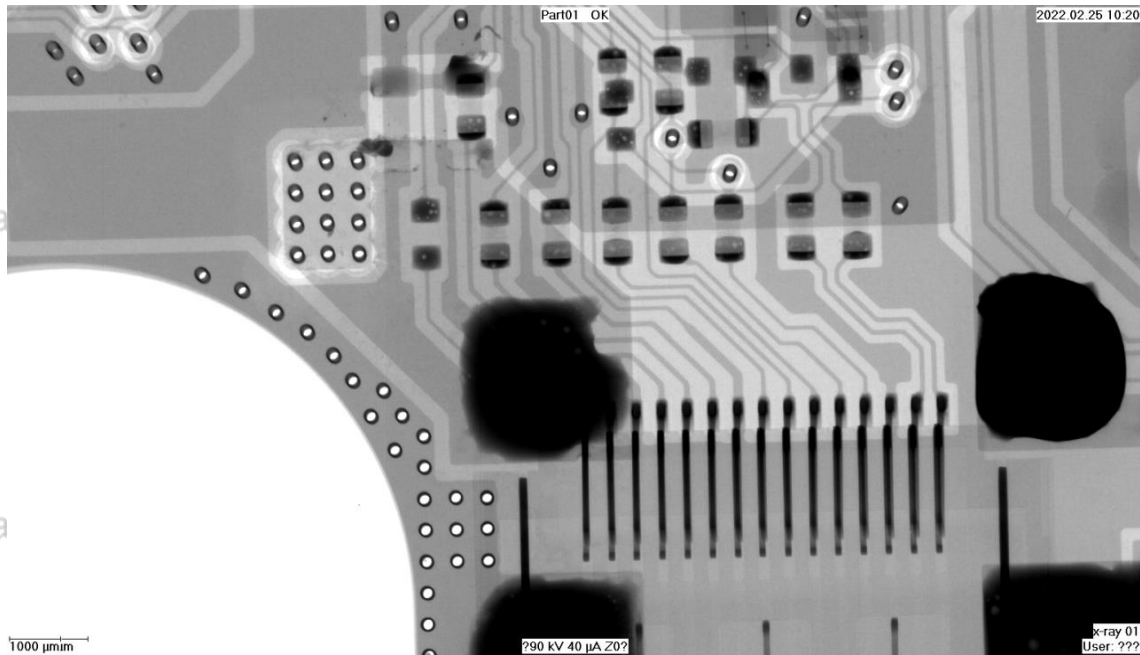
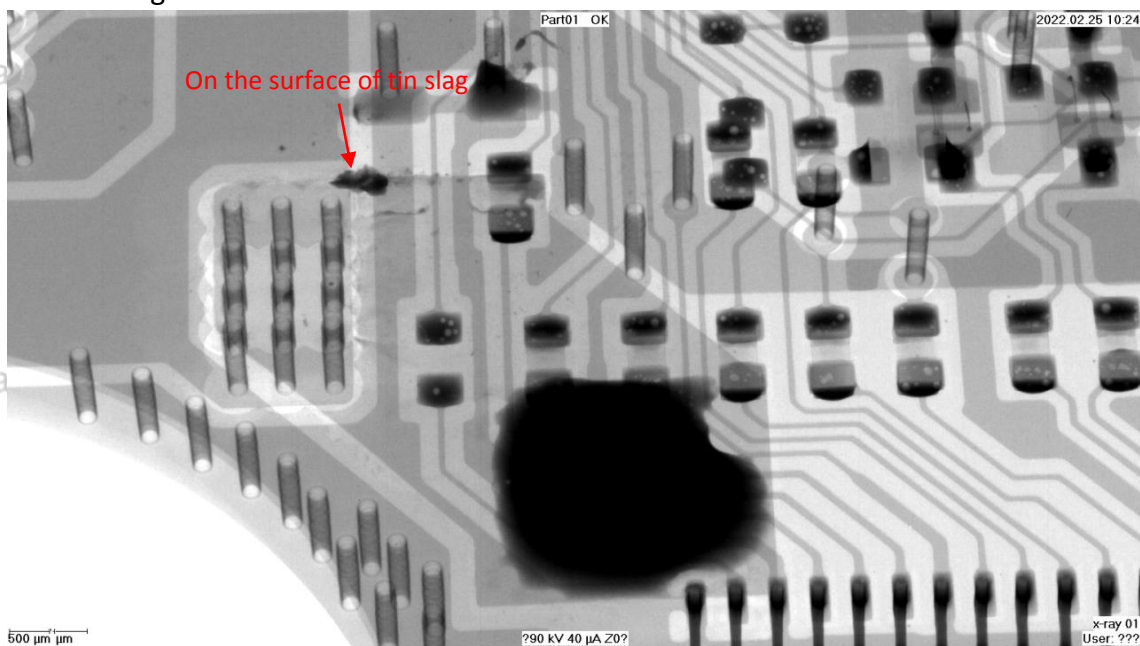
Description : X-ray observation was conducted on the sample burn loss position, and no obvious abnormal phenomenon was found between A/B network.

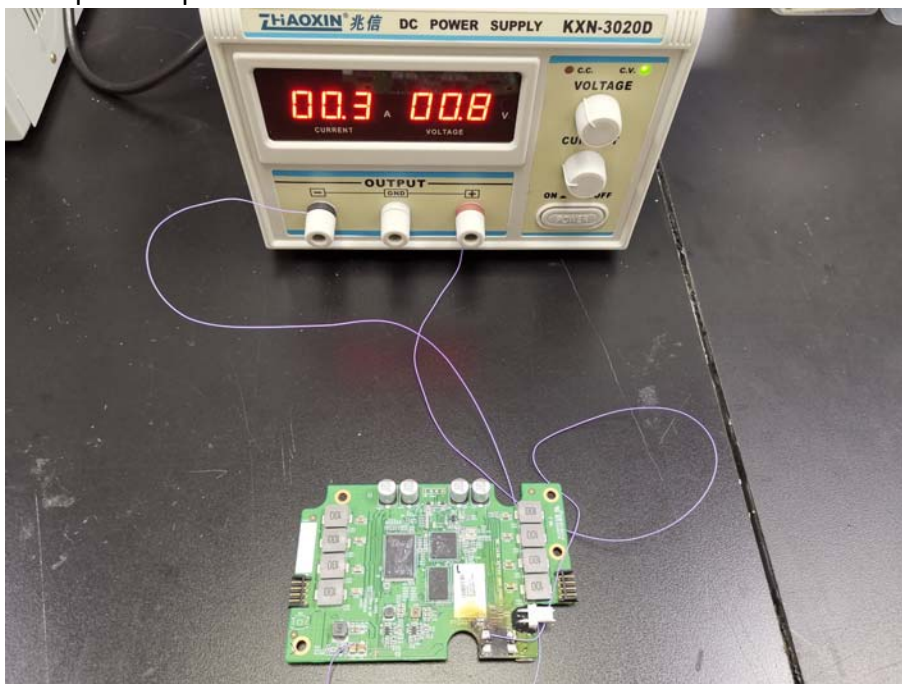
Test process picture

Description : Thermal imaging observation was carried out on the sample burning loss position, and 0.3A current was applied to A/B network to make the short-circuit point between the networks heated, and thermal imager was used to observe; On the next page to continue.

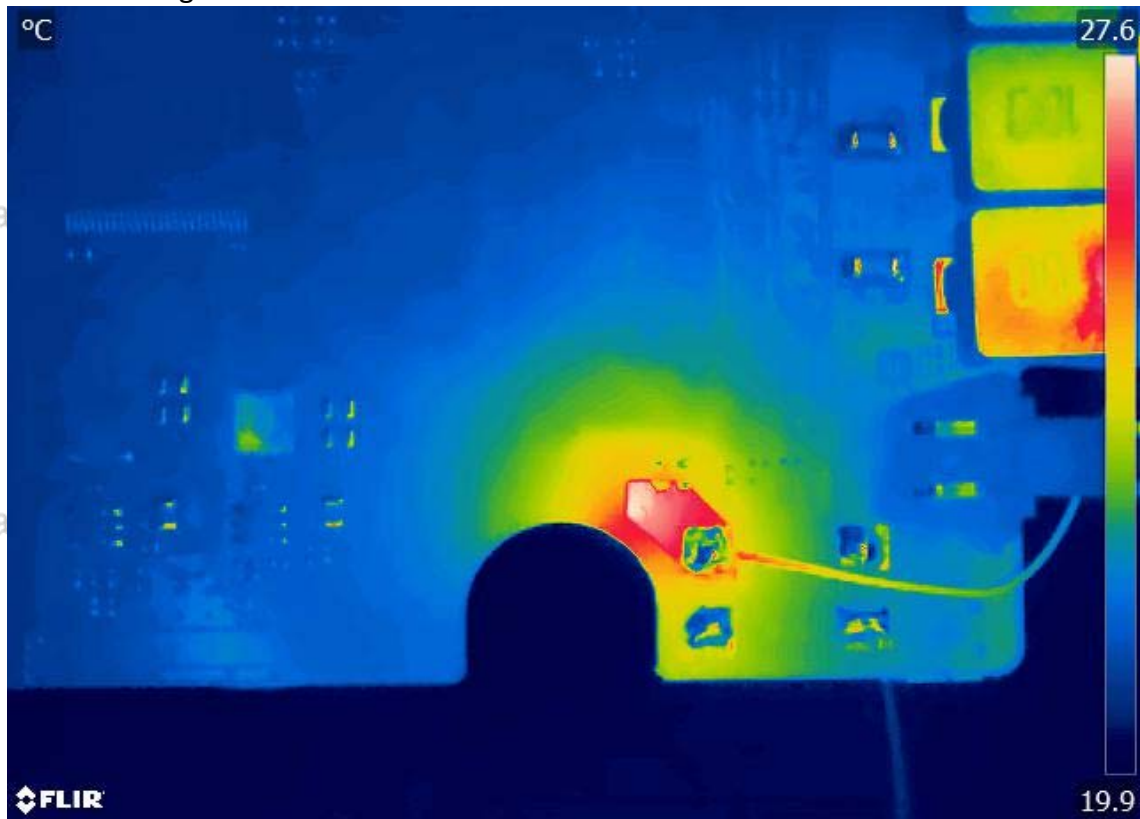
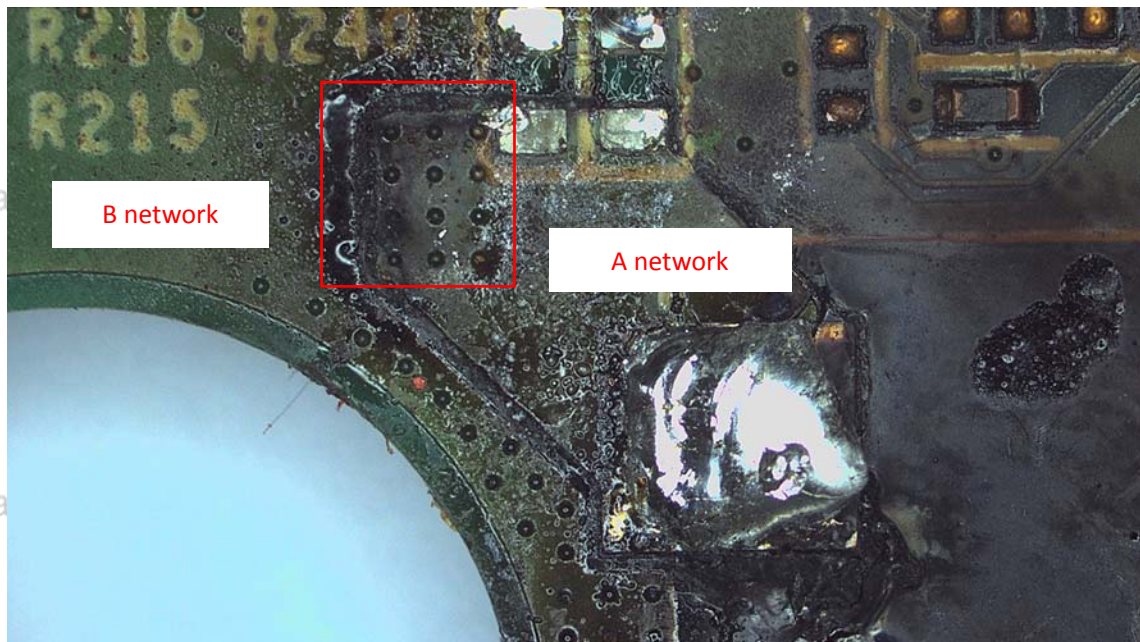
Thermal image of TOP surface

| Qualtec | 8.4、According to the thermal imaging picture of the top surface of the burning position, it is found that the hot spot is located in the via area of network A, indicating that the short point is located in the via area of network A。 See P10. |

Description : according to the thermal imaging picture of the top surface of the burning position, it is found that the hot spot is located in the via area of network A, indicating that the short-circuit point is located in the via area of network A.

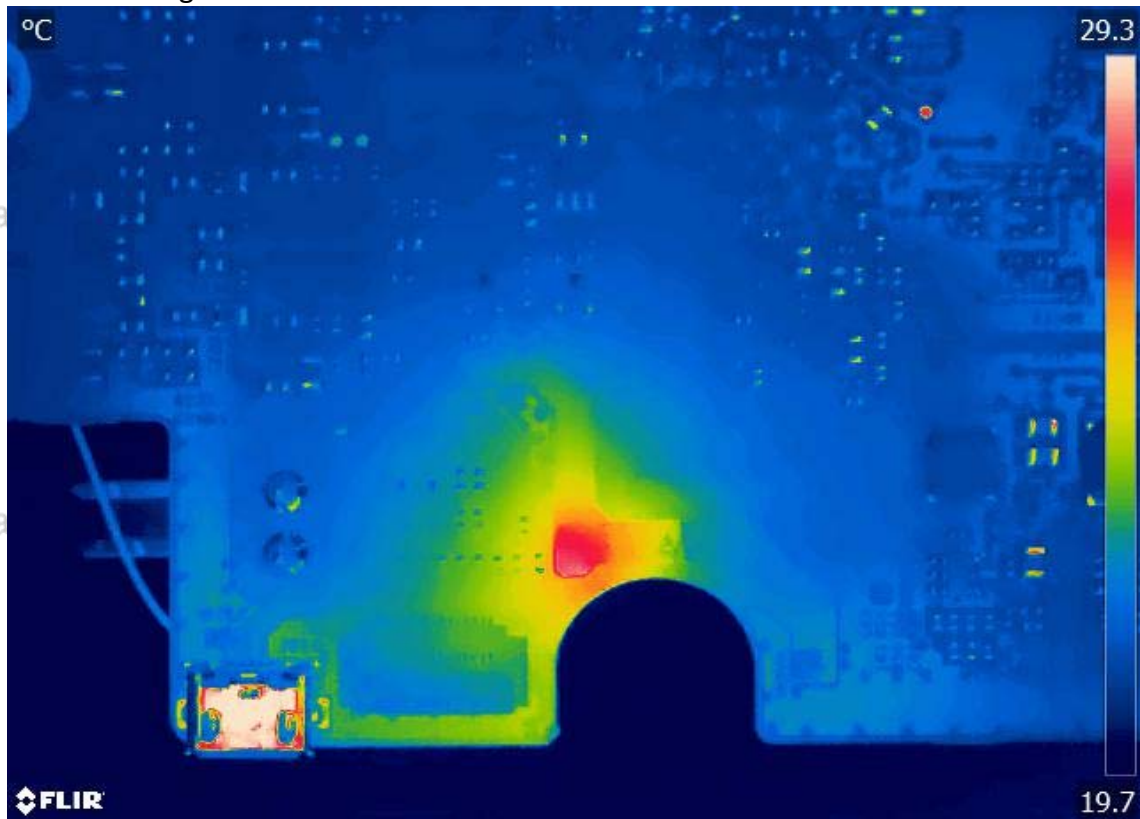
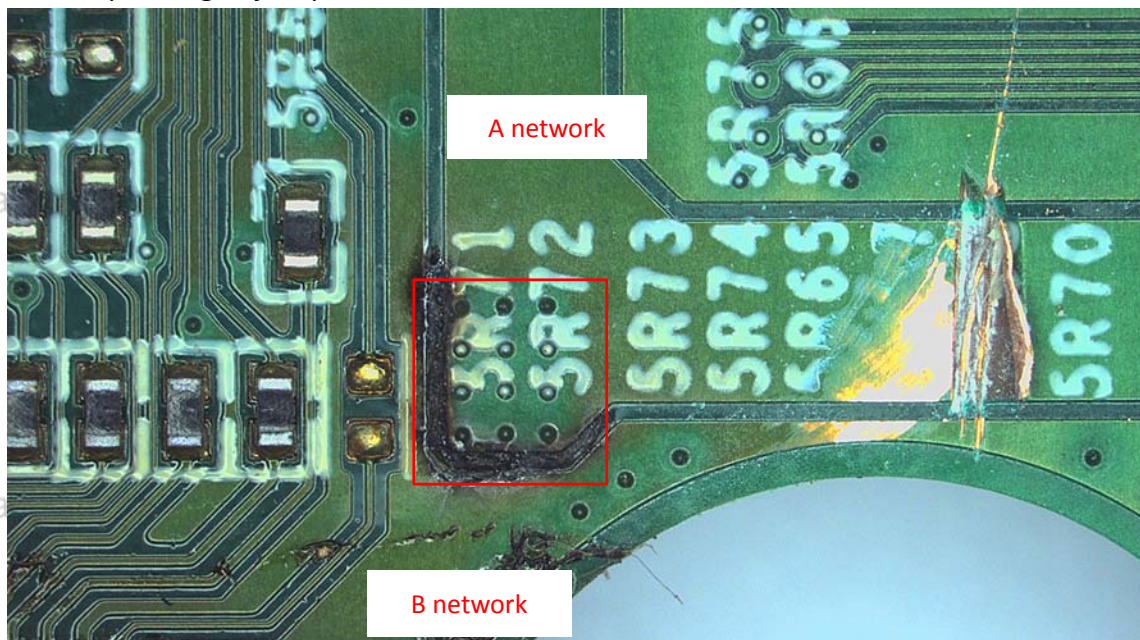
Thermal image of Bottom surface

| Qualtec | 8.5、according to the thermal imaging picture of the bottom surface of the burning position, it is found that the hot spot is located in the via area of network A, indicating that the short-circuit point is located in the via area of network A. See P11. |

Description : according to the thermal imaging picture of the bottom surface of the burning position, it is found that the hot spot is located in the via area of network A, indicating that the short-circuit point is located in the via area of network A.

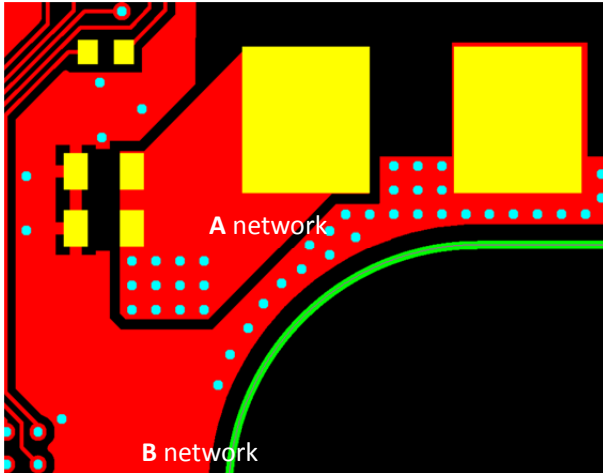
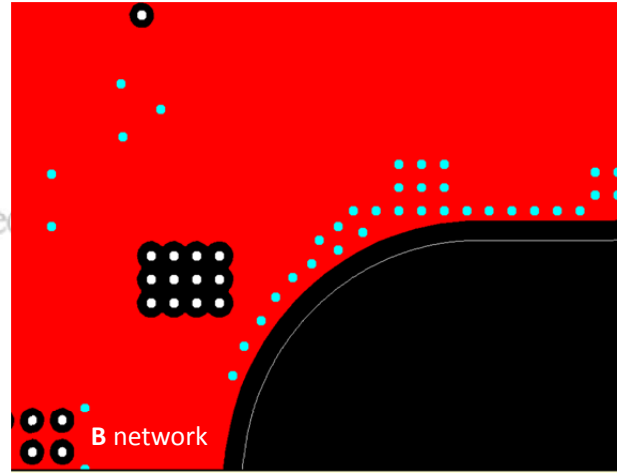
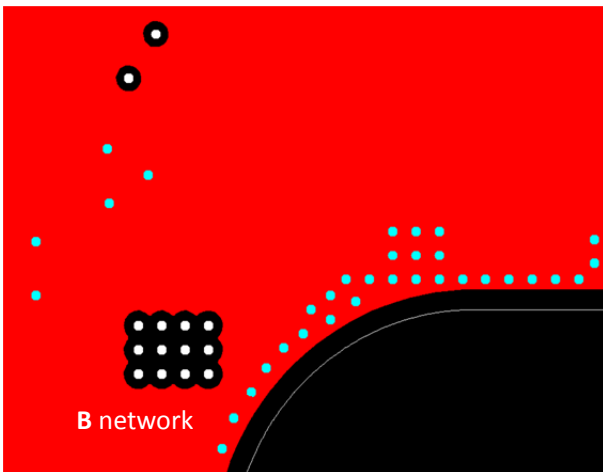
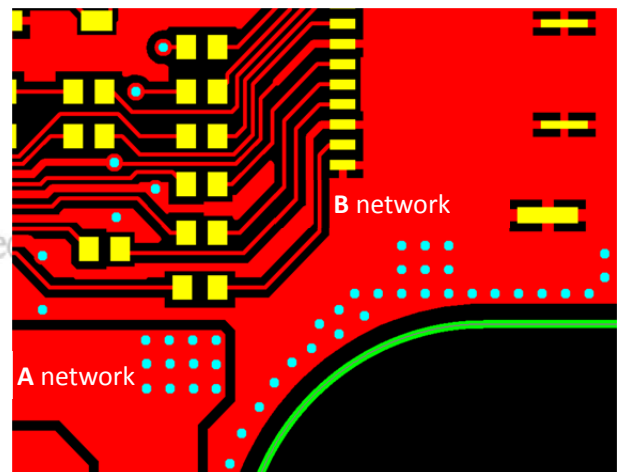
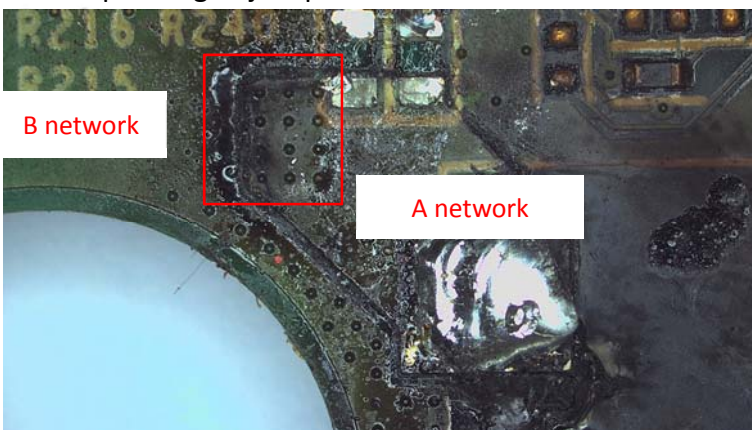
| Qualtec | 8.6、Compared with the actual picture of PCB layers, combined with the appearance characteristics of burn loss, thermal imaging observation results and PCB graphic structure, it is speculated that the short-circuit point of A/B network is located between the hole position of A network and the inner layer position of B network. See P12. |

Description : Compared with the actual picture of PCB layers, combined with the appearance characteristics of burn loss, thermal imaging observation results and PCB graphic structure, it is speculated that the short-circuit point of A/B network is located between the hole position of A network and the inner layer position of B network.

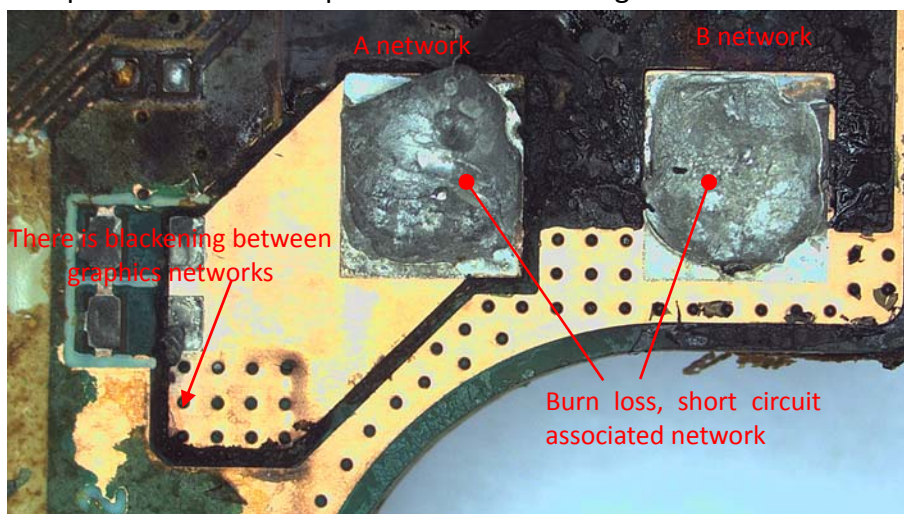
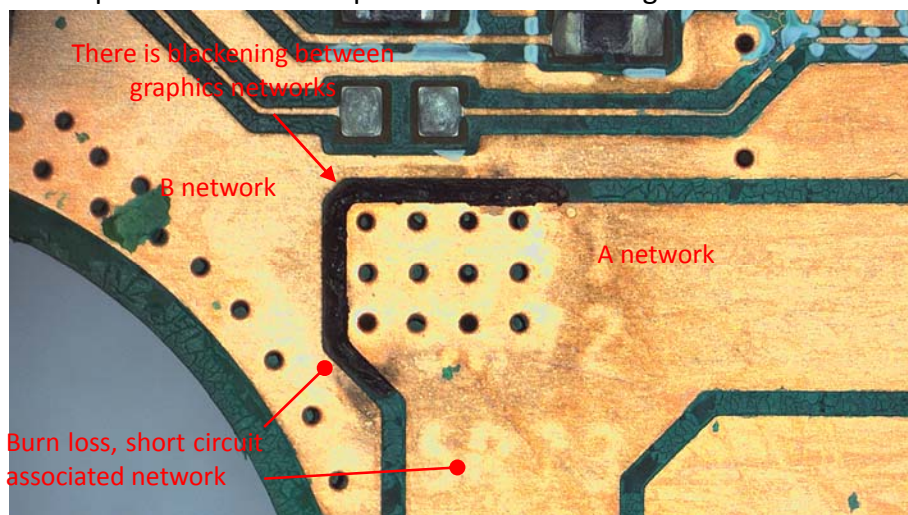
| Qualtec | 8.7、The surface observation of the sample TOP surface and BOTTOM surface after removing the solder ink was carried out, and it was found that the substrate between network A and network B was blackened, and the copper in the outer layer was relatively intact, and no copper melting was found. See P13. |

Description :The surface observation of the sample TOP surface and BOTTOM surface after removing the solder ink was carried out, and it was found that the substrate between network A and network B was blackened, and the copper in the outer layer was relatively intact, and no copper melting was found.

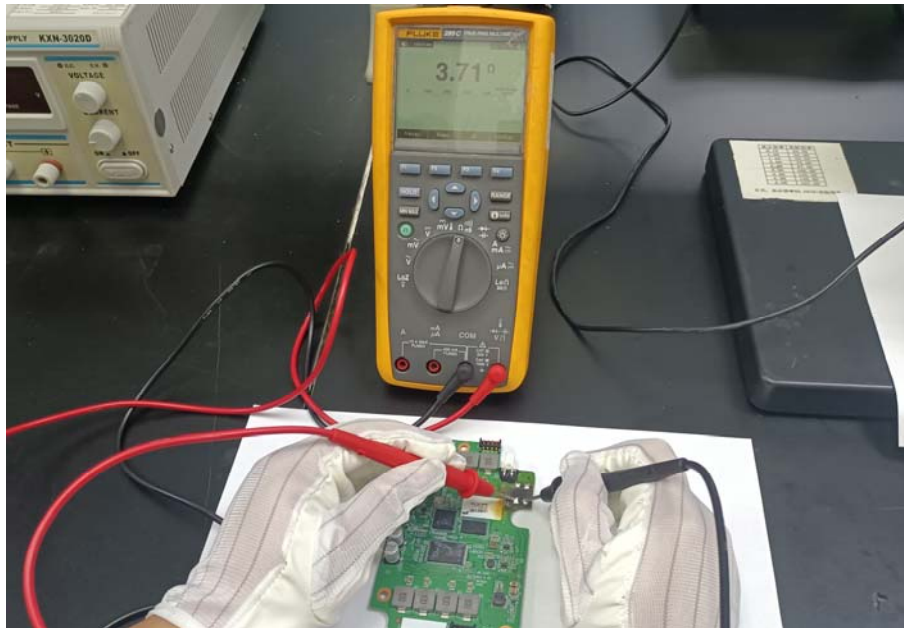
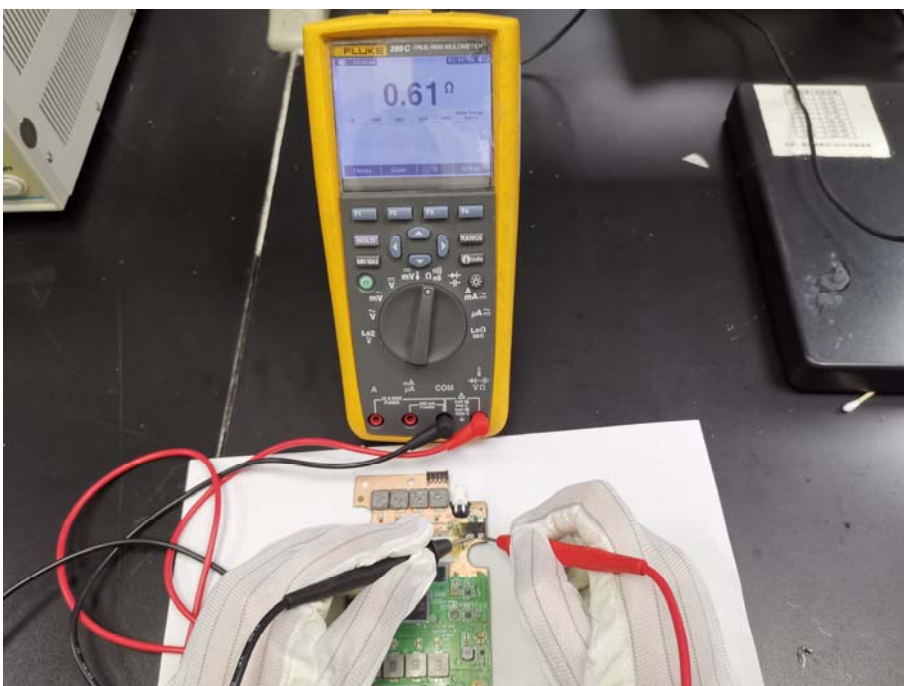
| Qualtec | 8.8、The resistance value before and after the solder mask ink was measured at the burned position of the sample. The resistance value before removing the solder mask ink was $3.71\Omega$ , and the resistance value after removing the solder mask ink was $0.61\Omega$ , indicating that the short circuit point still exists after removing the solder mask ink. See P14. |

Description : The resistance value before and after the solder mask ink was measured at the burned position of the sample. The resistance value before removing the solder mask ink was  $3.71\Omega$ , and the resistance value after removing the solder mask ink was  $0.61\Omega$ , indicating that the short circuit point still exists after removing the solder mask ink.

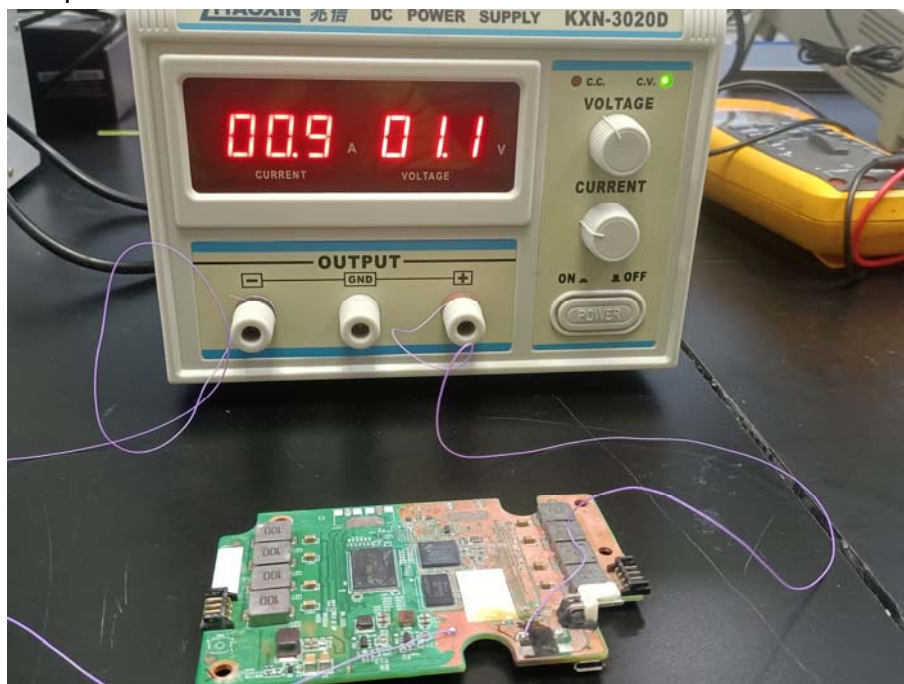
Test picture

| Qualtec | 8.9、Thermal imaging observation was carried out on the sample burning position after the removal of solder blocking ink, and 0.9A current was applied to A/B network to make the short-circuit point between networks heat up, and thermal imager was used to observe; On the next page. See P15. |

Description :Thermal imaging observation was carried out on the sample burning position after the removal of solder blocking ink, and 0.9A current was applied to A/B network to make the short-circuit point between networks heat up, and thermal imager was used to observe; On the next page.

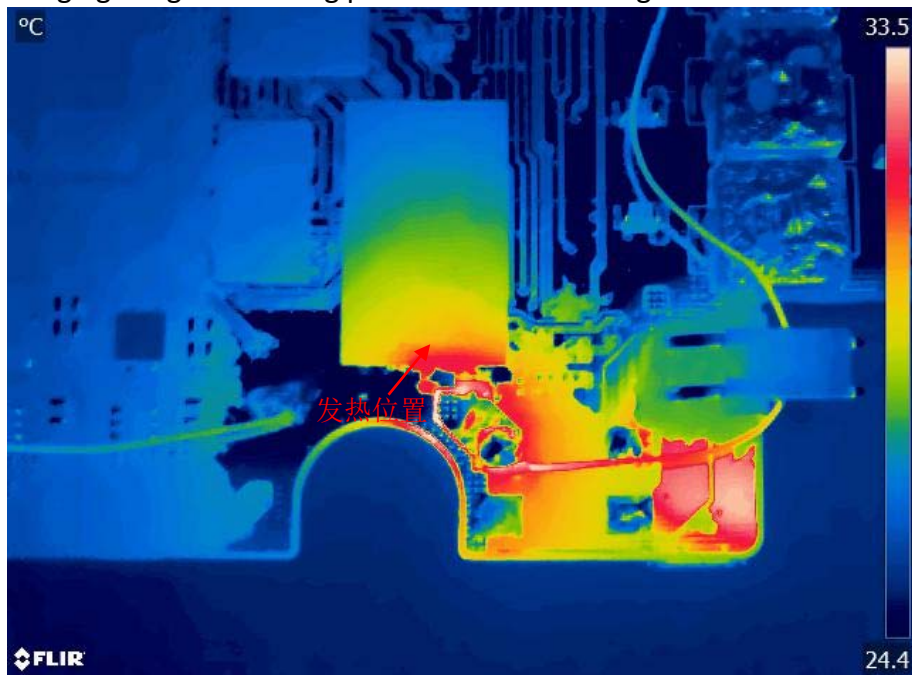
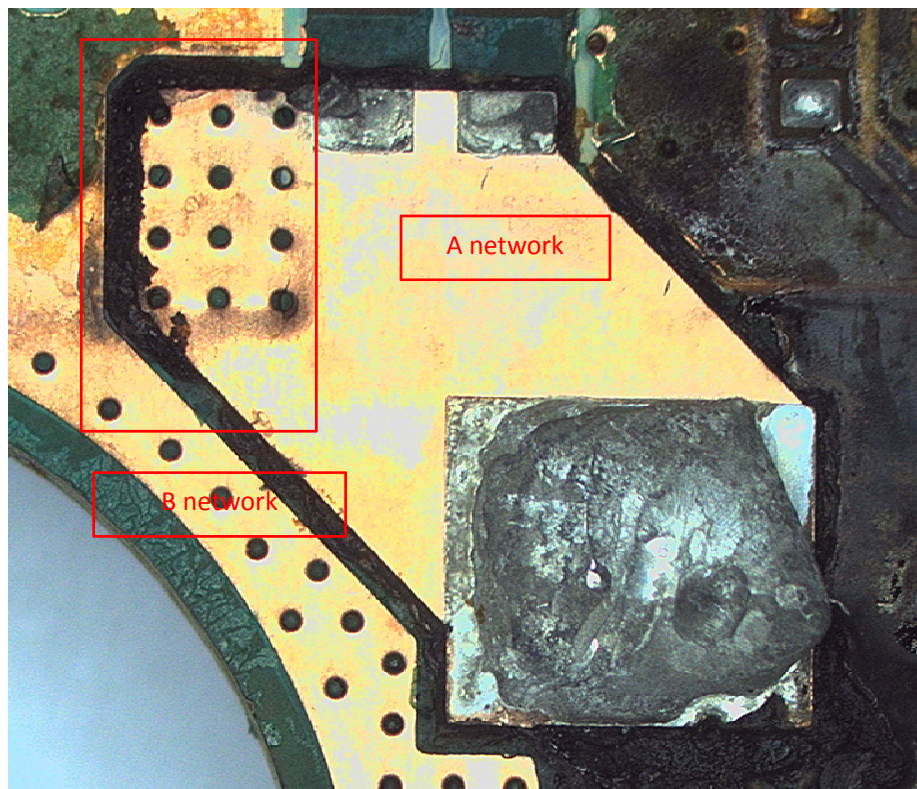
| Qualtec | 8.10、Thermal imaging observation after the removal of solder blocking ink on the TOP surface of the burned position showed that the hot spot was still located in the hole area of NETWORK A, indicating that the short circuit point was located in the hole area of network A. See P16. |

Description :Thermal imaging observation after the removal of solder blocking ink on the TOP surface of the burned position showed that the hot spot was still located in the hole area of NETWORK A, indicating that the short circuit point was located in the hole area of network A.

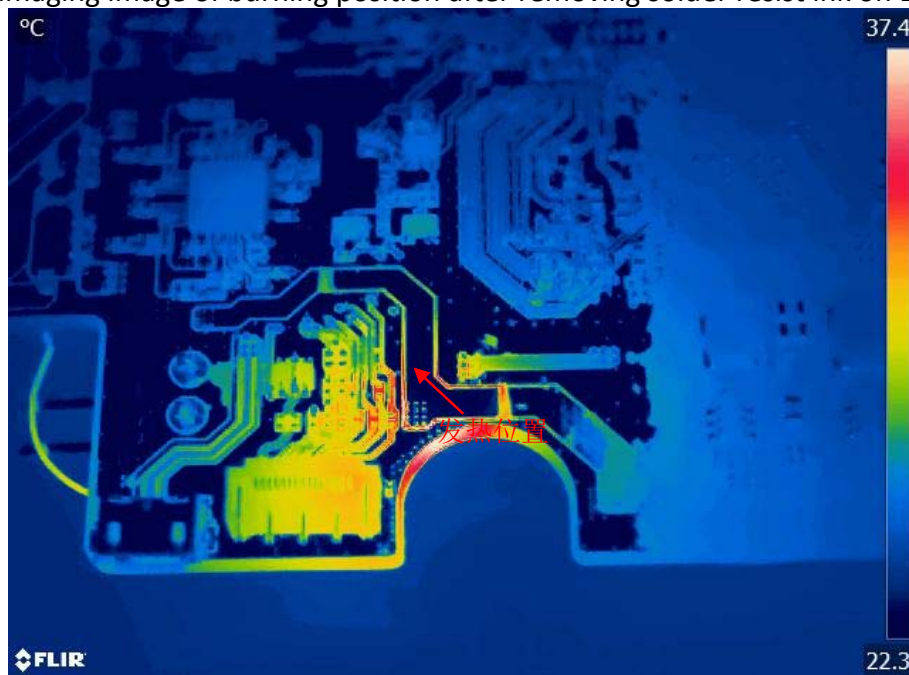
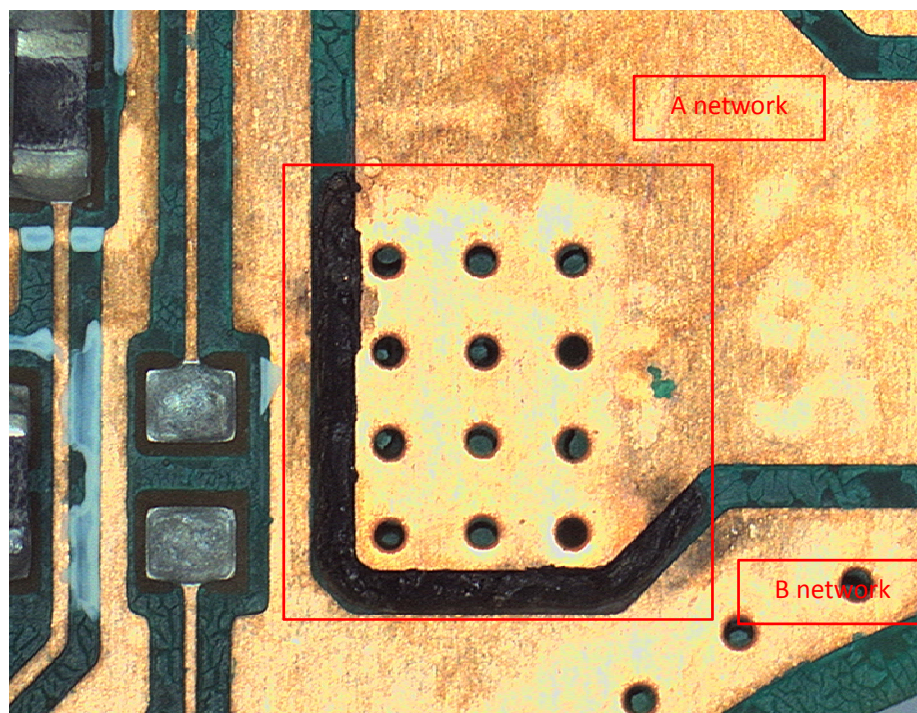
| Qualtec | 8.11、Thermal imaging observation after the removal of solder blocking ink on the BOTTOM surface of the burned position showed that the hot spot was still located in the hole area of NETWORK A, indicating that the short circuit point was located in the hole area of network A. See P17. |

Description :Thermal imaging observation after the removal of solder blocking ink on the BOTTOM surface of the burned position showed that the hot spot was still located in the hole area of NETWORK A, indicating that the short circuit point was located in the hole area of network A.

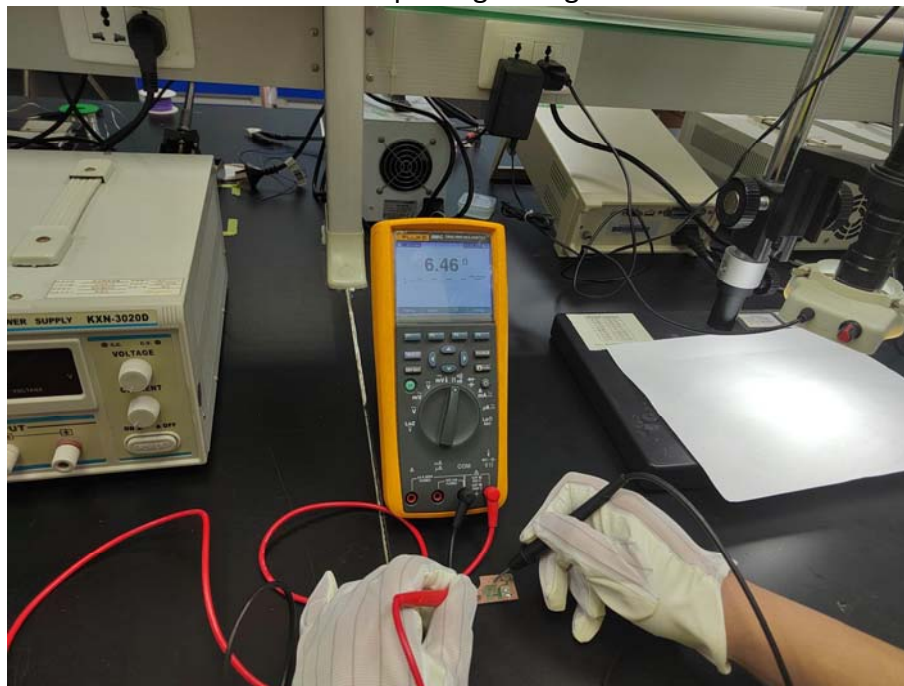
| Qualtec | 8.12、Measure the resistance value of the burned position of the sample after plane grinding, and the measured resistance value is $6.46\Omega$ . After grinding off the L1 layer, the short-circuit point still exists. See P18. |

Description : Measure the resistance value of the burned position of the sample after plane grinding, and the measured resistance value is 6.46 Ω. After grinding off the L1 layer, the short-circuit point still exists.

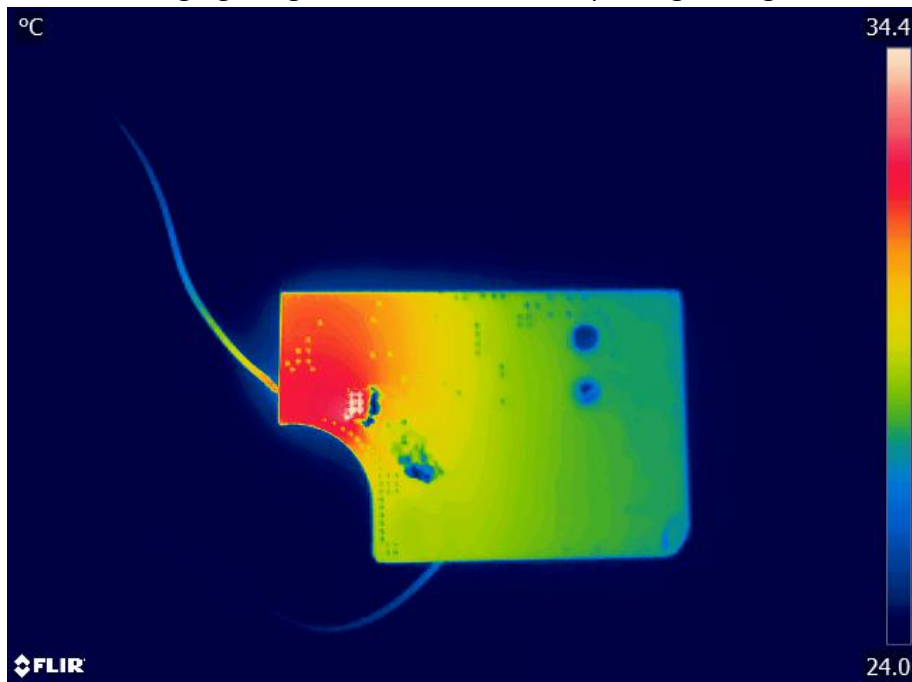
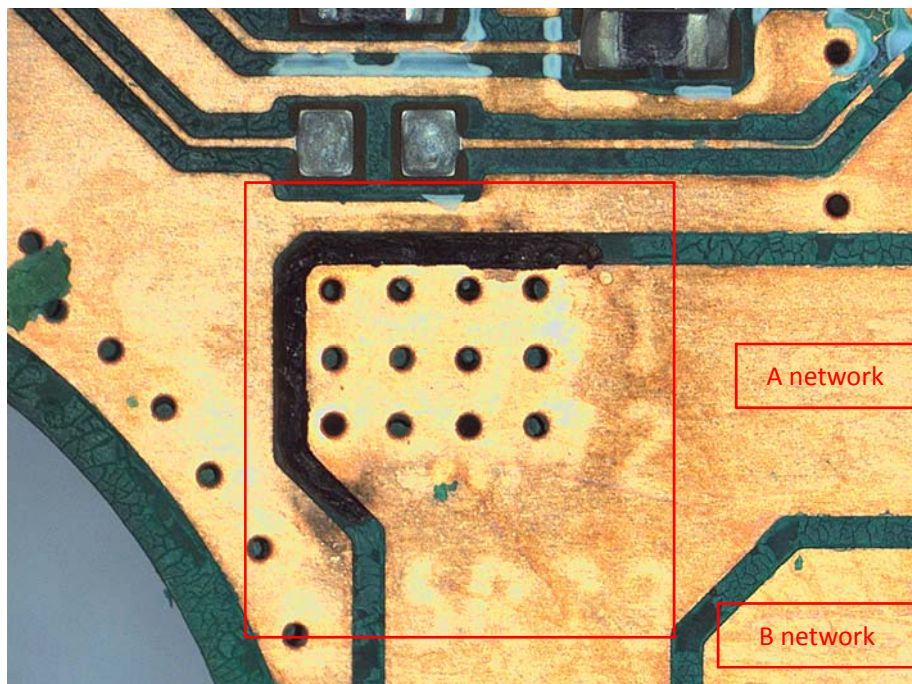
| Qualtec | 8.13、After the thermal imaging observation of the BOT surface of the burned-out position of the sample was carried out, it was found that the hot spot was still located in the via area of the A network. After grinding off L1 layer, the short circuit in the via area of the A network still existed. See P19. |

Description : After the thermal imaging observation of the BOT surface of the burned-out position of the sample was carried out, it was found that the hot spot was still located in the via area of the A network. After grinding off L1 layer , the short circuit in the via area of the A network still existed.

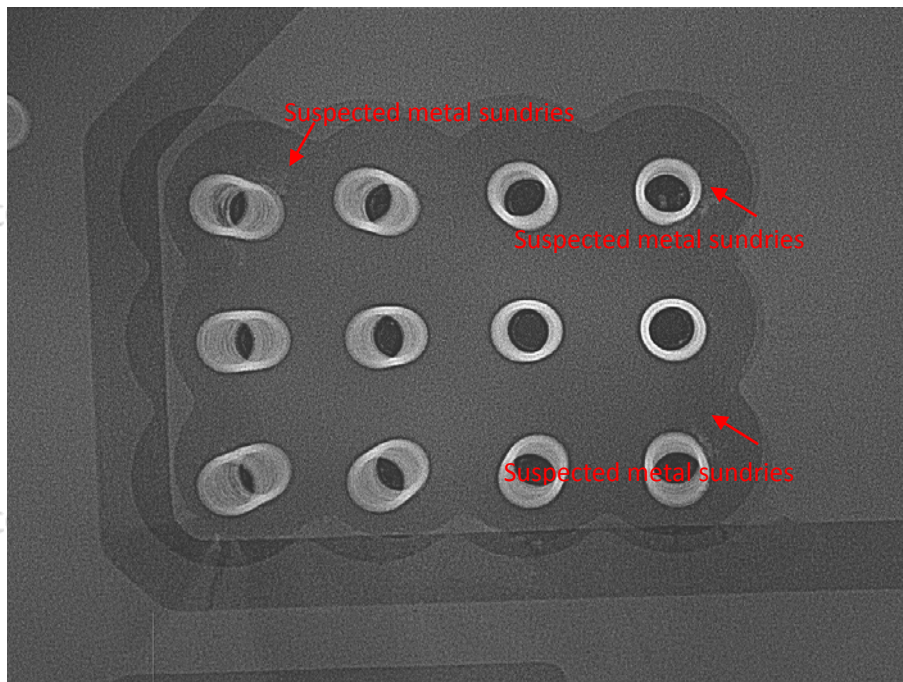
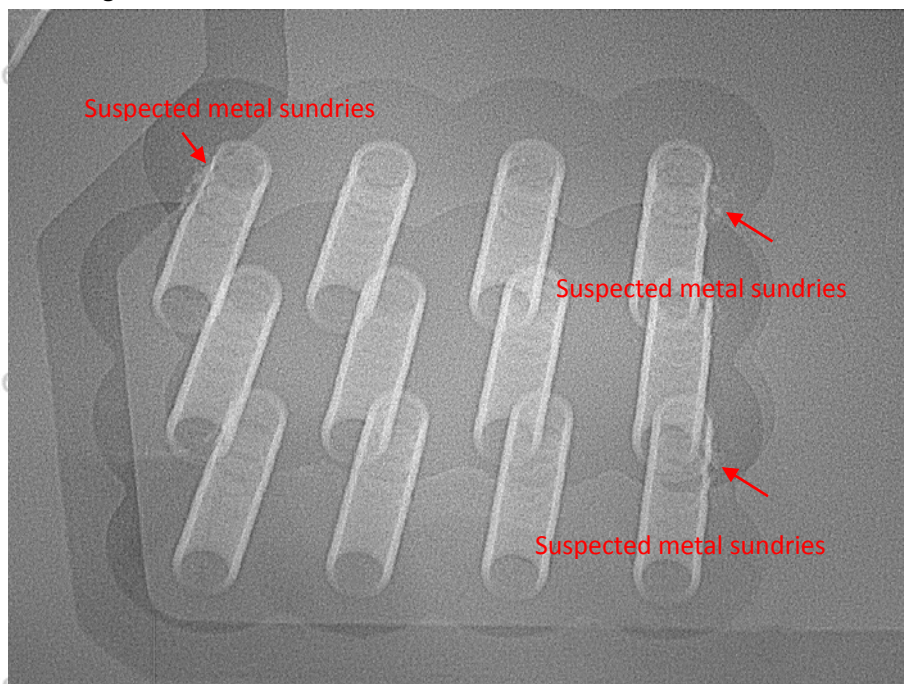
| Qualtec | 8.14、X-Ray observation of the burnt-out position of the sample after plane grinding, and it is found that there are suspected that there were suspected metal debris in the of L2 dielectric layer. See 20. |

Description: X-Ray observation of the burnt-out position of the sample after plane grinding, and it is found that there are suspected that there were suspected metal debris in the of L2 dielectric layer.

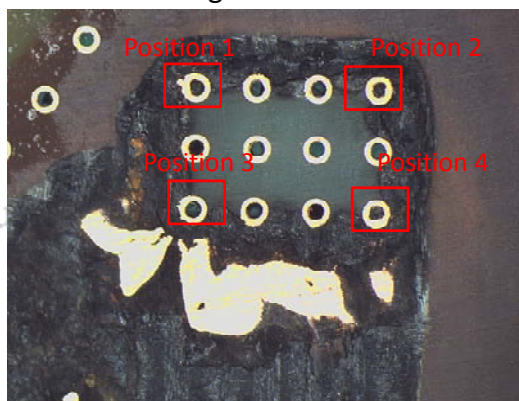
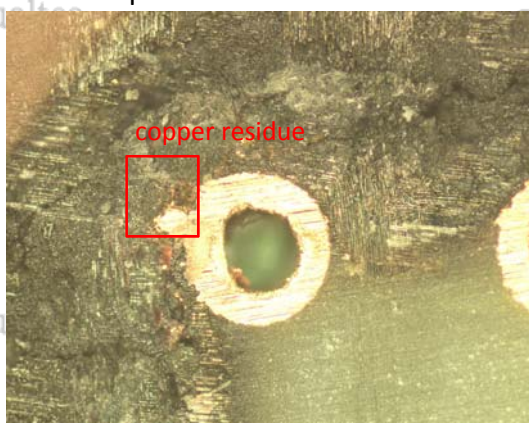
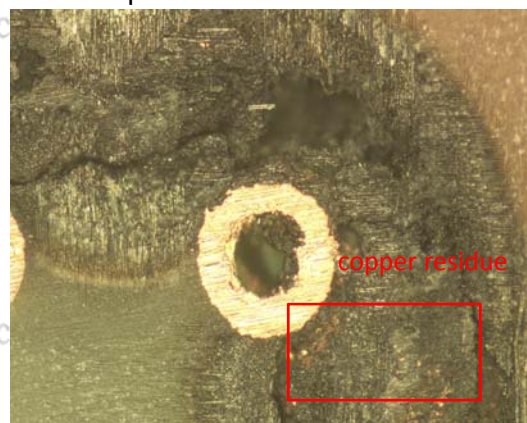
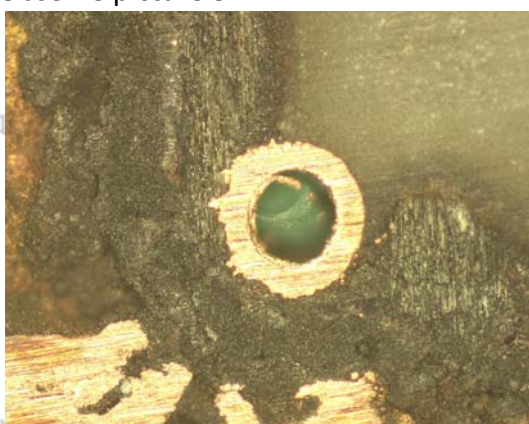
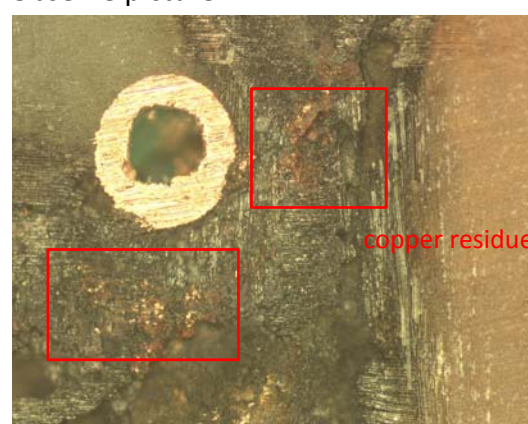
| Qualtec | 8.15、Surface observation after plane grinding was carried out on the burned-out position, and it was found that there was residual copper phenomenon at position 1, position 2, and position 4 of the base material between the A |

Description: Surface observation after plane grinding was carried out on the burned-out position, and it was found that there was residual copper phenomenon at position 1, position 2, and position 4 of the base material between the A network and the B network.

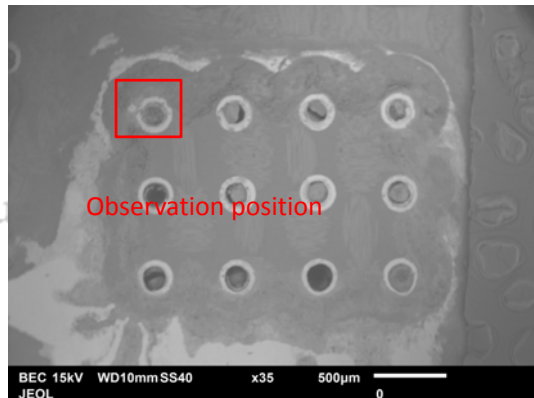
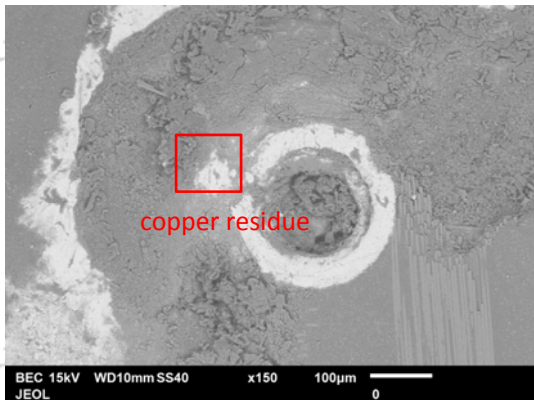
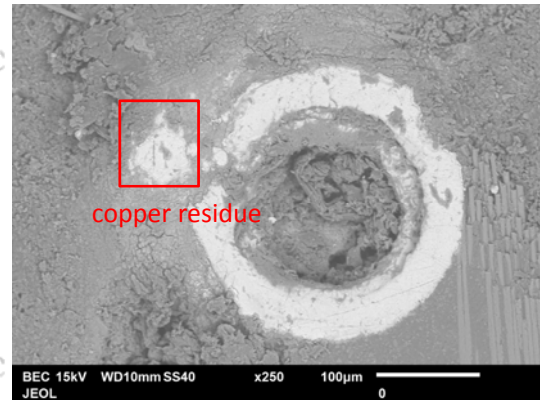
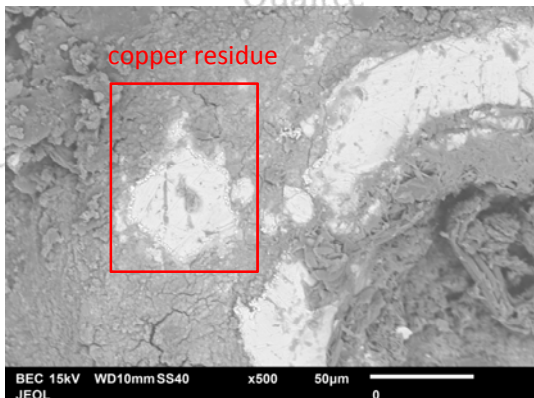
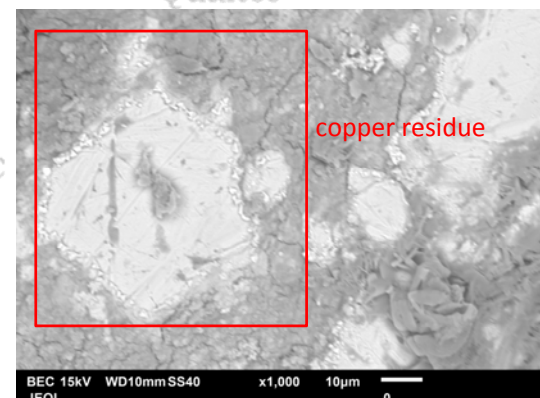
| Qualtec | 8.16、SEM observation was made on the surface of the burnt loss position after plane grinding, and it was found that there was copper residue in the base material position between NETWORK A and network B. See P22. |

Description: SEM observation was made on the surface of the burnt loss position after plane grinding, and it was found that there was copper residue in the base material position between NETWORK A and network B.

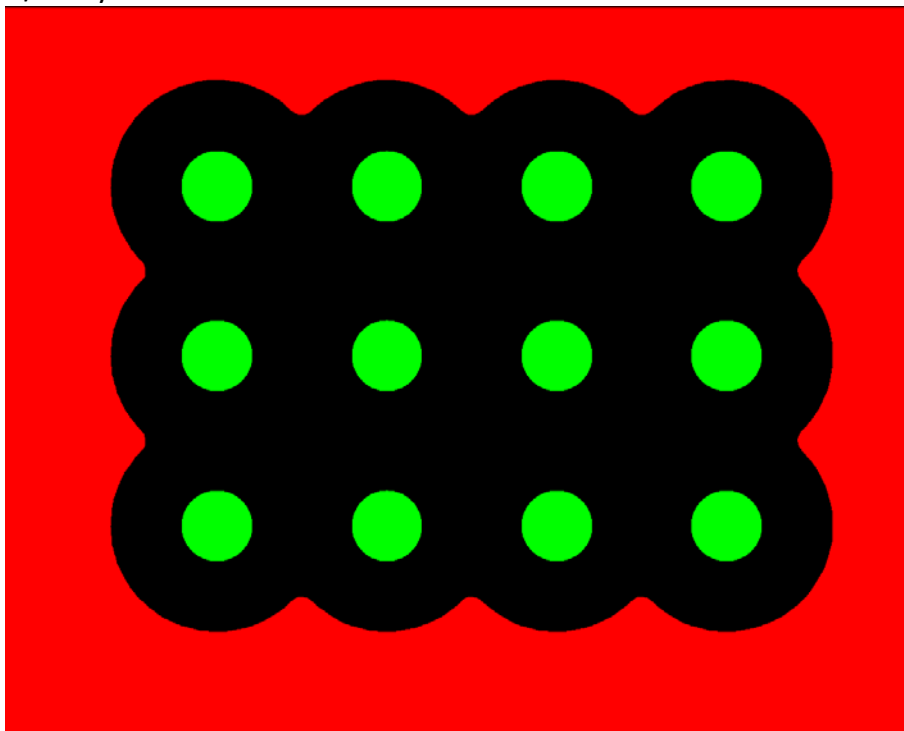
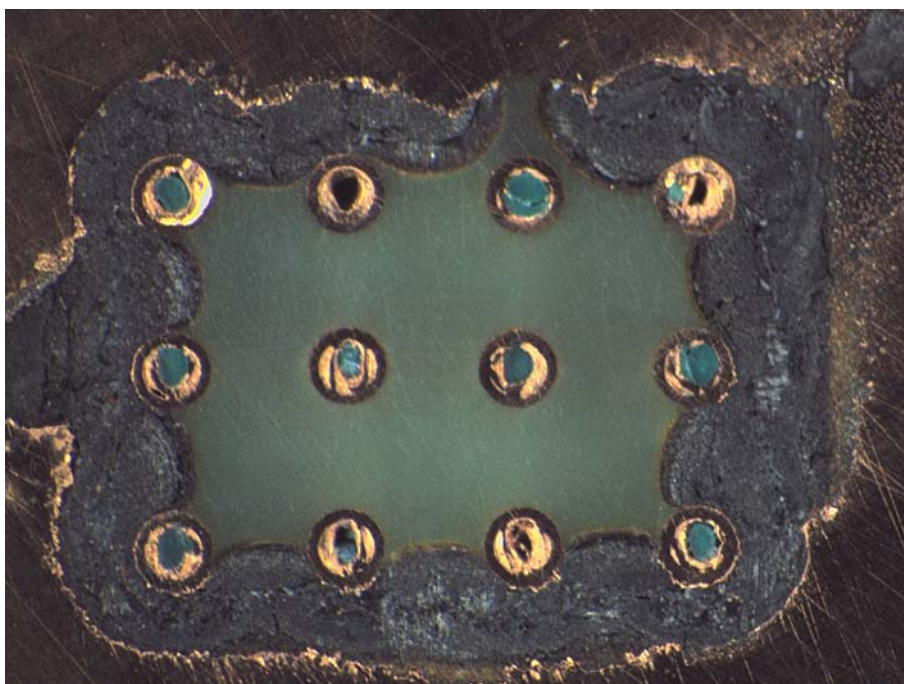
| Qualtec | 8.17、Observe the burned position after plane grinding. The outline of the burned position is similar to that of the inner copper. See P23. |

Description: Observe the burned position after plane grinding. The outline of the burned position is similar to that of the inner copper.
