# Test Report

Sample Name : PCB

Report NO. : REP220300400038

| 1. Test title: | Burning plate short circuit analysis | | | | |

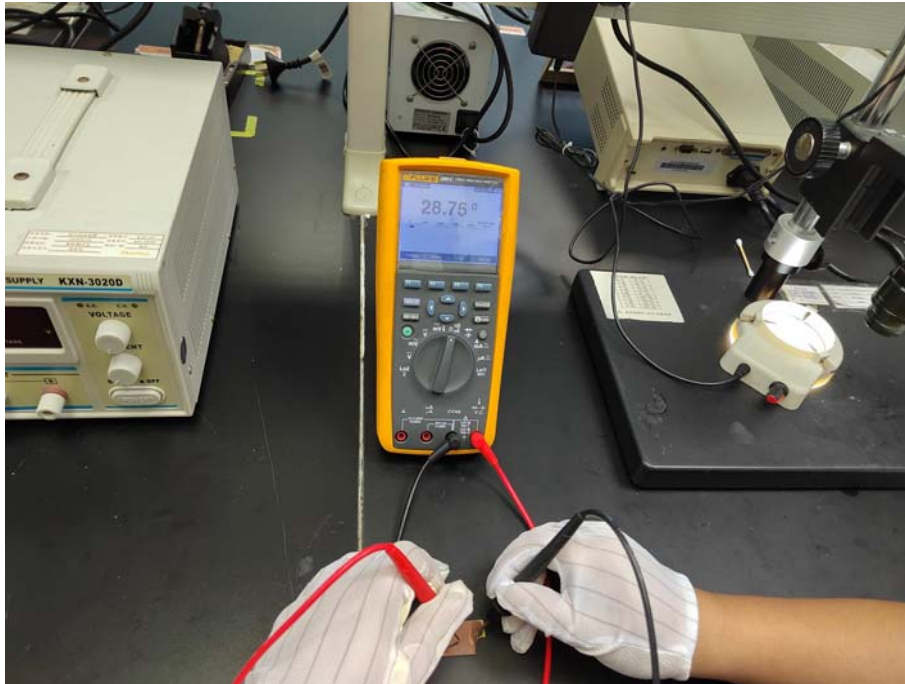
Resistance measurement picture

| Qualtec | 8.18、measure the resistance value of the burned position of the sample after plane grinding. After grinding off the L4 layer, the short-circuit point still exists, and the measured resistance value is 28.75 $\Omega$ . See P24. |

Description:measure the resistance value of the burned position of the sample after plane grinding. After grinding off the L4 layer, the short-circuit point still exists, and the measured resistance value is 28.75 Ω.

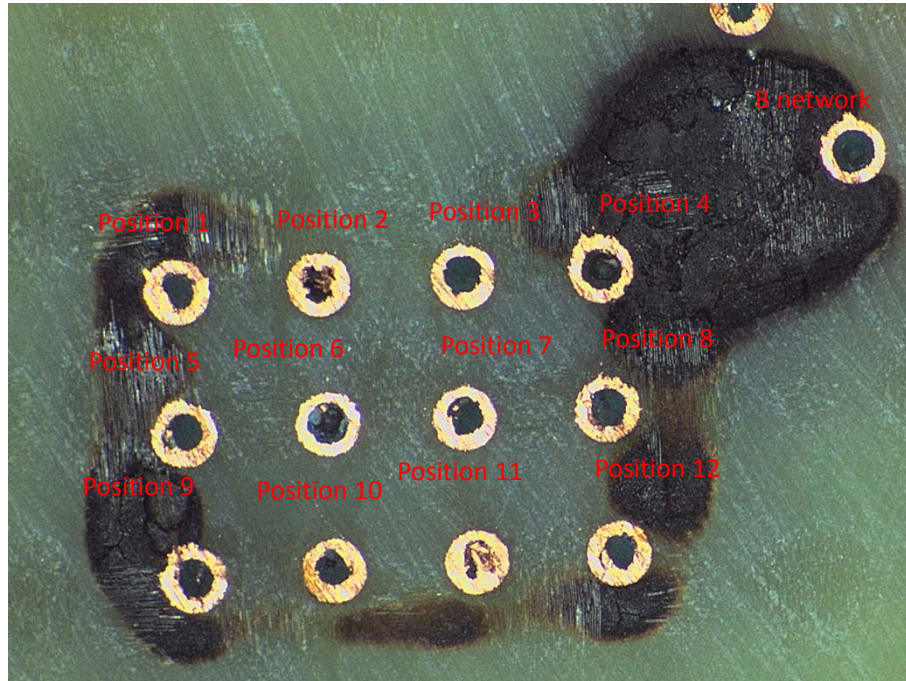
| Qualtec | 8.19、After plane grinding of the sample burning position, the resistance value between position 1 ~ position 12 and network B was measured respectively. The resistance value of position 3 was the lowest, 187.19 $\omega$ . After grinding off L3 layer, the short circuit point still existed, and L1/L4 layers were all ground off, indicating that the short circuit point was located in L2 layer, and position 4 had the most serious burning loss. See P25. |

Description: After plane grinding of the sample burning position, the resistance value between position 1 ~ position 12 and network B was measured respectively. The resistance value of position 3 was the lowest, 187.19 Ω. After grinding off L3 layer, the short circuit point still existed, and L1/L4 layers were all ground off, indicating that the short circuit point was located in L2 layer, and position 4 had the most serious burning loss.

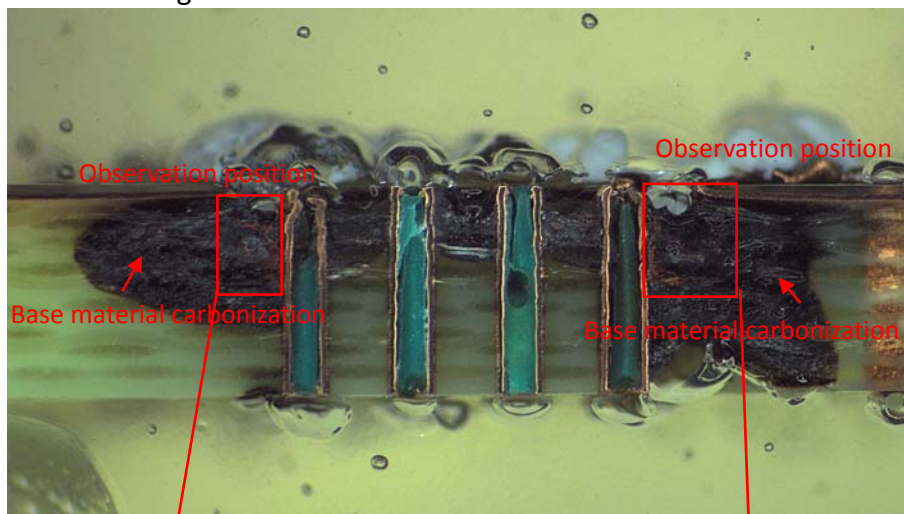
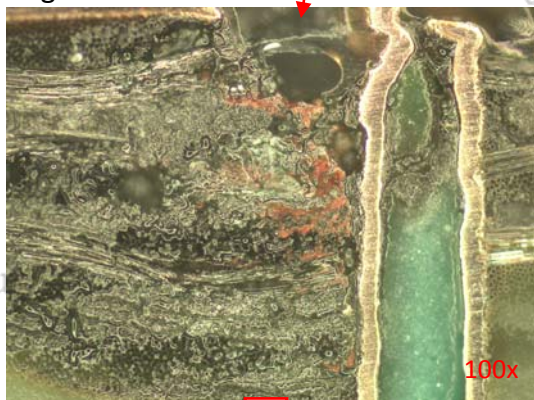
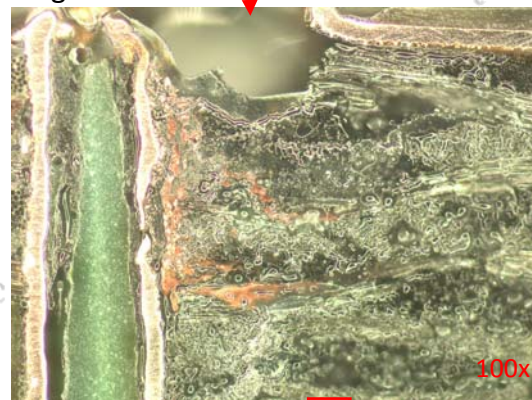
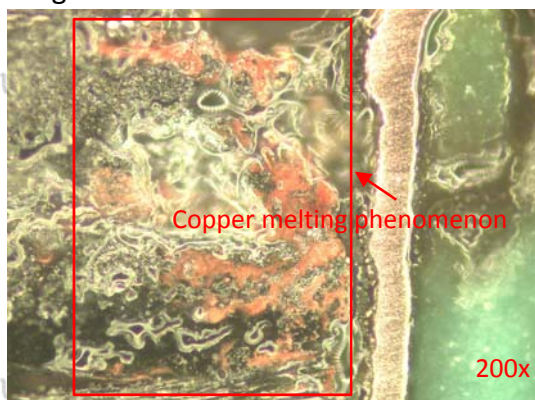
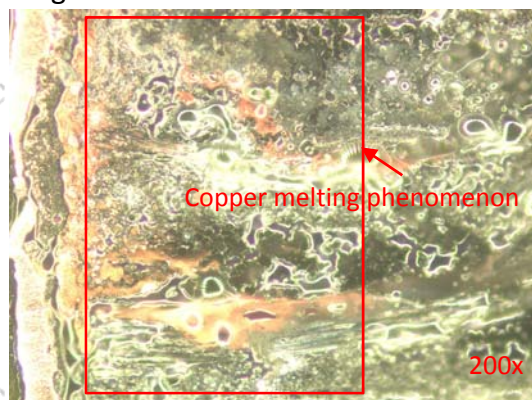
| Qualtec | 8.20、the metallographic observation of the section after removing the solder resist ink at the burned position shows that the substrate at the core plate position is carbonized, and there is copper melting at the carbonized position of the core plate substrate. Continue on the next page. See P26. |

Description: the metallographic observation of the section after removing the solder resist ink at the burned position shows that the substrate at the core plate position is carbonized, and there is copper melting at the carbonized position of the core plate substrate. Continue on the next page.

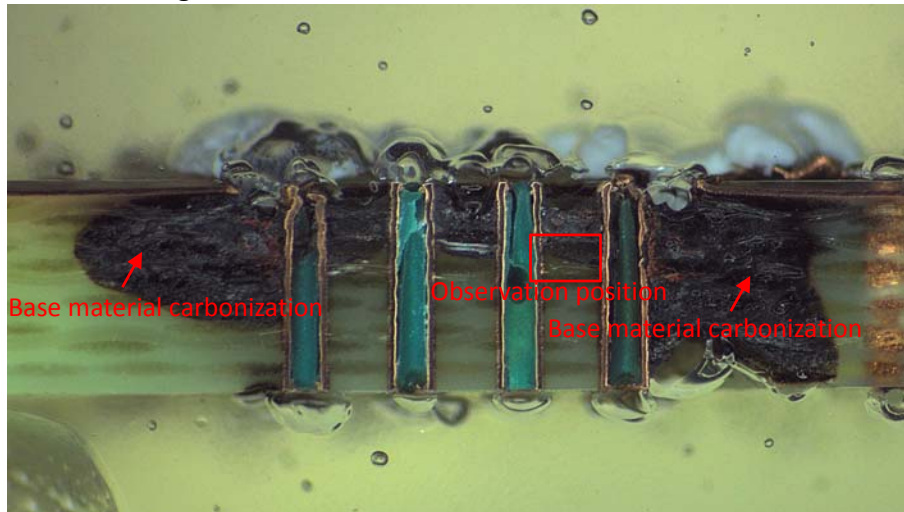
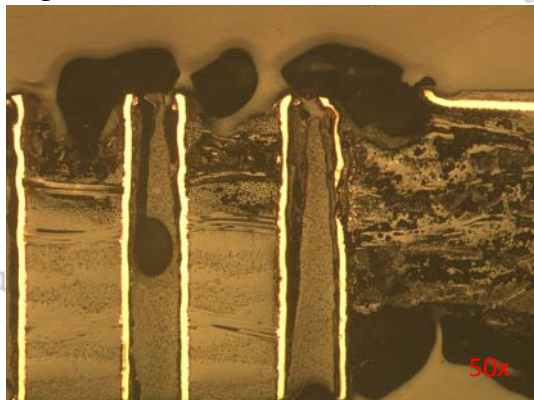
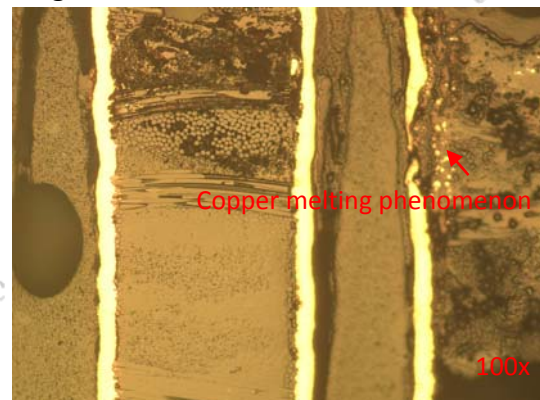
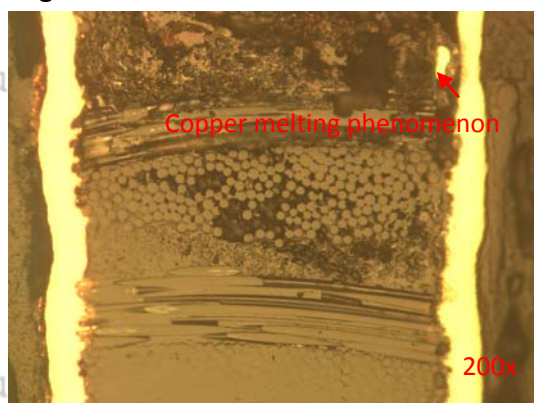
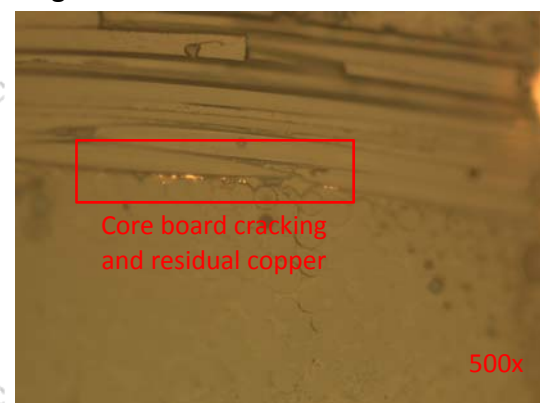
| Qualtec | 8.21、the metallographic observation of the section after removing the solder resist ink at the burned position shows that there are cracks and residual copper on the core plate, and there is copper melting at the carbonized position of the core plate substrate. See P27. |

Description: the metallographic observation of the section after removing the solder resist ink at the burned position shows that there are cracks and residual copper on the core plate, and there is copper melting at the carbonized position of the core plate substrate.

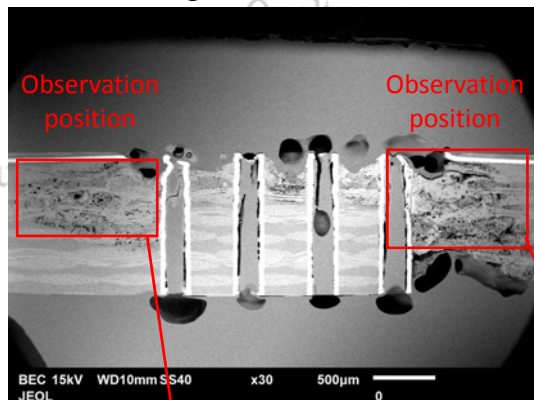
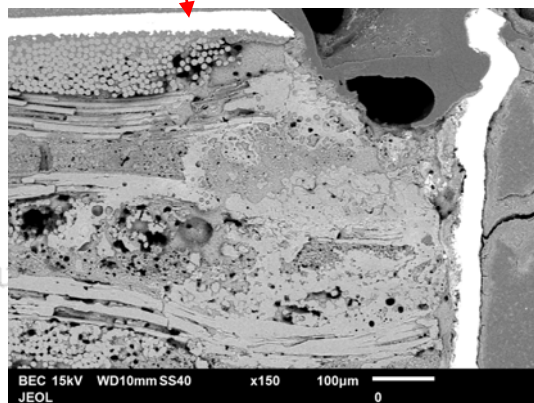
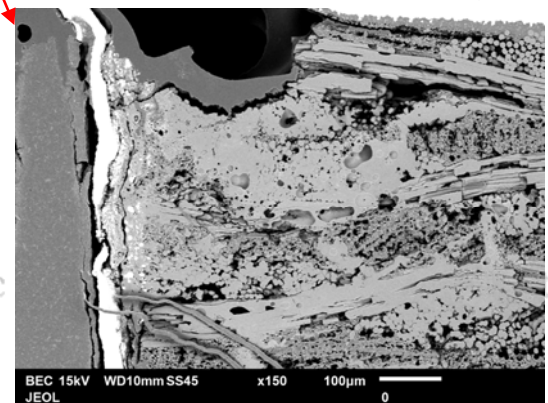
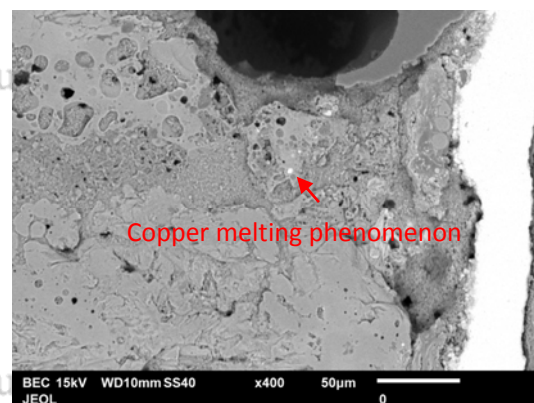
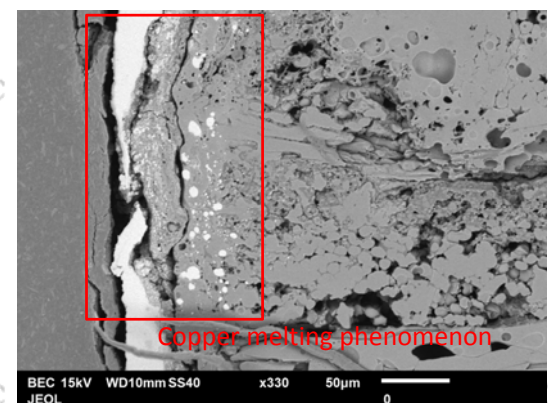
| Qualtec | 8.22、SEM observation of the section after removing the solder resist ink at the burned position shows that the substrate at the core plate position is carbonized, and there is copper melting at the carbonized position of the core plate substrate. Continue on the next page. See P28. |

Description: SEM observation of the section after removing the solder resist ink at the burned position shows that the substrate at the core plate position is carbonized, and there is copper melting at the carbonized position of the core plate substrate. Continue on the next page.

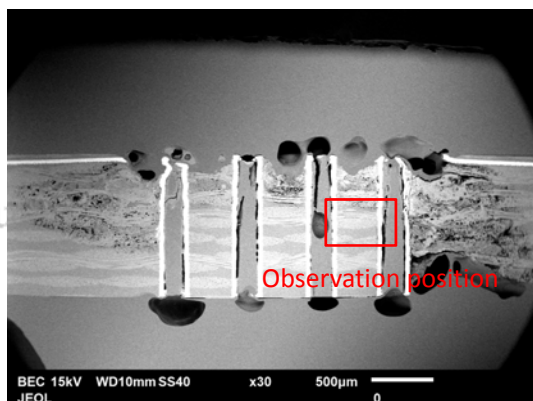
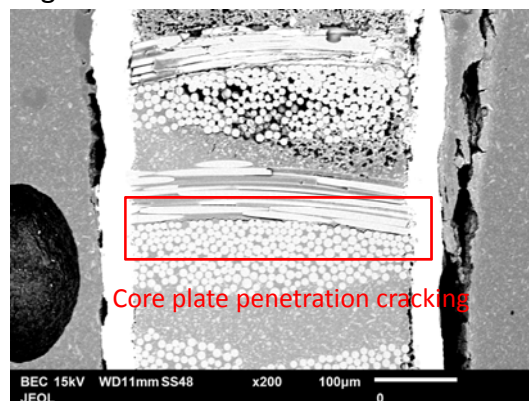
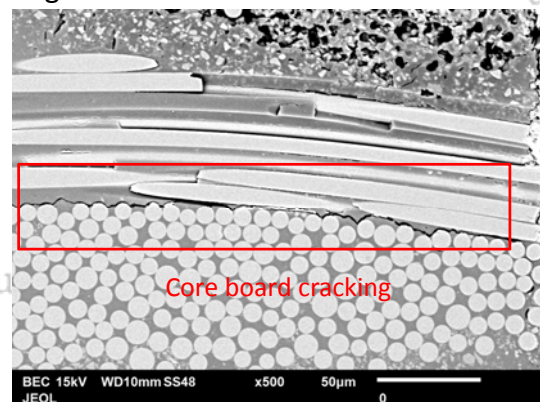
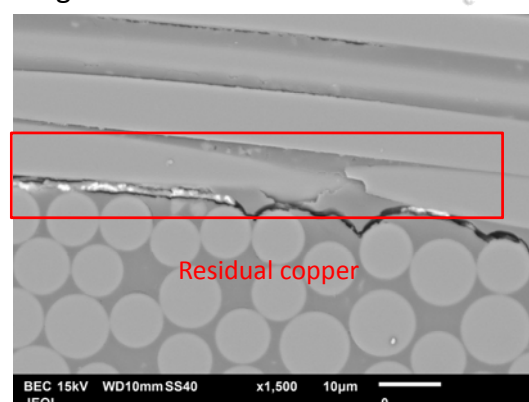
| Qualtec | 8.23、SEM observation of the section after removing the solder resist ink at the burned position shows that the core plate has penetrating cracking and residual copper. See P29. |

Description: SEM observation of the section after removing the solder resist ink at the burned position shows that the core plate has penetrating cracking and residual copper.

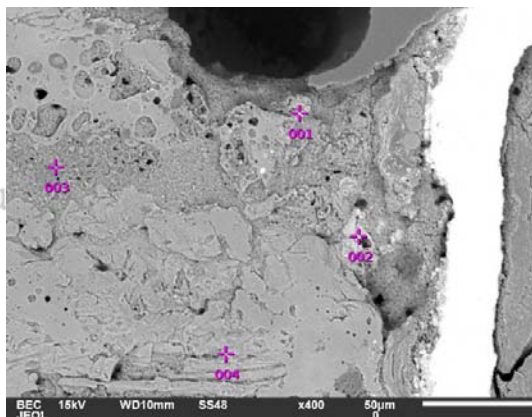
| Qualtec | 8.24、EDS analysis of the section of the burned position after the removal of welding ink, C, O, Si, Cu, Br elements were detected in the copper melting position, and C, O, Si, Ca, Br elements were detected in the carbonization position of the base material. See P30. |

Description: EDS analysis of the section of the burned position after the removal of welding ink, C, O, Si, Cu, Br elements were detected in the copper melting position, and C, O, Si, Ca, Br elements were detected in the carbonization position of the base material.

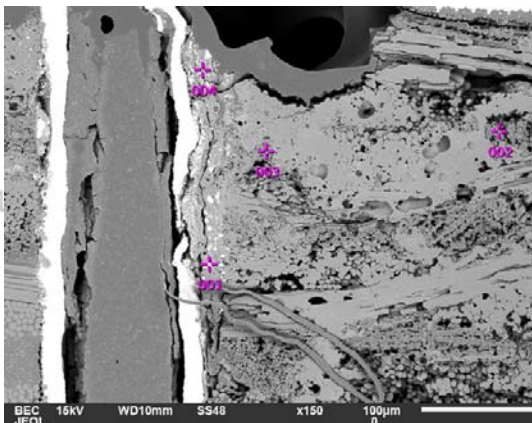
| Qualtec | 8.25、EDS analysis of the section of the burned position after the removal of welding ink, C, O, Si, Ca, Cu, Br elements were detected in the copper melting position, and C, O, Si, Ca, N, Cu, Br elements were detected in the carbonization position of the base material. See P31. |

Description: EDS analysis of the section of the burned position after the removal of welding ink, C, O, Si, Ca, Cu, Br elements were detected in the copper melting position, and C, O, Si, Ca, N, Cu, Br elements were detected in the carbonization position of the base material.

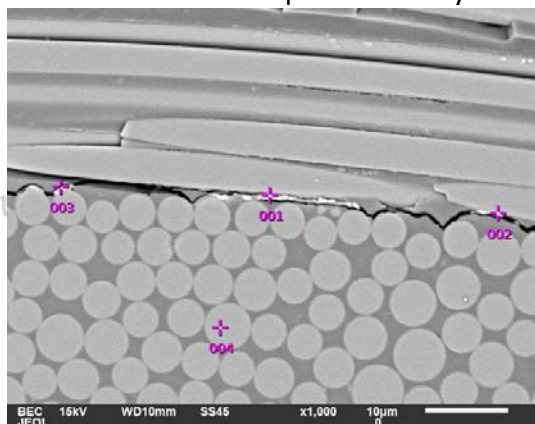
| Qualtec | 8.26、Description: EDS analysis of the cross-section after removing the solder mask thick film at the burn-out position, C, N, O, Si, Ca, Cu, Br elements were detected at the residual copper position, and C, O, Si, Ca were detected at the carbonization position of the substrate, Br element. See P32. |

Description: EDS analysis of the cross-section after removing the solder mask thick film at the burn-out position, C, N, O, Si, Ca, Cu, Br elements were detected at the residual copper position, and C, O, Si, Ca were detected at the carbonization position of the substrate, Br element.

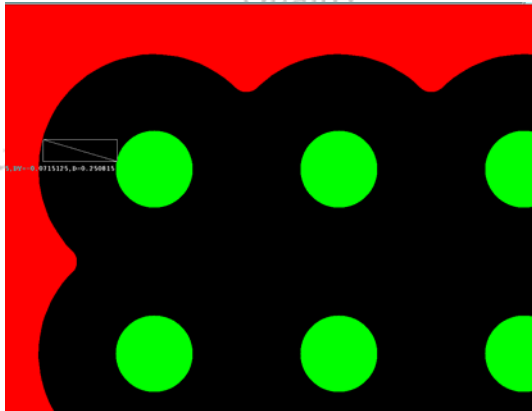
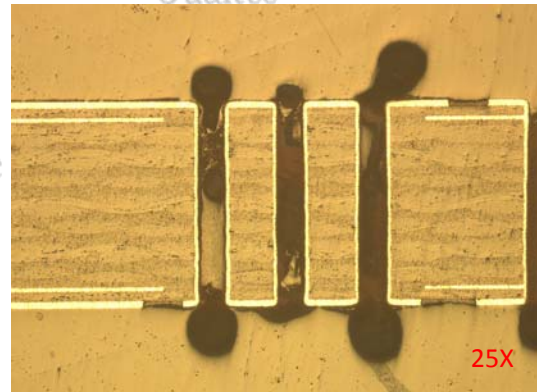
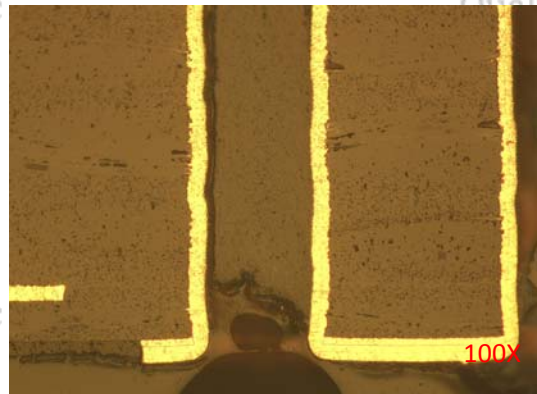
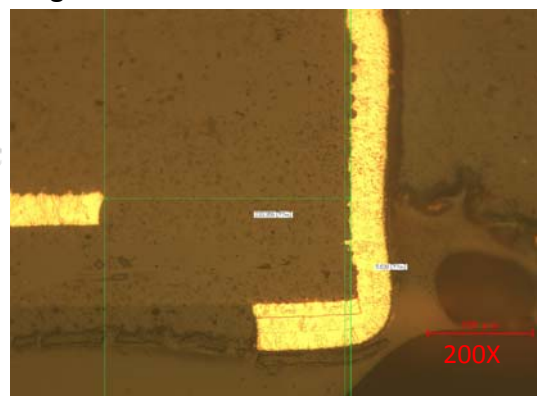
| Qualtec | 8.27、Inspection after micro sectioning with same pattern of others location, without found abnormal, space between innerlayer and PTH was 222.033 ~ 233.359 $\mu\text{m}$ (meet the requirements), roughness is 5.638 $\mu\text{m}$ and wicking is 69.815 $\mu\text{m}$ . See P33. |

Description: Inspection after micro sectioning with same pattern of others location, without found abnormal, space between innerlayer and PTH was 222.033~233.359 $\mu$ m(meet the requirements), roughness is 5.638 $\mu$ m and wicking is 69.815 $\mu$ m.
