# Swan soundbar

## - No boot issue

Issued Date 2021.08.11

Ver.1.0

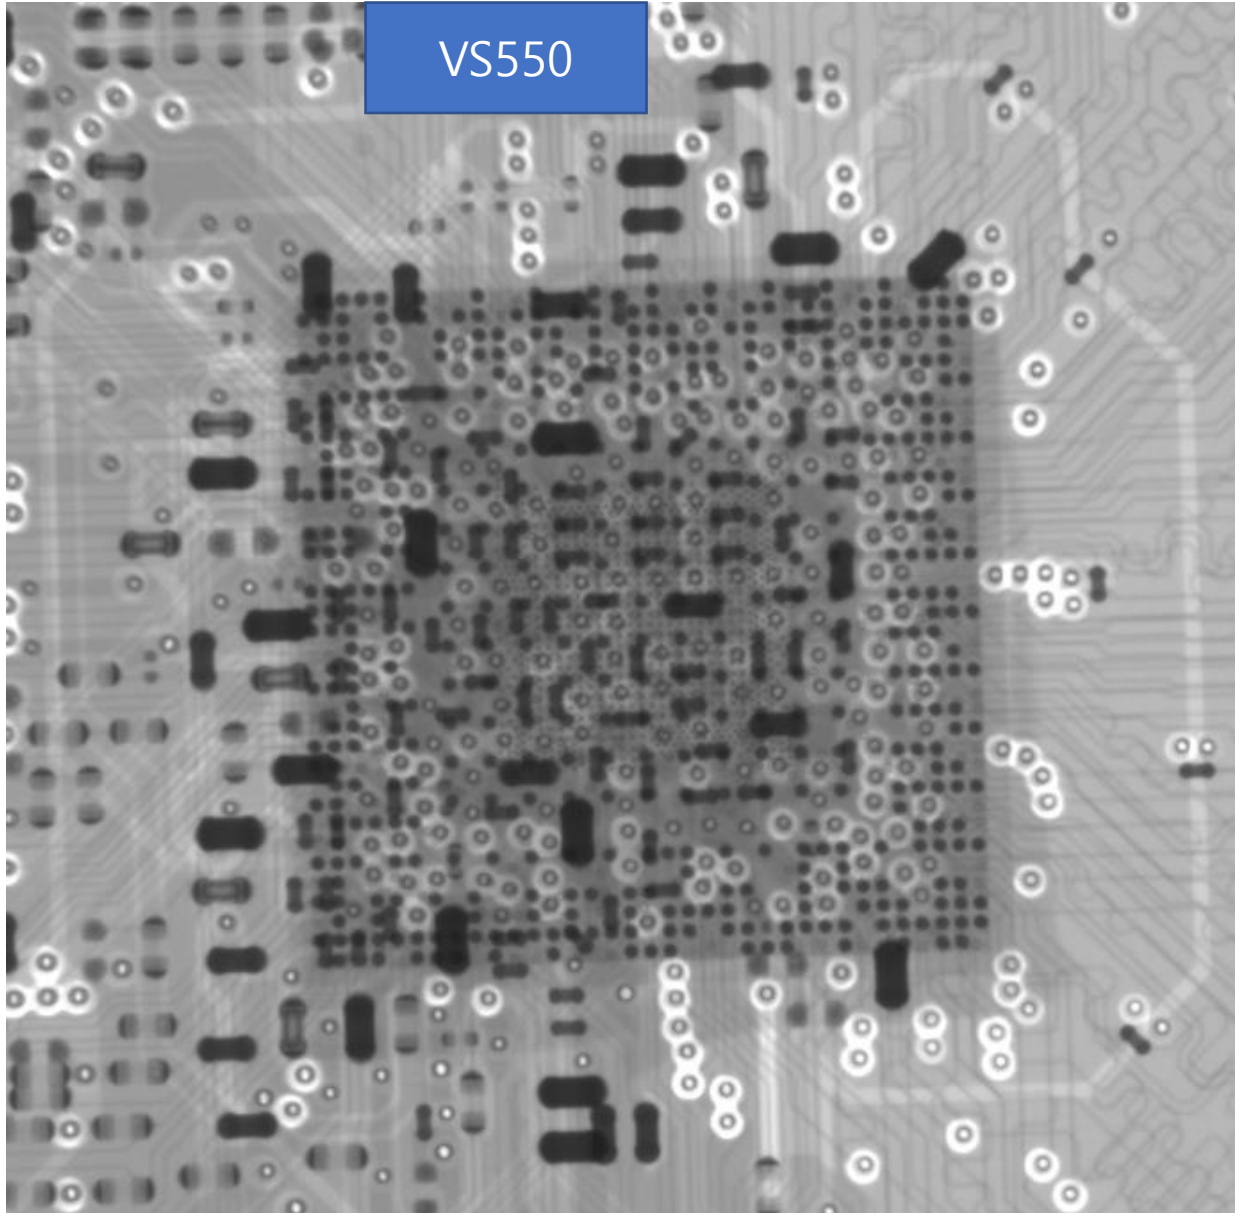
VS550

- Symptom
  - No booting after power on
  - in no boot status, power consumption is 1.9~2W
  - unscrew a half turn near the eMMC screw
    - Start the booting
  - Video clip
    - [https://www.dropbox.com/s/tbiauamcmdkonge/20210802\\_185409.mp4?dl=0](https://www.dropbox.com/s/tbiauamcmdkonge/20210802_185409.mp4?dl=0)
- ALT reviewed
  - Visual inspection : Normal
  - System review on board level : Normal
  - BGA X-ray inspection : Normal
- ALT is suspected that Physical damage such as PCB cracks or BGA cracks.
- FII should be analyze the defect.
