### FAILURE ANALYSIS REPORT

To: ALT  
From: WH Lin  
Customer #: ALT/SKB  
Synaptics FACR #: 017191(SN1)  
CC: Pavan Singaraju  
Date: 6/3/2022

- (2) Problem Description  
Background information:  
AUX pin fixed low.

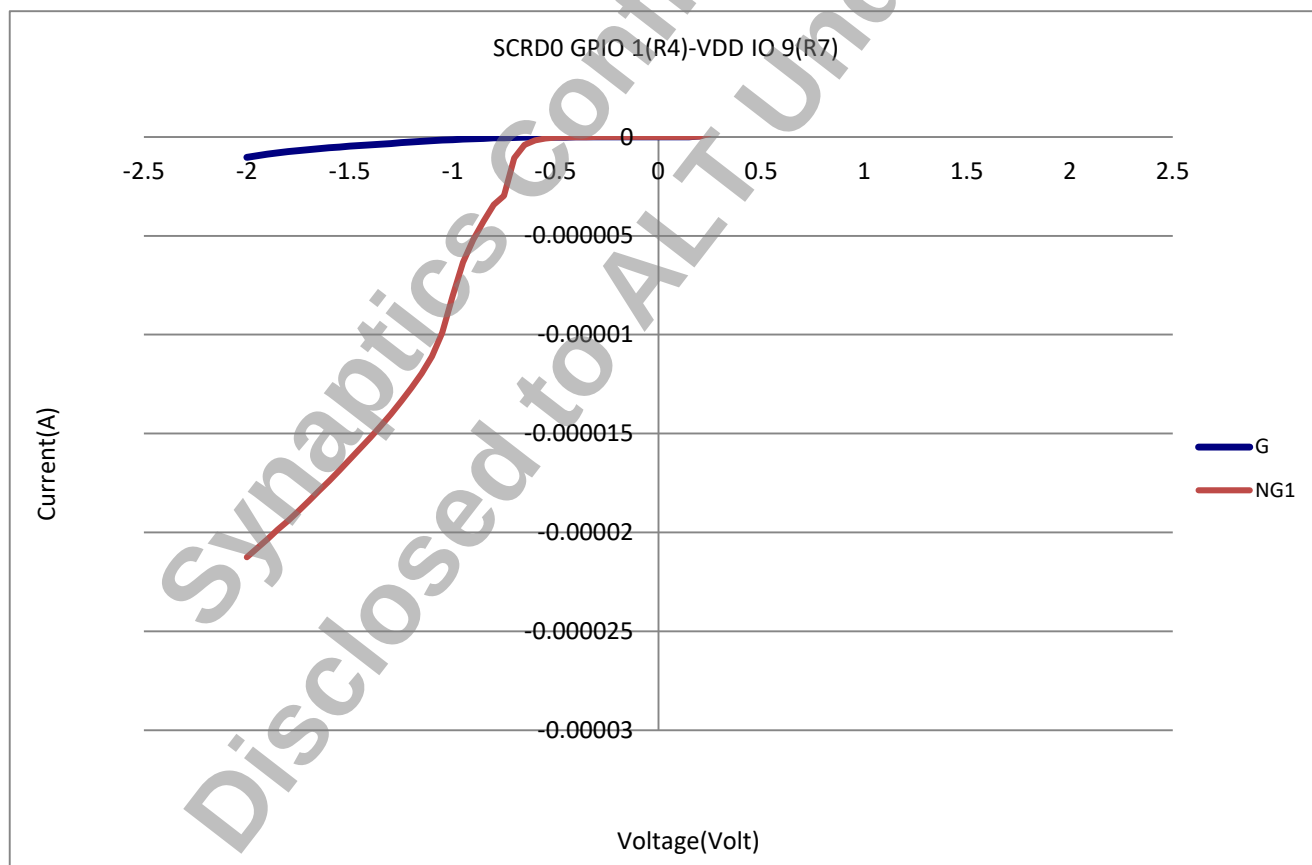
Figure 1. IV Curve analysis

- Synaptics FA team provided non-destructive analyses for visual inspection, CSAM, and X-ray on SN1 that no abnormalities found.
- ATE verification showed SN1 to fail ATE with current test program for pin\_SCRD0\_GPIO [1] (R4) leakage fail.
- Synaptics FA team conducted further IV curve measurement for SN1 to check leakage failure pin that leakage failure was confirmed. (Please refer to Figure 1).

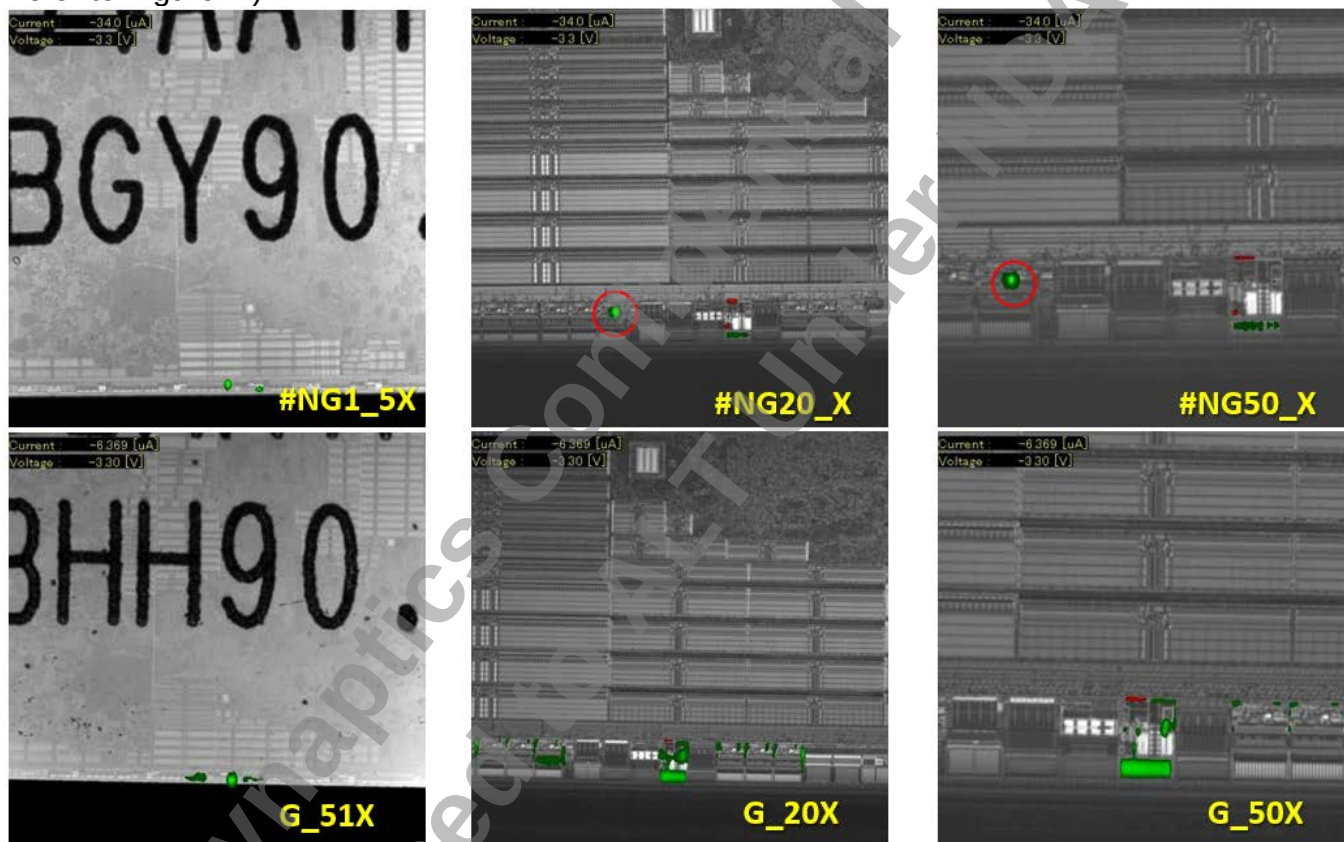
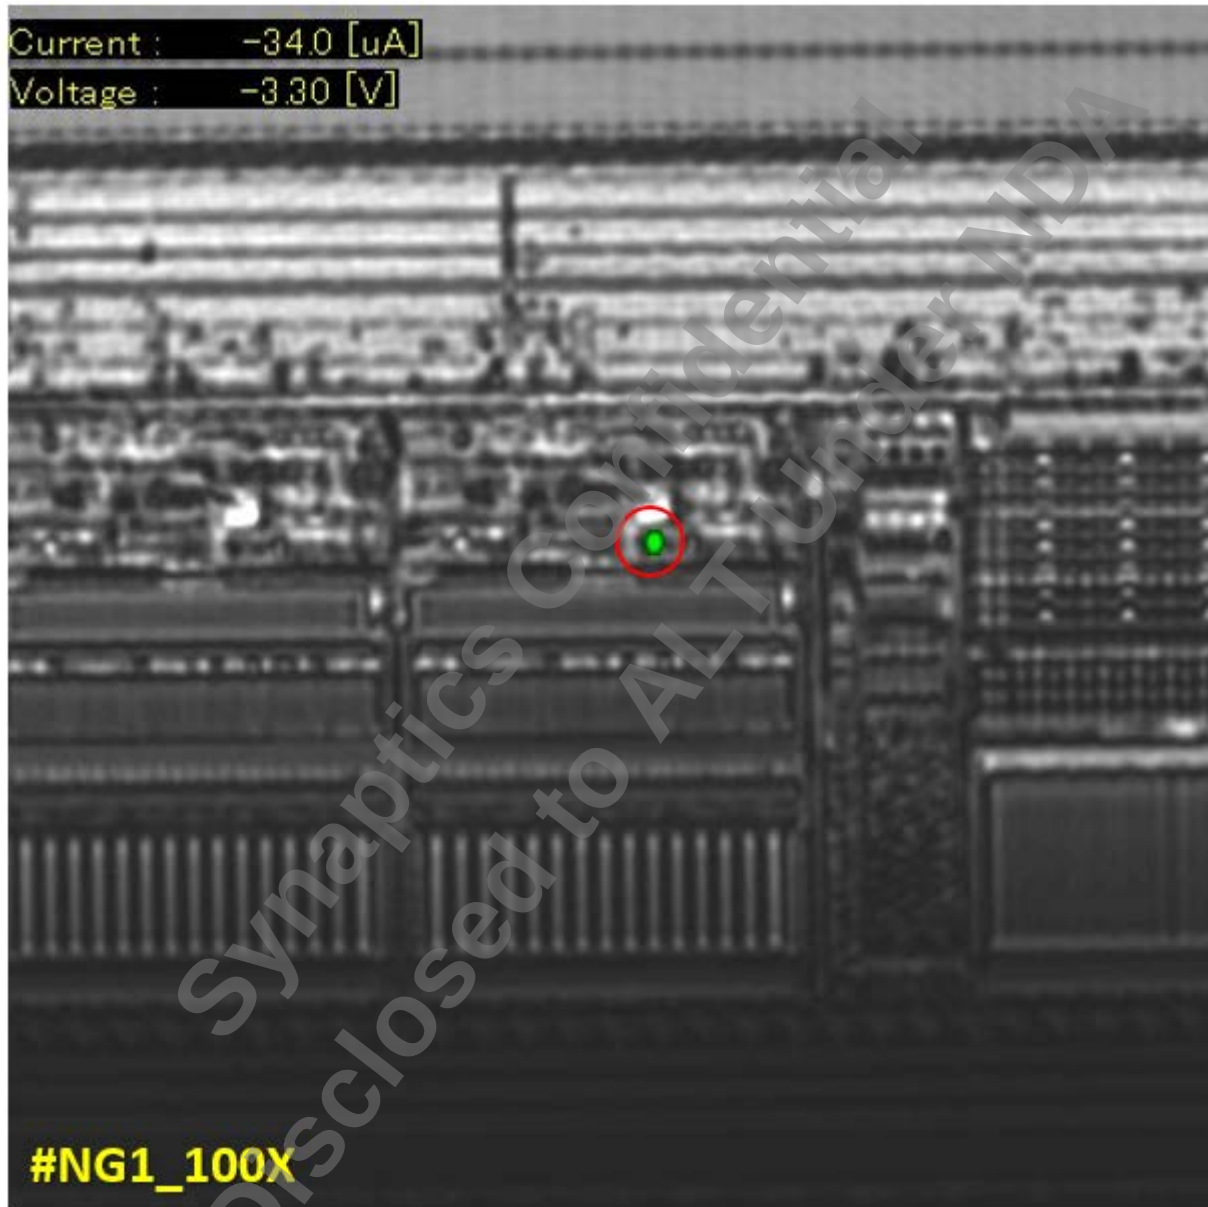
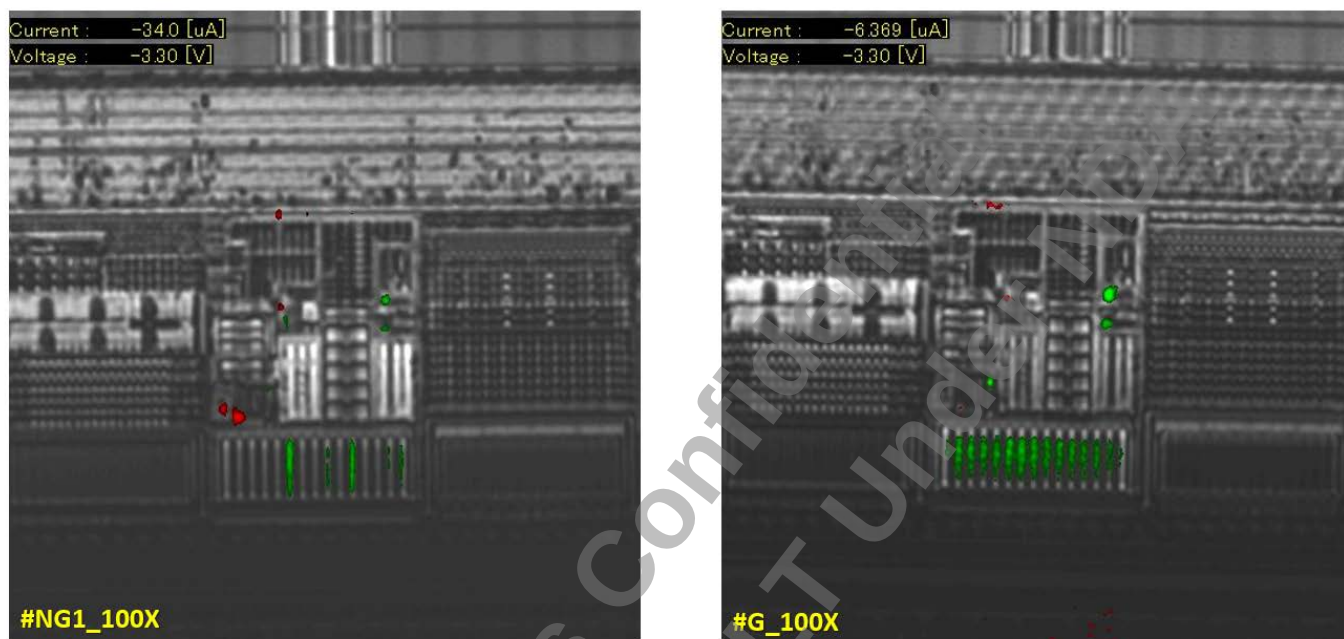
Figure 2. OBIRCH analysis

- Synaptics FA team provided OBIRCH analysis for SN1 to analyze the leakage failure pin for SCRD0\_GPIO [1] (R40) to VSS that obvious burnt marks were confirmed (Please refer to Figure 2.)

- Based on above analyses that SN1 revealed as EOS failures from the pin for SCRD0\_GPIO [1] (R40). However, we suspect the returned units of SN1 was exposed to electrical overstress conditions. EOS occurs when a high voltage is inadvertently applied to a device for tens to several hundred milliseconds. In particular, it is important to ensure that power supplies to power pins must be clean and have good regulation. Also, it is important to ensure that the system has good signal integrity to prevent ground bounces due to abrupt variation in current consumption and over or undershoots due to transmission line reflections. Stresses beyond the recommended operating conditions may cause permanent damage.

Synaptics' devices have been extensively tested in accordance to industry's standards. A robust customer system design can help mitigate damages to its' internal components including Synaptics' device. Please feel free to reach out to our sales team for any applicable design guides pertinent to your Synaptics' product.
