**Suspected root cause****①GND PLATE too thin**

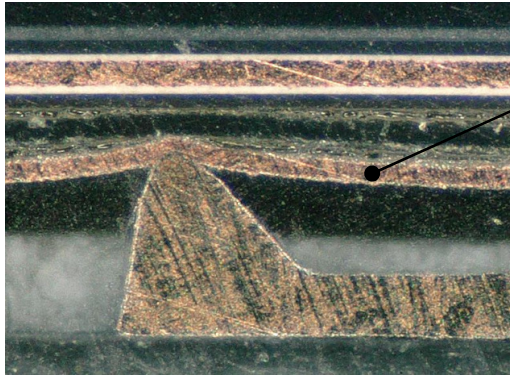
| GND PLATE thickness | | unit: $\mu\text{m}$ |
| Moter board side | 44 | |
| AMC board side | 43 | |

| GND PLATE thickness | | unit: $\mu\text{m}$ |
| HRS recommendation evaluating use | 72 | |

The GND plate's thickness is only 60% of HRS recommendation.

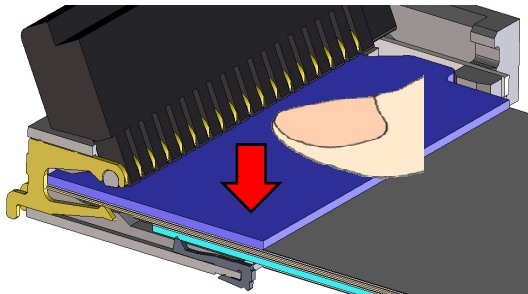
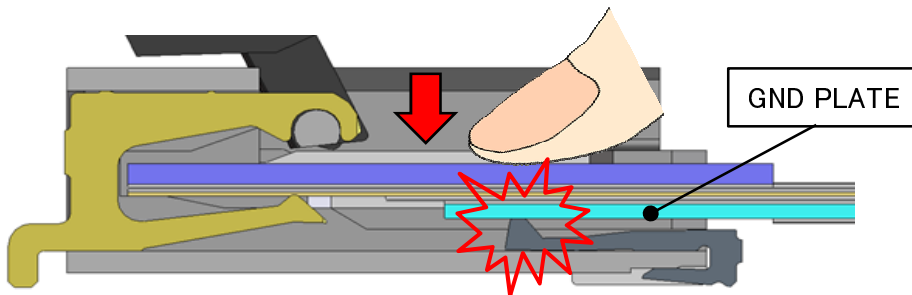
**②Additonal extra force applied when inserting FFC**

When inserting FFC, given additional downward force applied directly on FFC(see above), the extra pressure could cause the pierced-thru
