## Button issue

## Gap issue

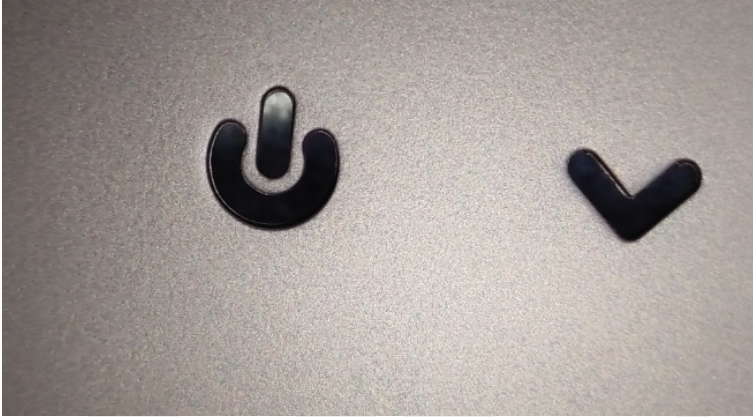
1. There are still burrs on the top cover after INKEL sorting.

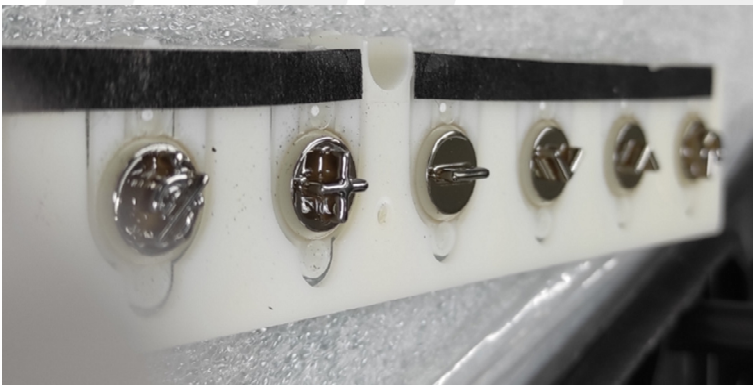
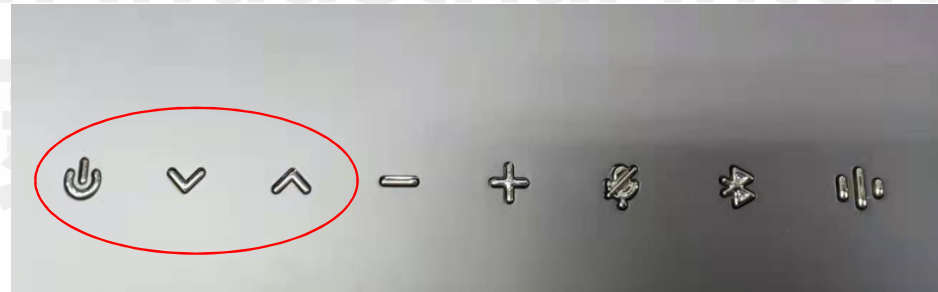
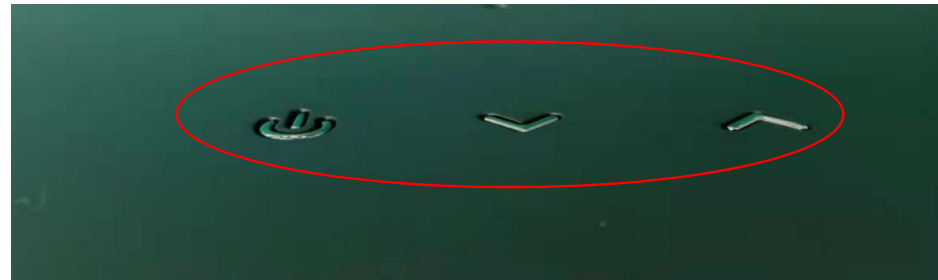
2. The button is crooked, so that the button won't pop up.

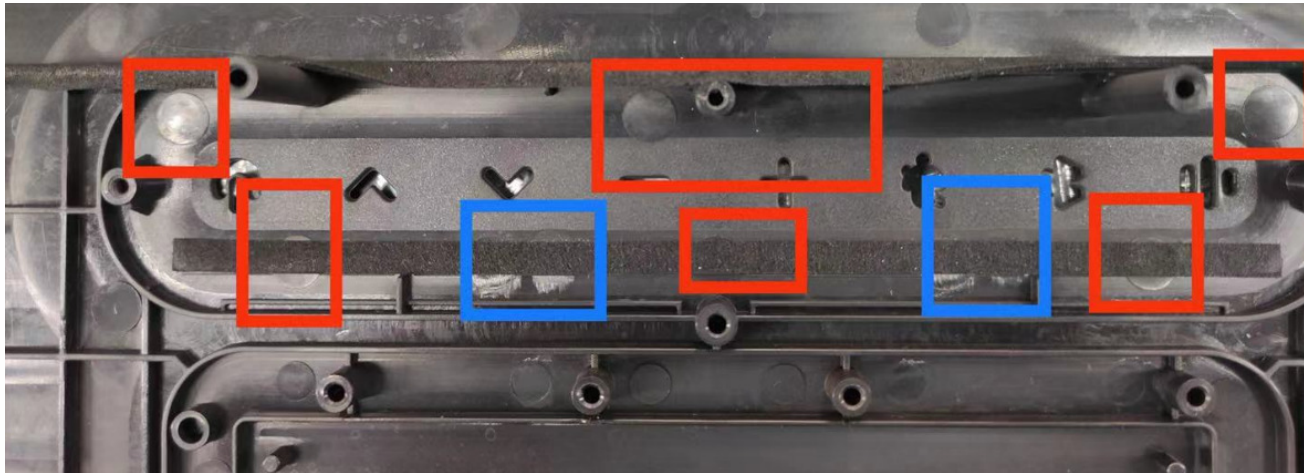
3. The height of the ejector marks is higher than the plane of the top cover, which will push up the button. And the appearance of the button will sink.

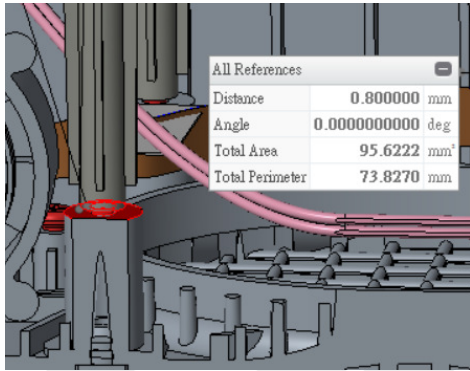
Gap of top cover and bottom cover screw boss

1. The gap of top cover and bottom cover screw boss is 0.8mm, and the thickness of the speaker on 3D model is 0.7mm. But the actual speaker thickness is 1.04mm, which causes the gap to out of spec. If we remove the speaker, the gap will be much smaller.

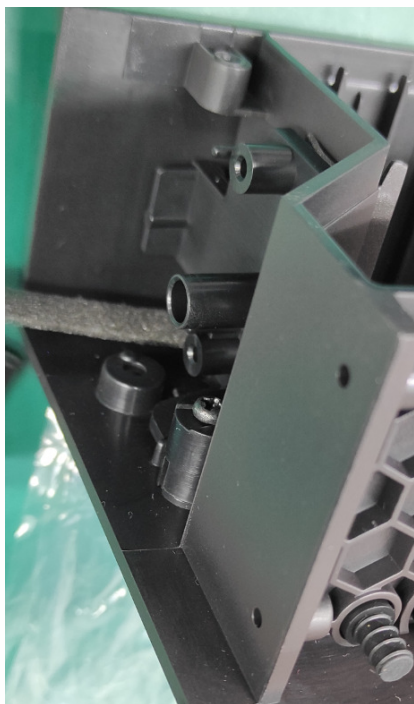
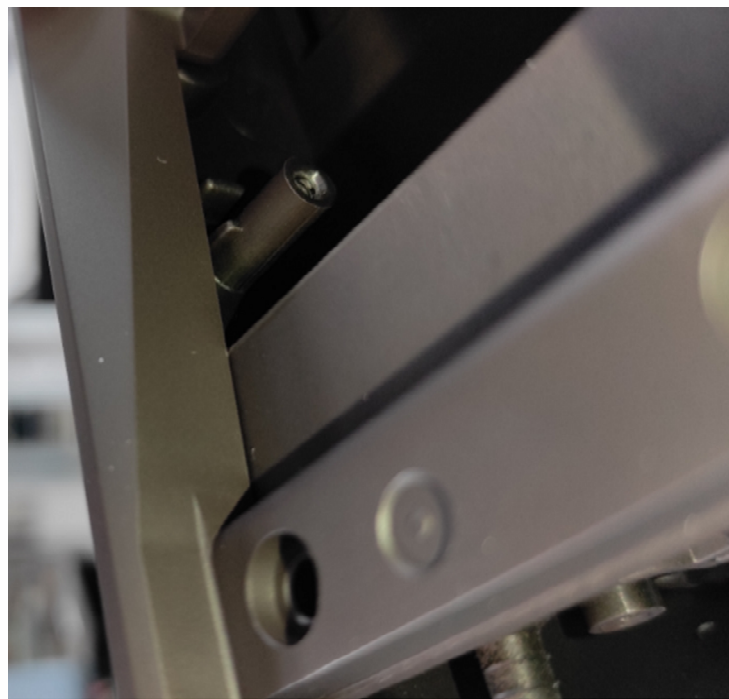
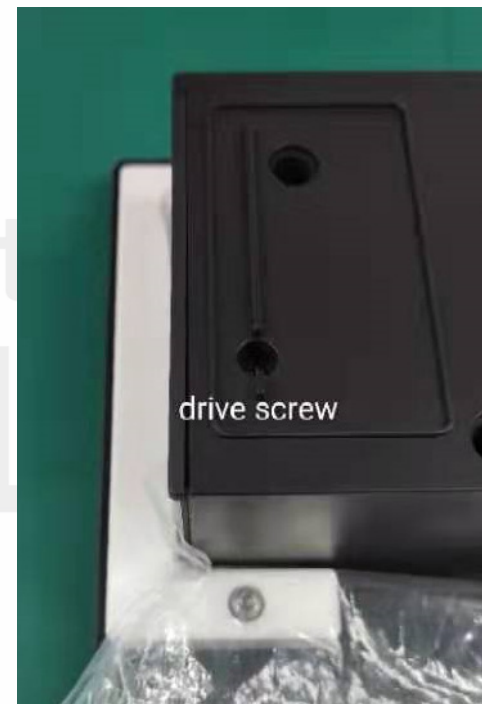
2. There are burrs on the bottom cover, and the burrs will interfere with SIDE\_DECO\_ASS'Y during assembly. The gap between bottom cover and SIDE\_DECO\_ASS'Y will become larger. The gap will be much smaller after sorting these burrs.
