# BFW-UA300 Field Failure Vol down & BT Key Function Report

Organization  
R&D Lab. 2

Issued Date  
2022.10.07

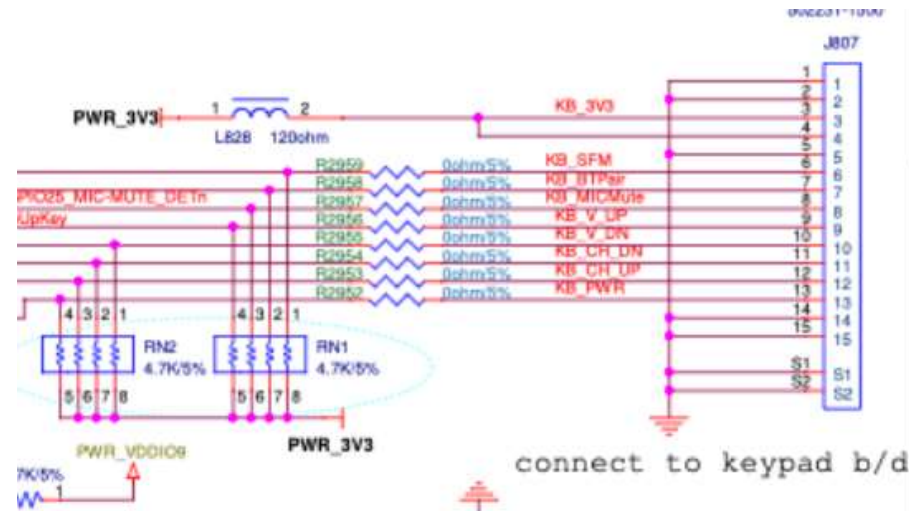
- **Check impedance on button block -> No abnormality**
  - Follow circuit diagram at button block, The remote signal from SoC to keypad jack (J807 location) go through resistor R2955 (0 ohm) & R2958 (0 ohm) with pulled resistor RN1 (4.7K ohm)
  - Measure impedance at R2955 & R2958 location and compare with OK product -> Normal
