# BFX-UA300 Control Run New FFC Cable Result Report

**Prepare by: PE Thuc**

**Date : 2022.07.16**

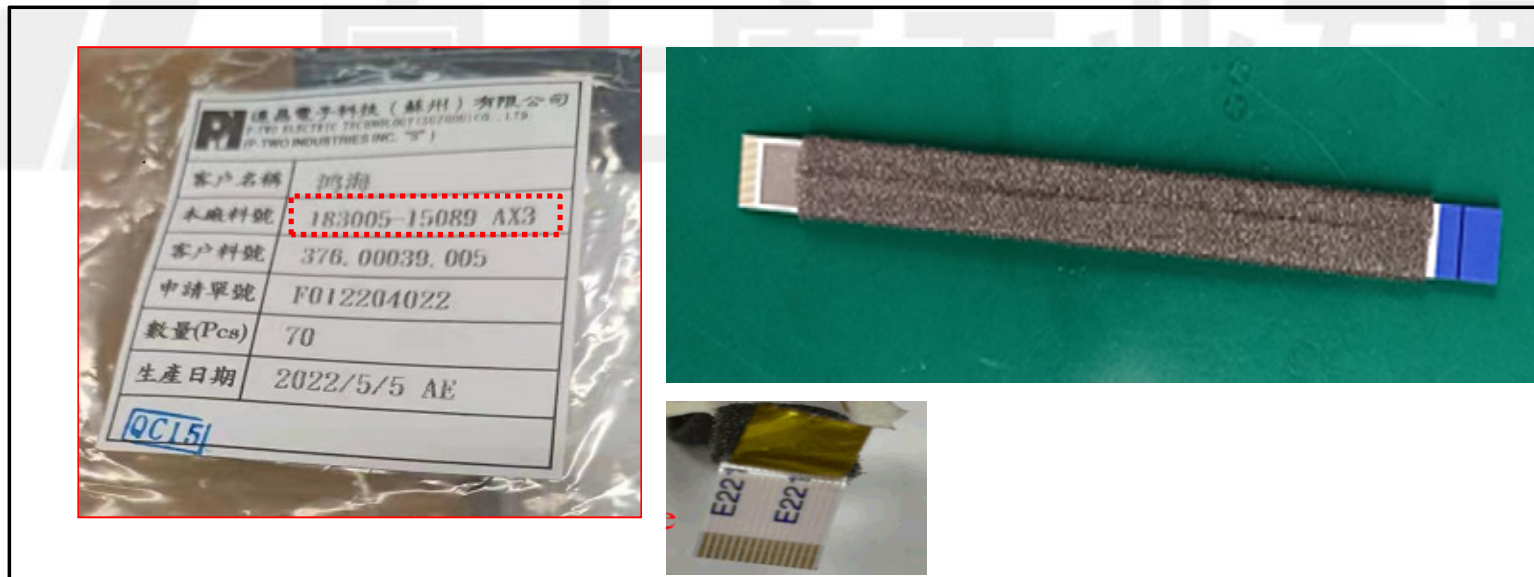
Date: 2022.07.07 PM request ALT agree to use new AMP FFC cable (with Kapton tape) for long-term solution to avoid AMP FFC cable pierced issue.

+ P/N : 376.00039.005

+ Vendor: P-TWO

+ Date code: 05/05/2022

+ Control Run: 50pcs

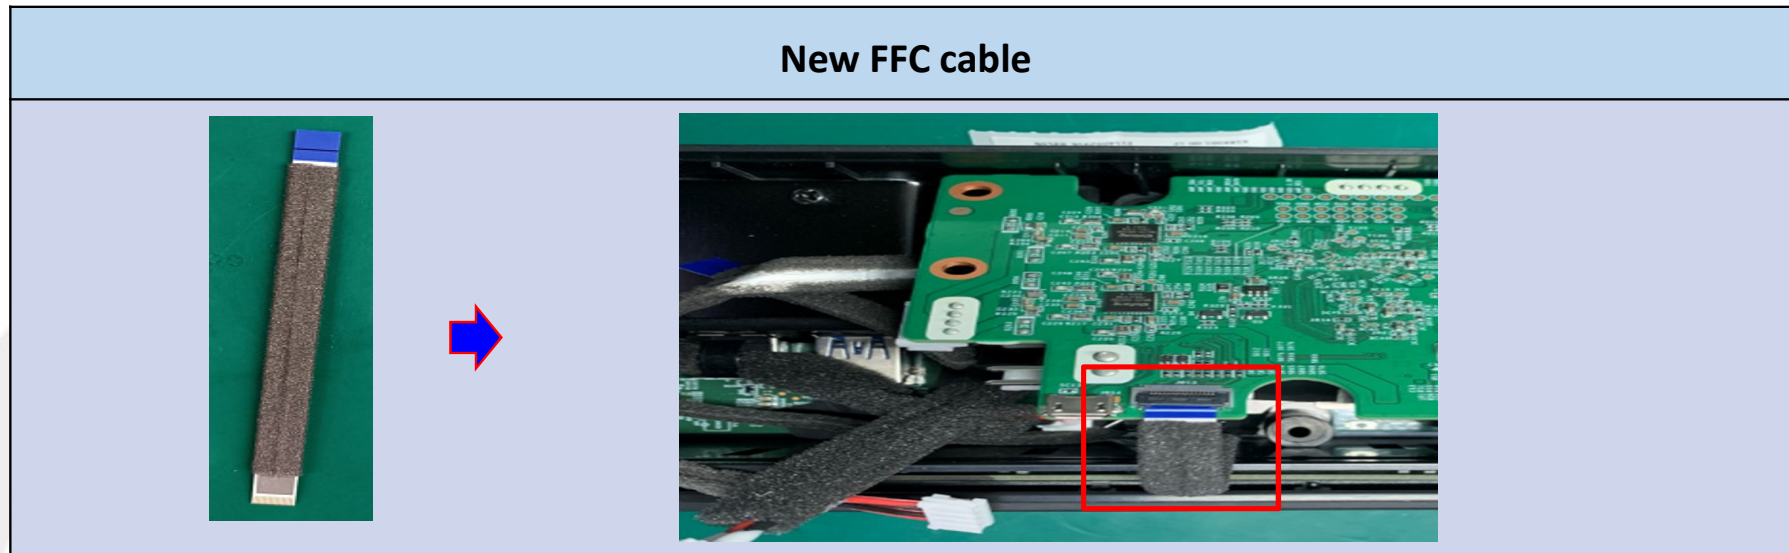
## 2. Review new material and assembly

| TYPE | Overview | | | Dimension | Thickness |
|---|---|---|---|---|---|
| New FFC cable | | | | No difference with old FFC cable | Mylar stick inside copper foil |

No need stick Mylar for FFC AMP cable

➤ Summary: Check OK or not on FATP to apply new FFC AMP cable on mass production
