# BFX-UA300

## Hardware Unit Test Report

### 4 \*MIC Test

**Test DVT sample for far field MIC sealing issue: 2021/3/8**

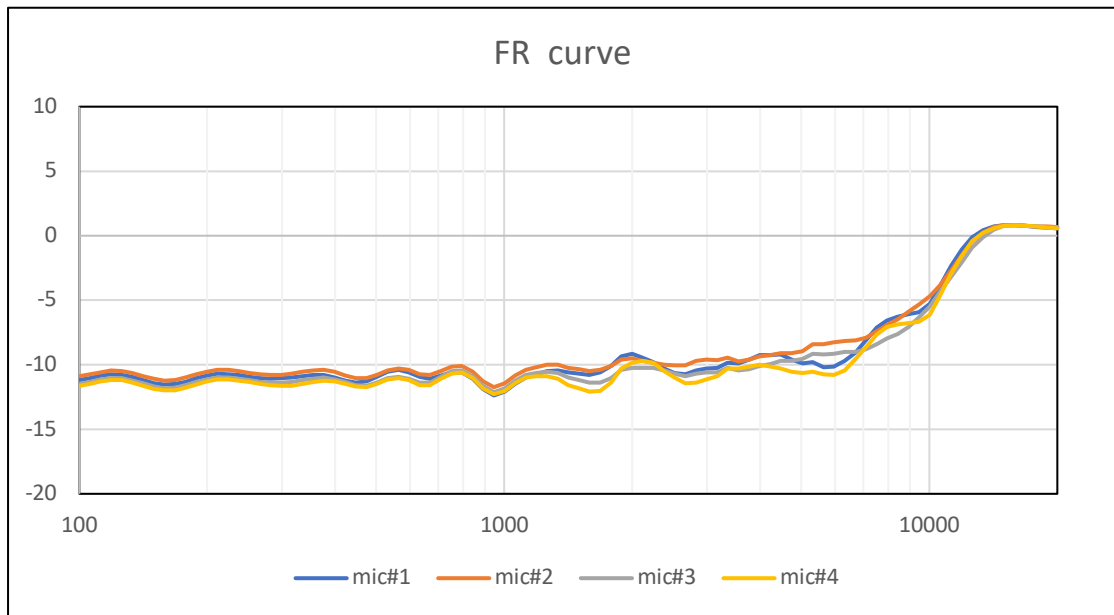
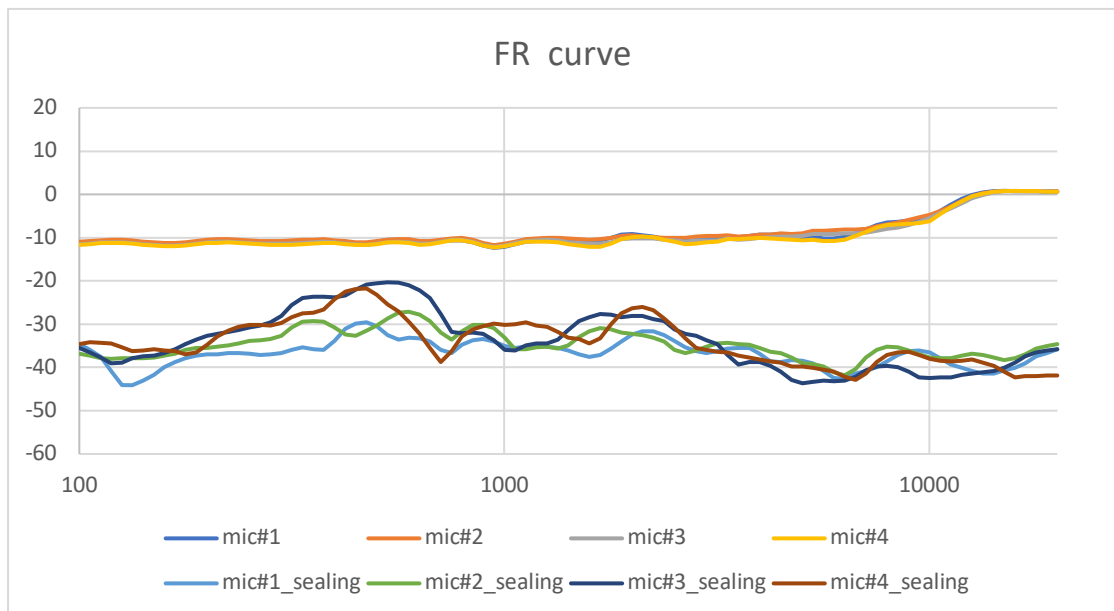
0.7 mm rubber w/o adhesive:

Mic#3 and MIC#4 maybe not assemble well or mockup sample has some deformation to cause not sealing well.

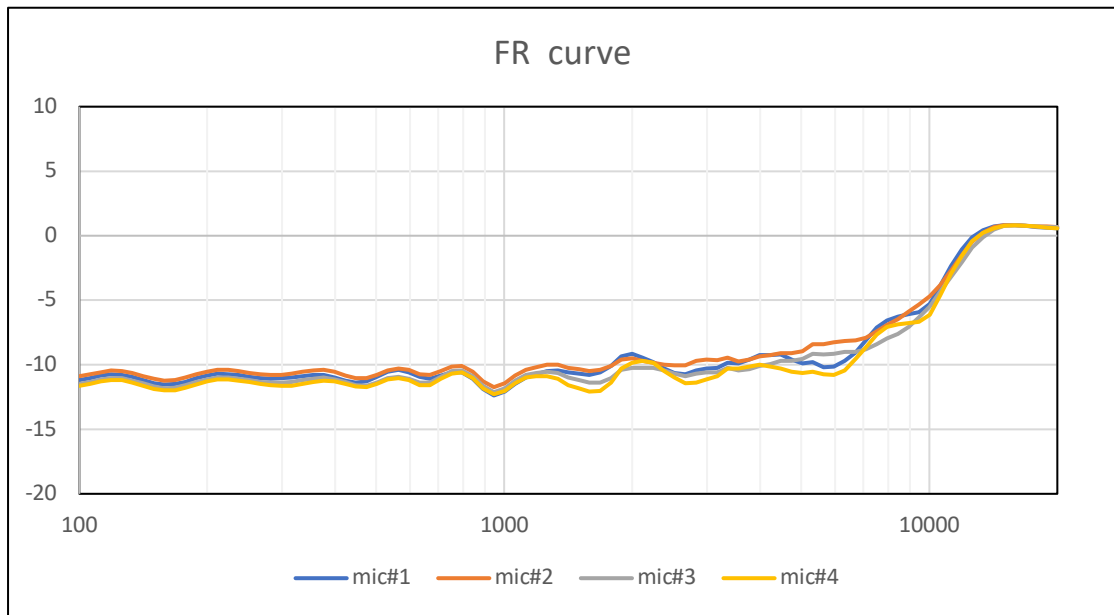
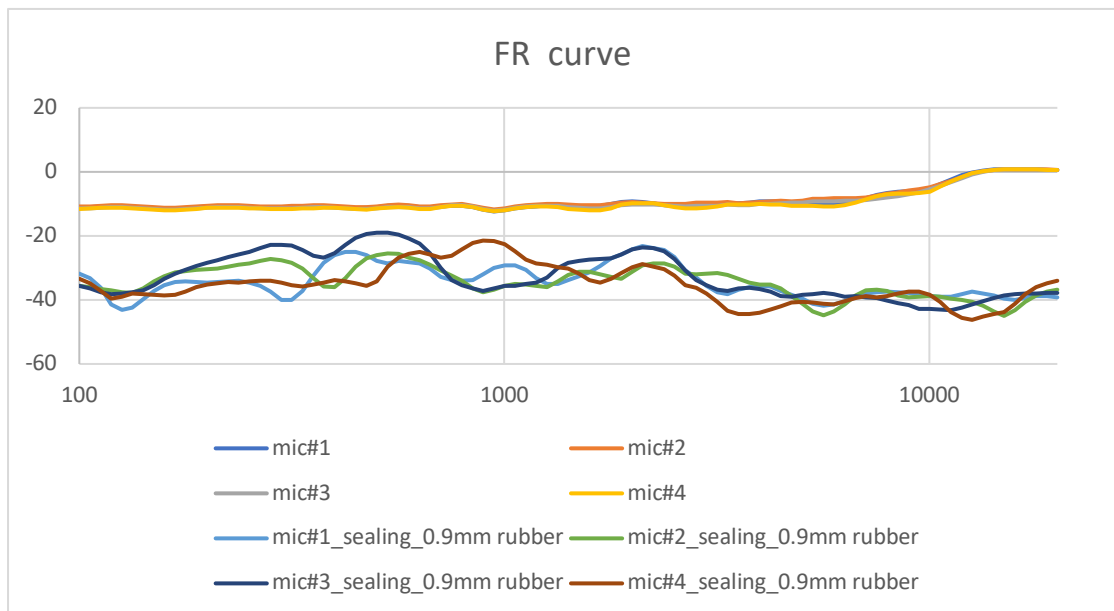
0.9 mm rubber w/o adhesive:

0.9mm rubber is not better than 0.7mm rubber.

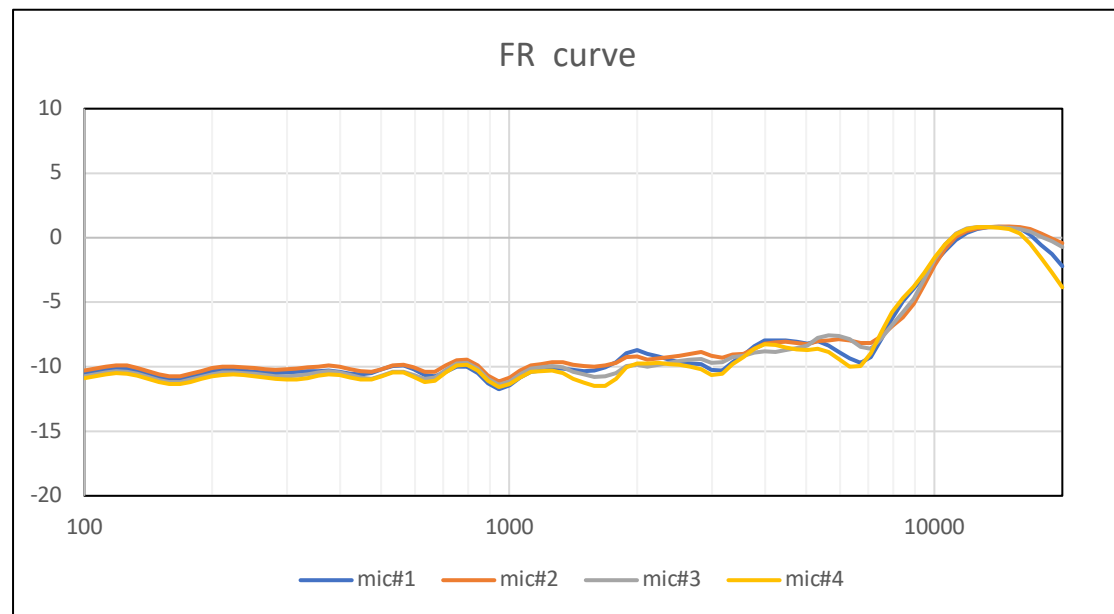
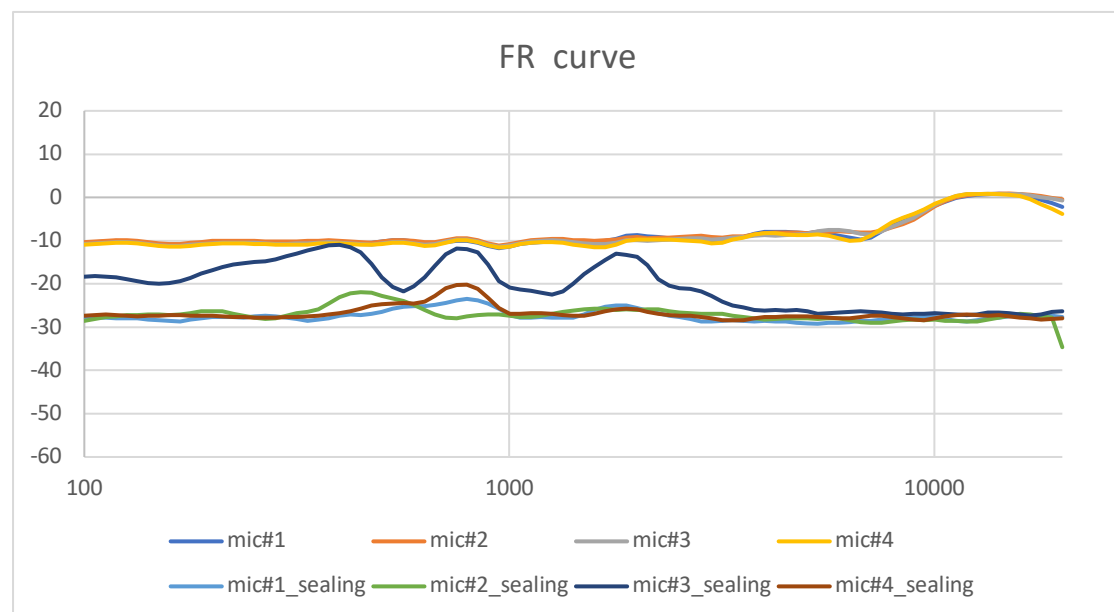
0.7 mm rubber w/ adhesive at top side:

Mic#3 maybe not assemble well or mockup sample has some deformation to cause not sealing well..

The adhesive at top side of rubber seems better than w/o adhesive. But bottom side test result is not completed due to MIC board broken. But vendor suggests to test with hard tooling on DVT build and also can test gasket if that can help to seal the mic board.

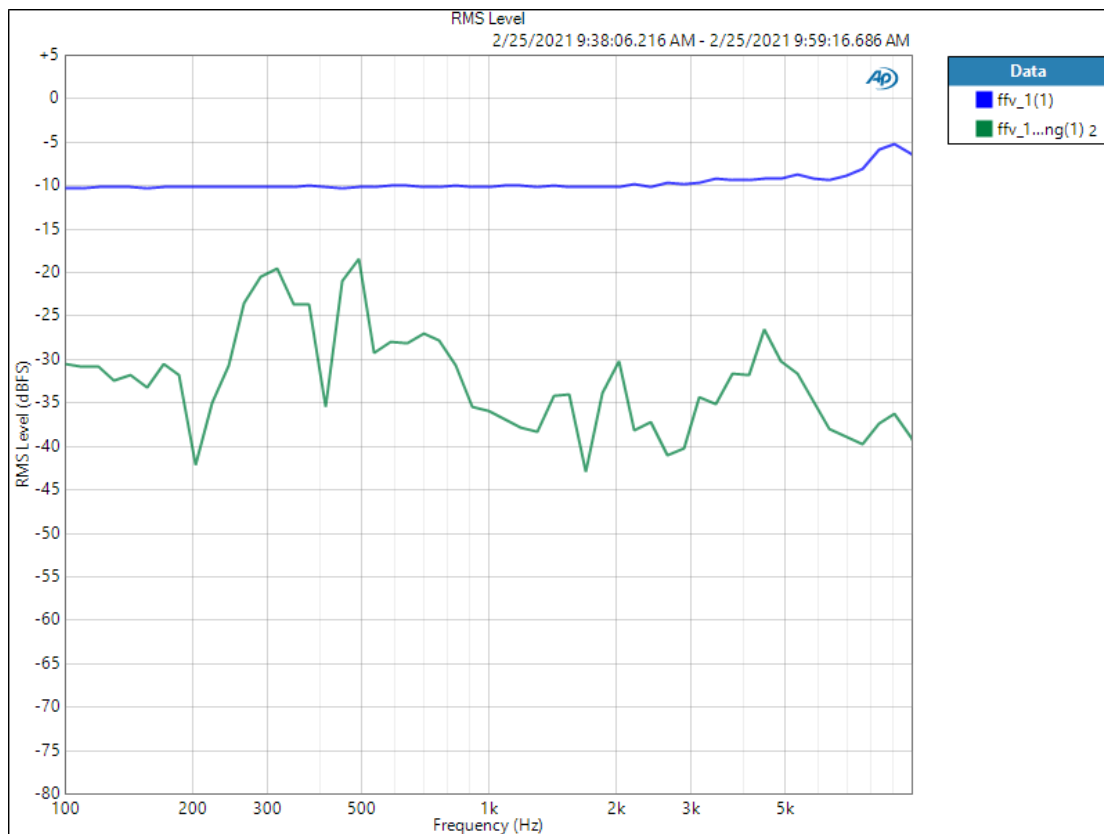
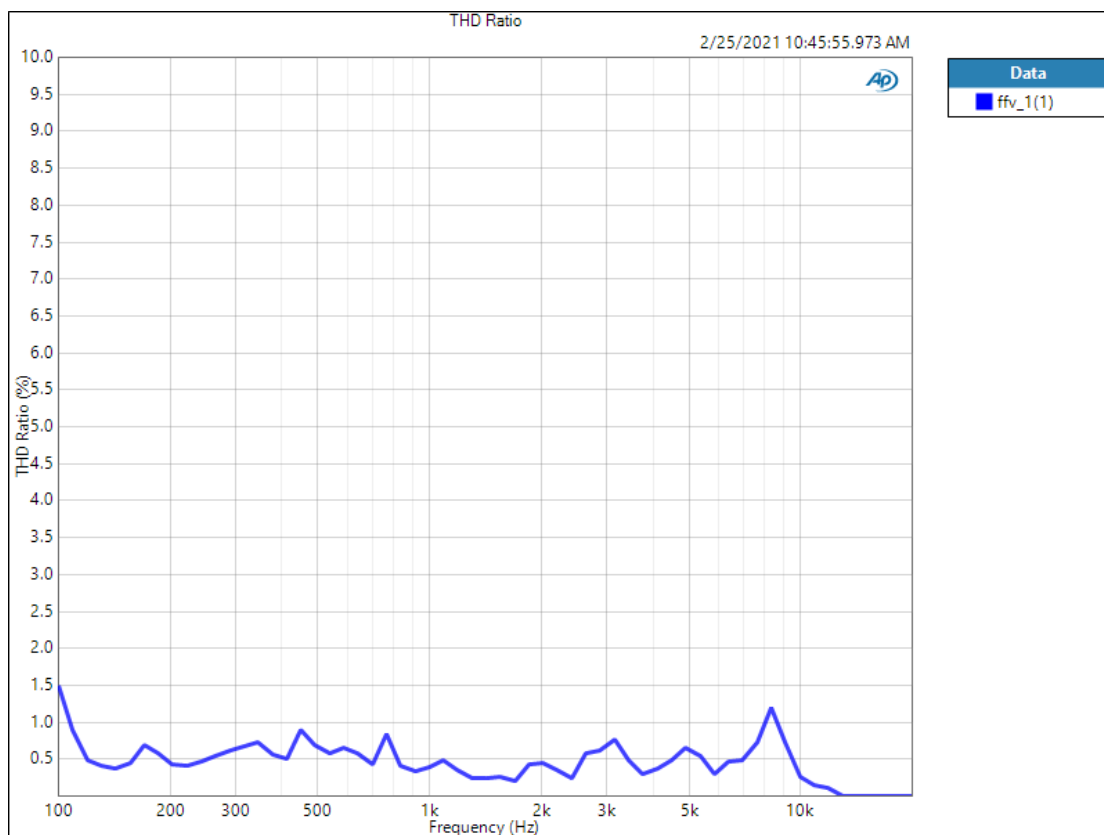
MIC1: fail, over -25dB

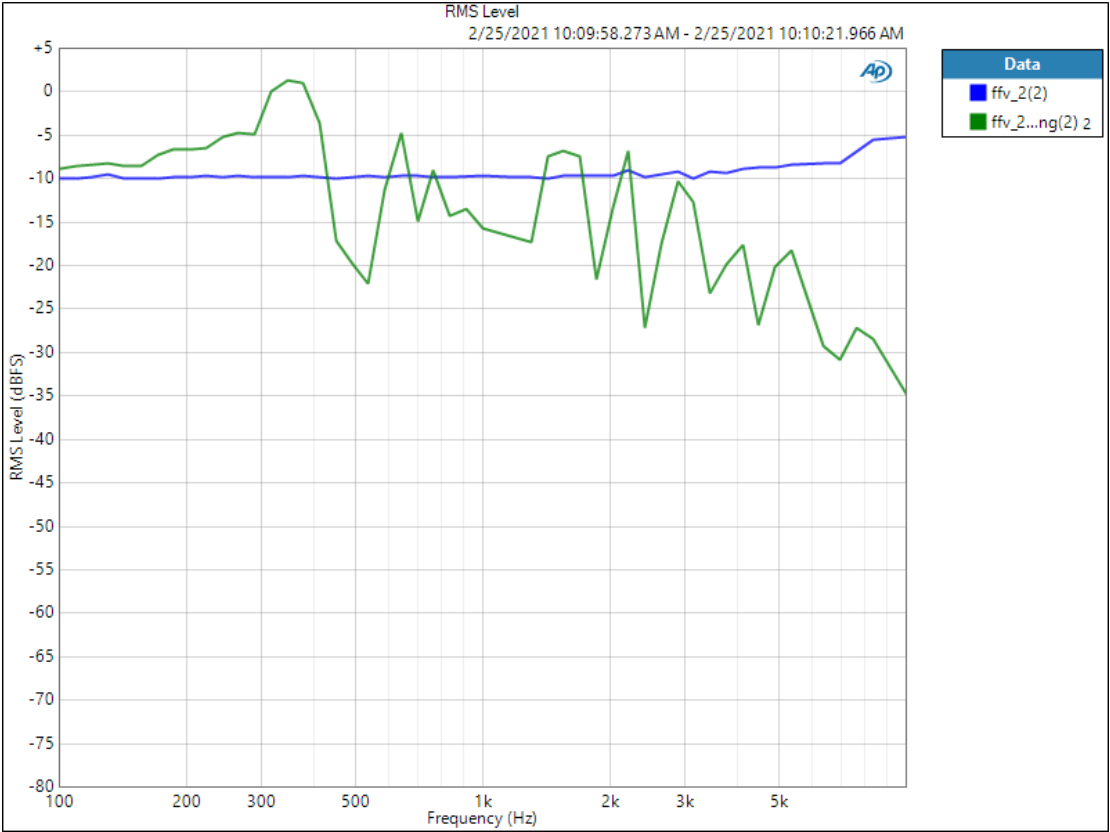
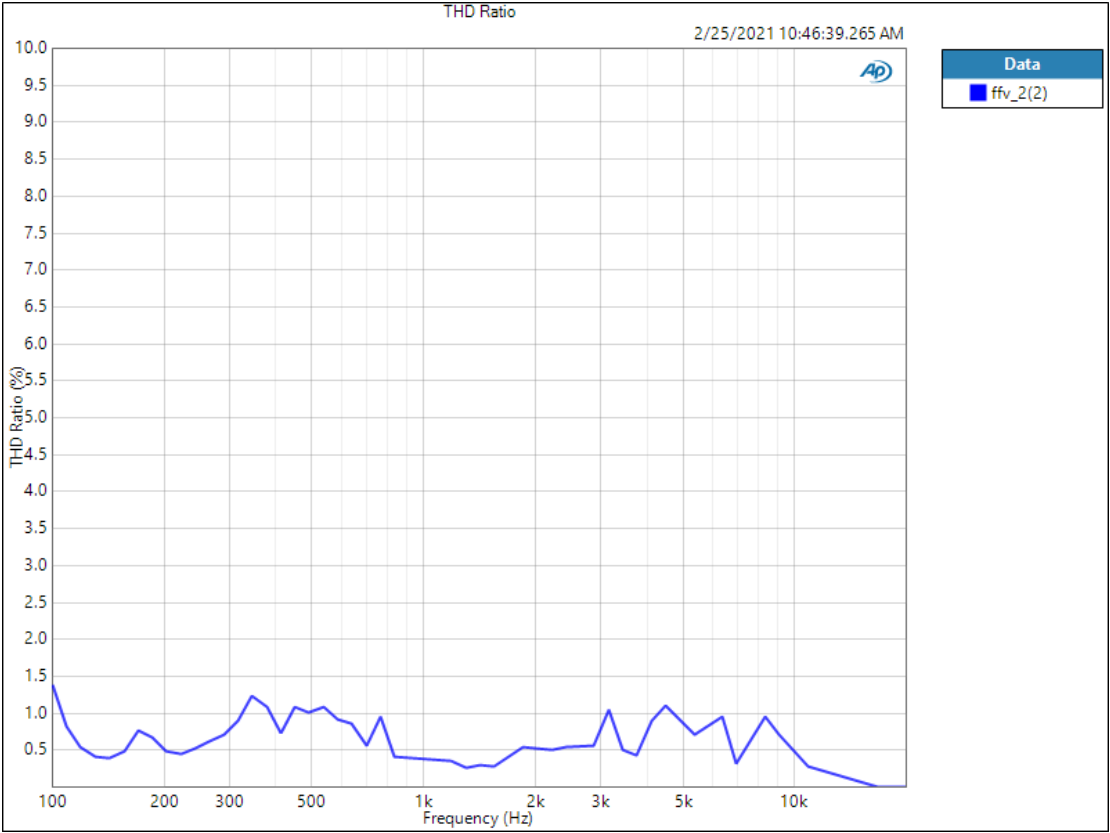
MIC2: fail over -25dB and no sealing effect

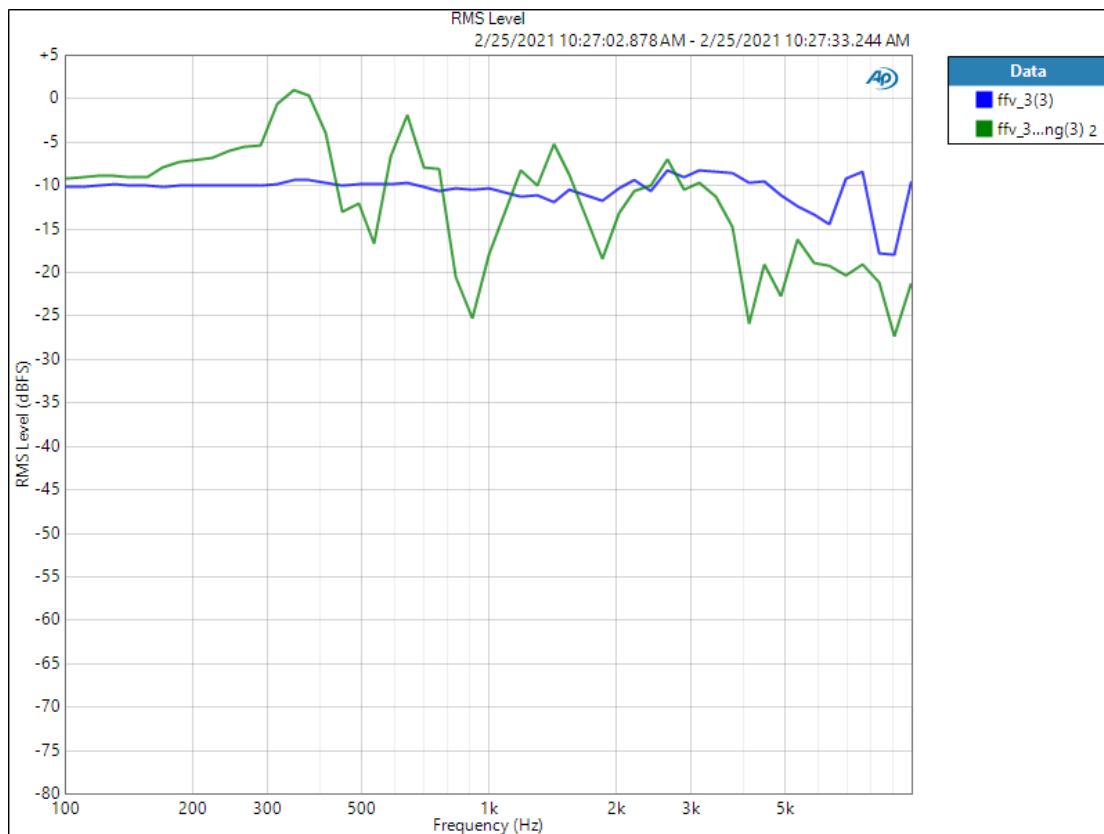
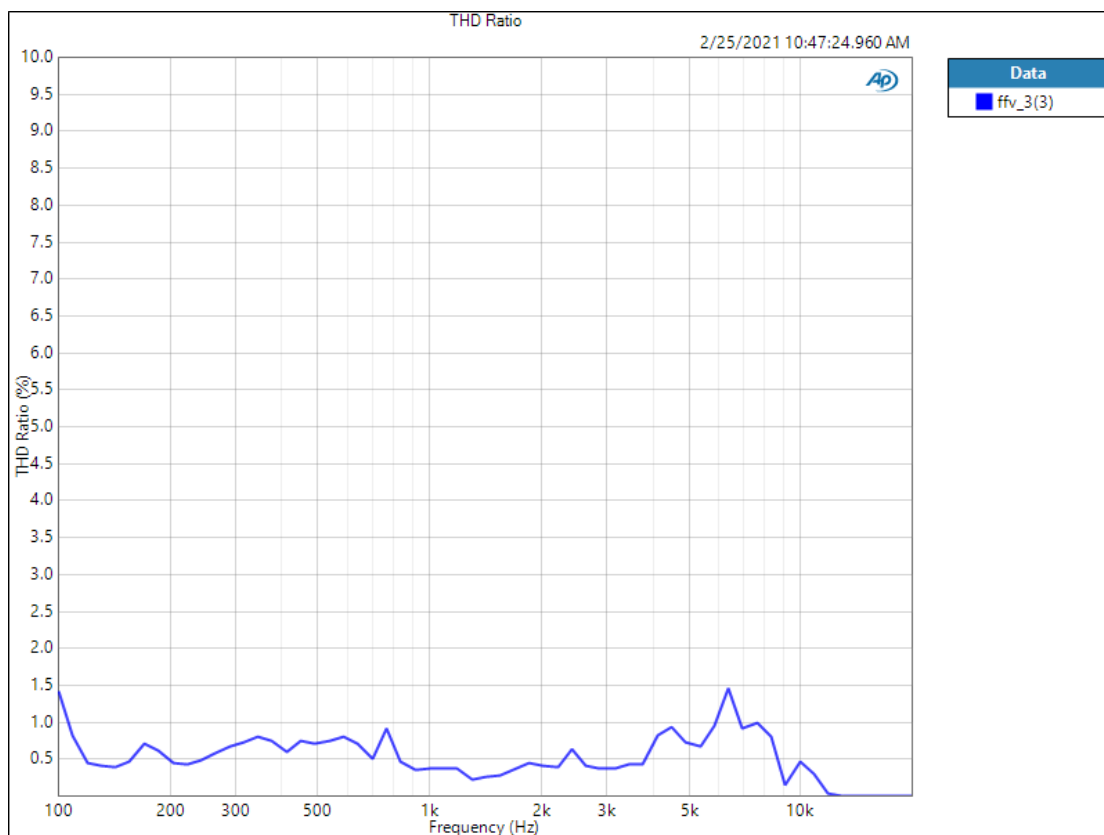
MIC3: fail over -25dB and no sealing effect

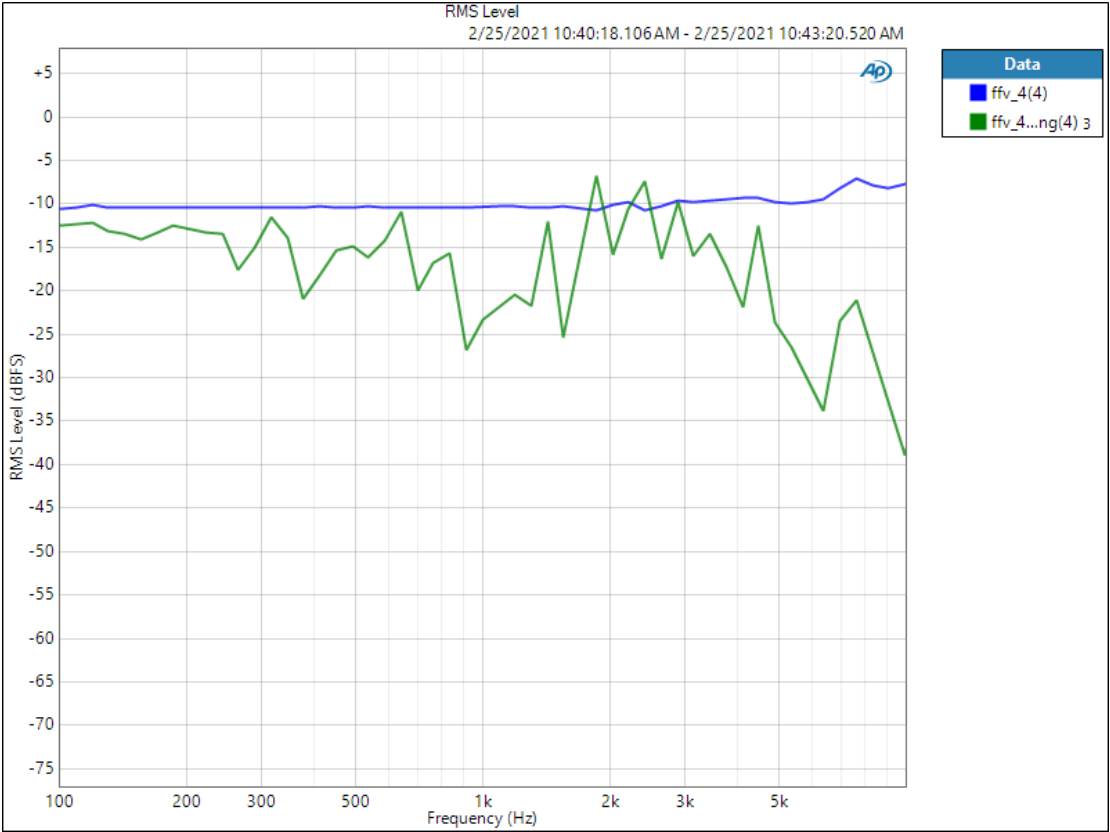
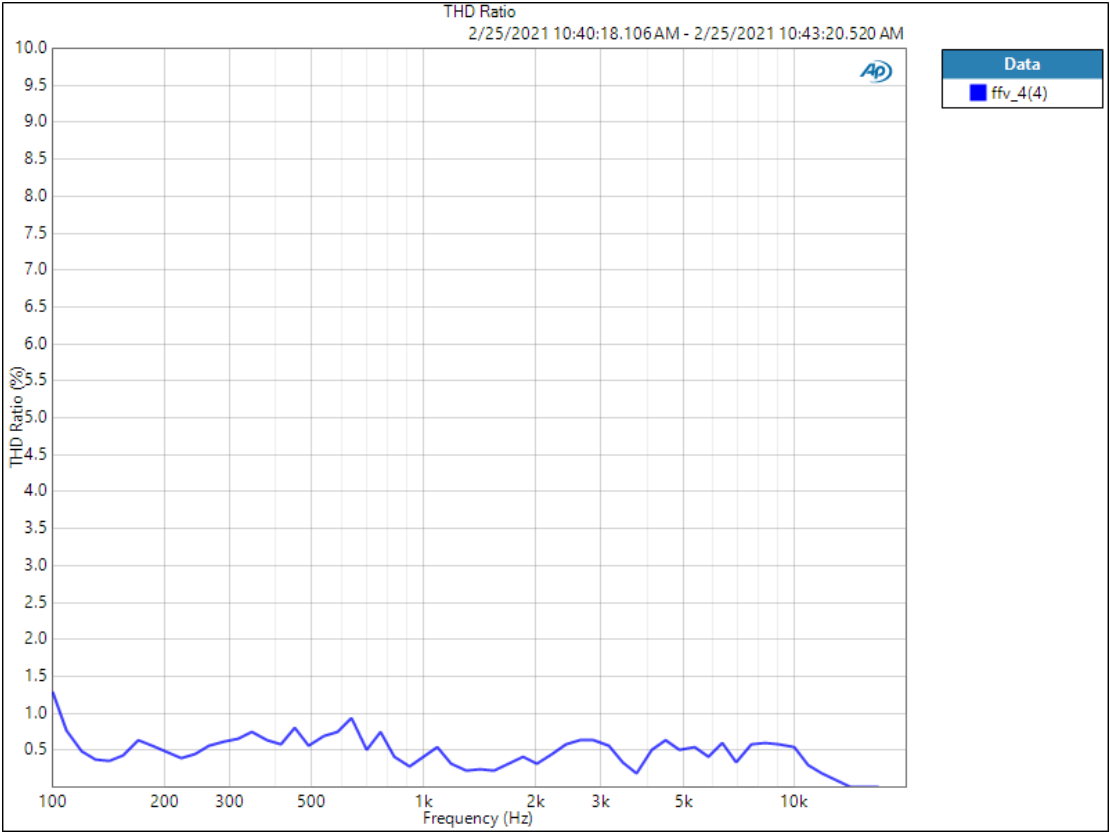
MIC4: fail over -25dB and no sealing effect

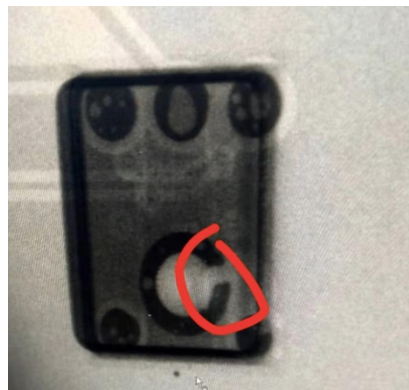
Picture 1. Soldering ring is NG.

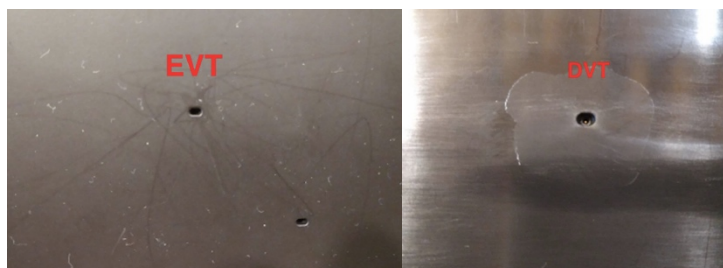
Picture 2. Far field mic hole on top cover.

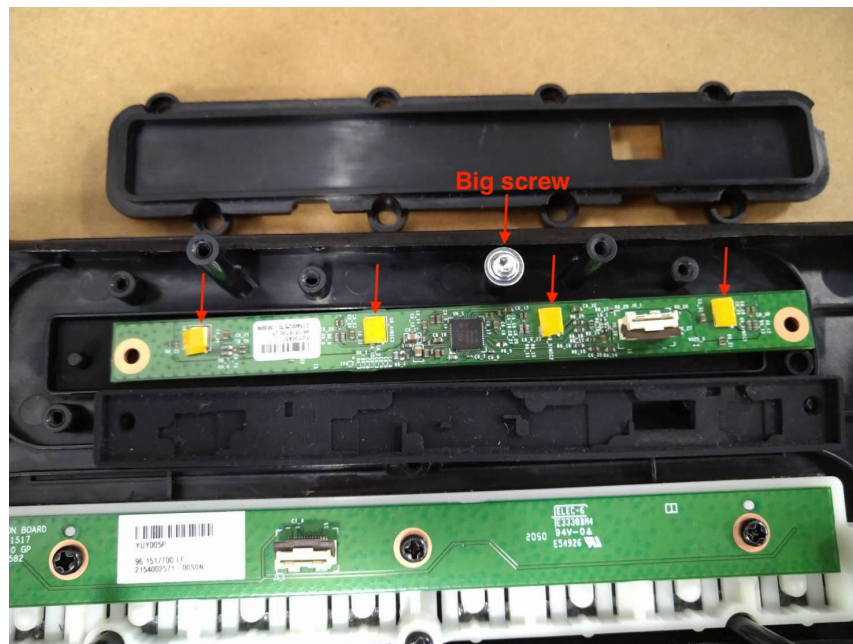
Picture 3. Fill the MIC component, and change big screw.

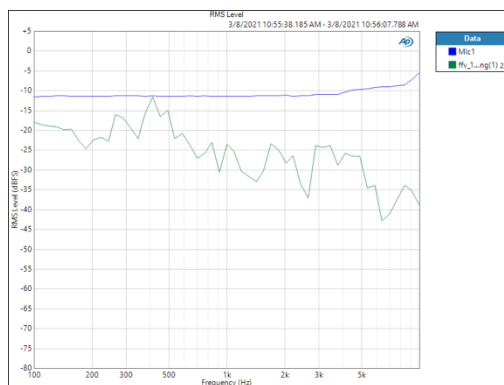
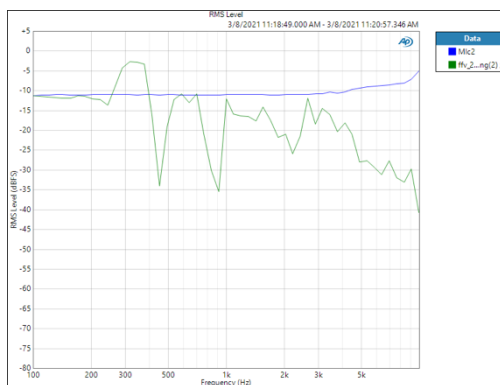
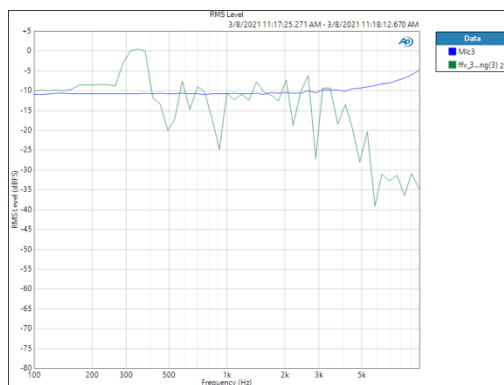
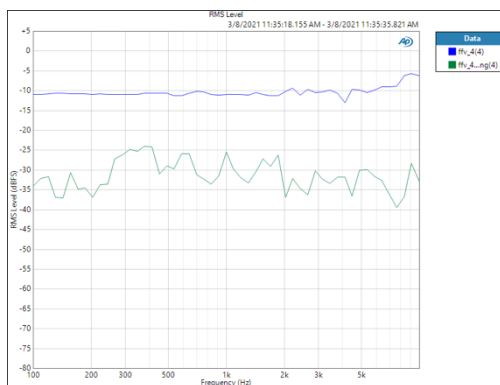
Picture 4, MIC1~MIC4 sealing test results.

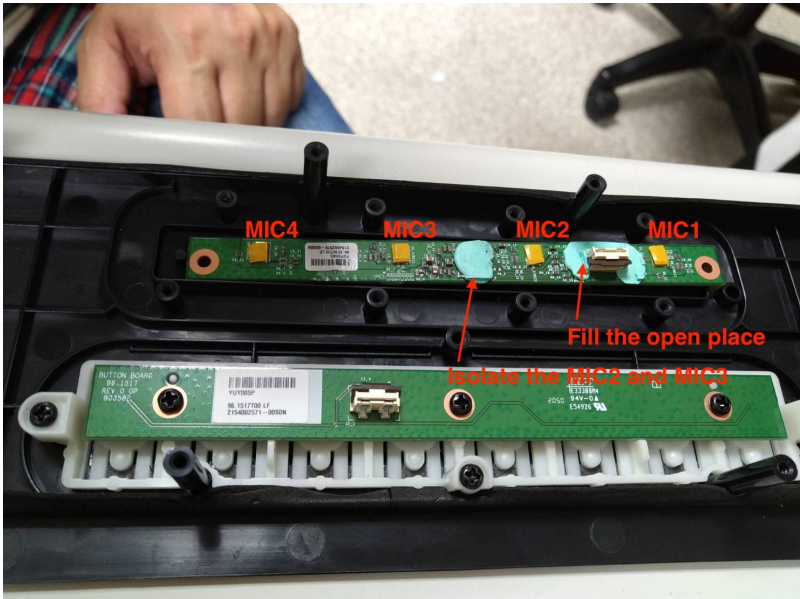
Picture 5. Fill the open place and isolate the MIC2/MIC3.

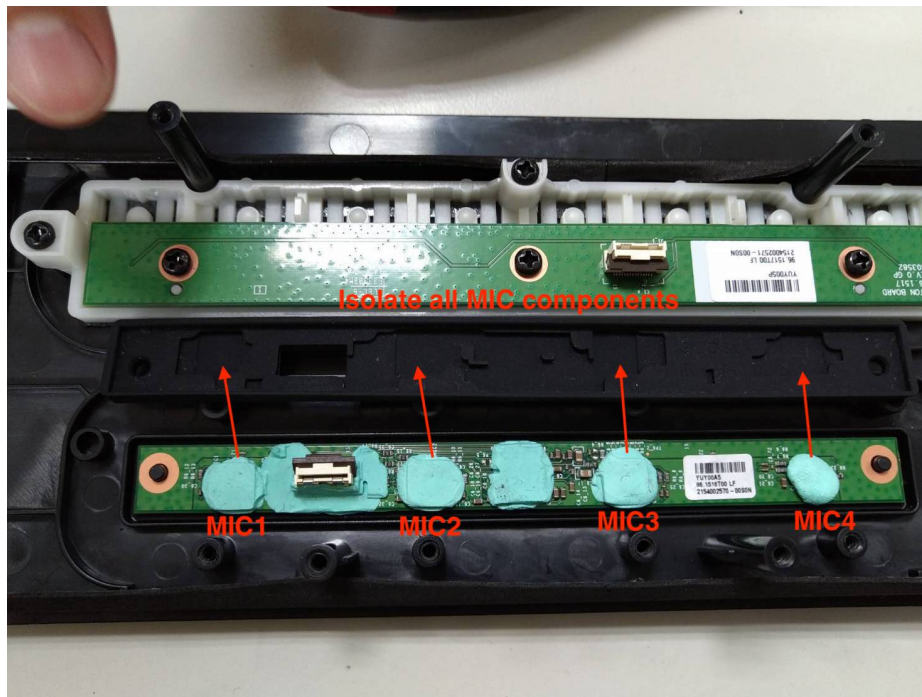
Picture 8. Isolate all MIC components.

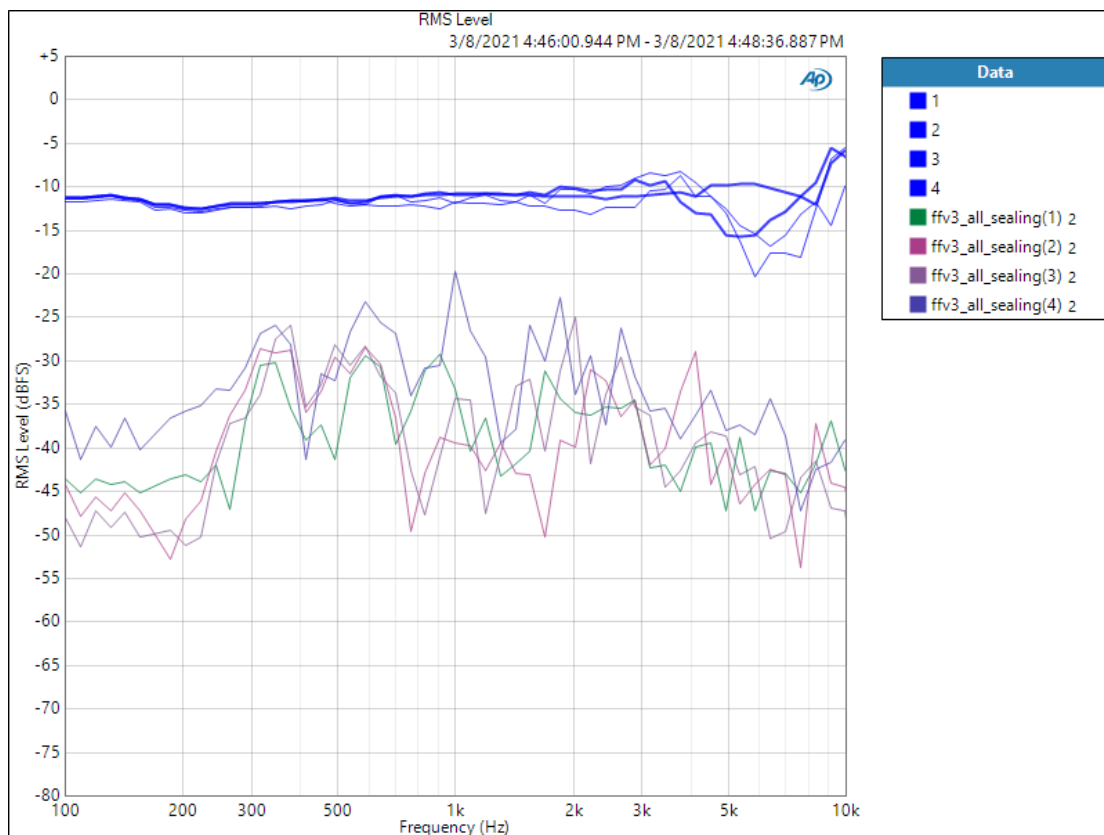
Picture 9. Sealing seems good.

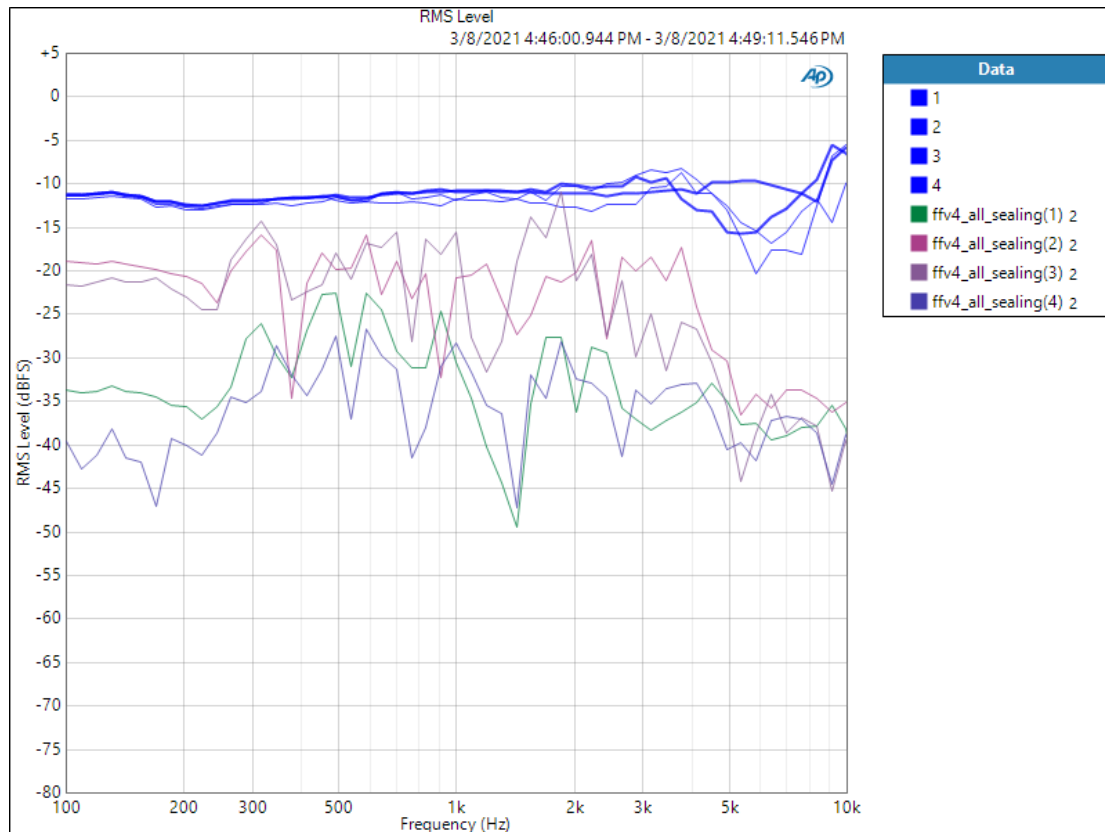
Duplicate to another top cover for FFV mic sealing, but seems has some assembly issue. If ignore the assembly issue, the isolation for all mic components seems correct trend.

Picture 10. Duplicate to another top cover.

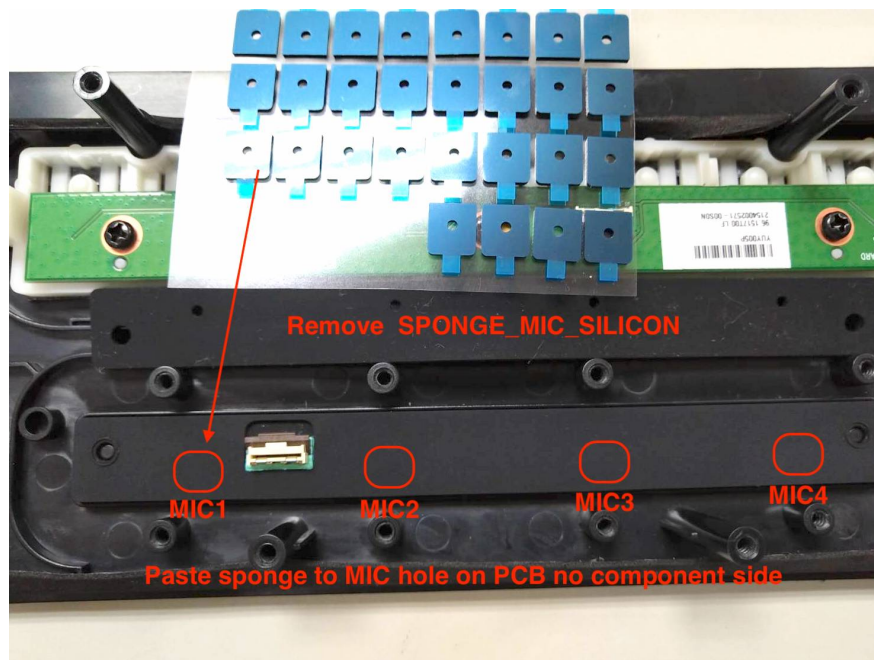
Picture 11. Paste sponge to mic hole with 1.1 thickness.

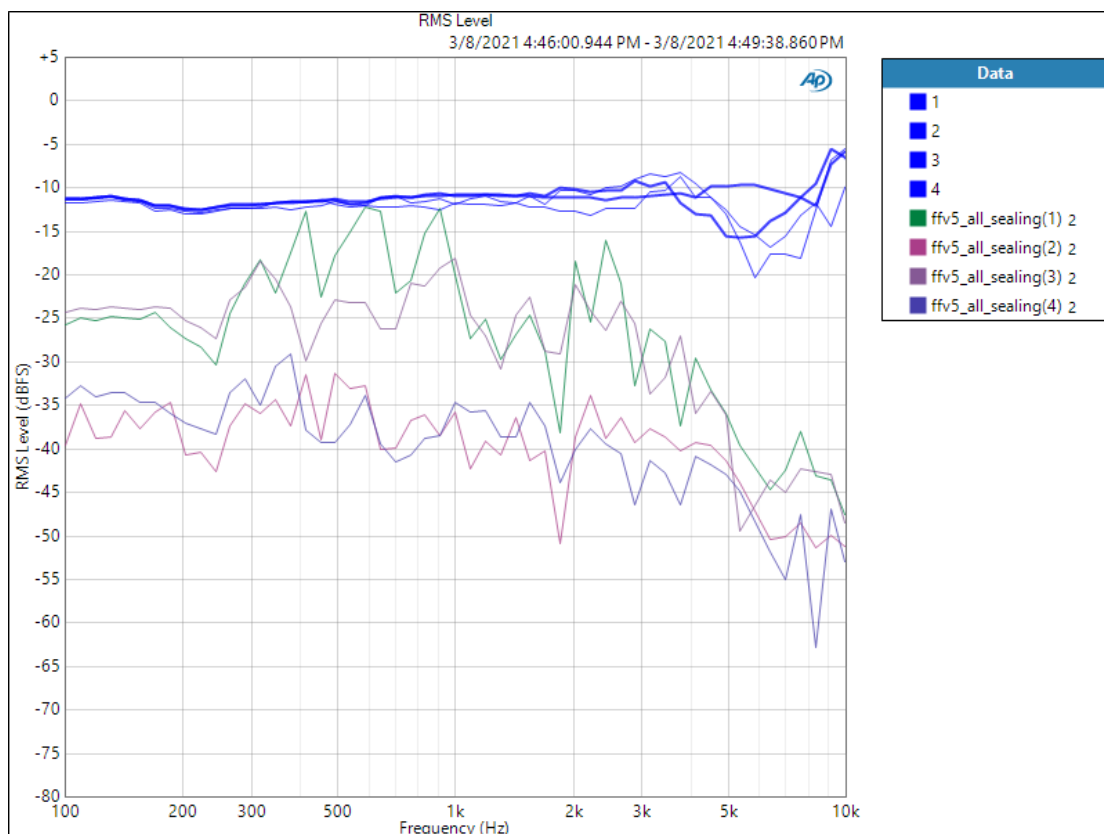
Picture 12. The sealing curve seems more smooth but sealing is fail with wrong thickness.
