## **FH41-15S-0.5SH(05) contact failure analysis report**

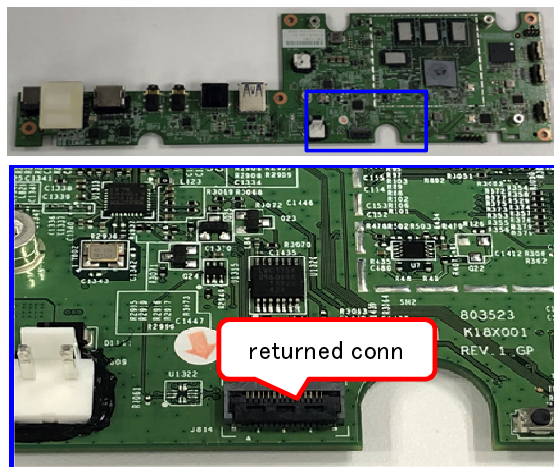
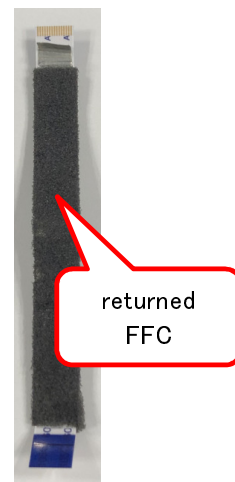
- 6) content of claim  
contact failed and FFC was pierced thru

FFC's GND plate has been pierced thru  
And on mother board side, GND pin has touched conductive layer  
In addition, the thickness of returned FFC's GND layer is only 40um, thinner than HRS's recommendation 70um  
See appendix 2 for details

The thinner GND plate is prone to be pierced thru when assembling FFC  
In addition, as the issue seemed only to be found on mother board side  
we assumed there was a additional force applied on conn when assembling  
The AMC board, on the other hand, the FFC was almost been pierced thru, there is a risk for contact failure, too  
See appendix 3 for details

The returned FFC's GND plate thickness is only 43-44um  
It's too thin compare to HRS's suggestion(70um)  
It would make the FFC more prone to be pierced thru after inserting  
Advised to increase the GND plate thickness  
In addition, prevent applying additional downward force on FFC when inserting/assembling
