# New AMP b/d+DVT2 Main Board Rework SOP

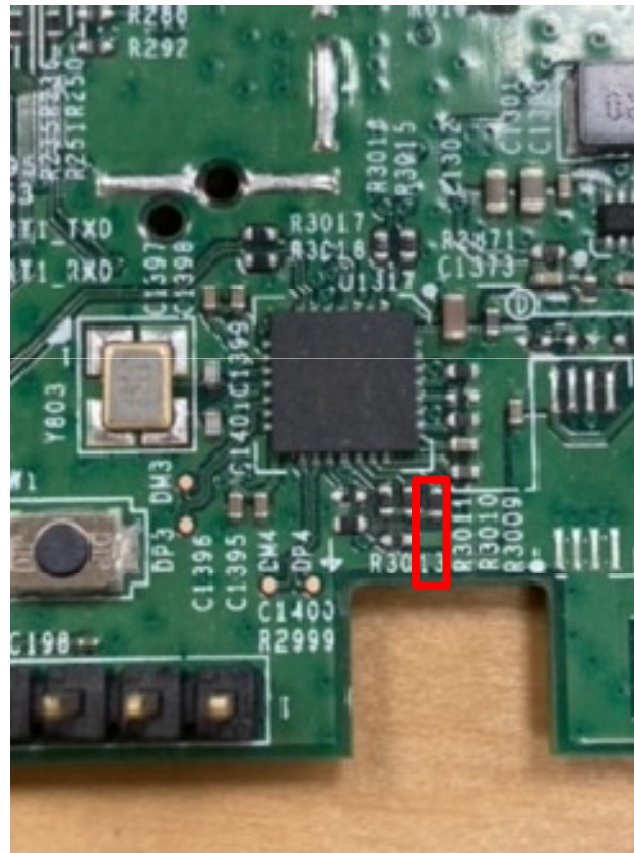
Figure 4: R3009 location on main board

- Please remove R3009, to enable port3 of USB HUB

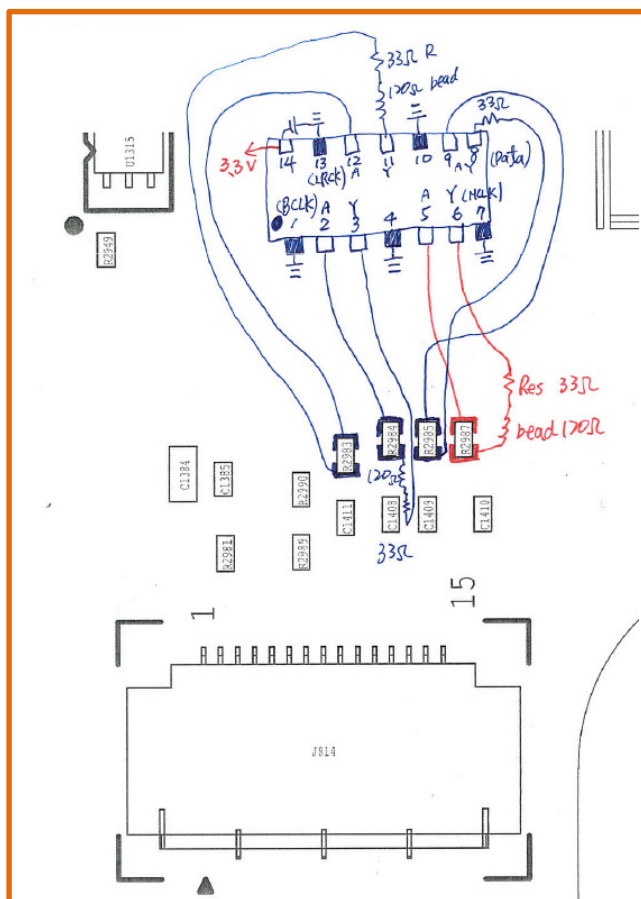
### Figure 5: Rework guide of buffer IC

- If I2S bus has output gap issue of AMP board, PLS add a buffer IC (74LVC125APW) near J814.

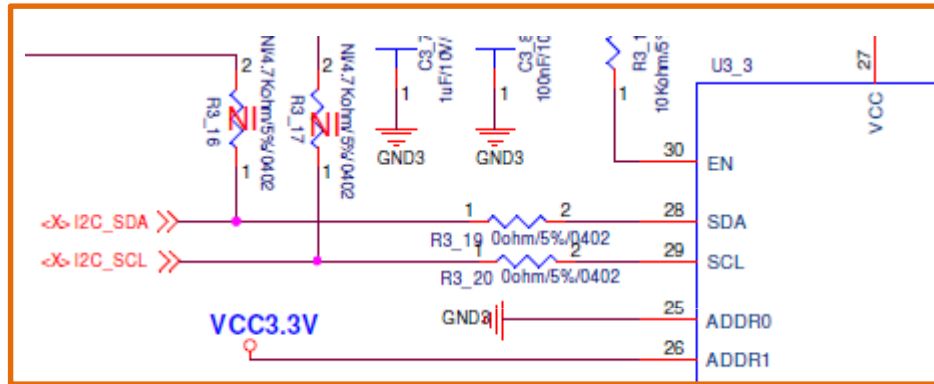
Figure 8: U3\_3 schematic of DVT2 LED board

- Please cut connection between VCC3.3V and pin26 of U3\_3, then short pin25 and pin26 together. To avoid I2C address conflict with AMP IC.
