# SWAN R-LED connector interference

2021/10/1

# Defective phenomenon

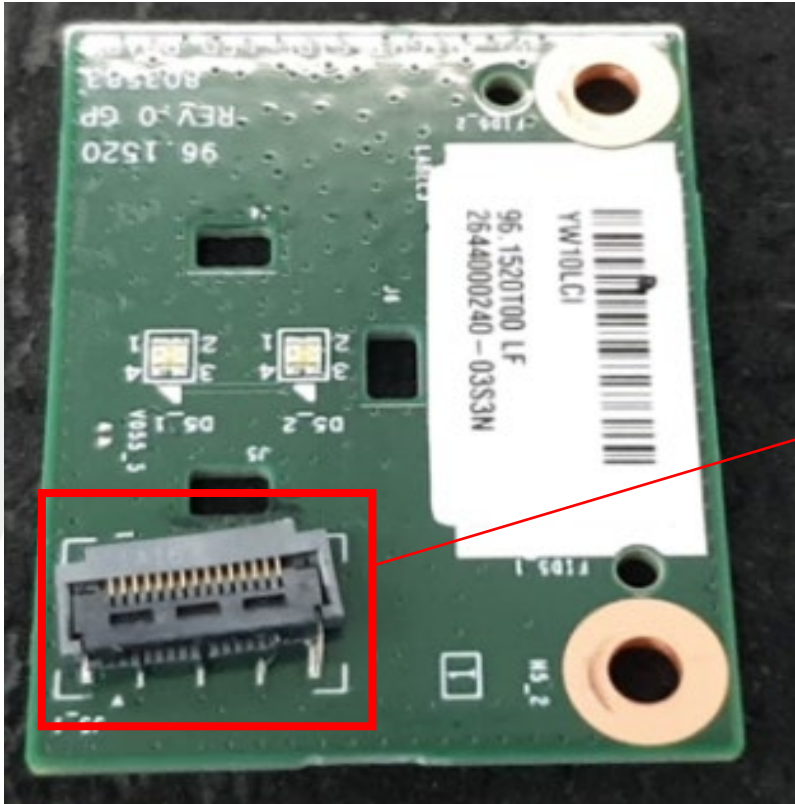
The FFC connector on right side LED PCBA was crooked.

FFC connector was crooked

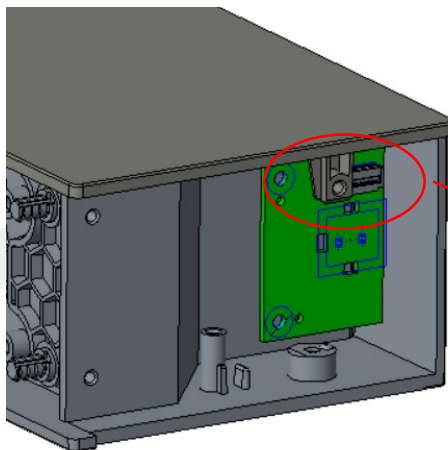
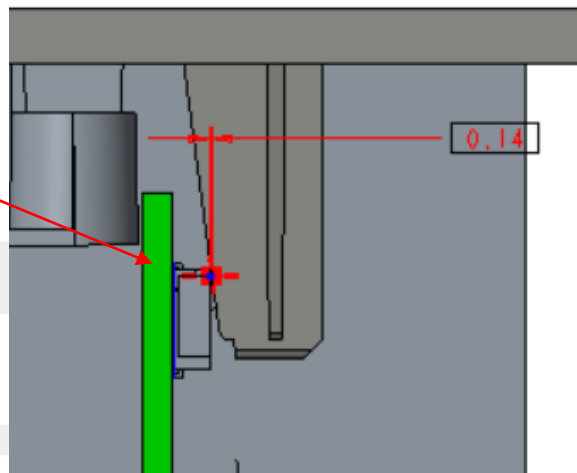
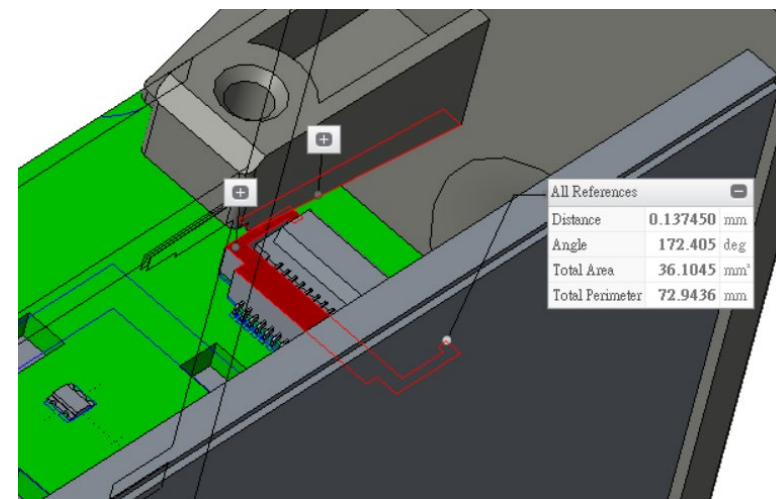
DVT3 & PerMP

1. Open the defected DUT to analyze the problem. We found out the crooked issue is come from extrusion between the connector and top cover screw boss.
2. RD confirmed that we changed the right side LED PCBA FFC connector from bottom side to top side for the convenience of assembly FFC cable from DVT3. The gap between connector and top cover screw boss is 0.1~0.2mm only.
3. Considering material (housing, connector, PCB)/SMT/assembly tolerance, it's high risk to get interference problem.

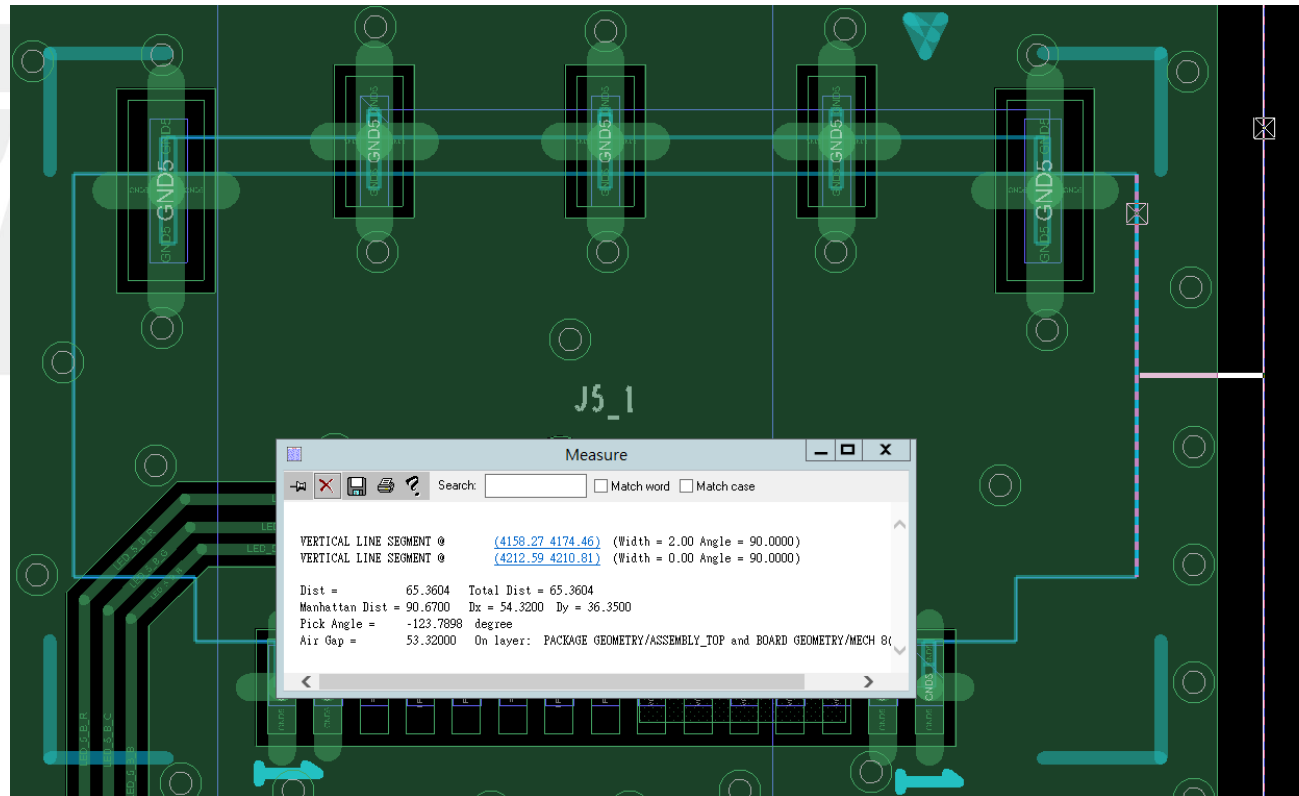
# Long-term solution - possibility to re-layout LED PCBA

1. The current distance between FFC connector (J5\_1) and board edge is 53.2 mil,
2. If Fii to move FFC connector (J5\_1), the limitation is right shift 33 mil based on SMT rule (greater than 20 mil).
3. However, the problem cannot be solved by re-layout because factory needs 80mil assemble tolerance between FFC connector and screw boss.
