# Swan\_soundbar\_DVT2\_Assembly review v0.1

ALT Co., Ltd.

Issued Date 2021.05.11

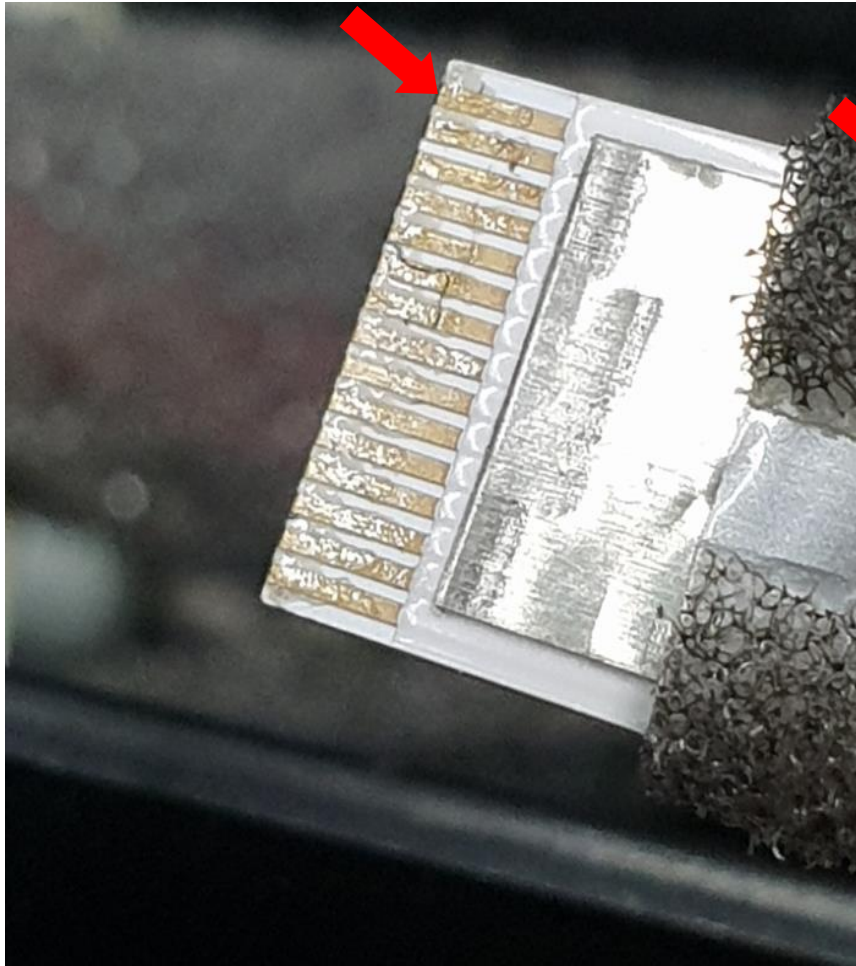
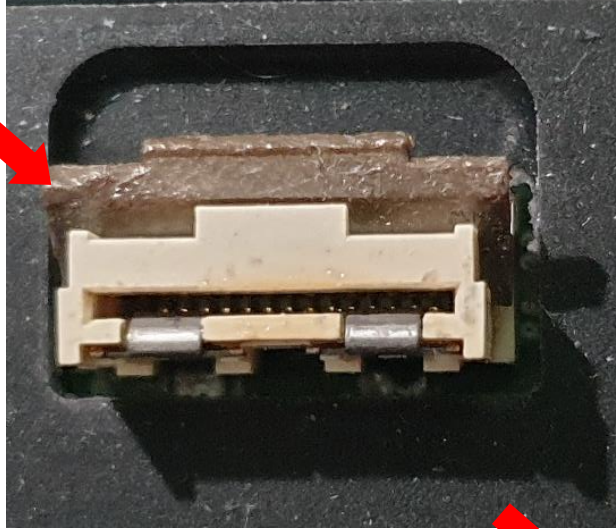
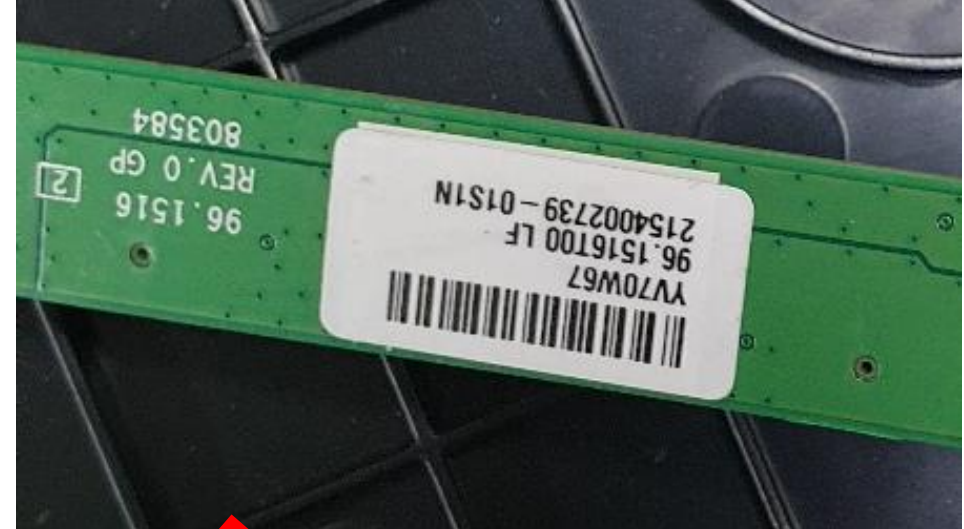
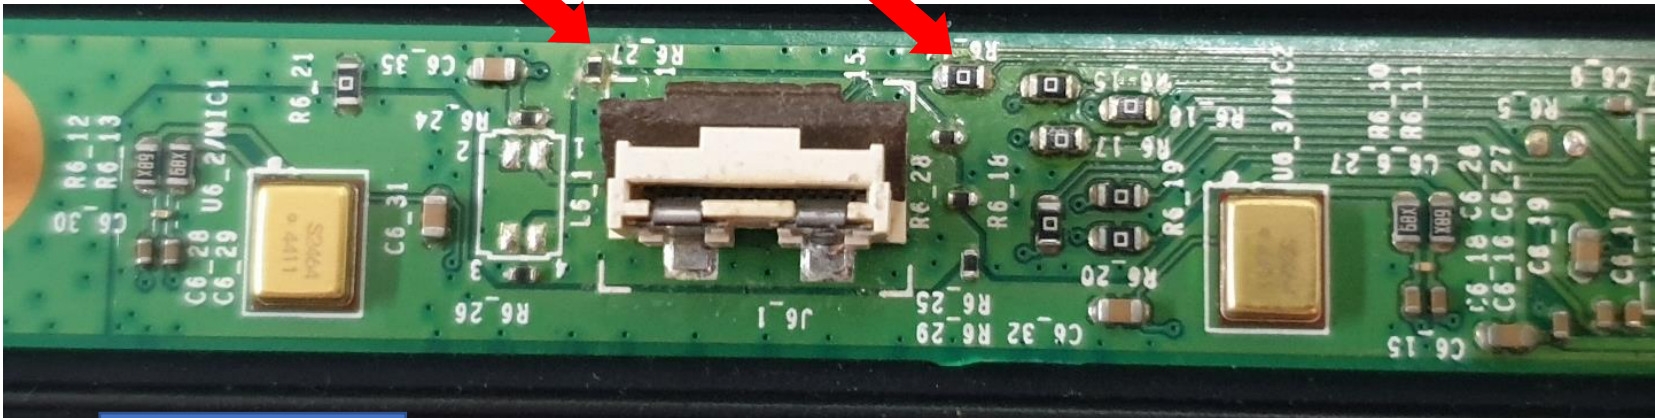
- PCB/FFC contamination

NG

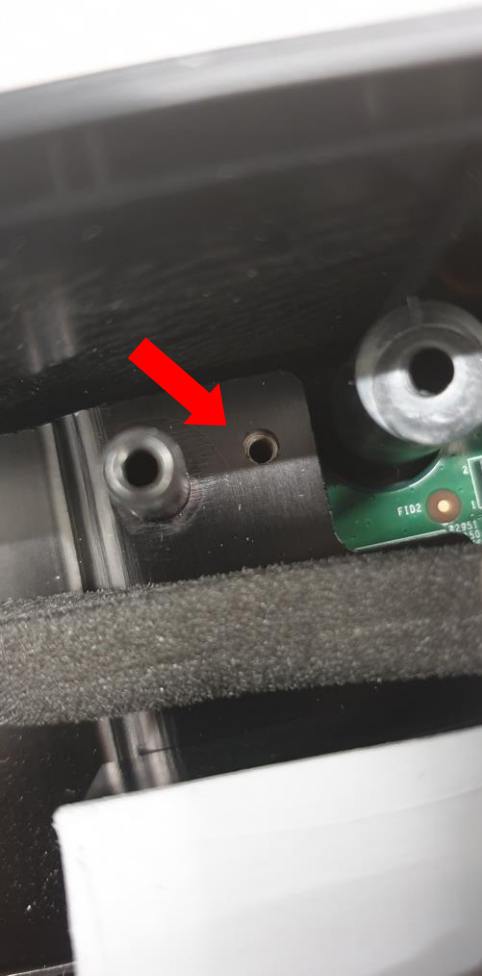
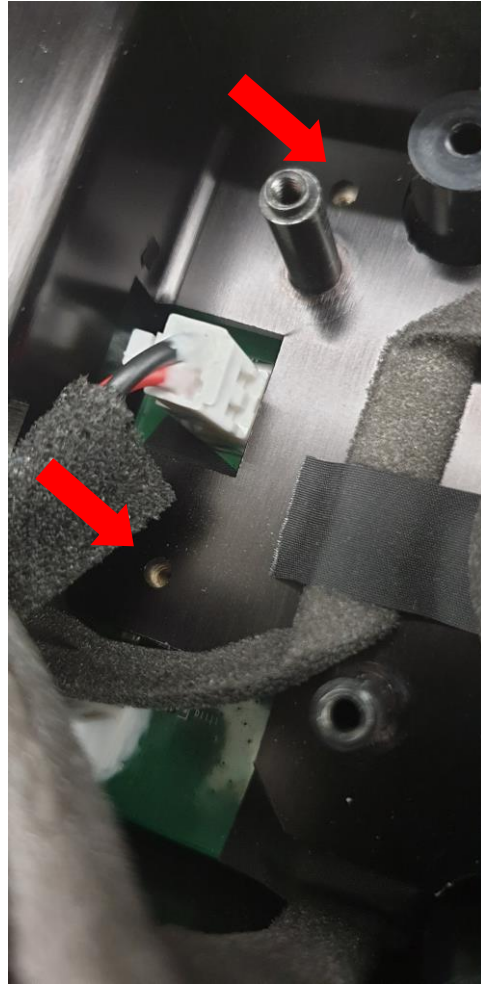
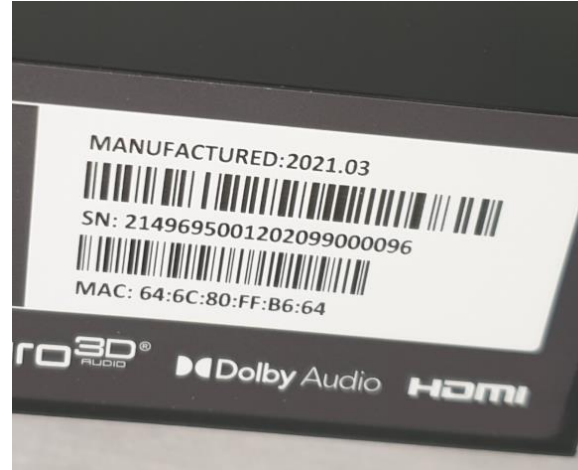
- AMP Bottom heat spreader screws are not fastened.

NG

- ALT Comment
  - If inner structure is not fastened, can be make vibration noise
  - Please update Fii SOP as a CTQ

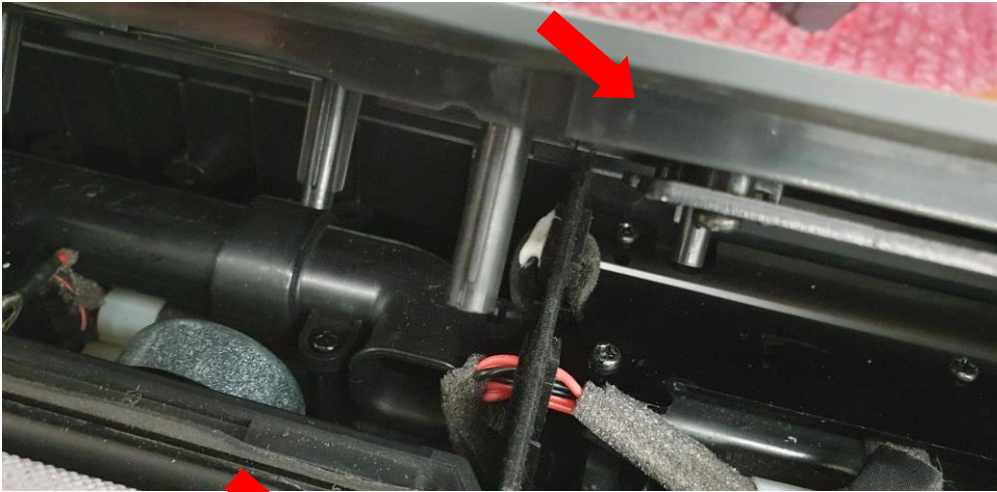
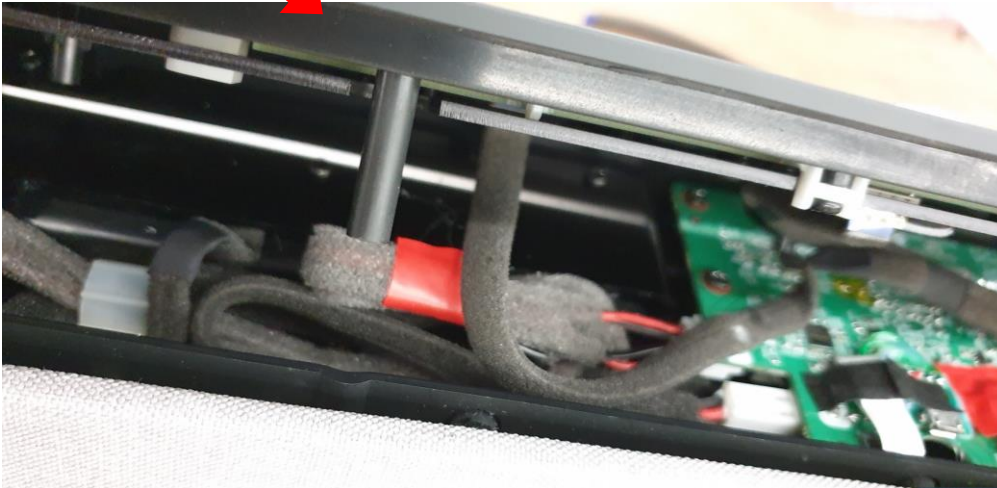
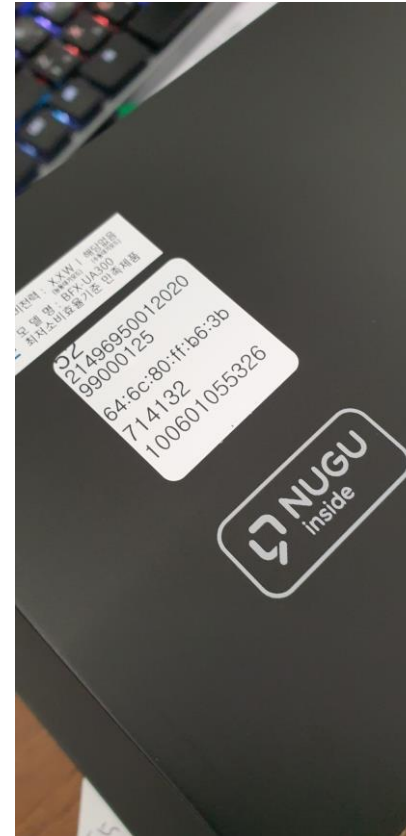
- Top Gasket is missing

NG

- ALT Comment
  - Top gasket is critical to quality (CTQ) to prevent air leakage.
  - Please update Fii SOP as a CTQ

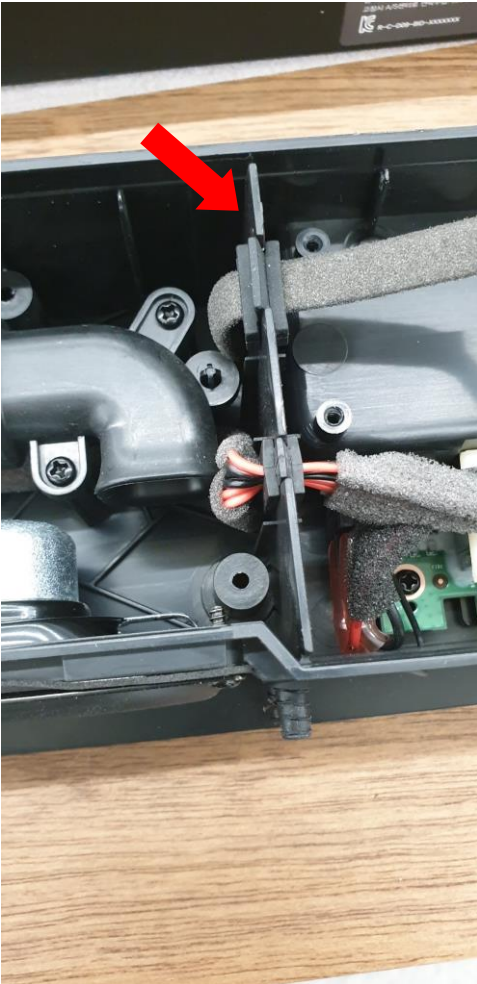
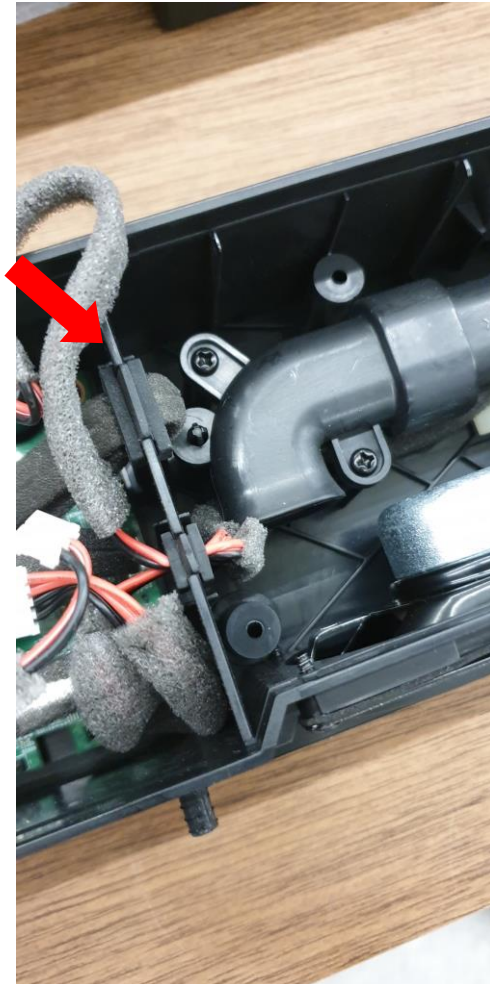
- Inner Gasket is missing

NG

- ALT Comment
  - Top gasket is critical to quality (CTQ) to prevent air leakage.
  - Please update Fii SOP as a CTQ

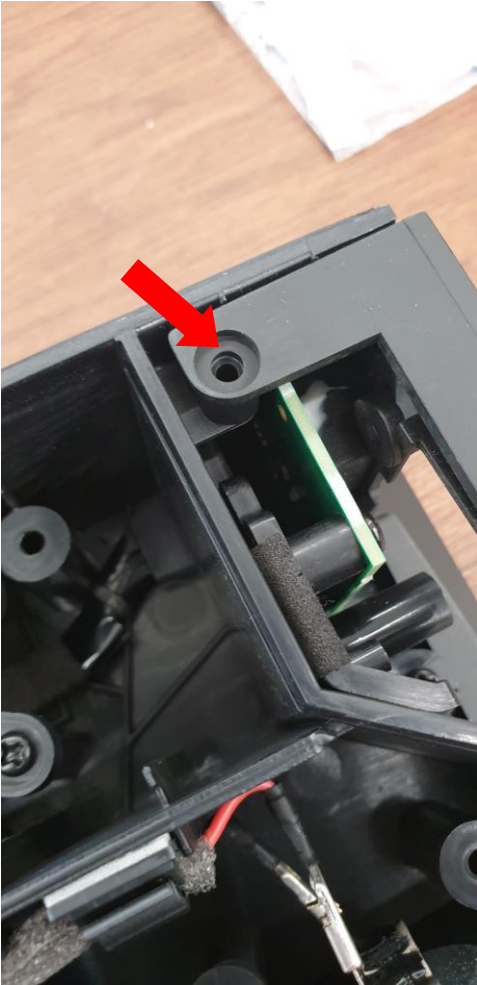
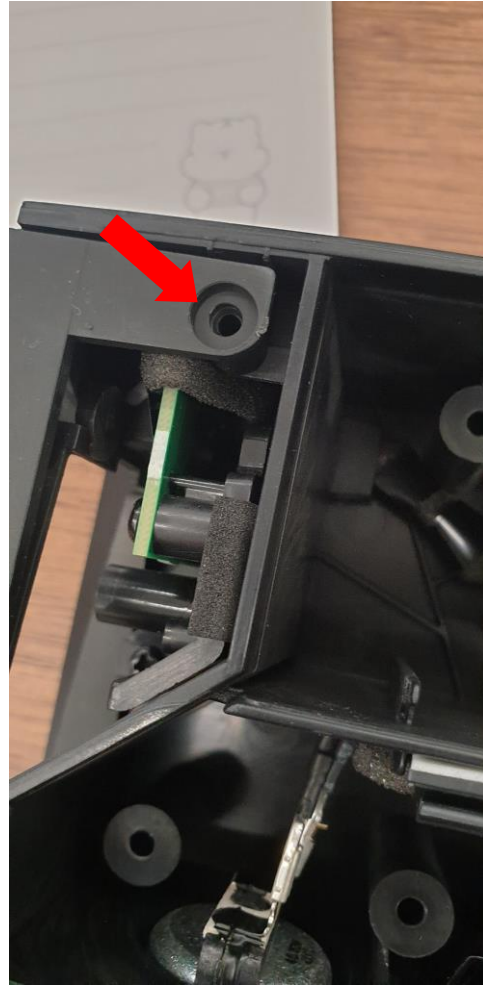
- Screw is missing

NG

- ALT Comment
  - If inner structure is not fastened, can be make vibration noise
  - Please update Fii SOP as a CTQ

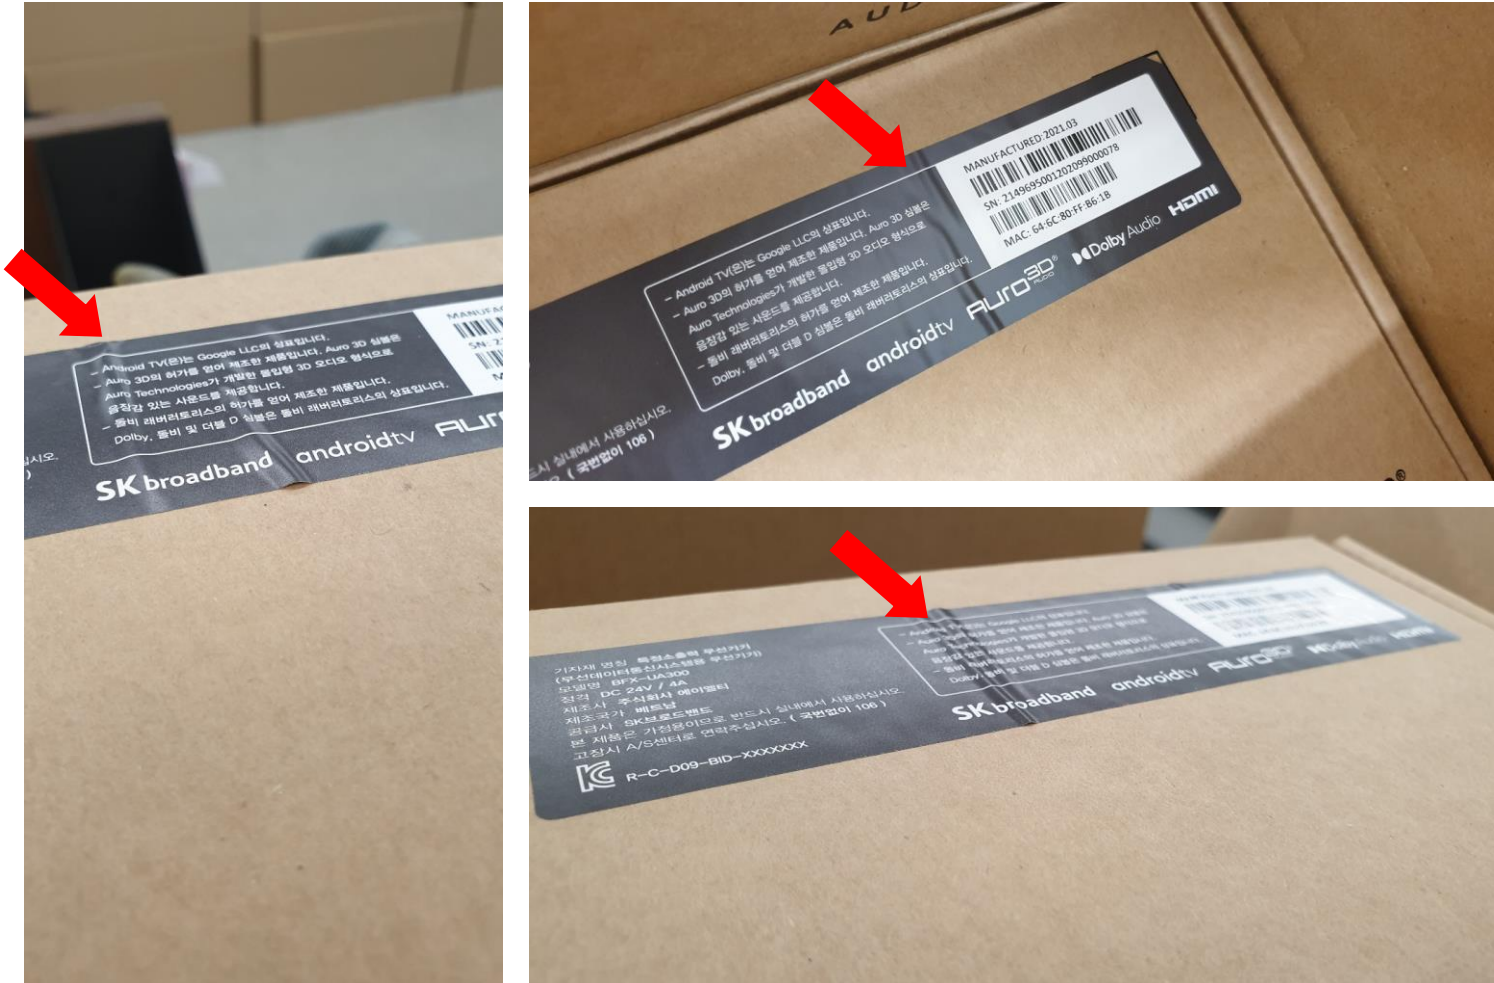
- Label attachment NG

NG

- ALT Comment
  - to be updated VI spec as a failure example
  - Please update Fii SOP
