# SWAN

## Cross section Test report review

Model Name: BFX-UA300

Document Version: ALT\_STB\_MP\_CSMTINS\_001

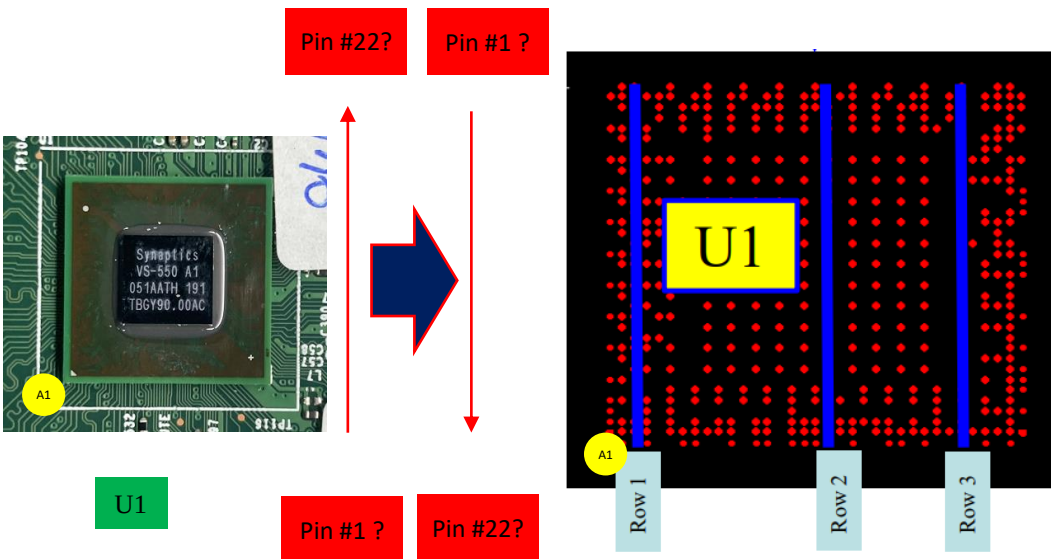
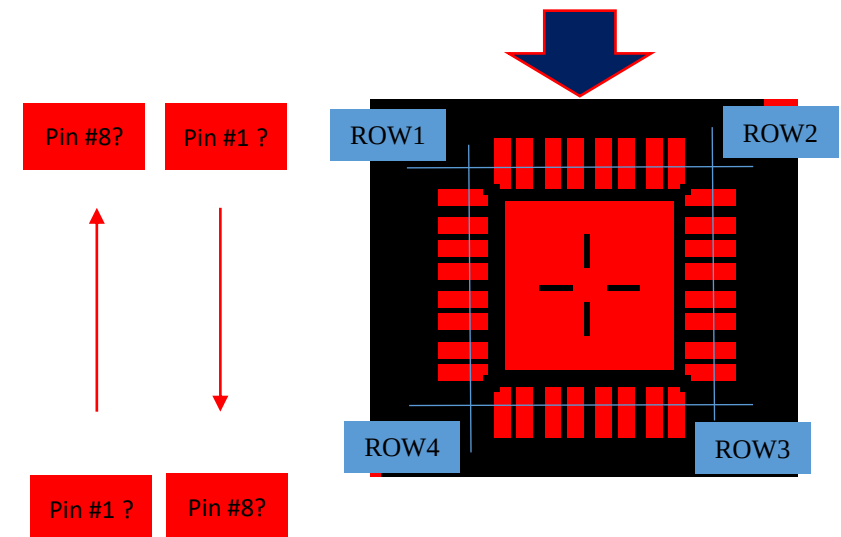
- Update the section direction
  - Where is point start #1 ?
- Please explain why chose the section Row 1, 2, 3?

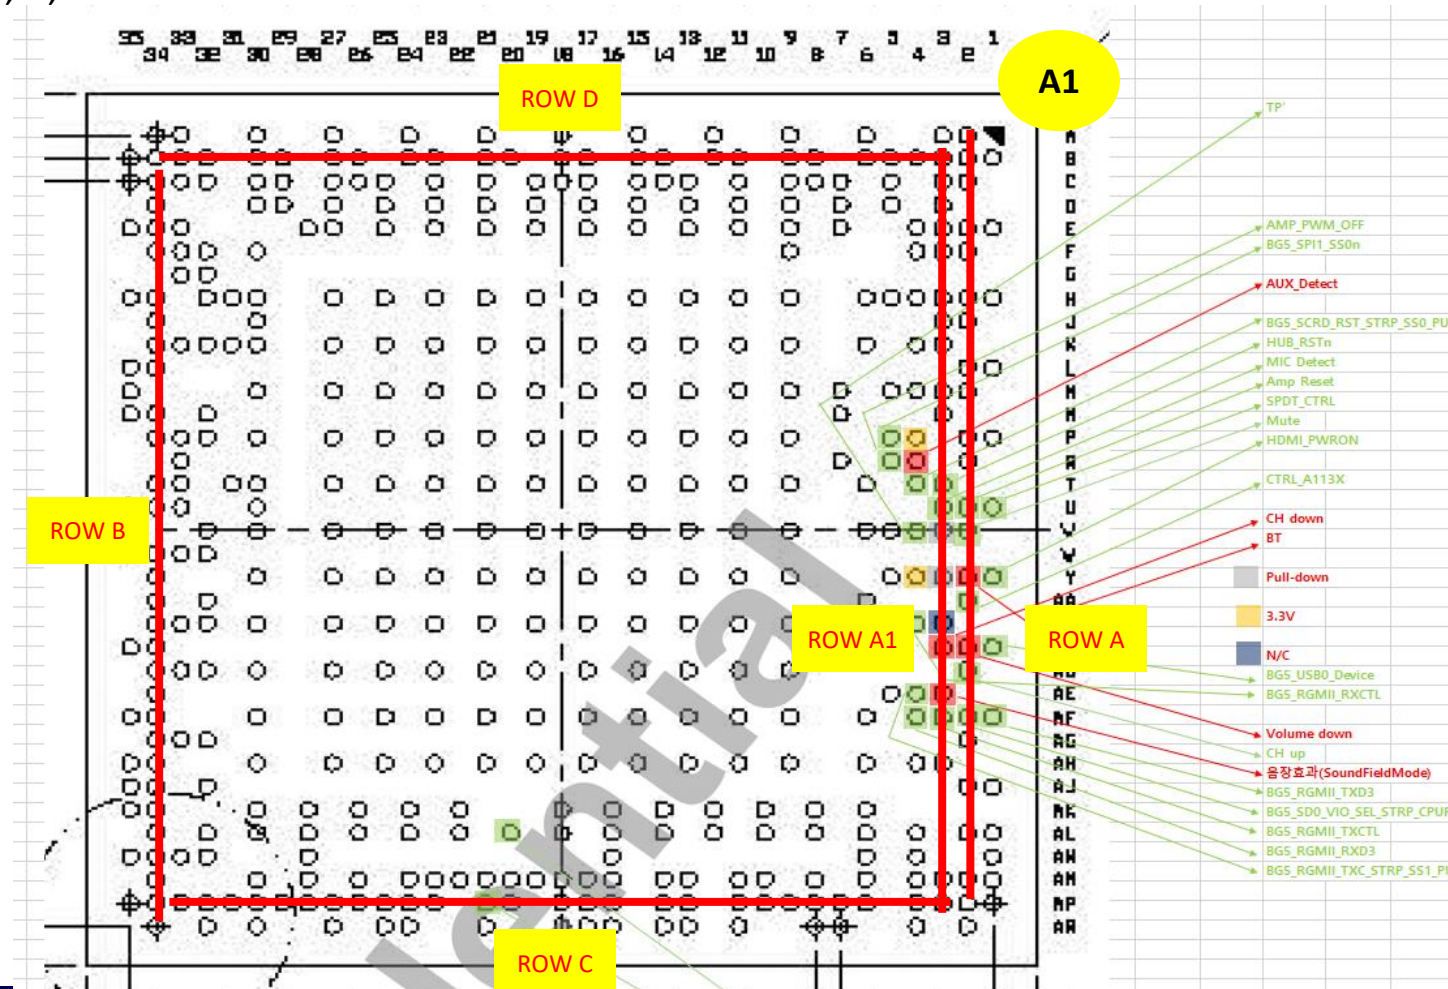
- Please check possible to add a section line
  - Row B, C, D
  - If proceed Next section test, please analysis below in order
    - Row A, A1, B, C, D

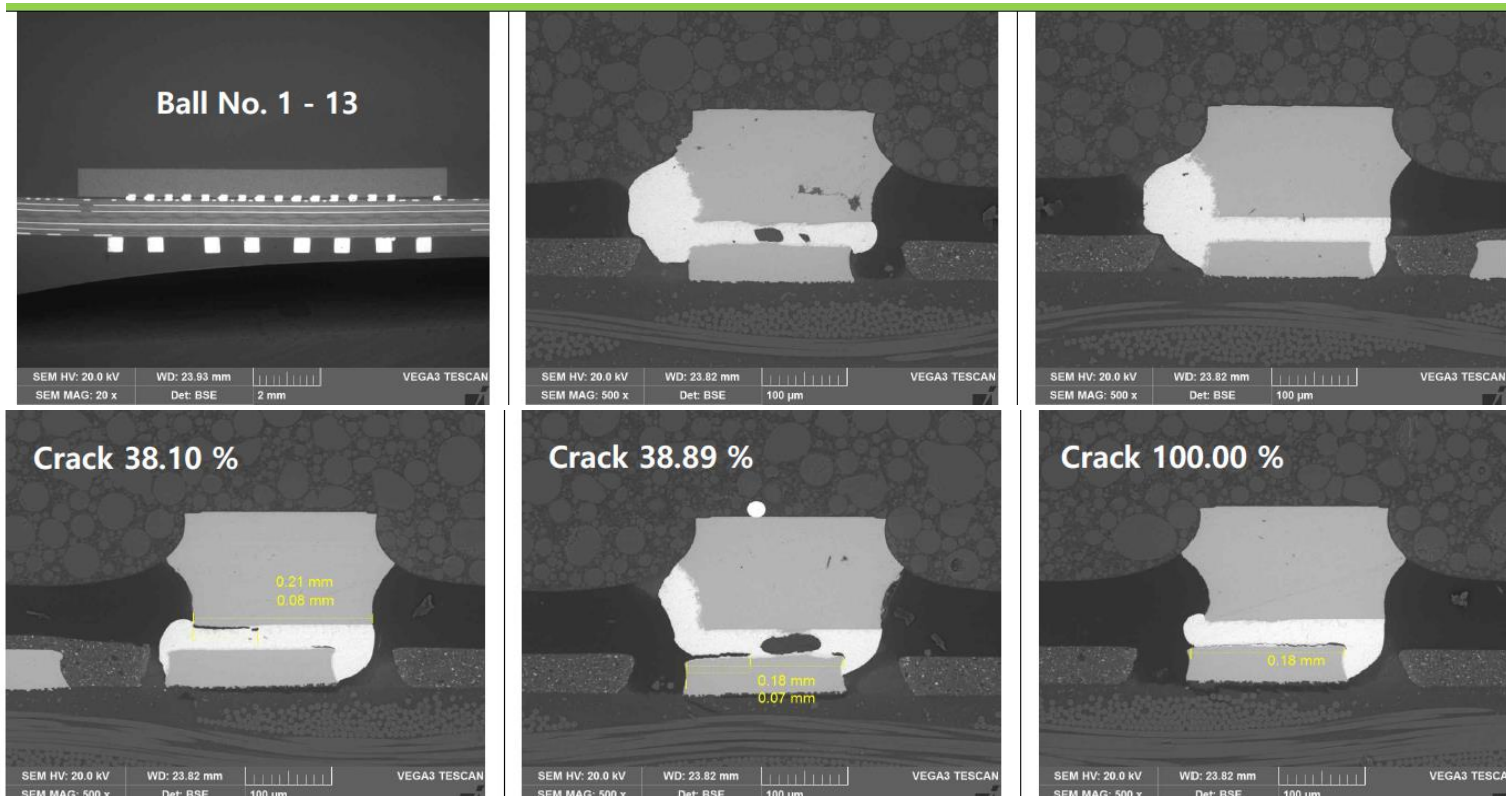
- Please polish more with finer sandpaper.
  - It is difficult to distinguish between the IMC layer and the solder layer because the image is not clear.
  - After polish, update the image : red marked pin
    - Add the add 500x image
    - Add the SAM image
      - i.g. SAM image

- Red point
  - Add the add 500x image
  - Add the SAM image

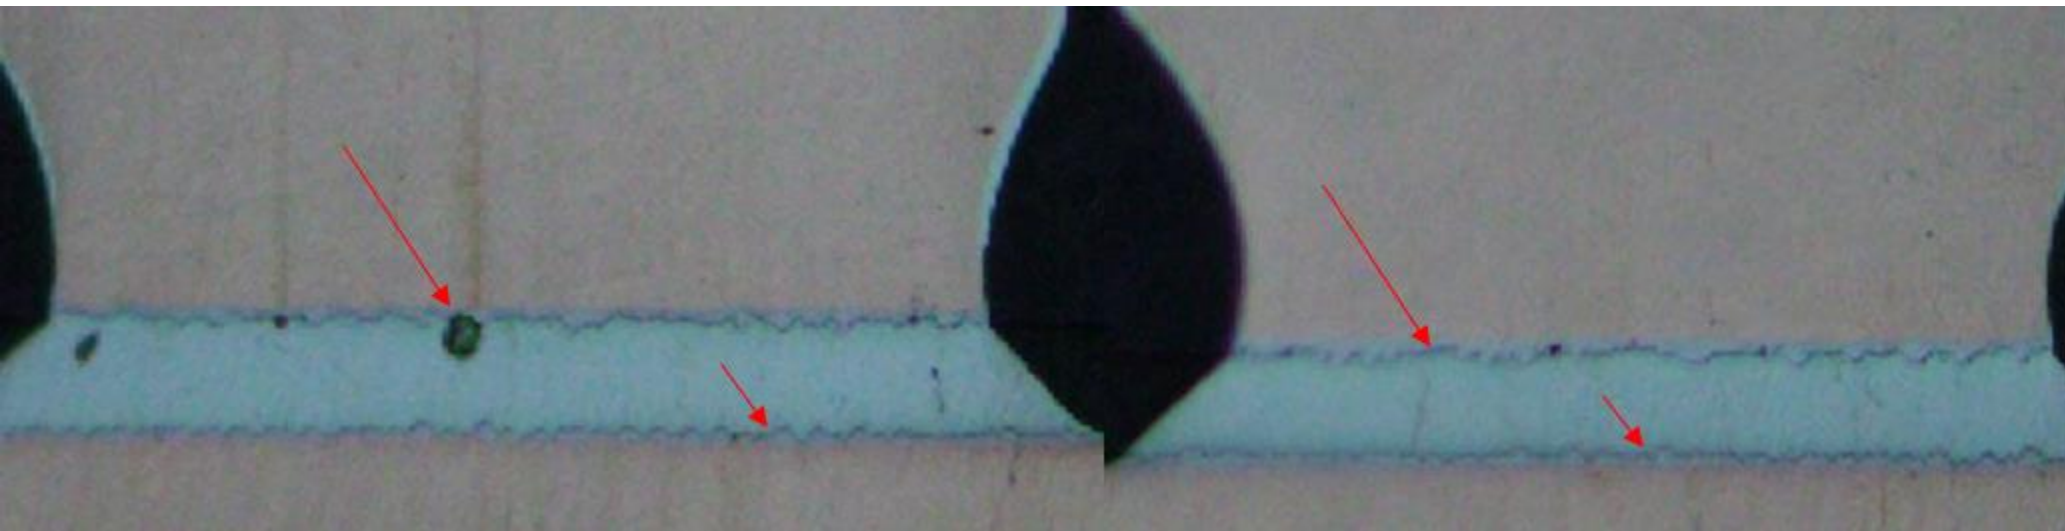
- B. Location U1313 (QFN) Row-4 : 6#, 7#
  - In my opinion, it is judged as a IMC layer crack
    - Prove it's not a solder crack

Row-4 6#

Row-4 7#

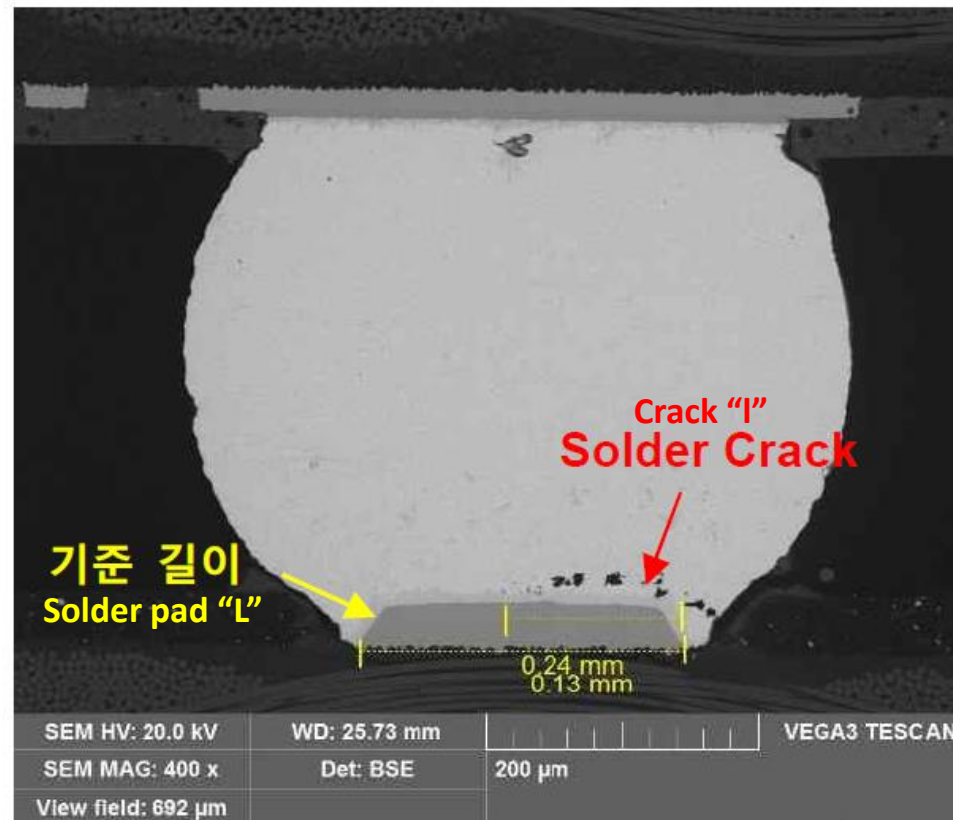
- Define the Solder crack

- Solder Crack (%) : Crack "l" / solder Pad "L" X 100
- ※ criteria : Solder Crack < 25 %
  - $0.13/0.24 \times 100 = 54.16\%$
