## GPIO Issue review

Model Name: BFX-UA300

Document Version: ALT\_STB\_MP\_CSMTINS\_001

Issued Date: 2022.04.28

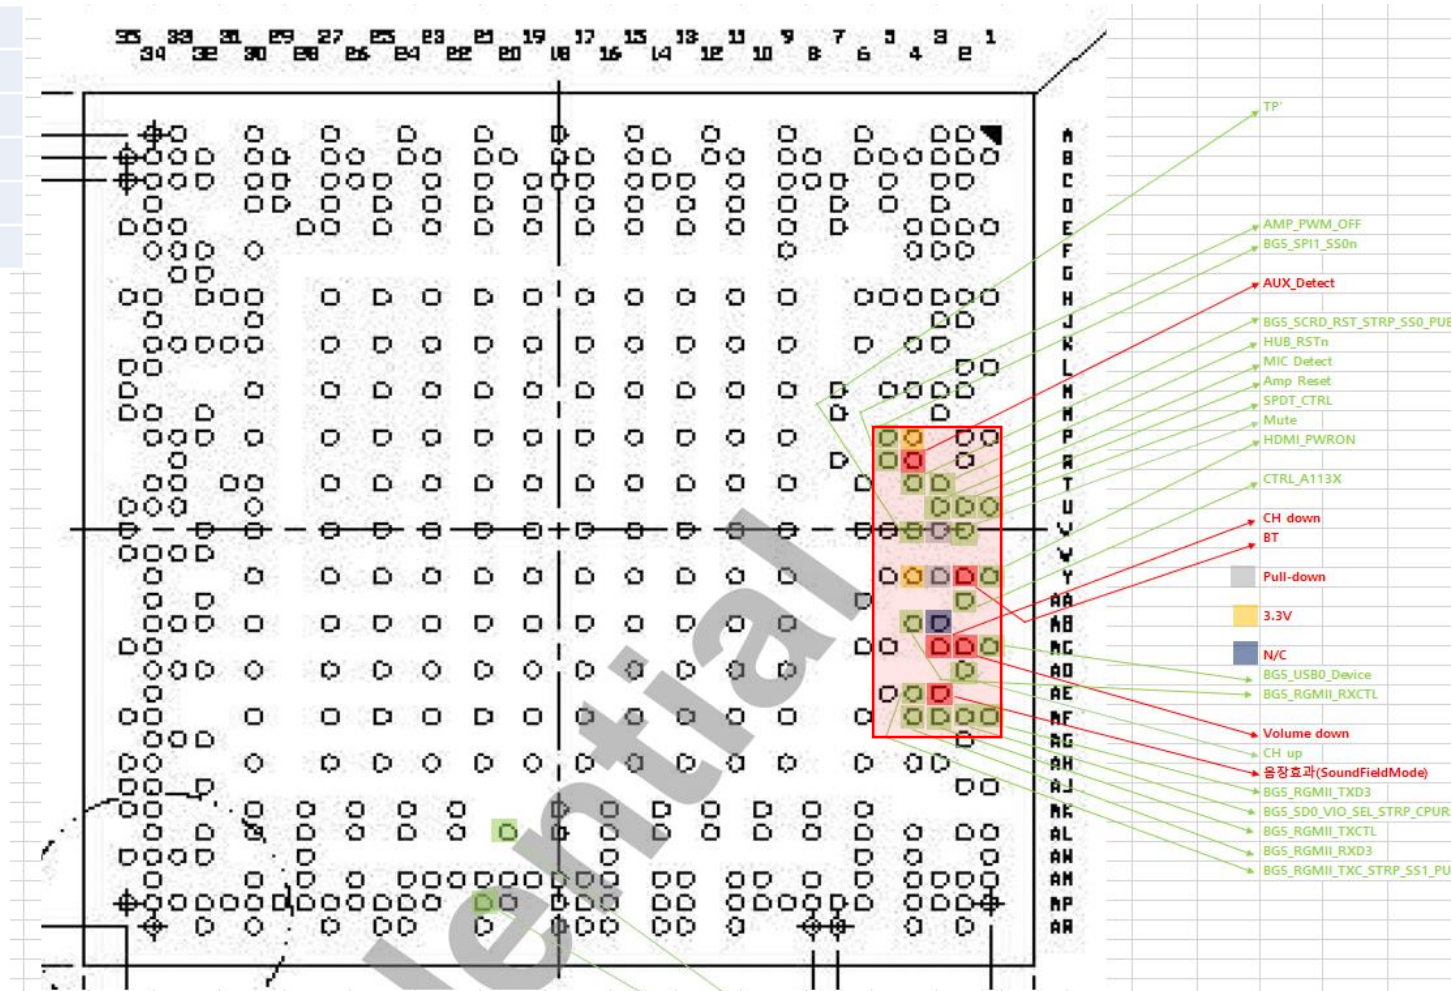
## • VS-550

| Fault key | Q'ty | Ball |
| AUX | 2 | R4 |
| BT | 1 | Y2 |
| Vol. Down | 1 | AC2 |
| CH down | 2 | AC3 |
| Sound Field mode | 1 | AE3 |

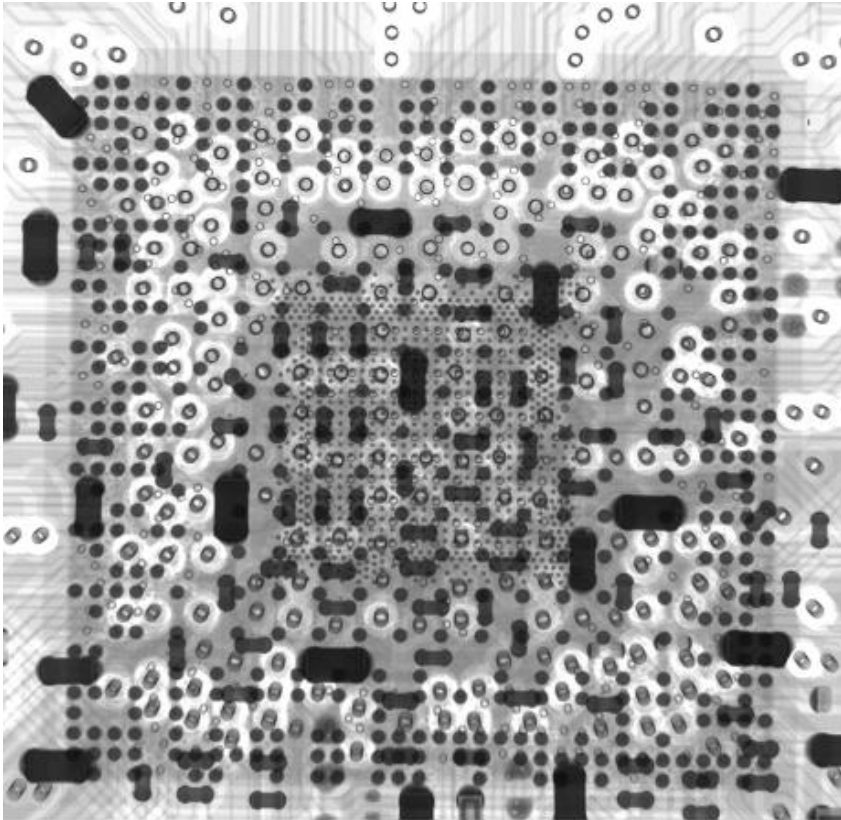
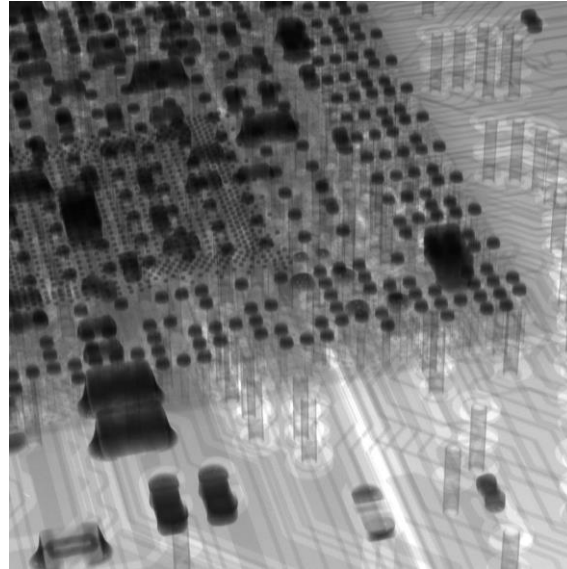
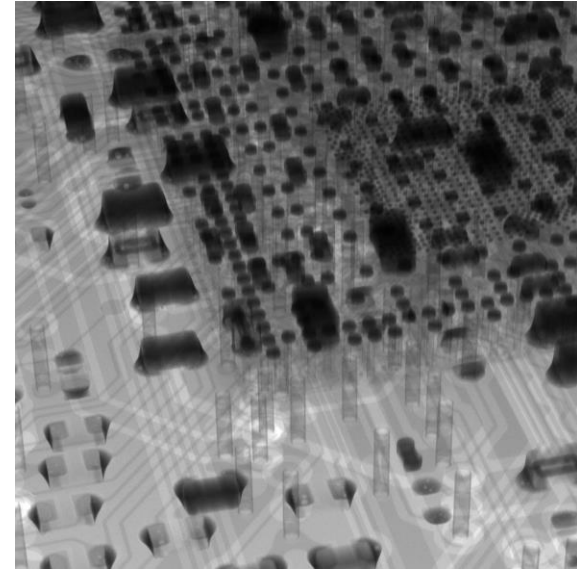
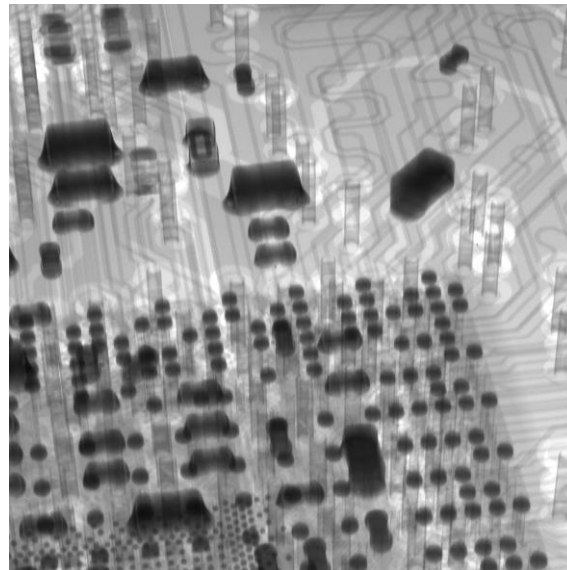
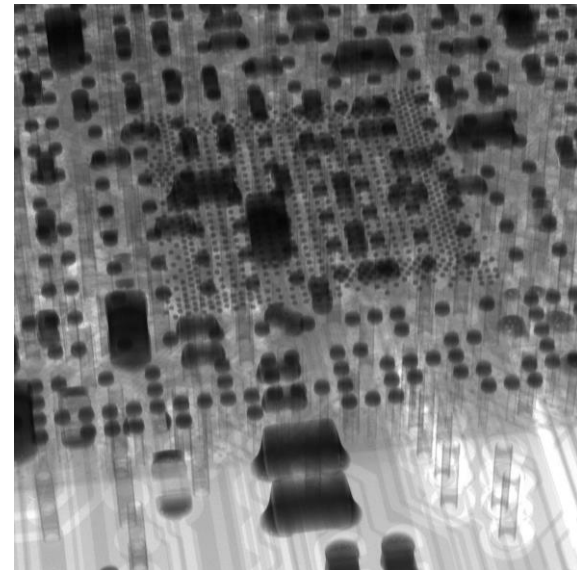
# X-ray inspection

- No Found abnormal : VS-550

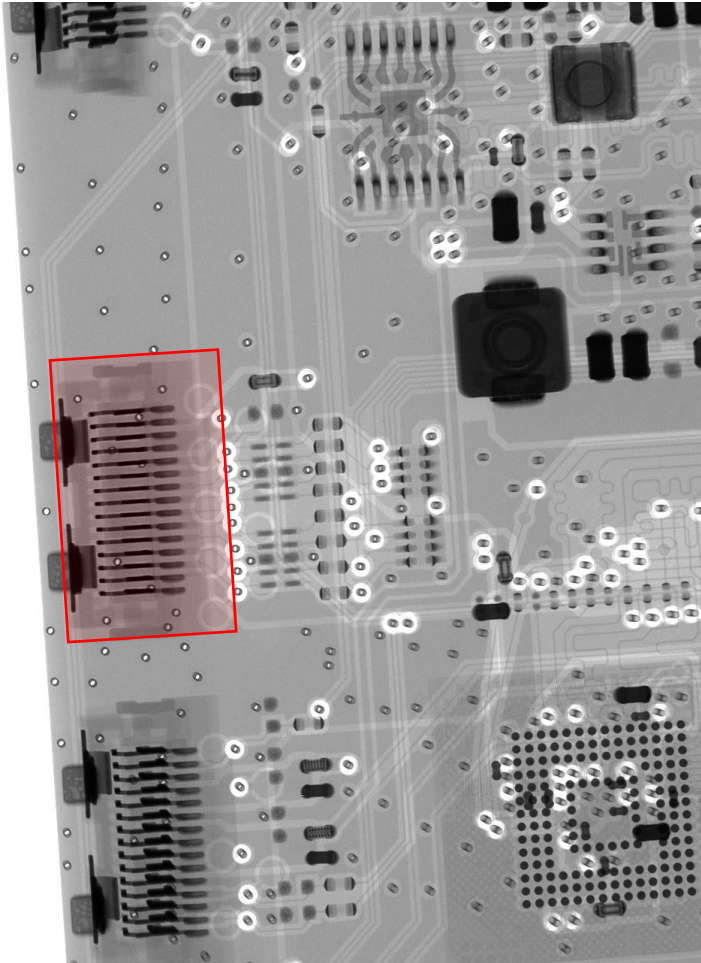
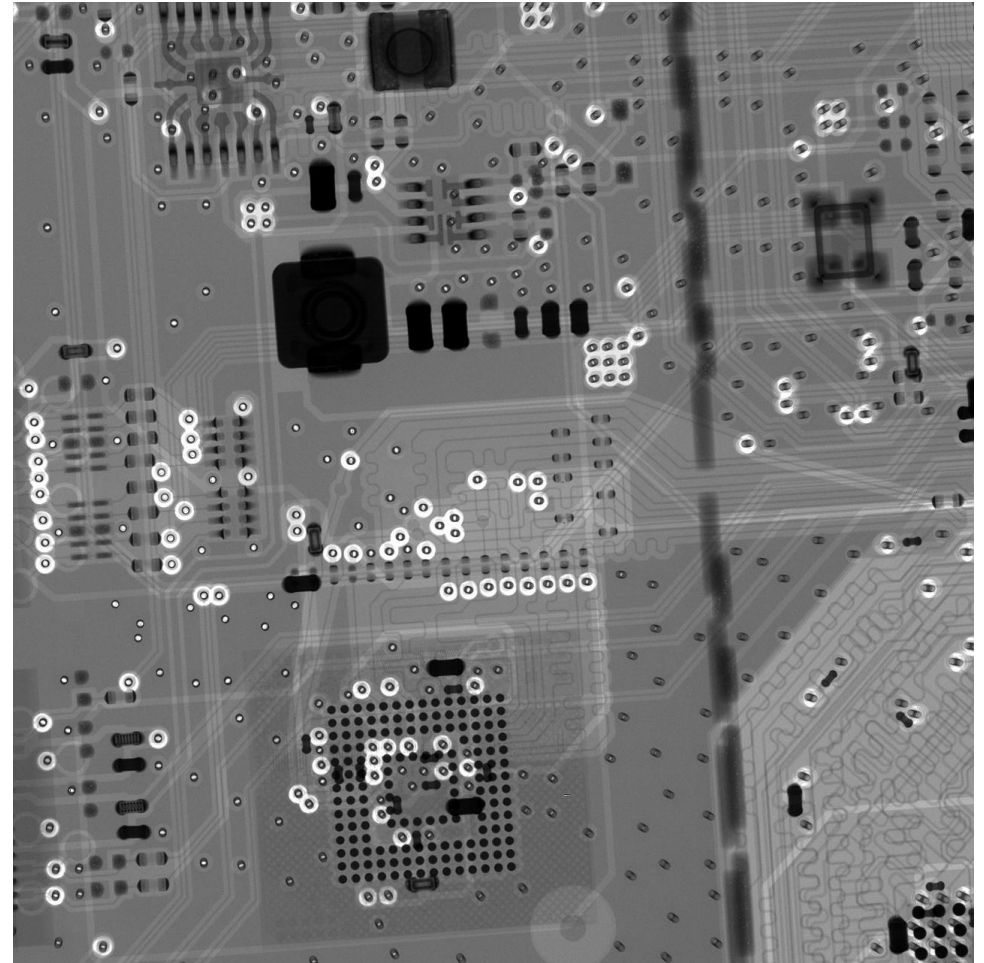
- Button PCB pattern : No Found abnormal

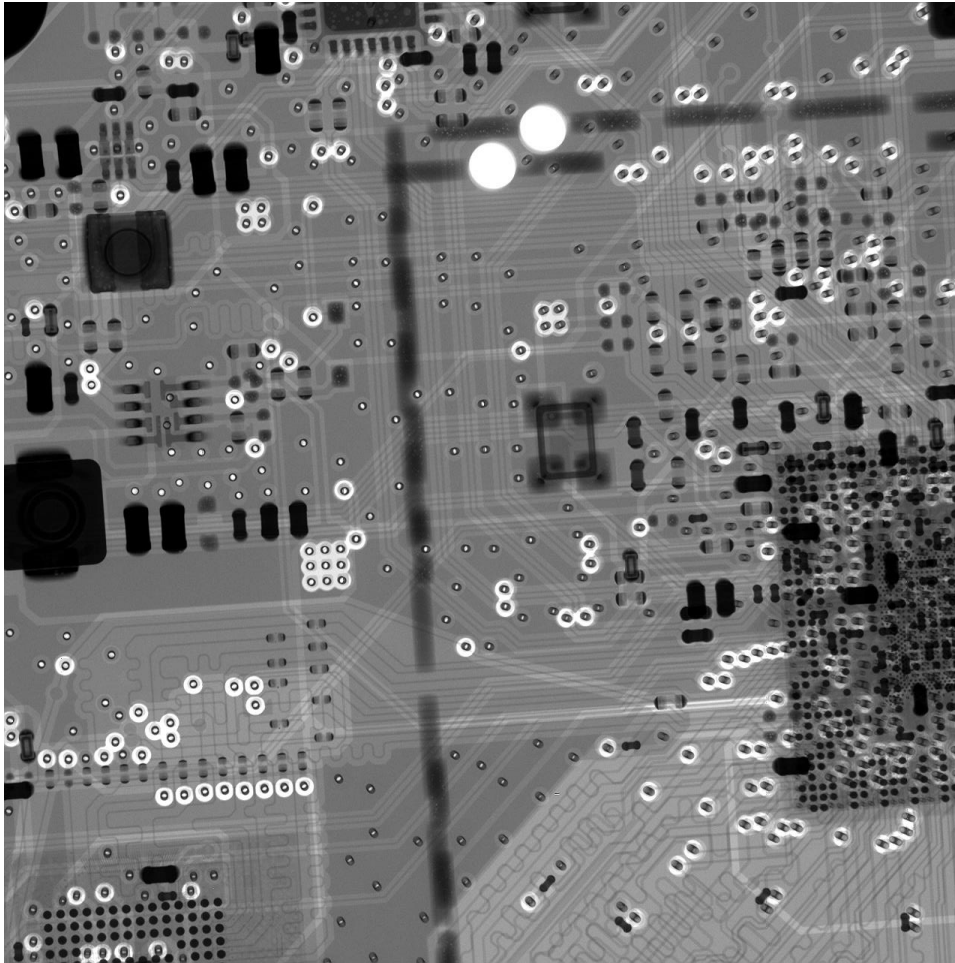
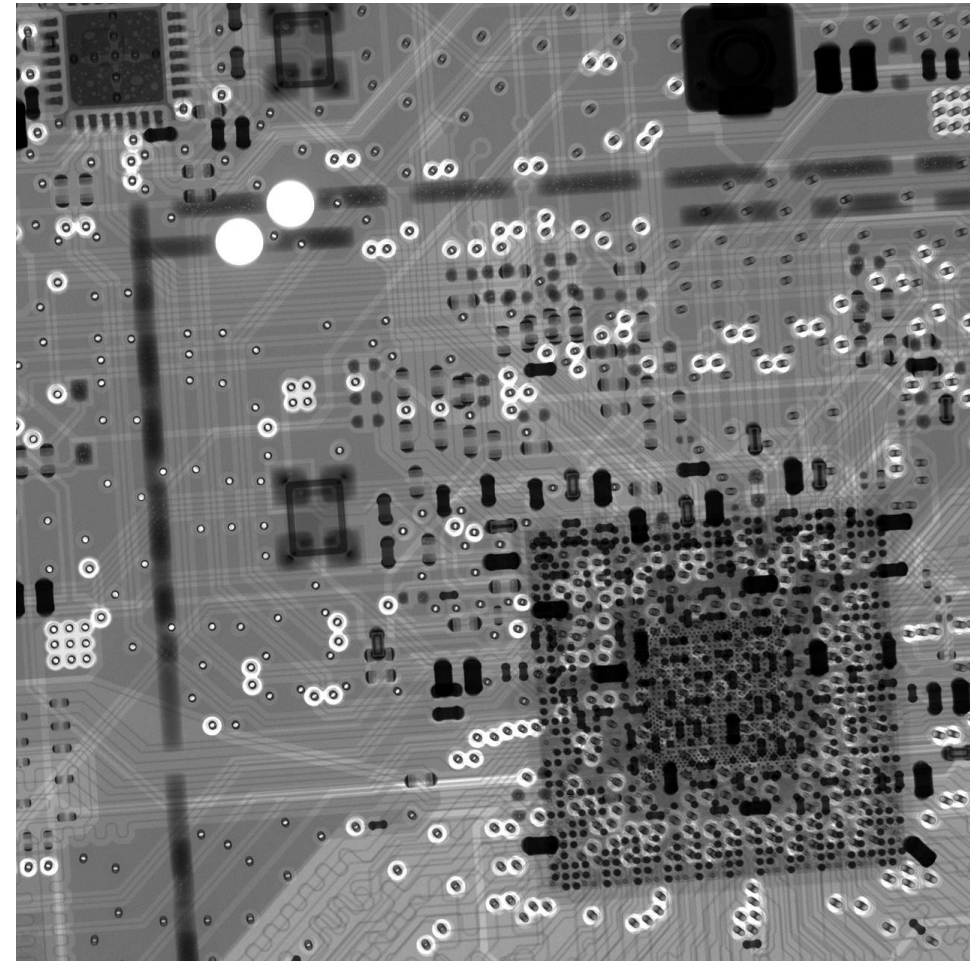
- Button PCB pattern : No Found abnormal

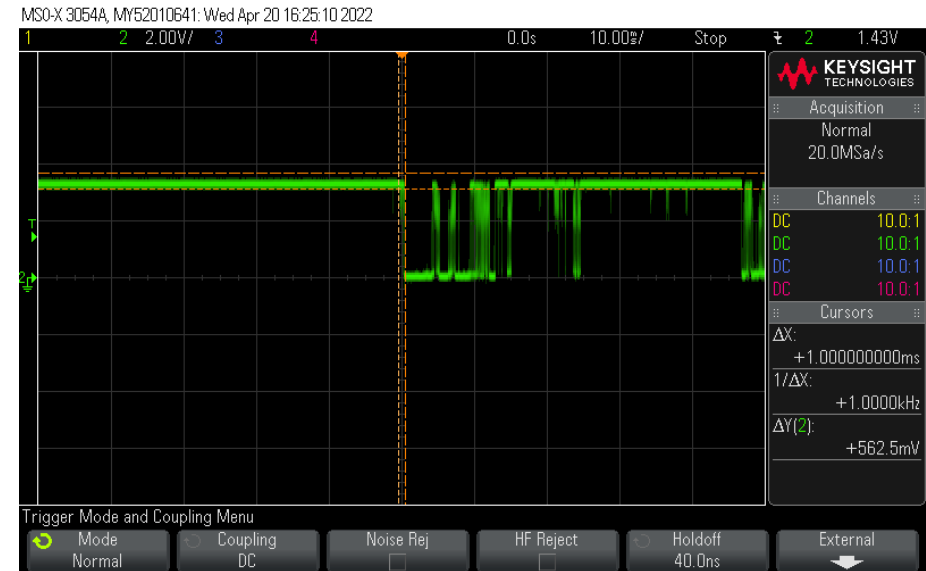
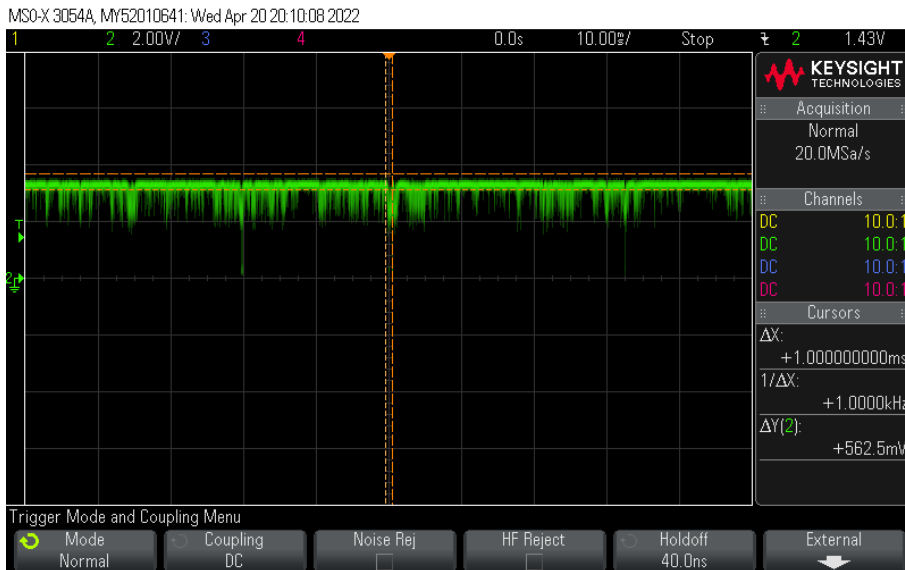
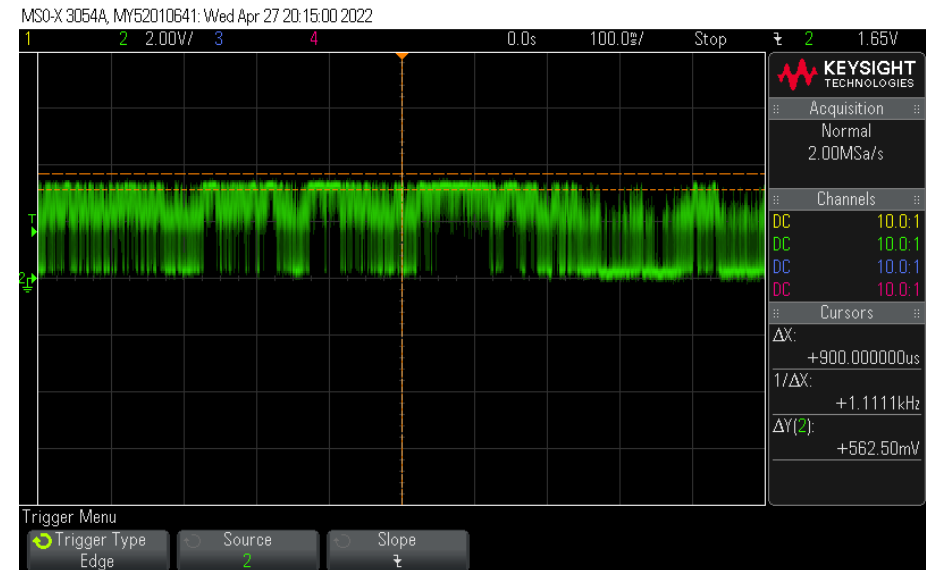
# Signal check

- Measure the “Vol-”, AC2 pin the signal when defects appear is abnormal

- These GPIO pins of VS-550 are located in the same area.
- ALT will analyze the following causes
  - a. PCB defect.
  - b. Soldering defect
  - c. Chip(VS-550) defect

- NEED TO ANALYZE AND FIND THE ROOT CAUSES
- Foxconn have to analyze the following causes
  - a. PCB defect.
  - b. Soldering defect
    - Factory should check the SMT log to review if there is an abnormal.
    - So far, the defects have been concentrated on the initial production.
    - S/N range : 2149695001202109001011 ~ 2149695001202109002264
  - c. Chip(VS-550) defect
