# 8D Report

**for cosmetic issue of BFX - AT100 (T99X171)**

Date : 15 November 2019

**1 November 2019, ALT customer complain [BFX-AT100] 3rd Mass production  
Cosmetic issue.**

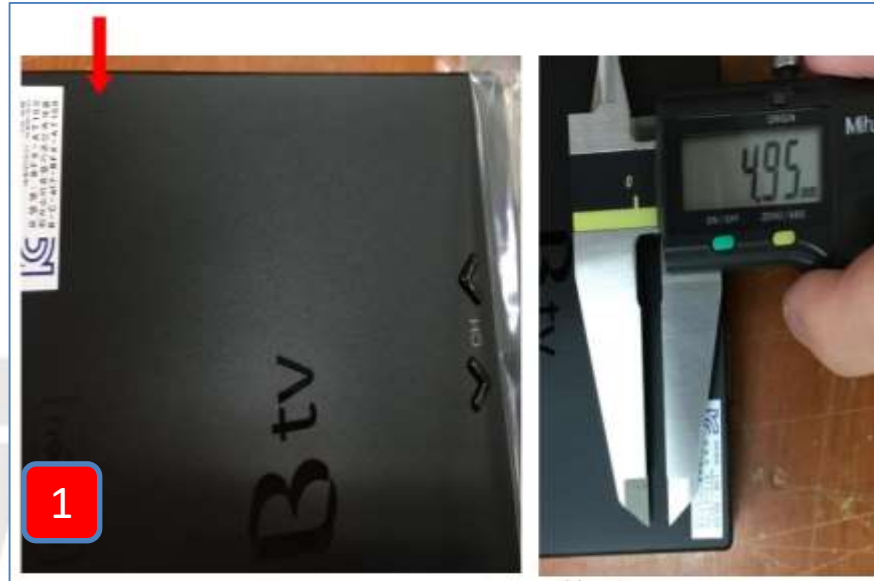
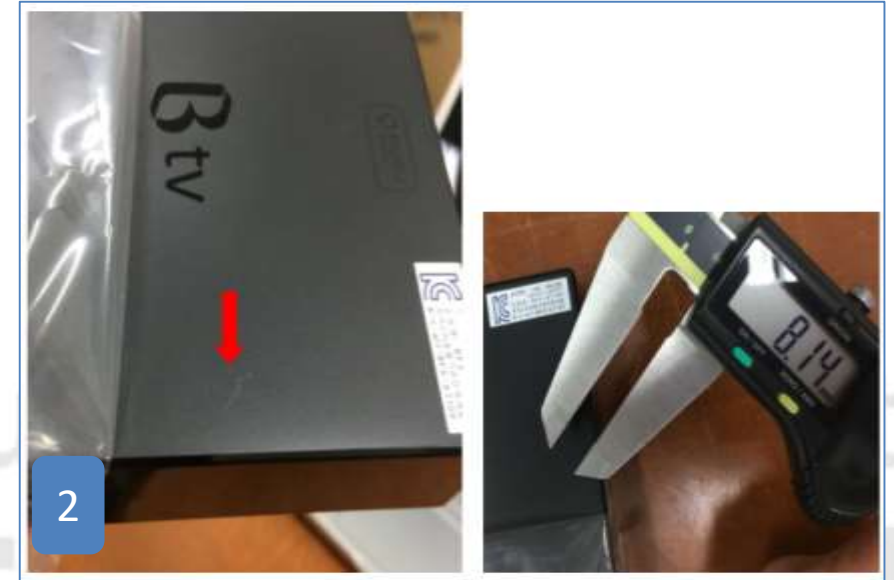
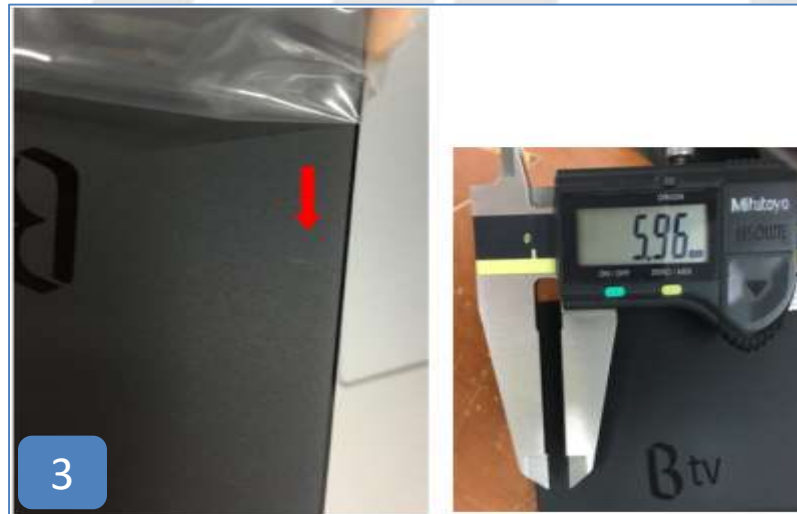
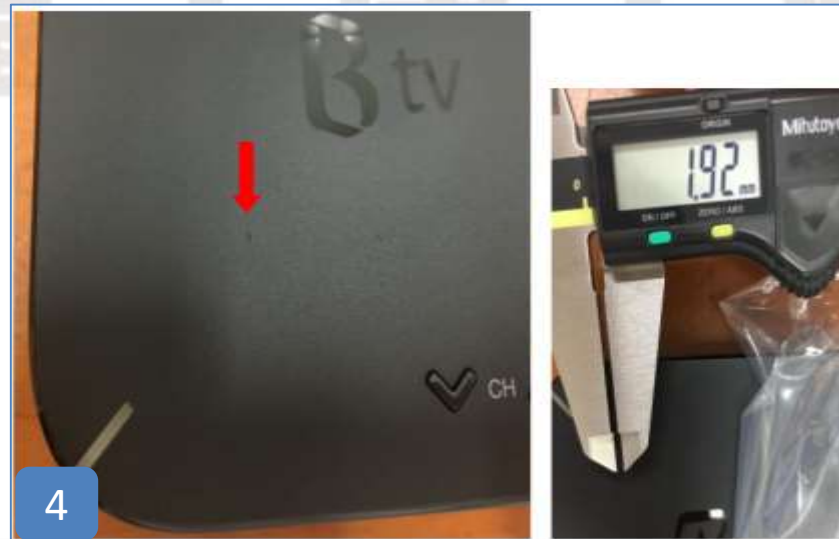
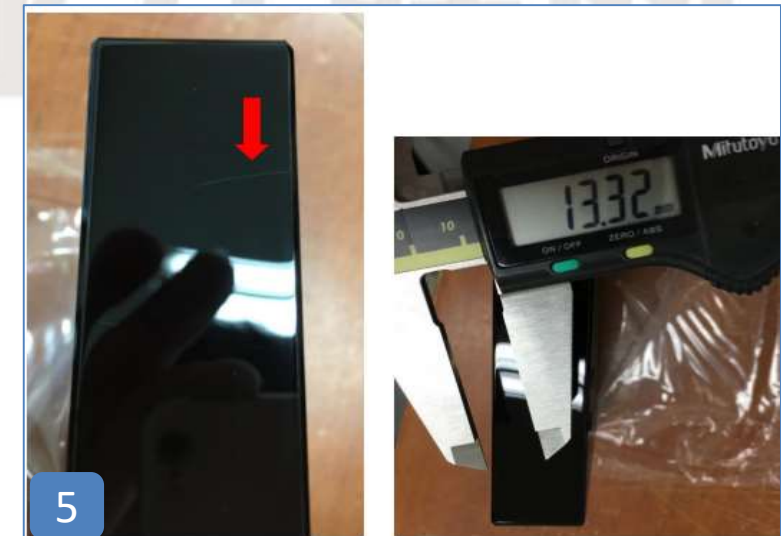
### 2.1. Scratch on the top housing

Defect q'ty: 5/500pcs

Defect rate: 1%

Operator at stick housing label station did not wear finger cover at little finger so during operating process her nail touched on housing lead to scratched housing.

5.1.1. Required operator at stick device label station wear finger cover at little finger when operating to avoid of finger nail touch to housing and cause scratching.

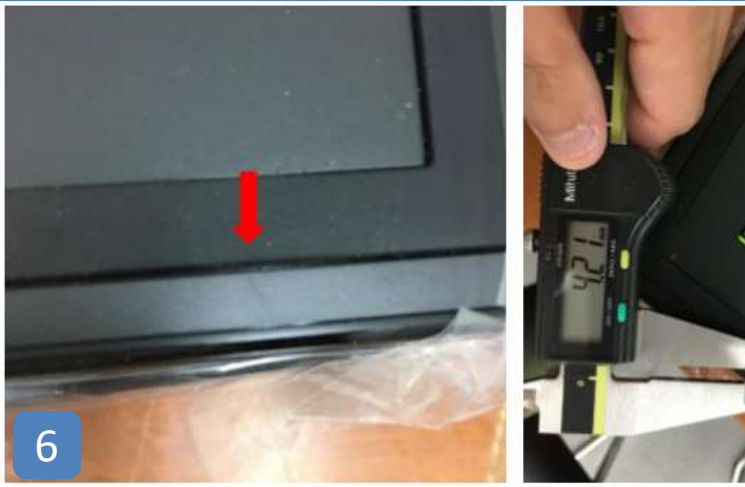
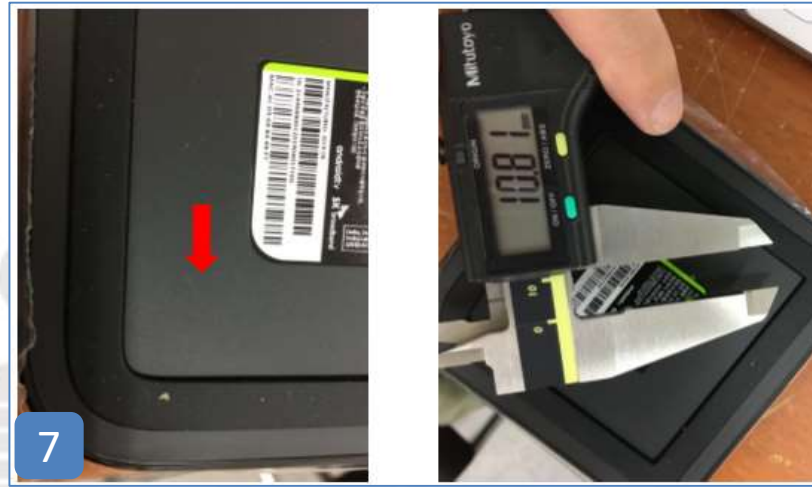
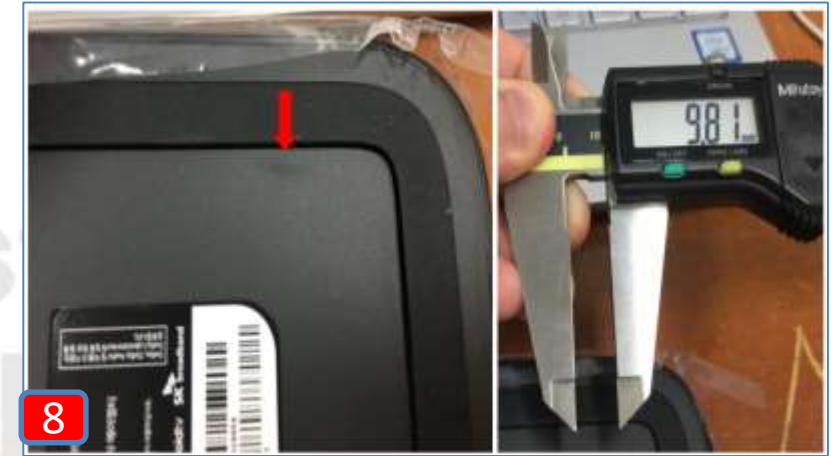
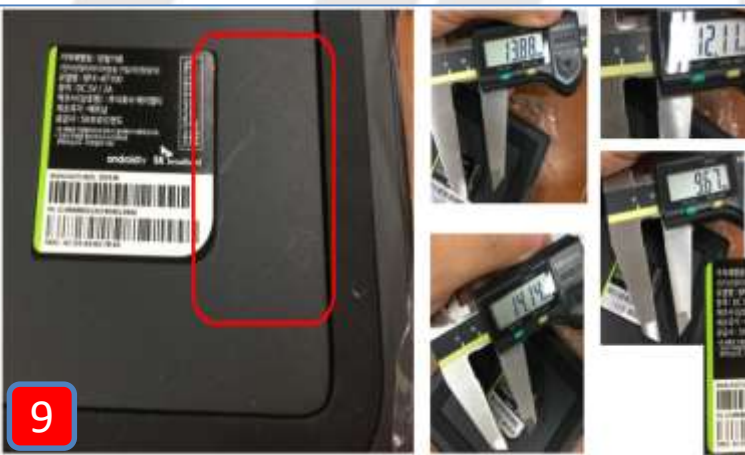
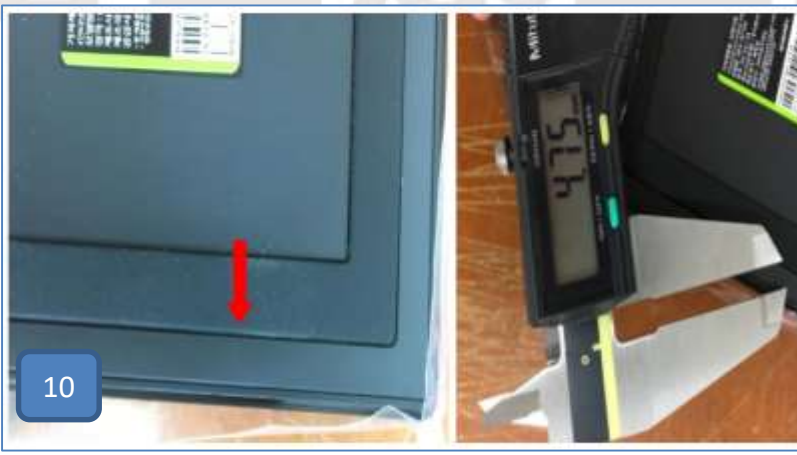
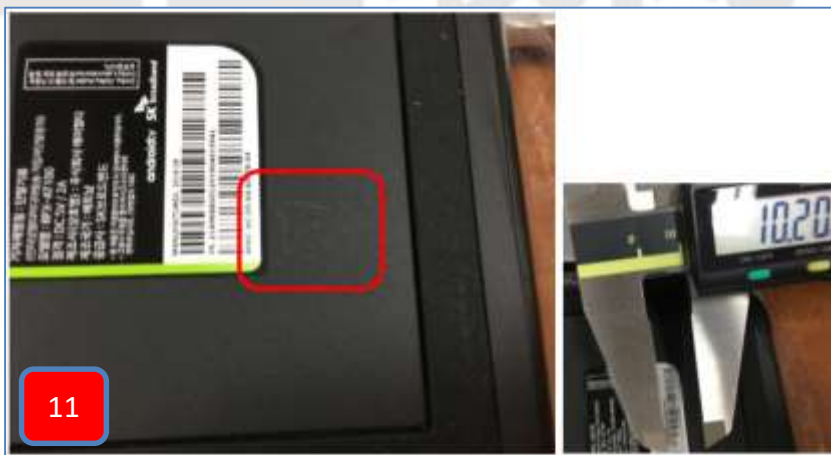
### 2.2. Scratch on the bot housing

Defect q'ty: 6/500pcs

Defect rate: 1.2%

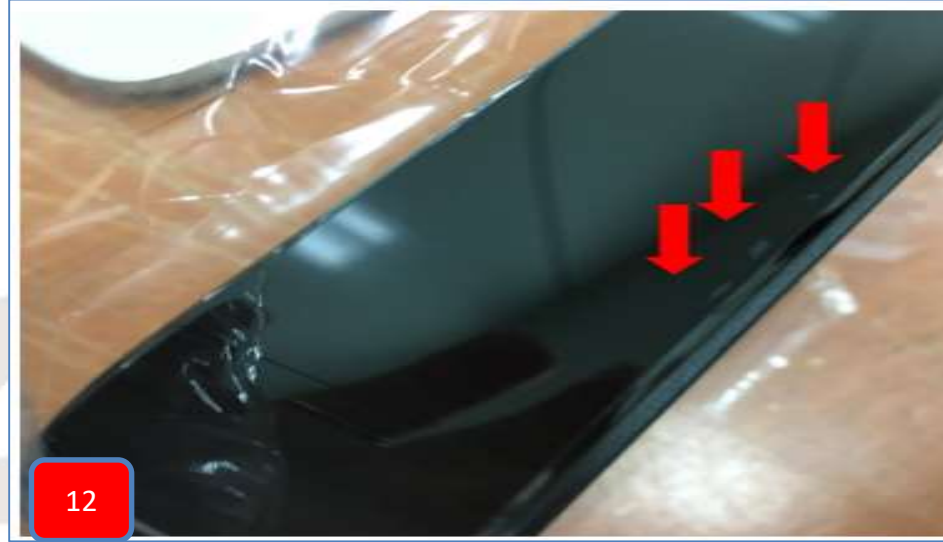
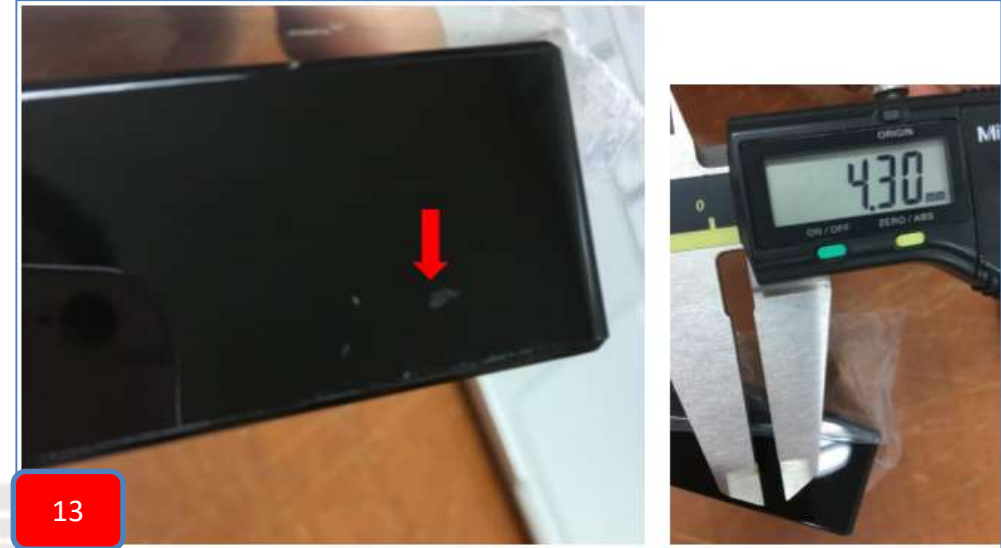
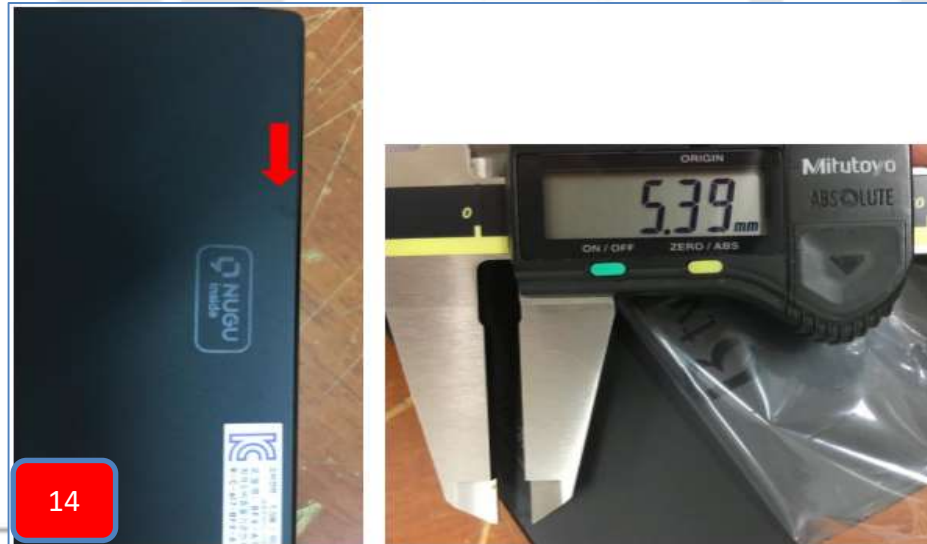
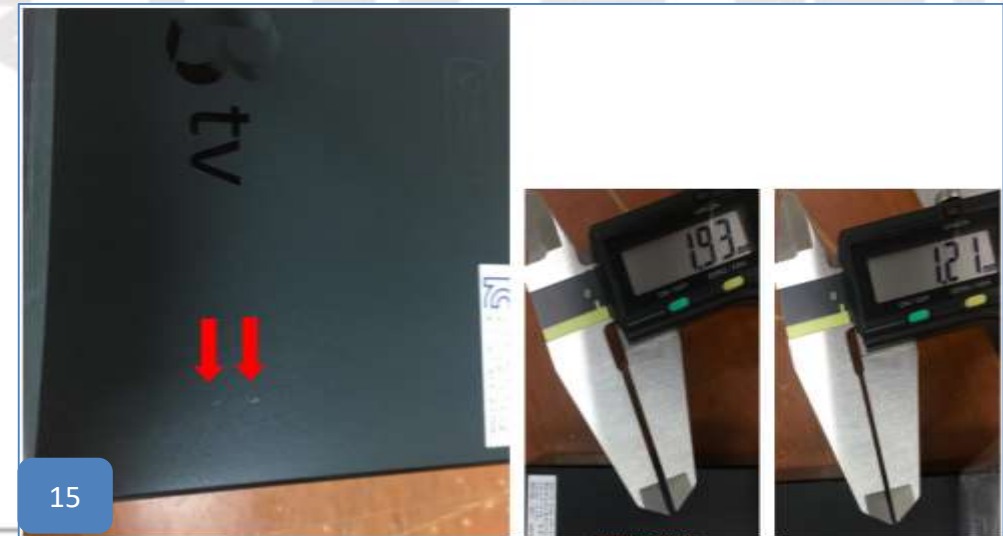
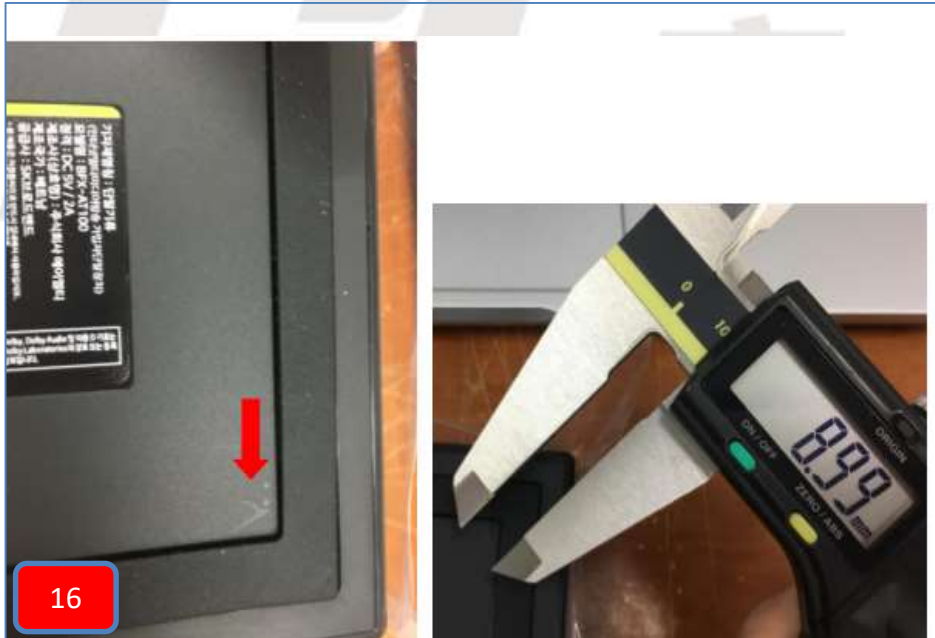
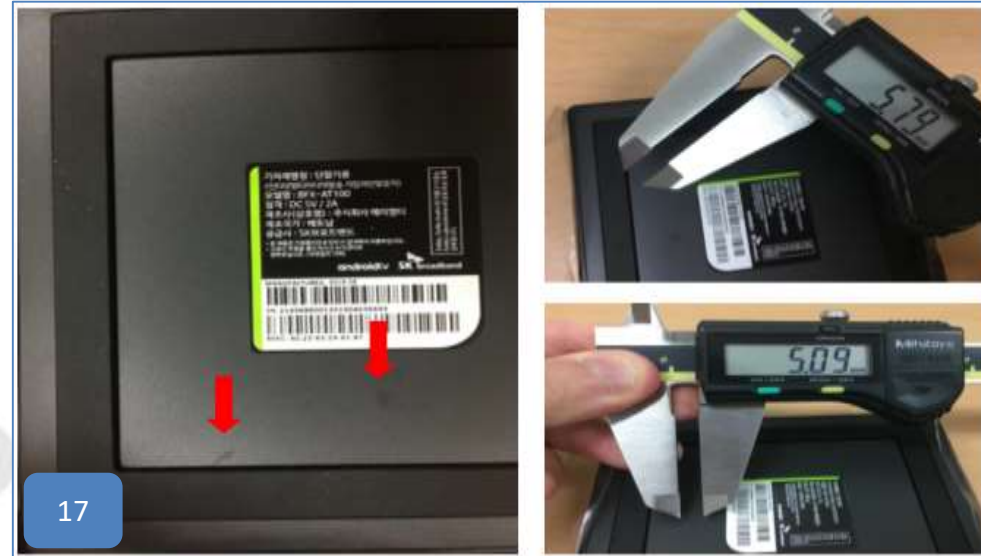
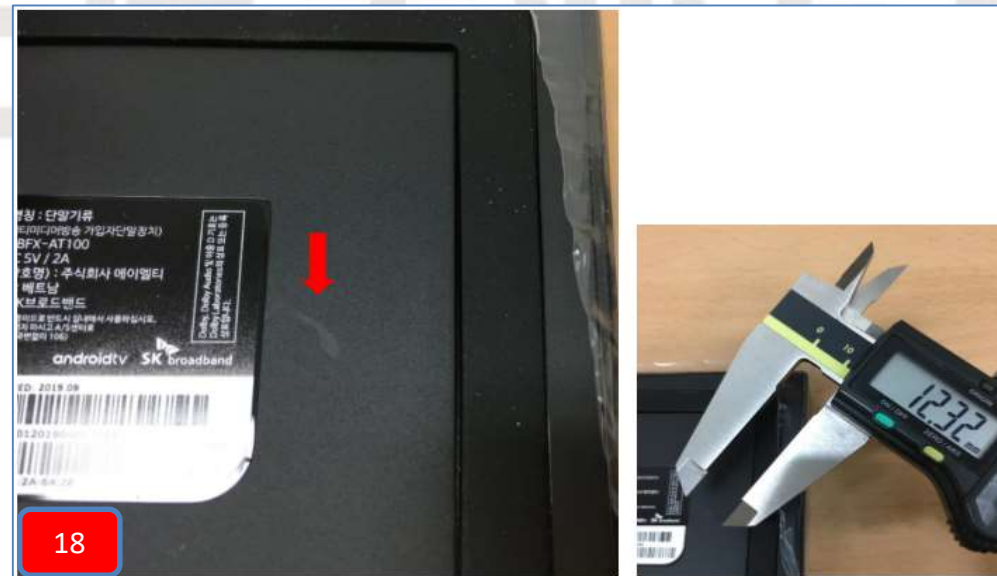
### 2.3. Damaged product (look like scratch)

Defect q'ty: 7/500pcs (1.4%)

**Root cause:** This defect was due to be impacted to rubber pad stick fixture during operator's operating. (we also found out DUTs be scratched in random when using this fixture to stick rubber pad)

5.2.1. We suggested our ME design a proper fixture as mentioned in previous report but the fixture was still not effective. Thus, we still manual stick rubber pad to avoid risk of scratch, dirty, damaged to housing,... caused by fixture.

5.2.2. We did work with vendor to change more customized protective film with connector hole cut already from the lot of 89K.

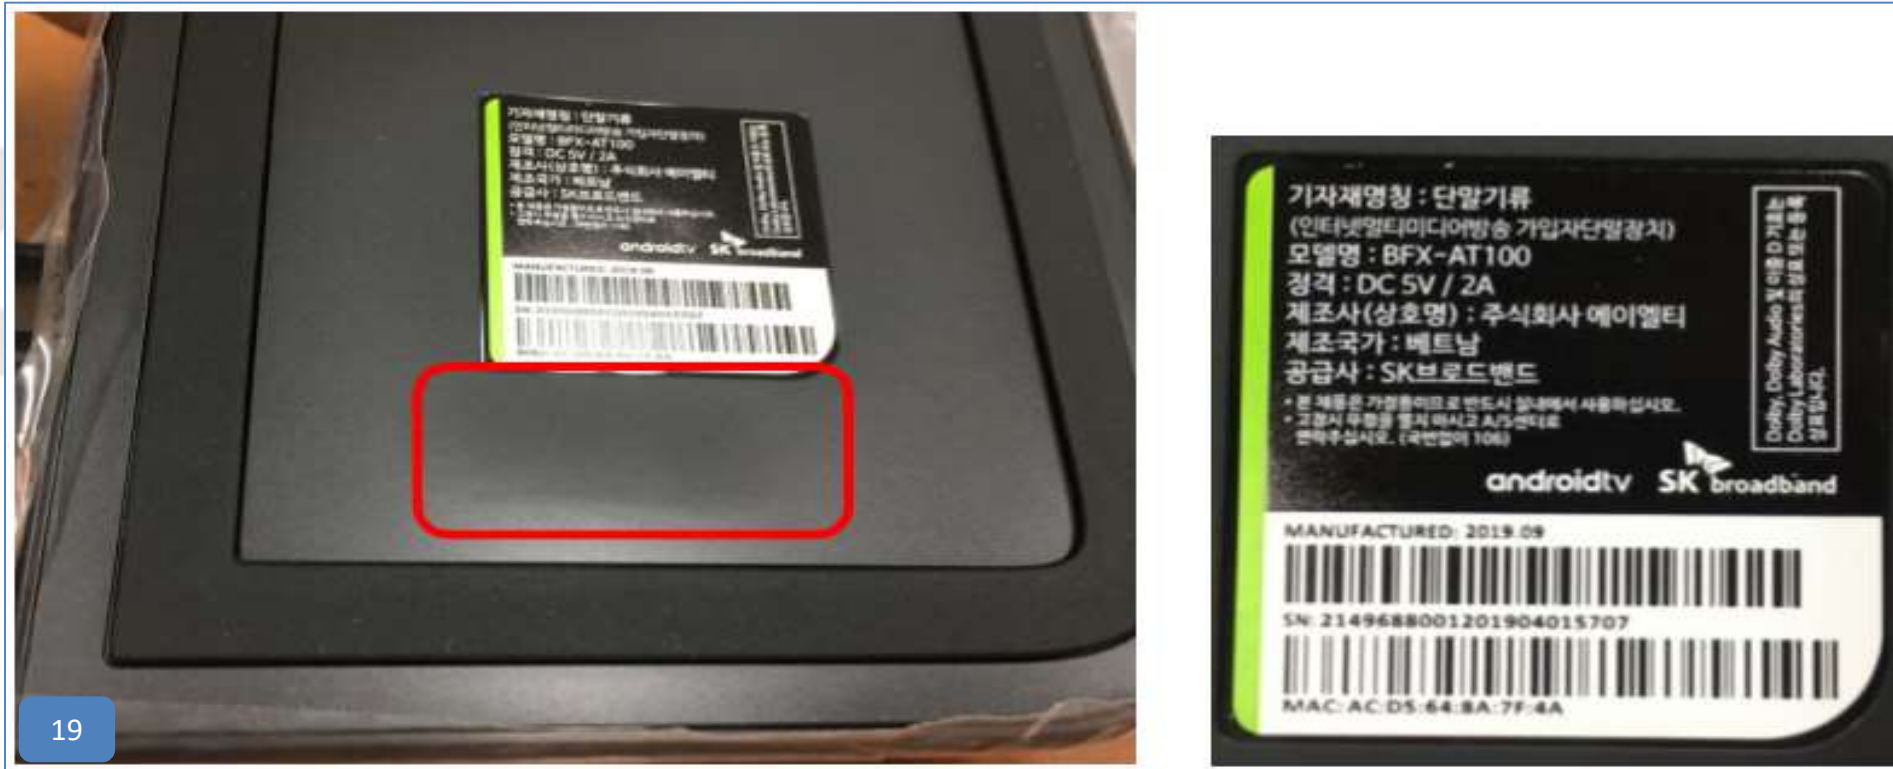
### 2.4. Buffing housing

Defect q'ty: 1/500pcs

Defect rate: 0.2%

Root cause: During checking cosmetic, VI operator found out this unit be dirty and cleaned it with strong force lead to buffing.

Alarm and remind line leader and all operators at production line **do not allowed clean housing in any case**. If find out cosmetic defect over inspection criteria, all defects need compulsory is scanned error code and then put them on NG tray for line leader double check and handle by changing housing.

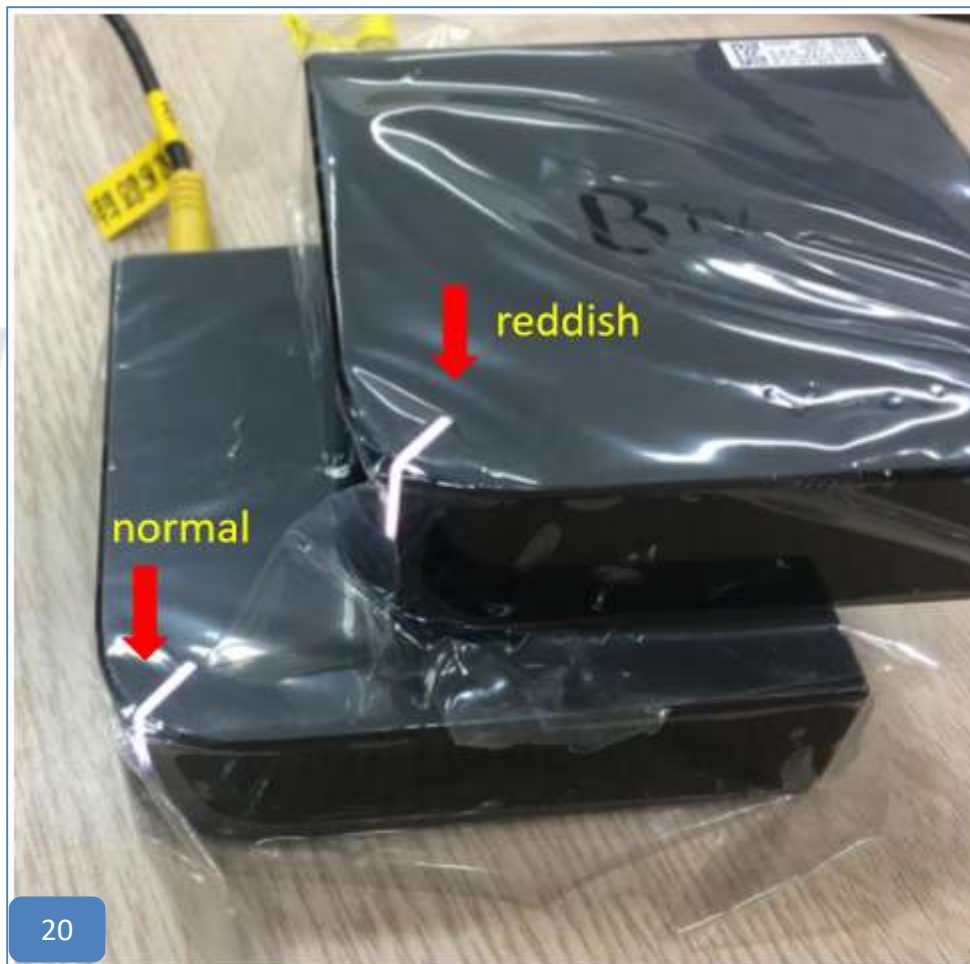
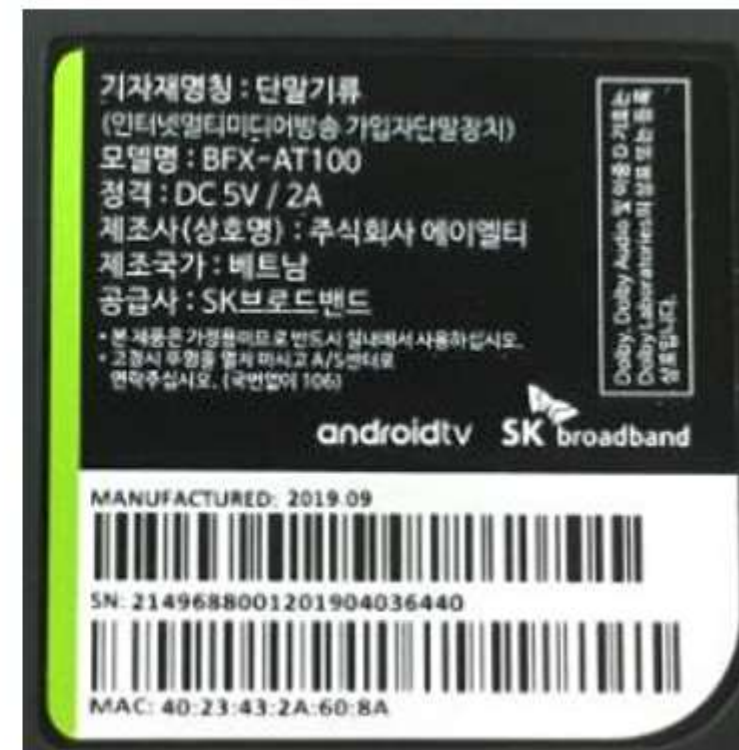
### 2.5. LED issue

Defect q'ty: 1/500pcs

Defect rate: 0.2%

This defect is belongs to bin code PW05 [in specification](#) with reddish color. Please see detail in corrective action page 31, 32.

5.4.2. RD will send to factory 2 samples with reddish color (bin code PW05) which customer approved as golden sample. In case of suspecting LED abnormal, we will compare with golden sample for judgement.

5.4.3. Required vendor add bin code information in Lot code in order to IQC upload to system for controlling. We will separate Lot code with PW05 bin code to run a MO and monitor if have any LED reddish color over specification and then send to vendor analysis and improve (as picture below)

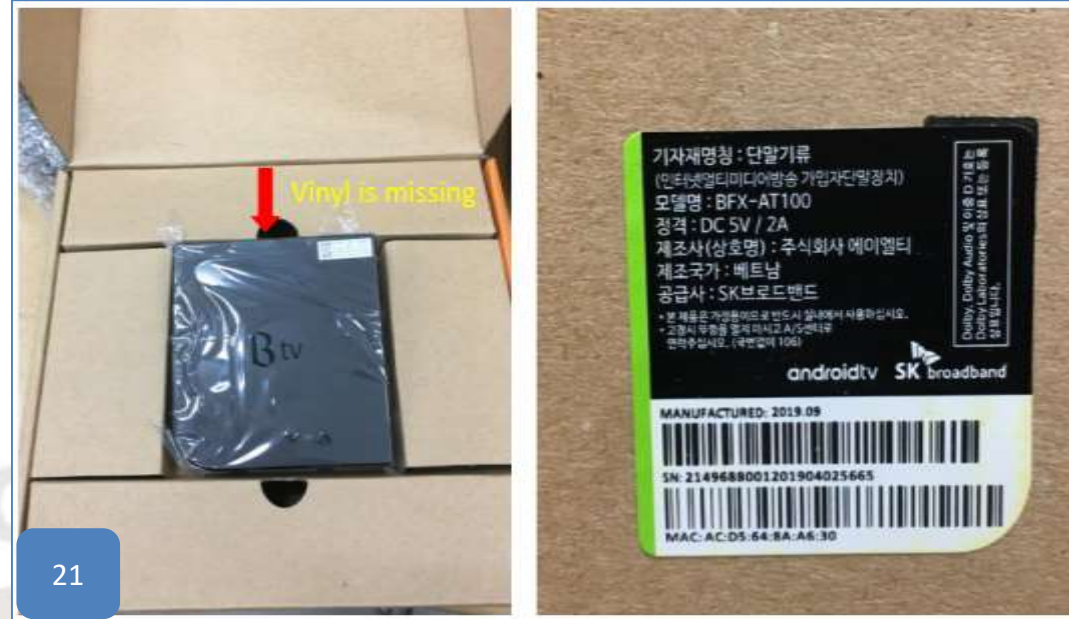
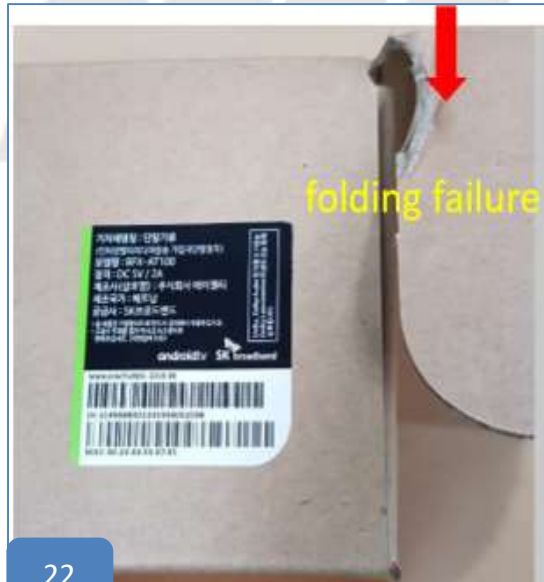
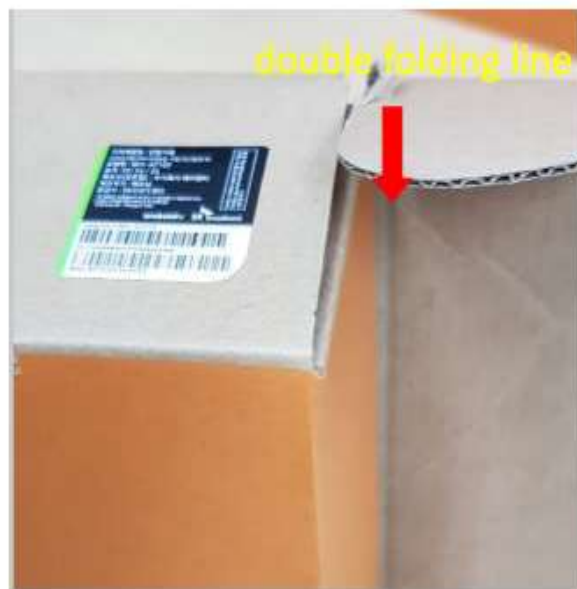
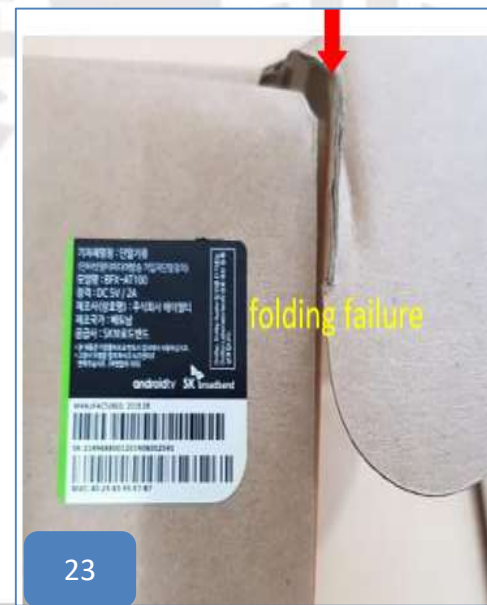
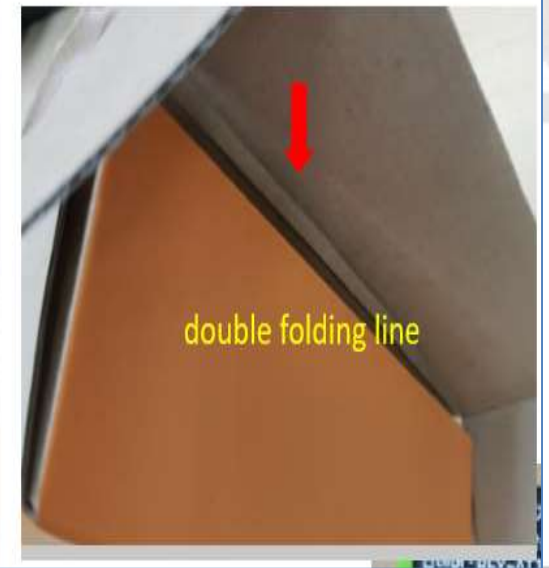
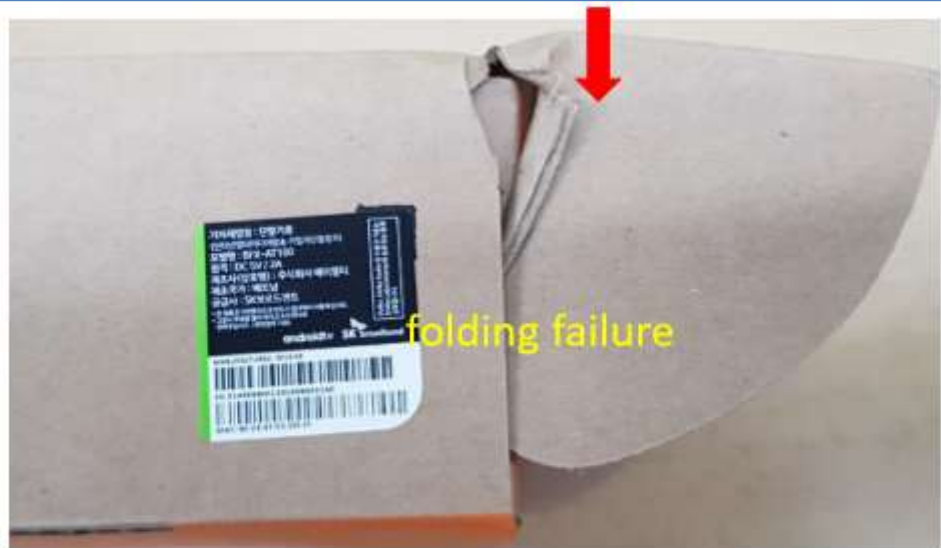
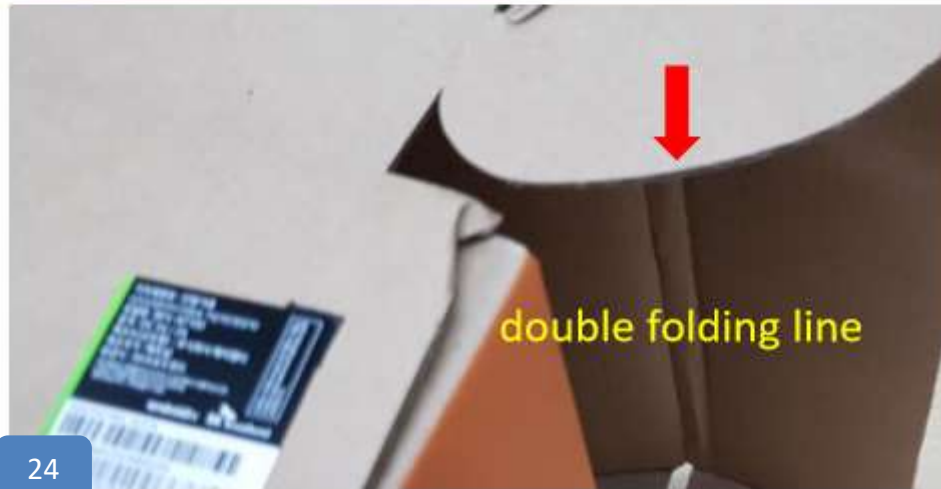
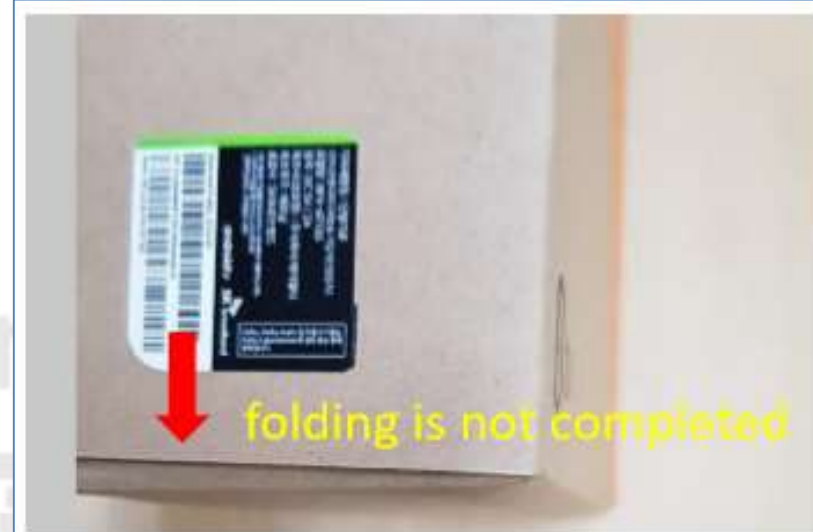
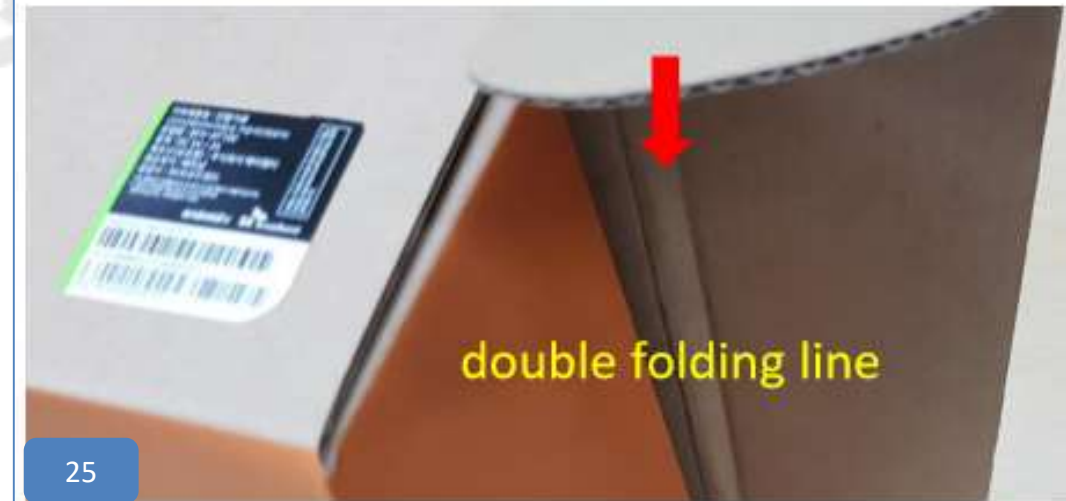
### 2.6. Giftbox defect

Defect q'ty: 6/500pcs

Defect rate: 1.2%

Root cause: Checked production history of this box and found out it was packed at line 8 (BFX-AT100 is run at line 7) at the middle of September when we added one more package line to push capacity for 51K. Operators of VI station being supported by the manpower resources from an other building so she was not acquainted with the job on the started time lead to forget put product into PE bag after checking cosmetic.

4.5.2.1. Pack box operator was performed by the support human resource so he did not fold carefully lead to make defect.

4.5.2.2. Through pictures, all defects were inside box at hide position after folding so we can not see these defects.

➤ According to pictures, defects are at hide positions after folding. These defects of pictures 22, 23, 25 are satisfy the criteria.

5.5.1. Showed and reminded all operators to pay attention to their operating and follow SOP. Operator at pack box and pack carton station need fold giftbox more carefully and recheck cushion sheet before packing carton to avoid missing.

5.5.2. Discussed with ME and PD to guide operator folding to avoid defects.

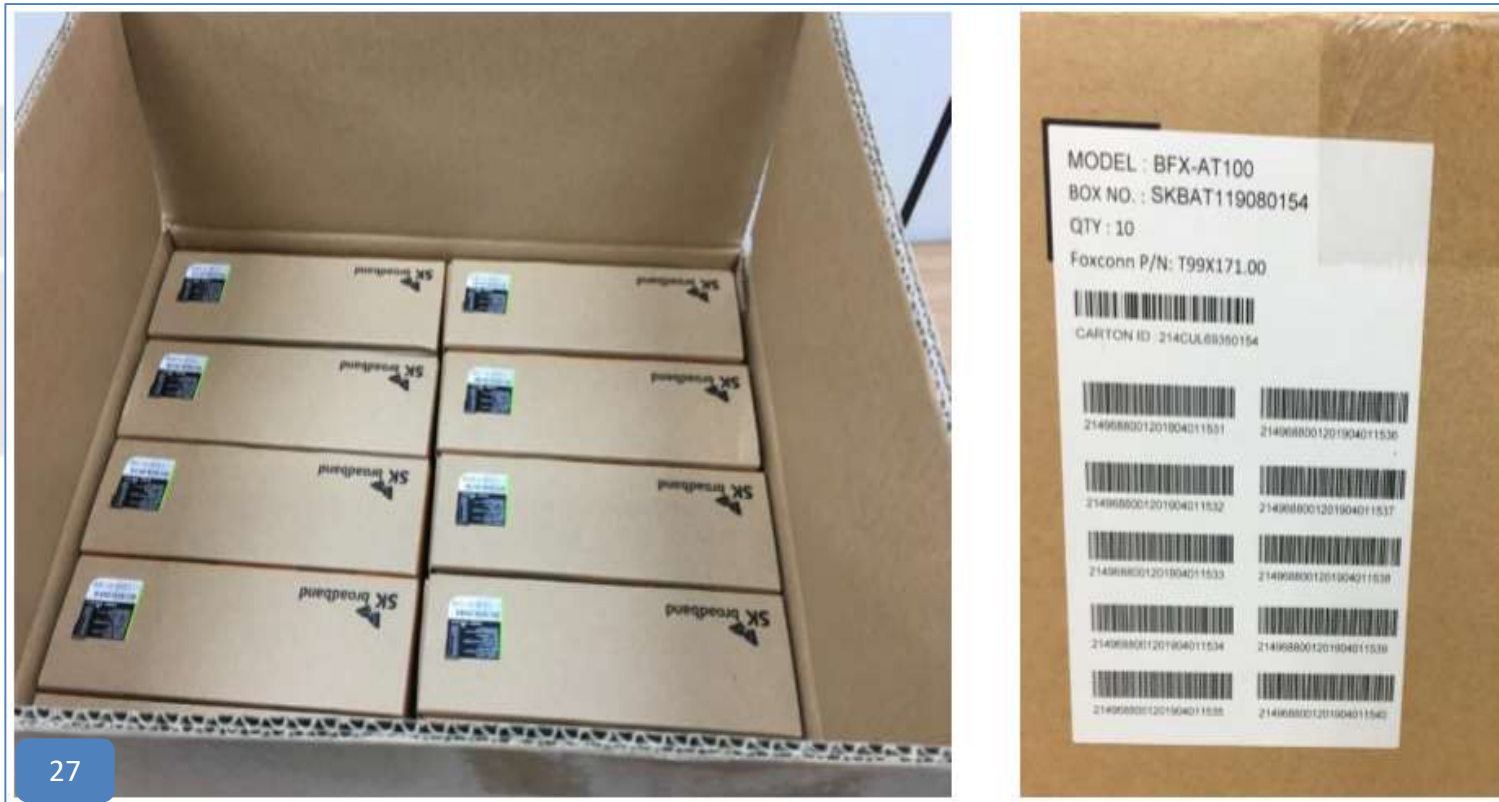
2.7. Carton defect (cushion carton sheet (Top) is missing inside carton box)

Defect q'ty: 1/500pcs

Defect rate: 0.2%

Root cause: Checked production history of this box and found out it was packed at line 6. Due to pushed capacity so production line took some cartons to line 6 for package and print carton label lead to forget put cushion sheet inside carton.

Escape cause: After pack carton, we can not see inside so defect escaped.

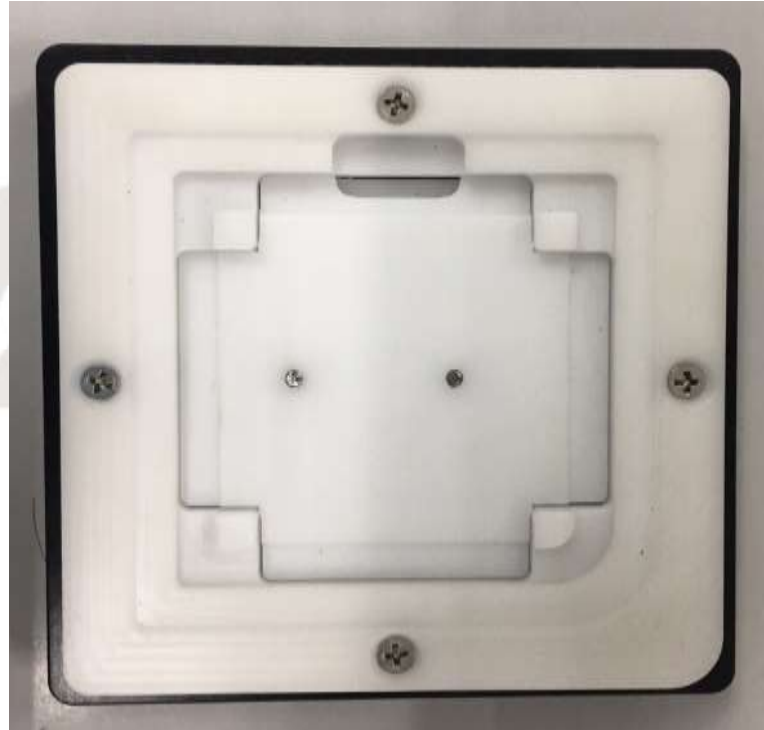
New fixture but not effective

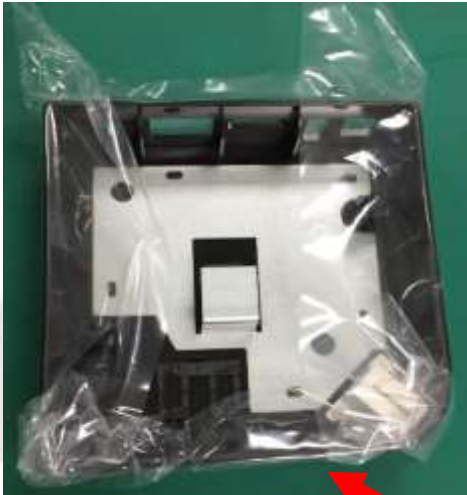
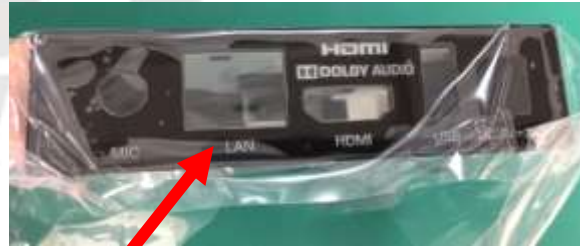
Old protective film is not customized without cutting connector hole

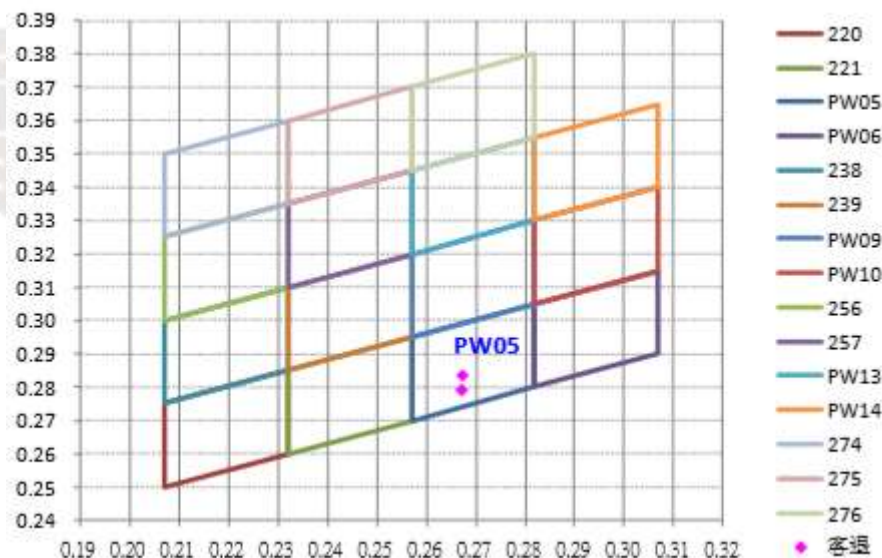
**Vendor report**

The result was the reddish LED belongs to PW05 bin code within CIE bin grading specification (see picture and vendor report below).
