## Returned Material Analysis Report (Final)

Returned Date : 2022/12/12QM Received Date : 2022/12/13QM Issued Date : 2022/12/21Customer : (弘憶)鴻海網通Part Number : RTL8211F-CGPackage Type : QFN-40

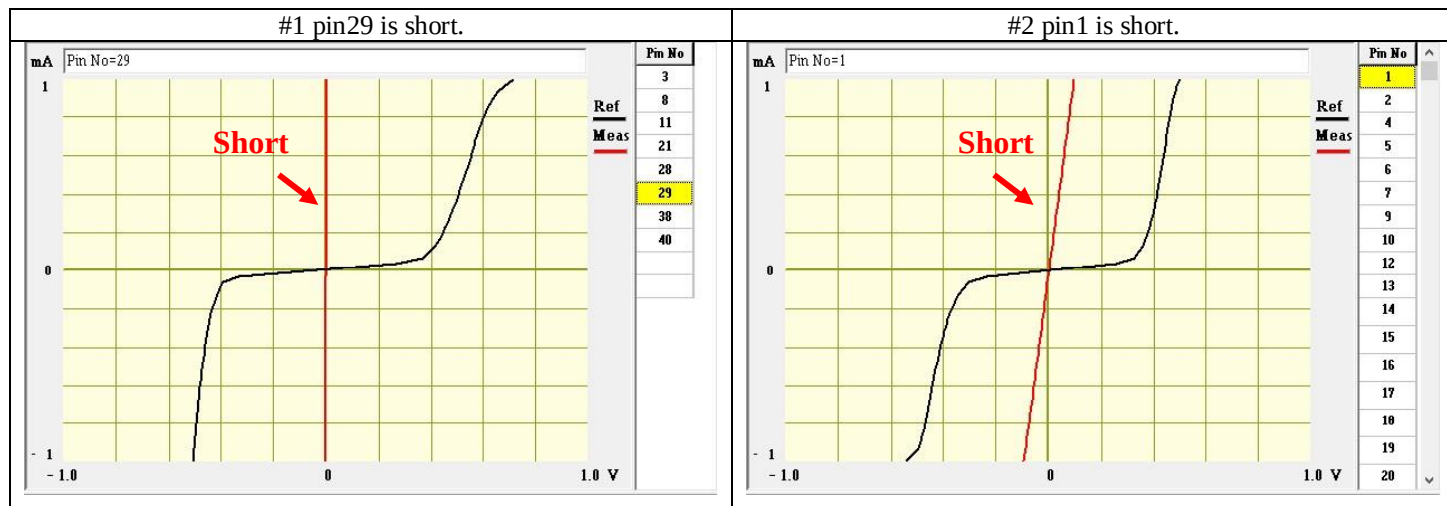
### Attachment 2 、 I-V Curves

- 1) [ ESD/EOS ] [ 100% ] All returned samples were damaged by ESD/EOS.

| No. | IV curve | Tester Verify |
|---|---|---|
| #1 | Short:3,8,9,11,29,30,40<br>Abnormal:10 | o/s fail |
| #2 | Short:1~3,8,10~12,21,28~30,40<br>Abnormal:9 | o/s fail |

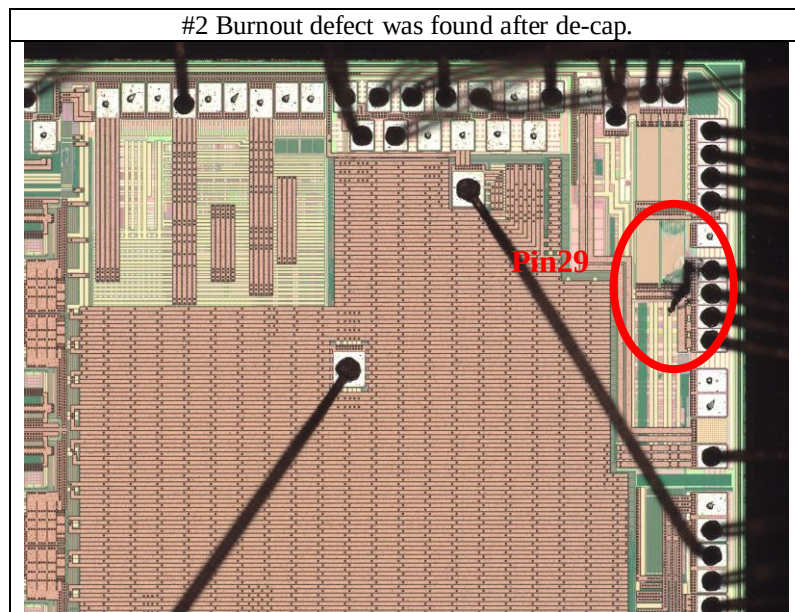
**Attachment 3 、 De-cap Photo**

- Definition : De-cap means removing the resin of sample to let IC be exposed that we could observe the IC from top view.
- Method : Use acid to etch the resin.
- Results : Decaping sample #2 burnout defect was found, please refer to attachment 3.

- Please check the application environment if any abnormal condition existed.
- Please check if the failure samples were produced from the same production line or operator.
