## 8D REPORT

| 客訴編號<br>Issue number | 8E191000014 | 客戶料號<br>Customer part number | NA |
| 機種<br>Model | 19-137/R6GHBHC/S1906/2T(HFX) | 批號<br>Lot number | 190821/190822/190907 |

19-137/R6GHBHC/S1906/2T(HFX) 8月至今出貨156K，為單機1pcs 用量，終端客戶的客戶發現偏紅色差，客戶廠內擺擺測反查10台機/批，發現廠內上件後30%偏紅，30%偏藍，客戶告知其電路生產未發生任何變更  
From Aug. 2019 till now, EL had delivered 156K pcs of “19-137/R6GHBHC/S1906/2T(HFX)” to End Customer. (Whole 156K pcs are loaded as a set for 1 Final Product.) End customer had found and reported the abnormalities of its color – Tend to RED. After 100% inspected the past 10 batches, 30% of the mounted devices were identified as “Tend to RED” and another 30% of the mounted units were identified as “Tend to Blue”. Customer insist that they do not have any change on their production.

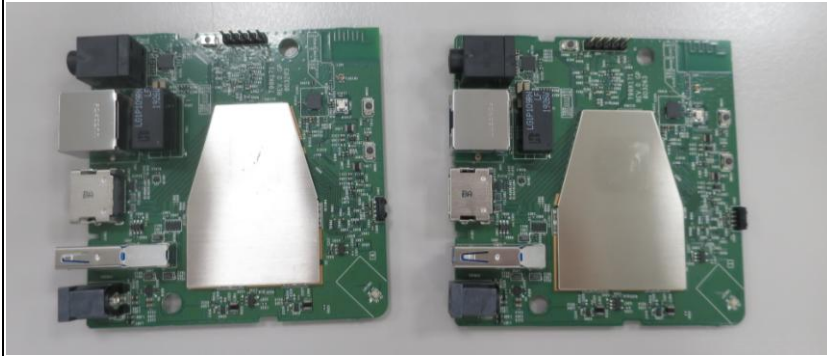
客戶提供 2 PCB

Customer provided 2 PCBs.

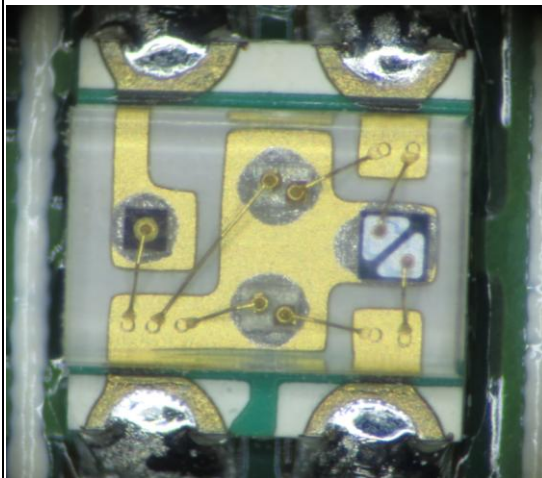
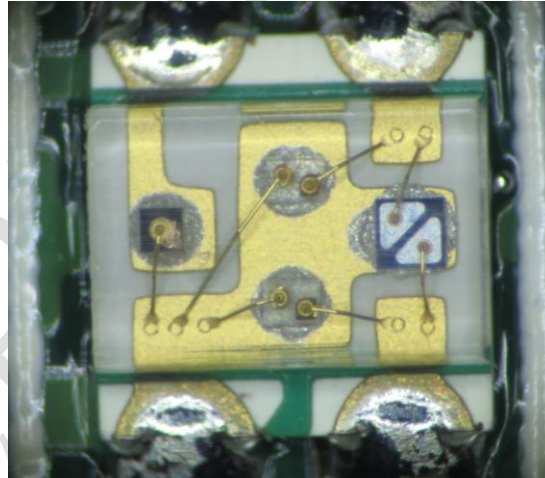
正常，無受損 The appearance of the returned units were normal.

PCB 1

PCB 2

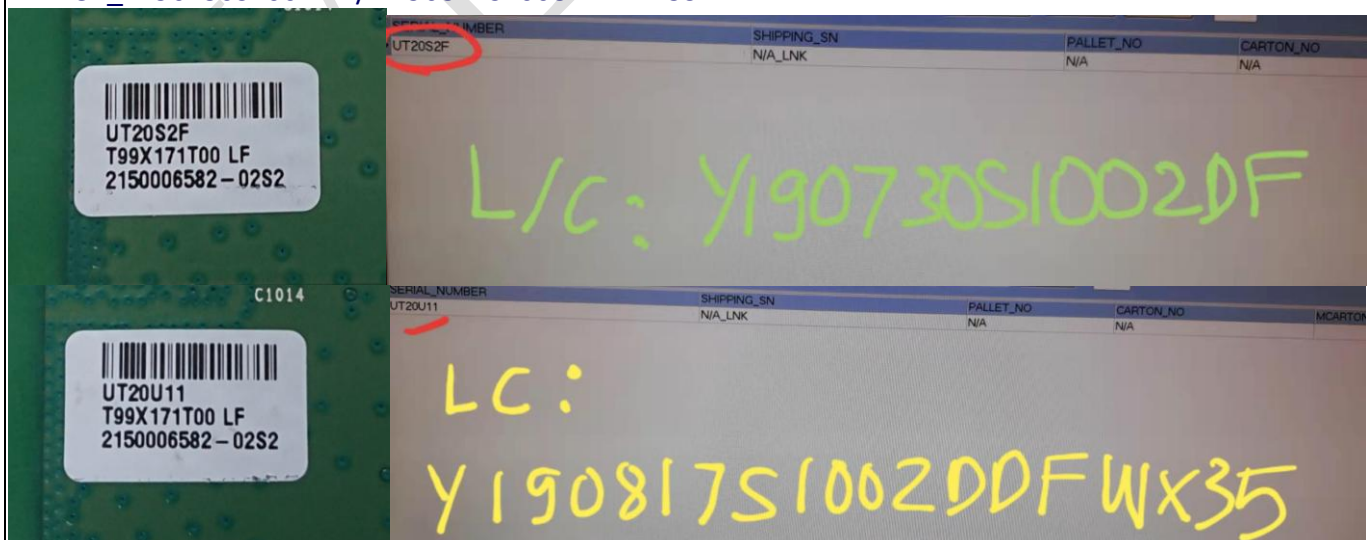
➤ 客戶反饋 2 片偏紅不良板上 LOT code，經客戶查詢屬於

EL LOT\_Y190730S1002DF / Y190817S1008DDFWX35

According to the LOT code of 2 issued PCBs (Tend to RED), we can retrieve the Lot Info. as

“EL LOT\_Y190730S1002DF / Y190817S1008DDFWX35”

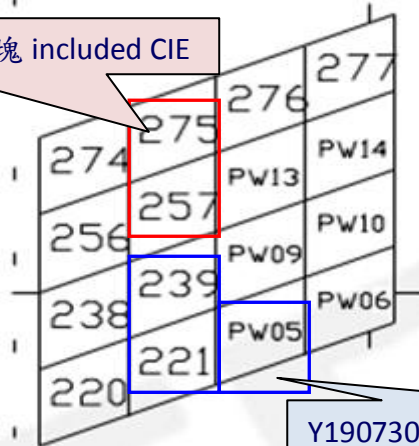
- 客退品經分析確認光電性均屬 PW05 色塊。Customer returned units were all identified as CIE "PW05".
- 客戶反饋不良板 LOT\_Y190730S1002DF 有 2 捲 PW05 色塊物料，且依客戶系統查詢 LOT\_Y190730S1002DF / Y190817S1008DDFWX35 上件時間是接續生產，因此可確定為客戶使用 PW05 色塊物料生產板子，造成與 275 色塊所生產板子發光顏色相較為偏紅。According to EL's shipping records, there were 2 reels of CIE "PW05" included in the reported Lot "Y190730S1002DF". And besides, according to customer provided SMT records, the Lot Y190730S1002DF & Y190817S1008DDFWX35 were consecutive production Lots. So that we can confirm the "Tend to RED" issue was came from the comparisons between the PCBs that mounted with CIE "PW05" & CIE "275".

Y190817S1008DDFWX35 出貨色塊 included CIE

Y190730S1002DF 出貨色塊 included CIE
