## 2023.02 Mass production inspection

Model Name: BFX-AT100

Document Version: ALT\_STB\_MP\_CSMTINS\_001

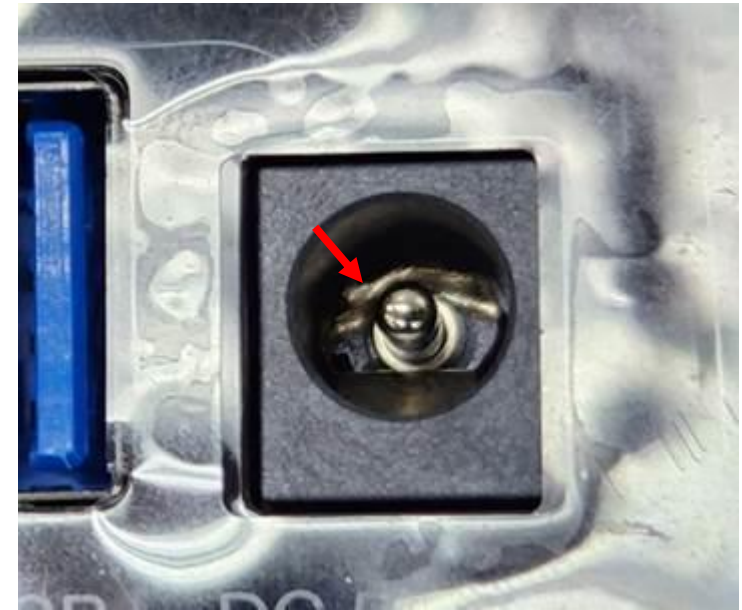
# Foreign object on DC connector

- Issue grade : Critical
  - Defect unit Q'ty : 1pcs / 1600pcs
  - SN :214968800120230125302
- Symptom
  - No power when fully inserted DC connector
- ALT initial review
  - Visual check : NG
  - Remove foreign object
  - ALT was assembled again.
- Action item
  - FXN should be submit 8D report
    - Find The root cause.
    - Find out what this object is and why it went in
    - Provide the preventive action

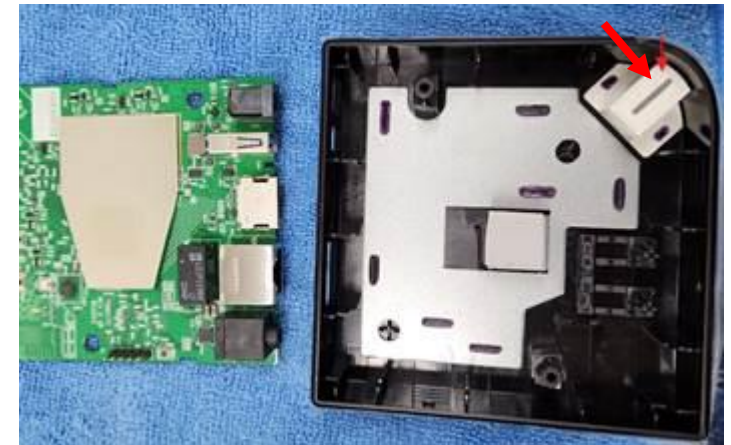
- Issue grade : Major
  - Defect unit Q'ty : 1pcs / 1600pcs
  - SN :214968800120230134831
- Symptom
  - LED light leakage when operation
- ALT initial review
  - Visual check : NG
  - The gasket was missing and Re attached gasket
  - ALT was assembled again.
- Action item
  - FXN should be submit 8D report
    - For short term solution
      - First find the filtering solution at FATP line
    - The root cause.
    - Provide the preventive action
