## 2023.02 Mass production inspection

Model Name: BFX-AT100

Document Version: ALT\_STB\_MP\_CSMTINS\_001

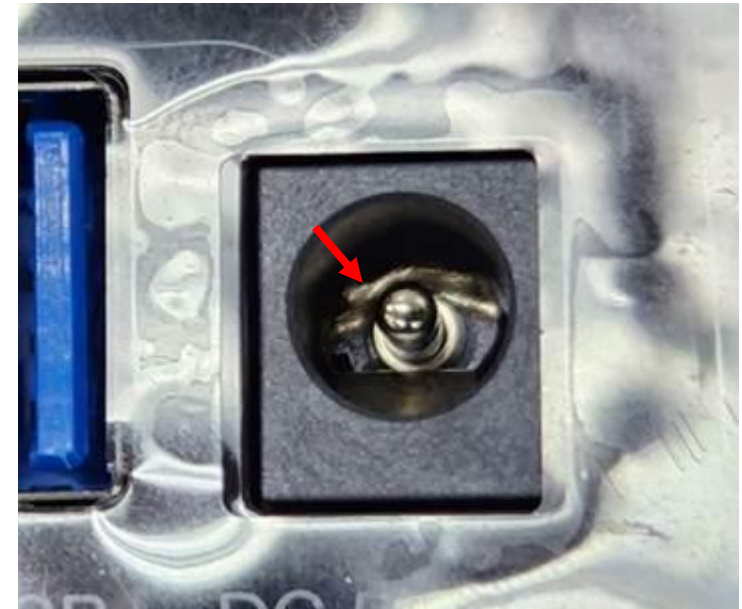
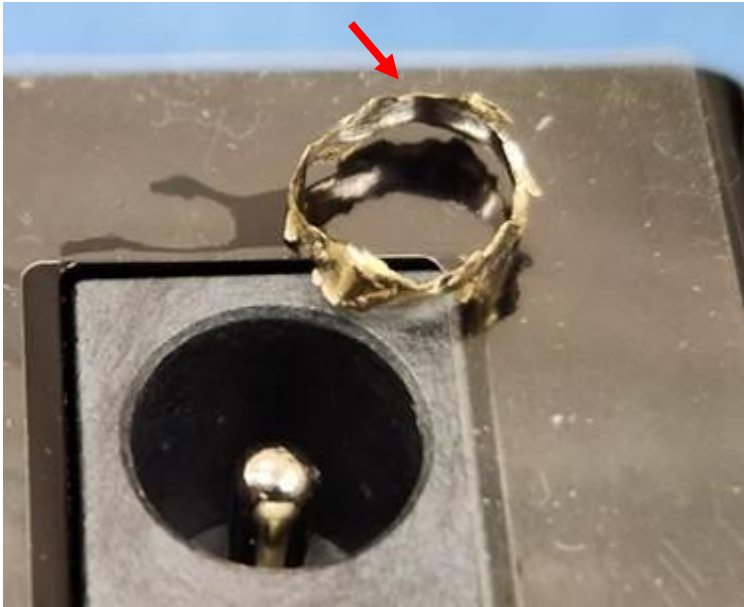
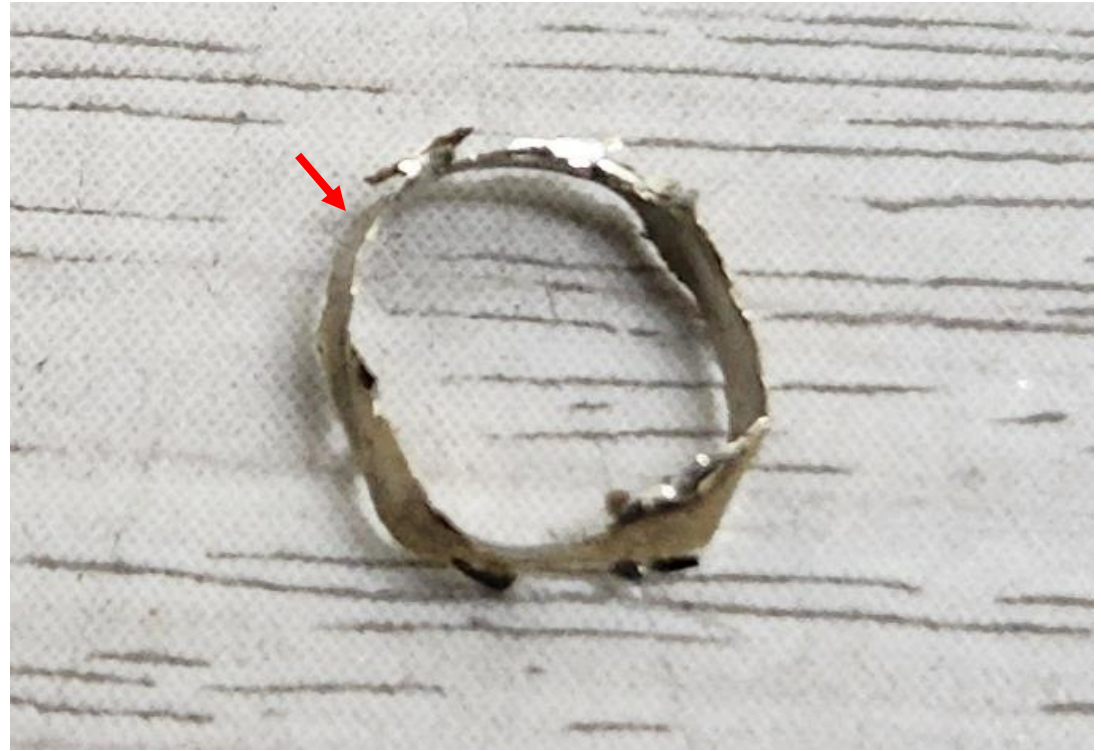
# Foreign object on DC connector

- Issue grade : Critical
  - Defect unit Q'ty : 1pcs / 1600pcs
  - SN :2149688001202301025302
- Symptom
  - No power when fully inserted DC connector
- ALT initial review
  - Visual check : NG
  - Remove foreign object
  - ALT was assembled again.
- Action item
  - FXN should be submit 8D report
    - Find The root cause.
    - Find out what this object is and why it went in
    - Provide the preventive action

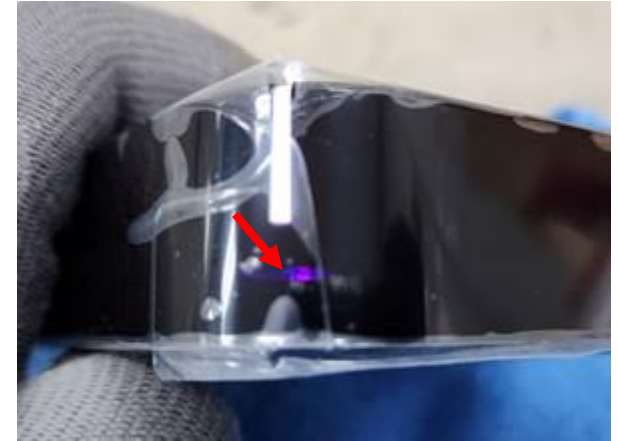
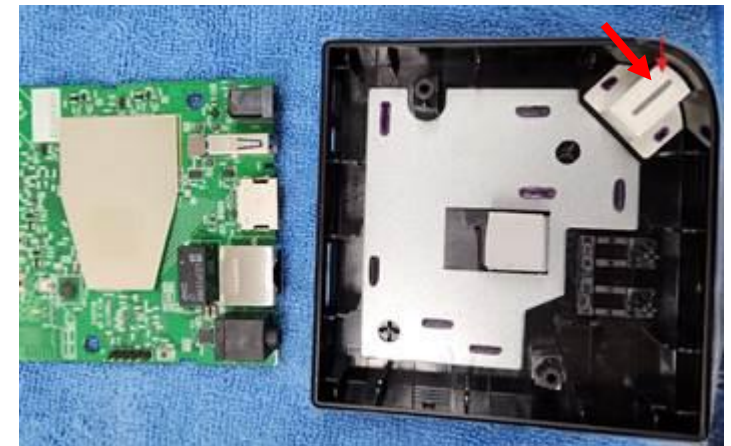
- Issue grade : Major
  - Defect unit Q'ty : 1pcs / 1600pcs
  - SN :2149688001202301034831
- Symptom
  - LED light leakage when operation
- ALT initial review
  - Visual check : NG
  - The gasket was missing and Re attached gasket
  - ALT was assembled again.
- Action item
  - FXN should be submit 8D report
    - For short term solution
      - First find the filtering solution at FATP line
    - The root cause.
    - Provide the preventive action

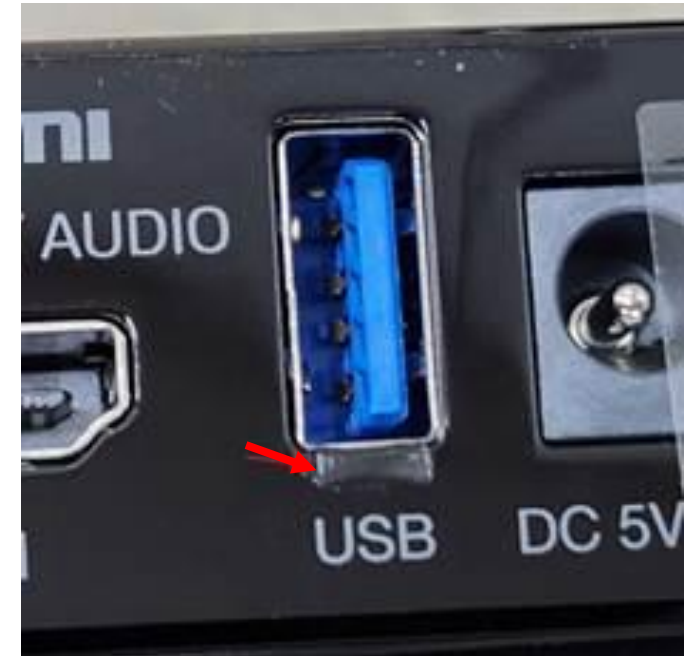
# Top housing damaged

- Issue grade : Major
  - Defect carton Q'ty : 1pcs / 1600pcs
  - SN : 2149688001202301024991
- Symptom
  - Physical damage on USB connector area
- ALT initial review
  - Checked exterior cosmetic : NG
  - Replace the TOP housing and re assembly
    - ALT was assembled again.
- Action item
  - FXN should be submit 8D report
    - Find the root cause : Add a detection process
    - Provide the preventive action
