## 8D REPORT

| 機種<br>Model | 19-137/R6GHBHC/S1906/2T(HFX) | 批號<br>Lot number | NA |
| 料號<br>Part number | S10B015513 | 批量<br>Lot size | NA |
| 客戶反應問題<br>Custom's Complaint | Color shift | | |

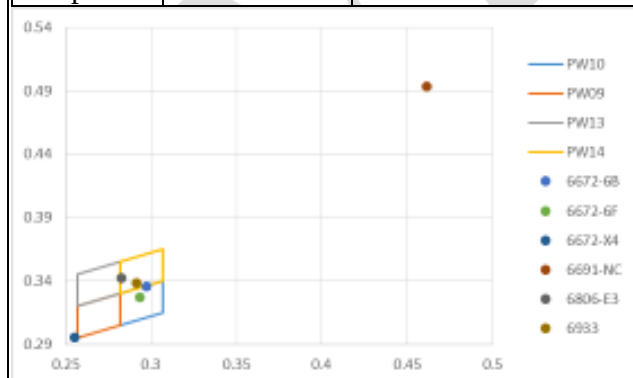
6691-NC CIE is not in the spec. 6672-Z0 is broken, can't be measured.

The blending brightness is all below the shipping Spec °

The red Mark part is out of specification.

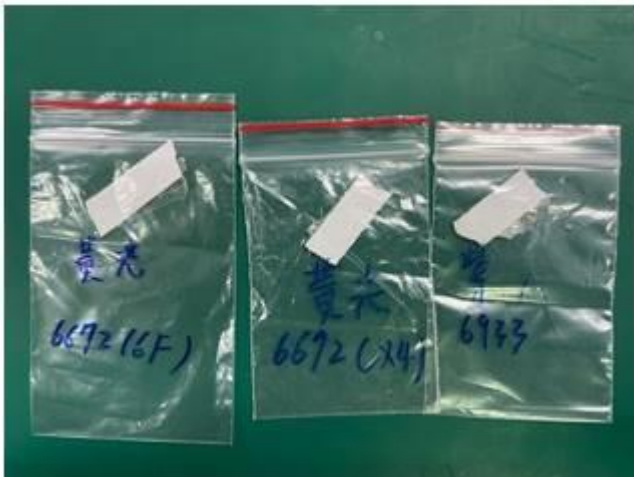
The customer (Everlight) provides an abnormal SMD sample of 3 eA. The appearance is as follows. Each SMD package contains an RGB chip and a Zener 1 eA each °

The surface of 6672(X4) was transparent, the surface of OG wafer N-pad had a more affectionate color, and the surface of 6672(6F) and 6933 samples was yellow °

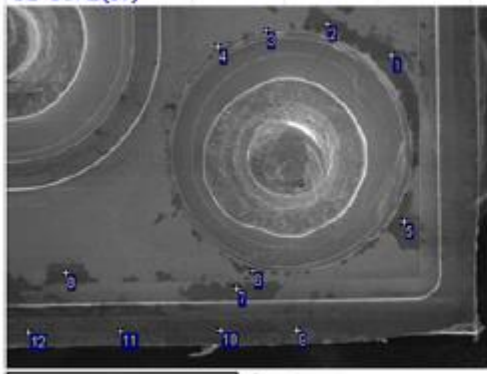
OB-6672(6F)

The wafer supplier (TXXXX) determines that there is no abnormality in the bare wafer °  
 3/19 Chip supplier EDX analysis:  
 After confirmation, there are faint bright Ag elements on the top of the wafer.

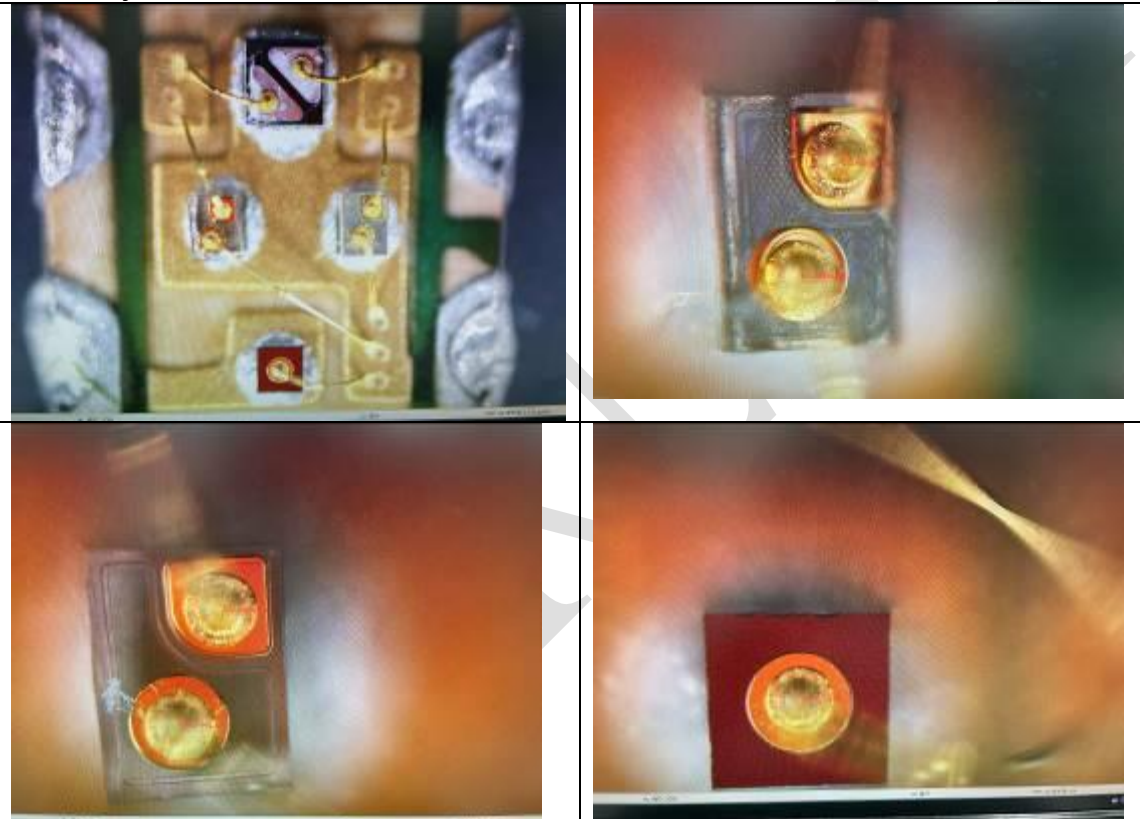
No abnormality was found after DE-CAP.

Bare crystal light to confirm the wafer condition:  
Light to confirm no electrical abnormality problem.

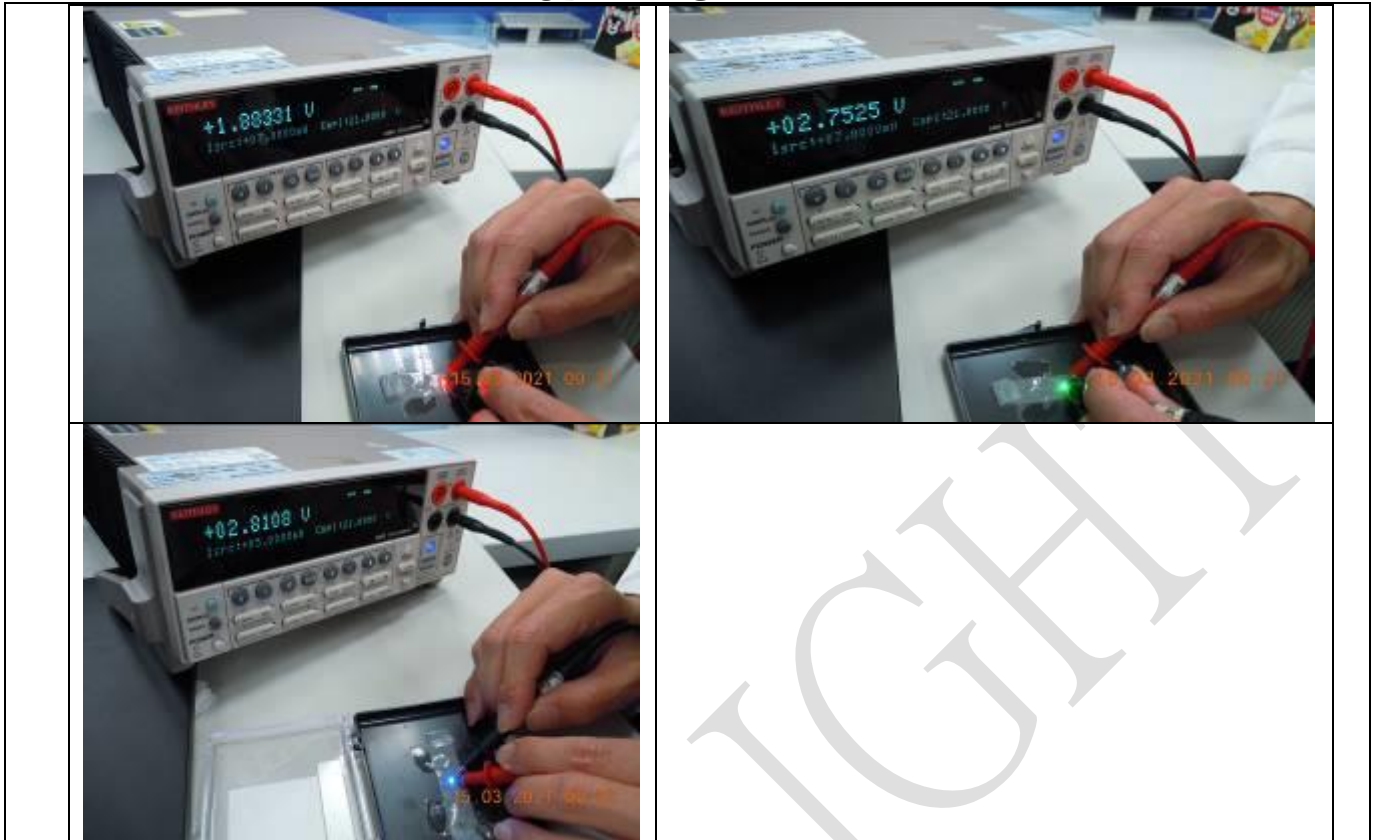
The 6806 cannot be measured because of the shift of wafer after DE-CAP/the broken wire by mistake.

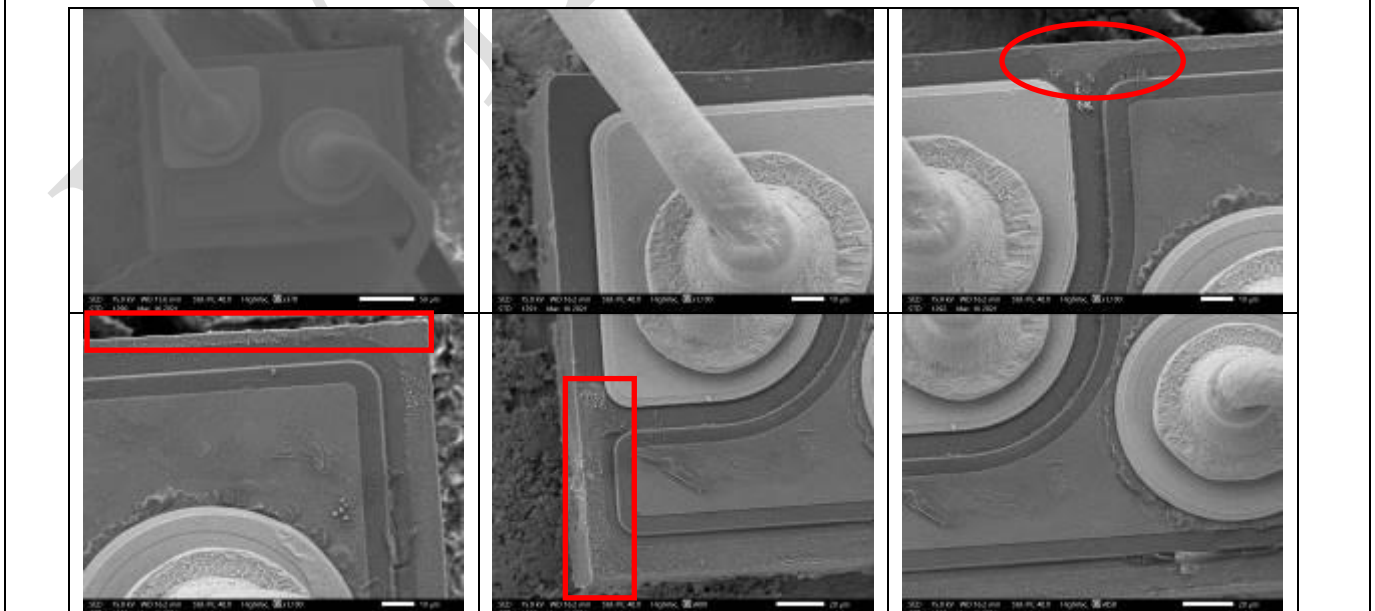
SEM(Scanning Electron Microscope)  
6672-6B:

Confirm suspected foreign body on red Mark on front of chip °

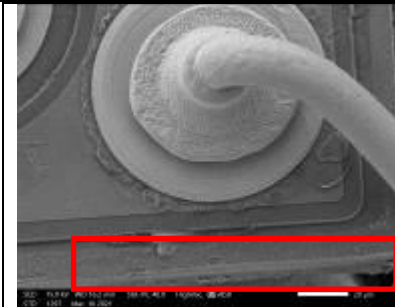
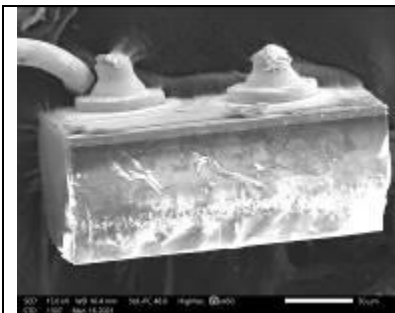
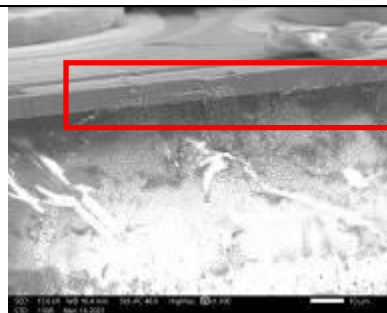
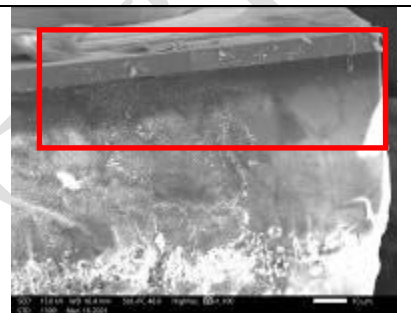
Suspected metal attachment on wafer side (red Mark) °

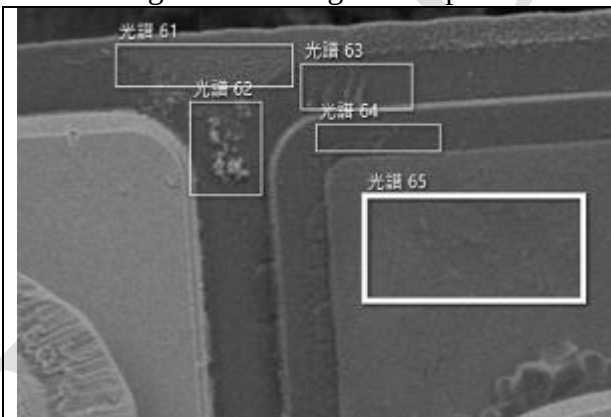
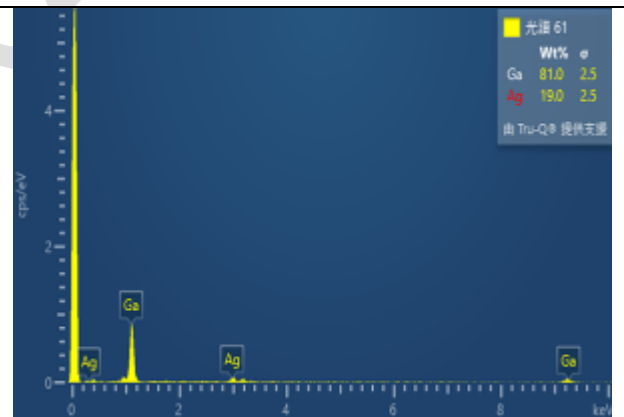
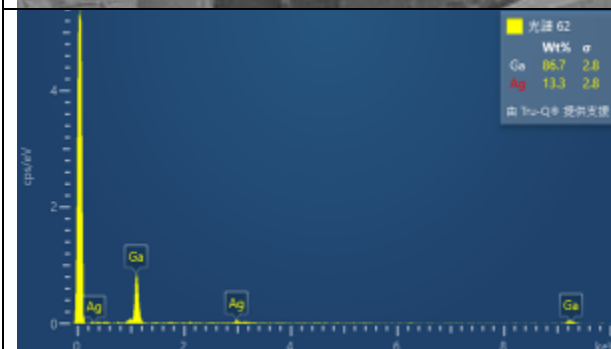
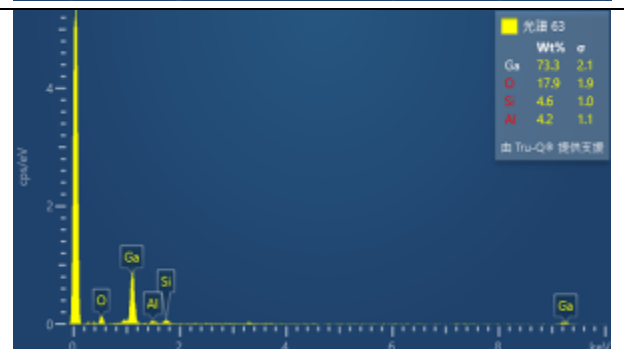
Ag, Ga, Si, Al, In after element confirmation; Among them, Ga, Al, In is the chip element /Si is the glue material /Ag is the silver glue composition.

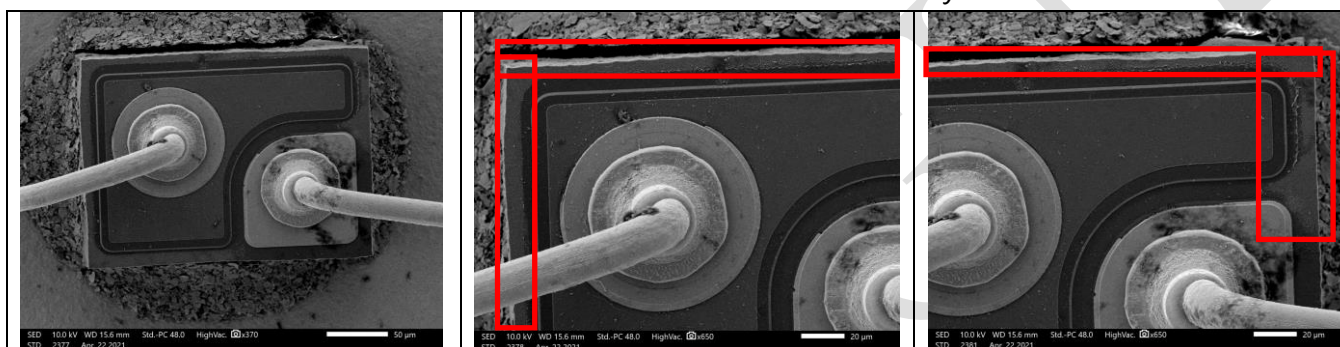
6691

The adhesion material around the wafer surface was observed by SEM.

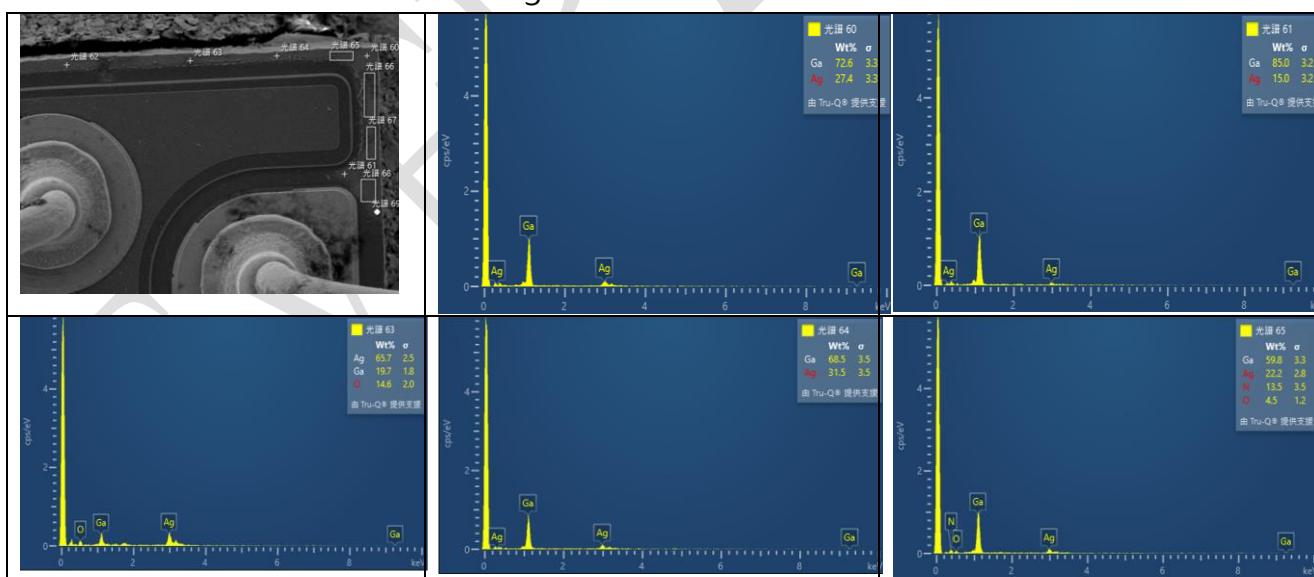
EDX confirmed the substance was Ag

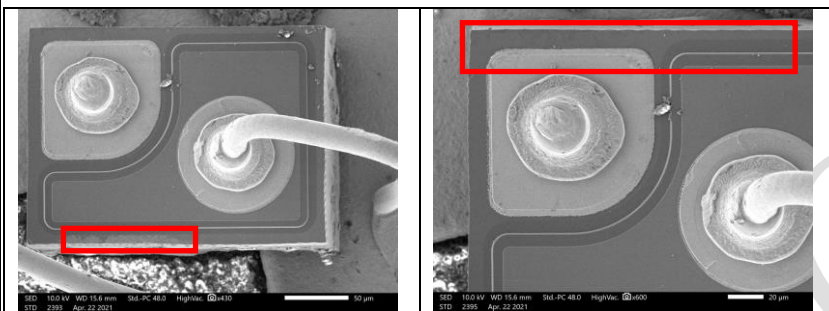
6806:

The adhesion material around the wafer surface was observed by SEM.

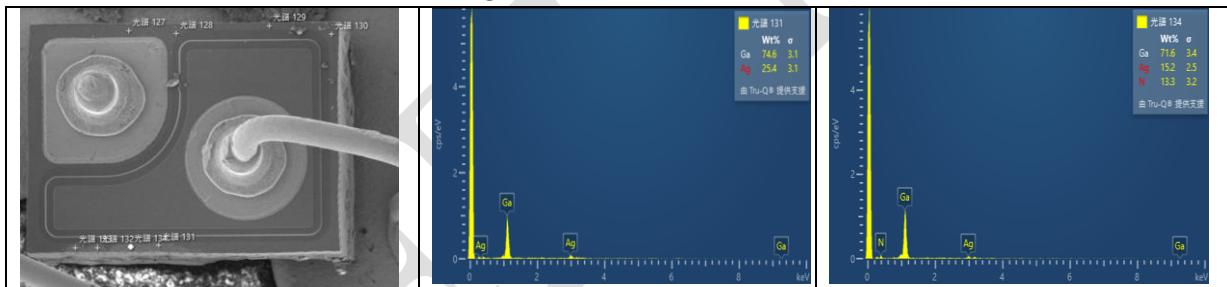
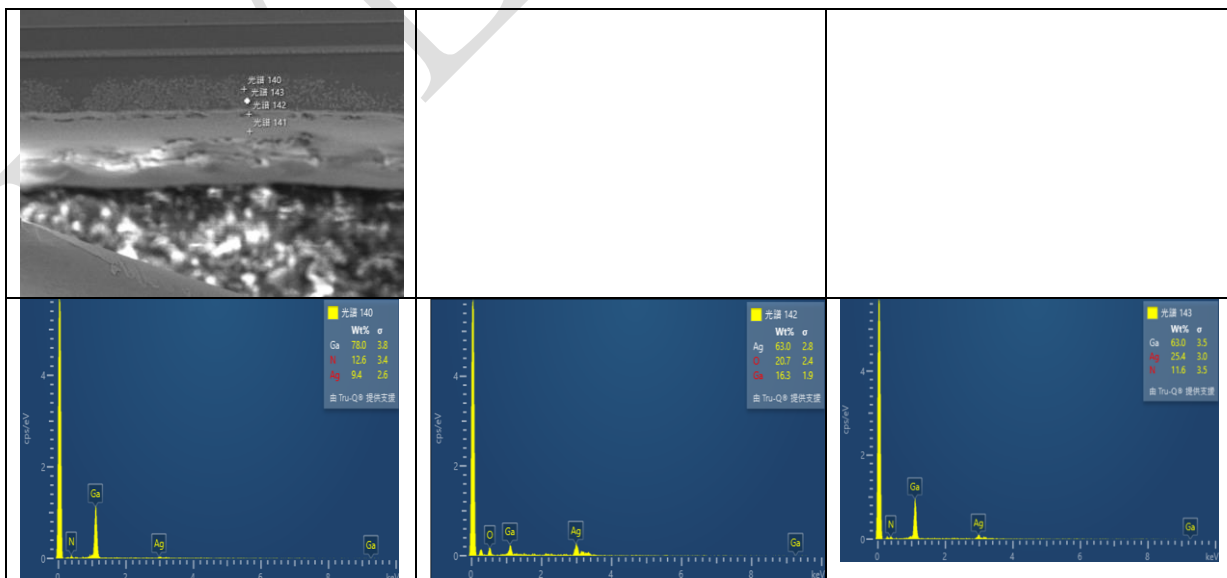
EDX confirmed the substance was Ag

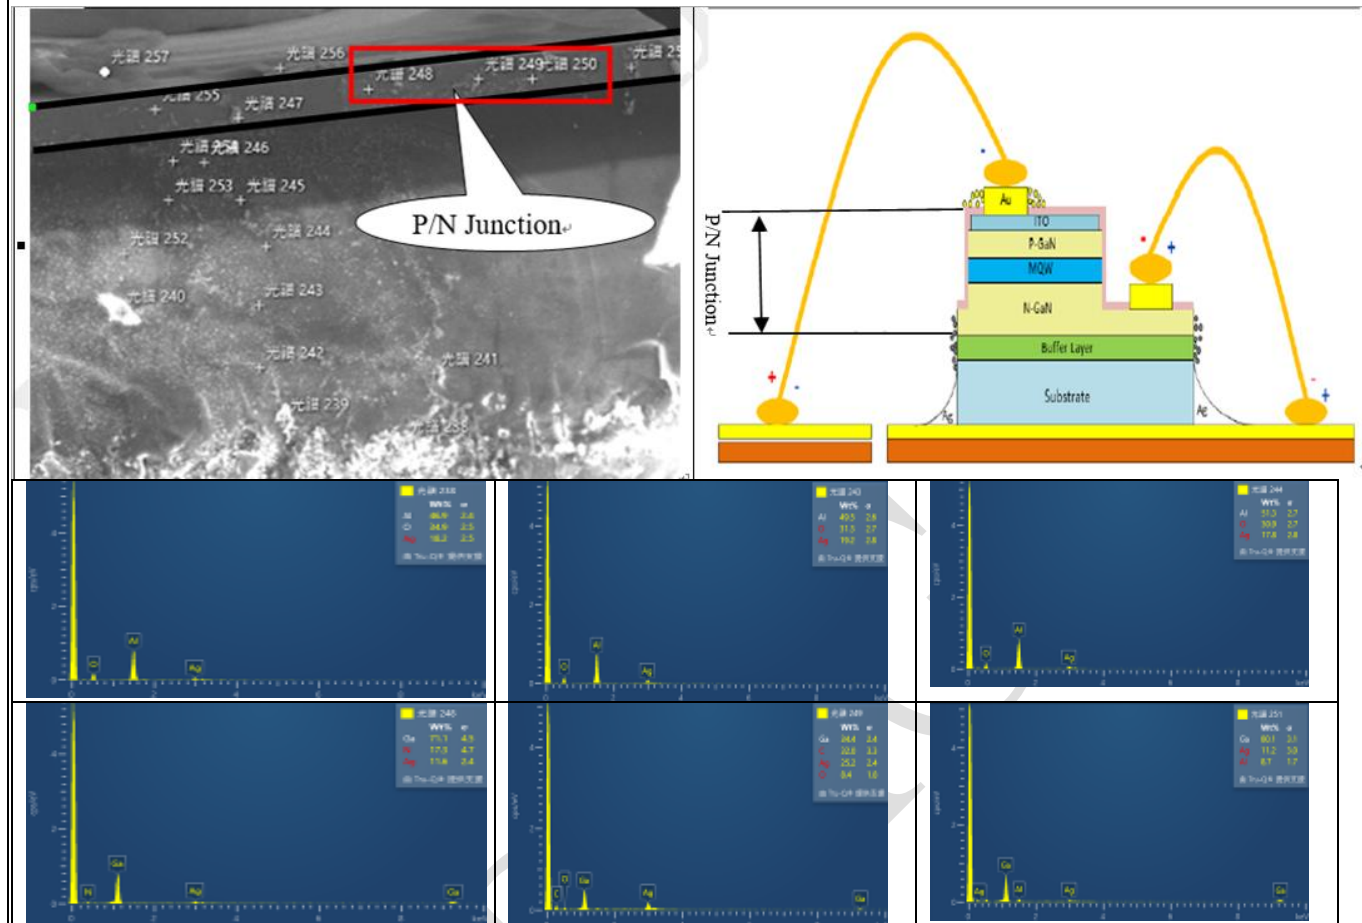
According to the results of EDX, the short circuit was caused by the adhesion of silver glue to the P/N Junction on the wafer surface.

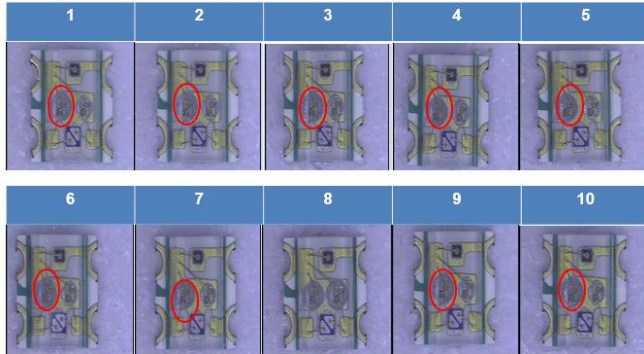
Take 10PCS for analysis and measurement to confirm the appearance as follows:  
Blue chip bottom glue amount is more than green chip (No.8  
blue/green chip bottom glue amount is No difference

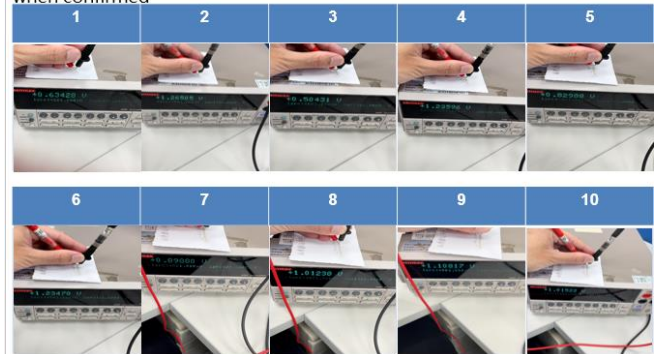
Take 10PCS for analysis and measurement to confirm the value of 1uA as follows:  
Small current (1uA) of materials numbered 1 to 10 were all lower than 2V  
when confirmed

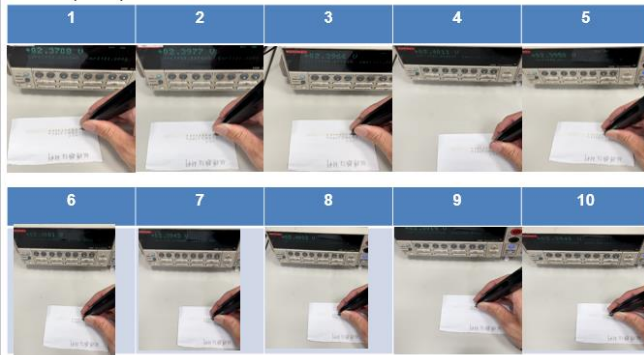
Take 10PCS for analysis and measurement to confirm the values of 10uA as follows:  
No short circuit electrical property was found under the confirmation of low  
current (10uA) of materials numbered 1-10.

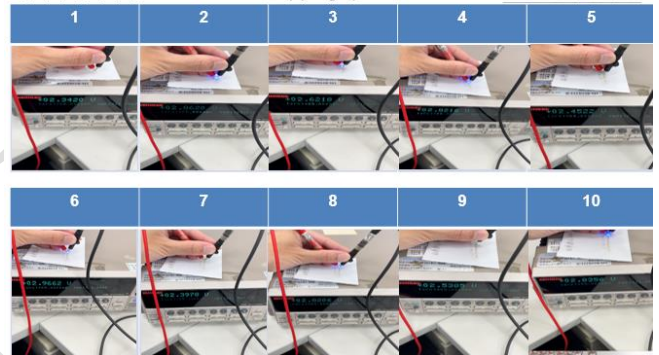
Take 10PCS for analysis and measurement to confirm the values of 5mA as follows:  
2/3/4/5/6/8/9/10 in line with shipping specifications

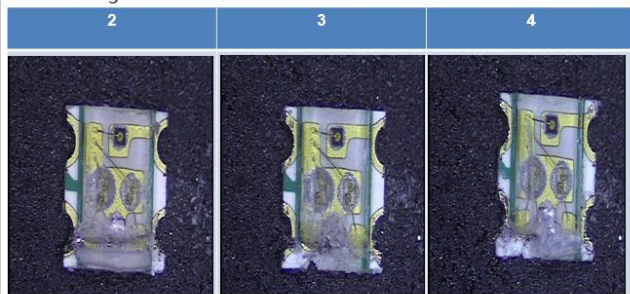
Take 3pcs of them and cut off the Zener gold wire. Appears:

Cut off the gold wire inside the material.

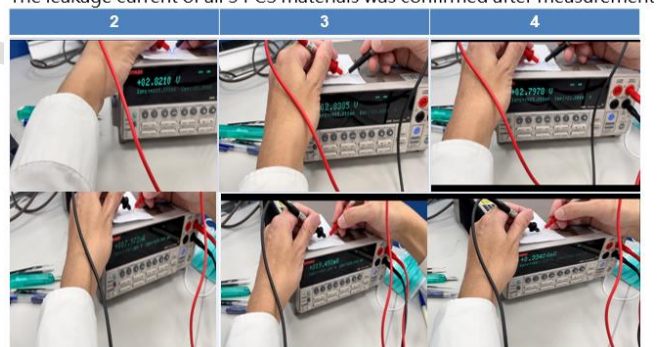
Take 3pcs of them and cut off the Zener gold wire to test the forward voltage  
and leakage current:

The leakage current of all 3 PCS materials was confirmed after measurement
