# ***8D report for top cover(T99X171) printing shift issue***

***Prepared by: NWEII QE***

***Issue Date: 2019/7/03***

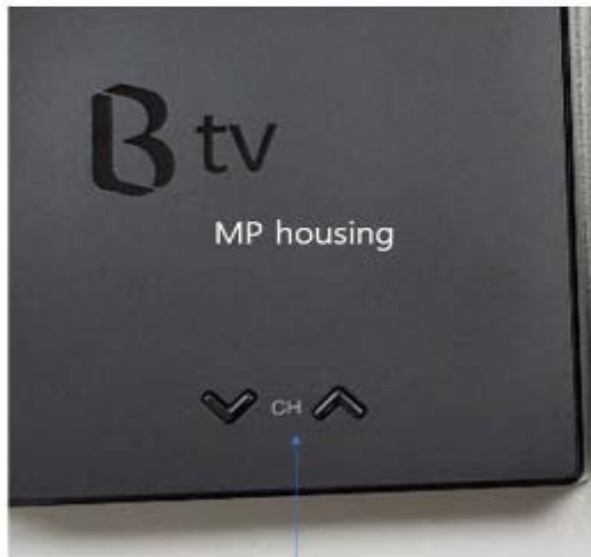
On 2019/6/25 Customer reported The printing letter” CH” shift to right side for T99X171 top cover. Please refer to below photo.

'CH' printing location is little bit shifted to rightward

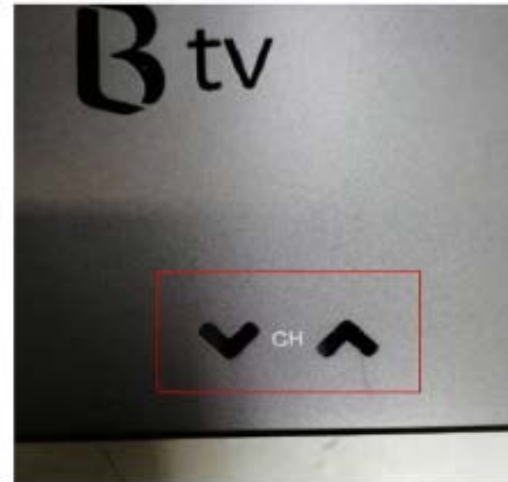
Confirmed the picture of improved issue before (6/13)

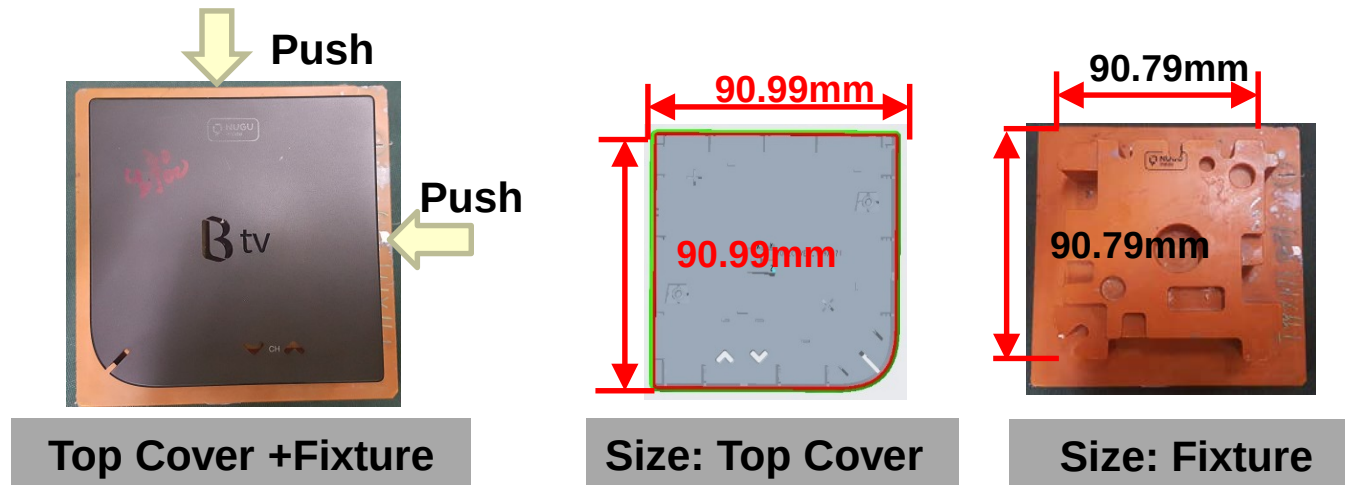
The printing fixture design is based on inside dimension of Top Cover to reduced by 0.2mm, causing the Top cover can be move and rotate slightly on fixture, as figure.

Actual move value(push cover on X/Y axis):

X direction: Max.0.4mm

Y direction: Max.0.4mm

**According to the analysis, the top cover can not be fixed on fixture. It can be moved about 0.4mm on the X/Y direction ,and tolerance on drawing: +/-0.2mm.**

**Therefore, the fixture caused this issue.**

According to datum of Top Cover drawing to redesign the fixture, half of the fixture is changed into a spring structure to ensure that Top Cover is fixed on fixture and zero gap between Top cover and fixture.
