## 8D REPORT

| Issue number | 20210220-1 | Customer part number | NA |
| Model | 19-137/R6GHBHC/S1906/2T(HFX) | Lot number | NA |
| Custom's Complaint | Color shift | | |

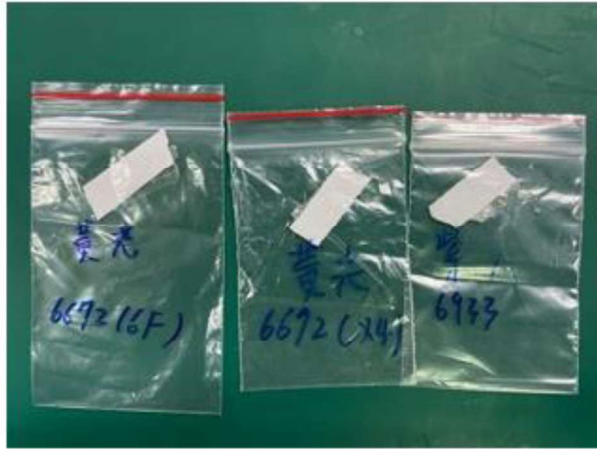
The customer (Everlight) provides an abnormal SMD sample of 3 eA. The appearance is as follows. Each SMD package contains an RGB chip and a Zener 1 eA each °

The surface of 6672(X4) was transparent, the surface of OG wafer N-pad had a more affectionate color, and the surface of 6672(6F) and 6933 samples was yellow °

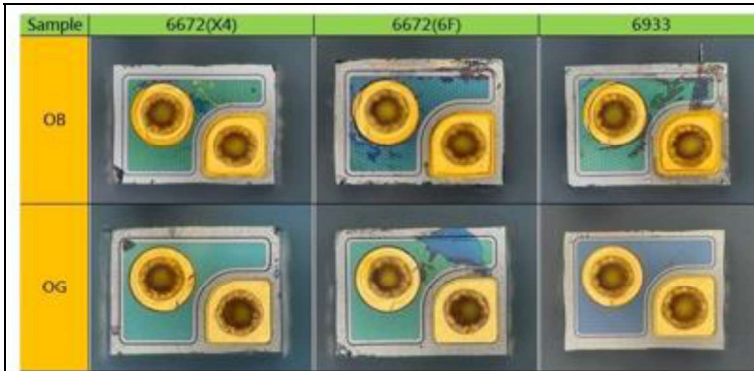
After chemically de-caping the sample, OB/OG wafers were removed and the appearance was examined by microscope as follows. Except for part of the residue, no obvious abnormality was found in the naked crystal appearance after disassembly, and no darker color was observed on the electrode surface before disassembly °

After the bare crystal was tested by our company's automatic testing machine, the voltage was within the normal specification range, and there was no high leakage problem, so it was determined that there was no failure of the chip itself °

Analysis :The wafer supplier (TXXXX) determines that there is no abnormality in the bare wafer °

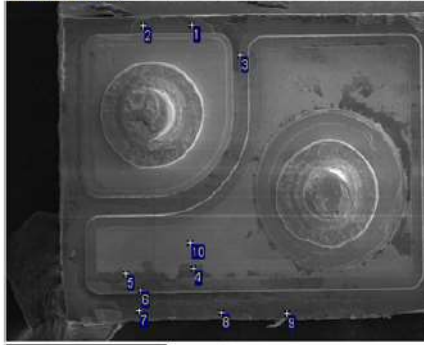
OB-6672(6F)

After confirmation, there are faint bright Ag elements on the top of the wafer.

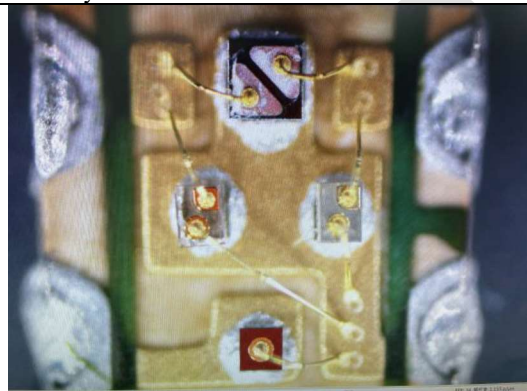
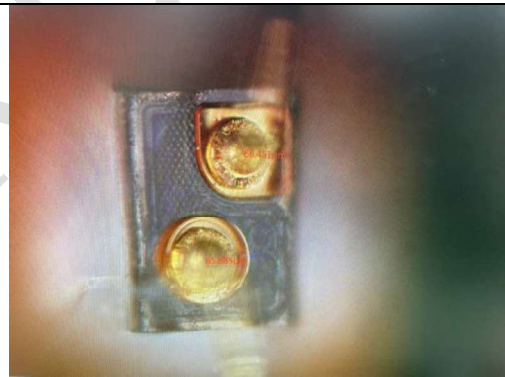
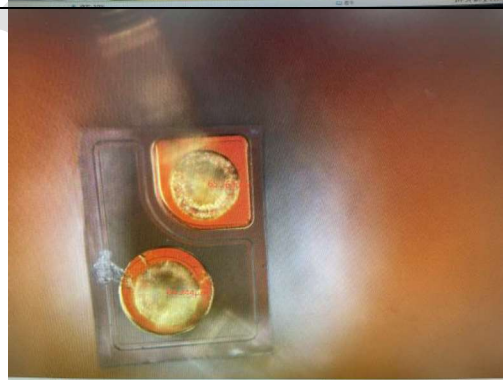
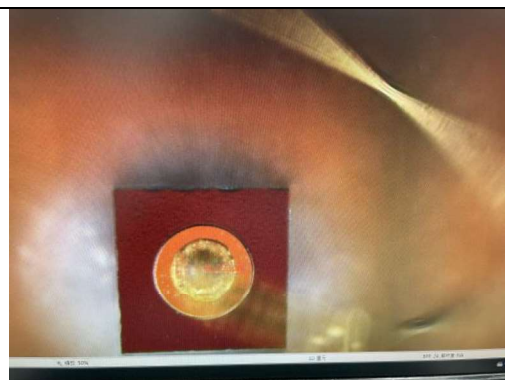
No. 6672-6B Conditions after removal of glue:  
No abnormality was found after DE-CAP.

5. After selecting 6672-6B, the internal situation was confirmed and no abnormality was found.

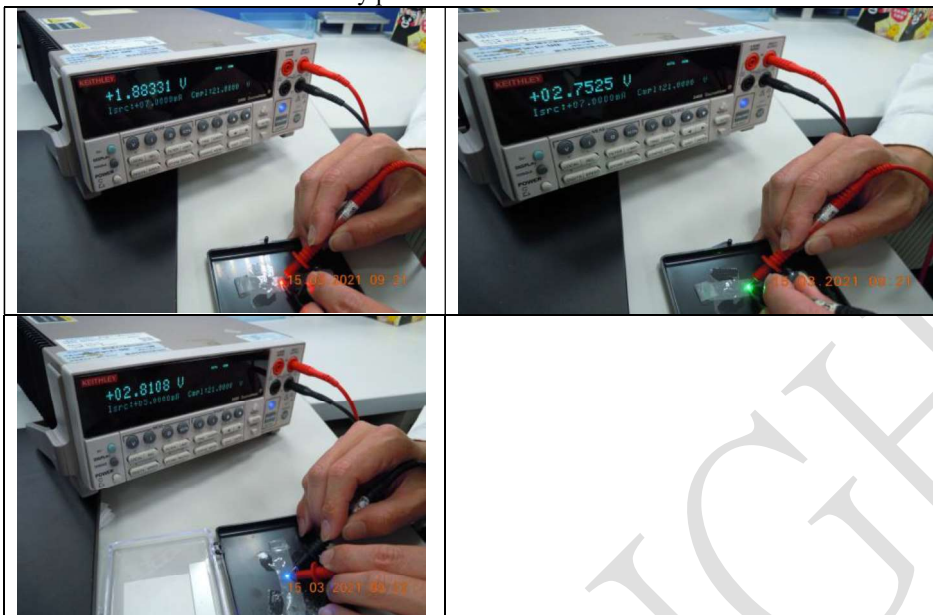
Bare crystal light to confirm the wafer condition:  
Light to confirm no electrical abnormality problem.

6. The electrical properties of bare crystal were not abnormal.

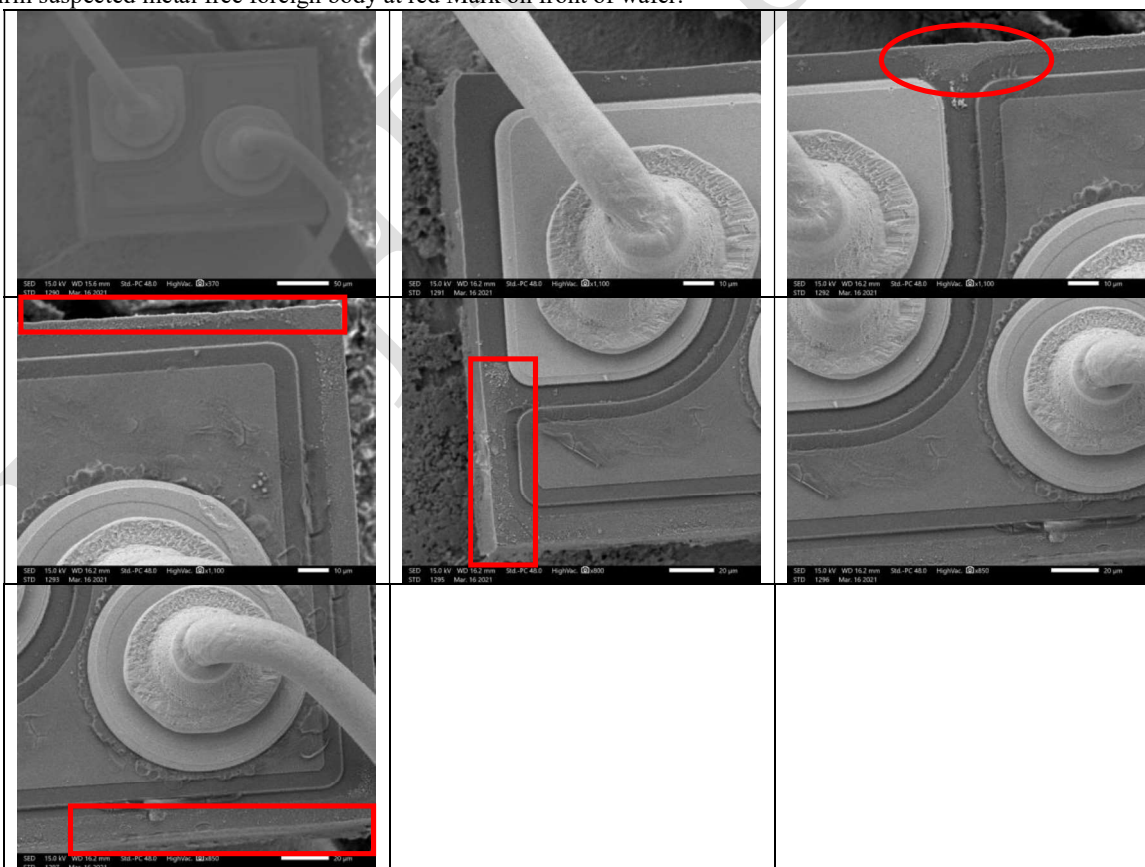
SEM(Scanning Electron Microscope):  
Confirm suspected metal free foreign body at red Mark on front of wafer.

7. SEM(Scanning Electron Microscope) showed suspected metal dissection in the front and side of the chip.

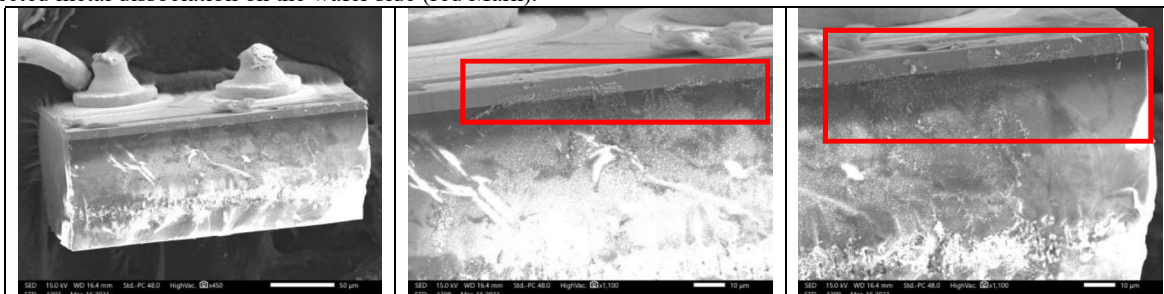
Suspected metal dissociation on the wafer side (red Mark).

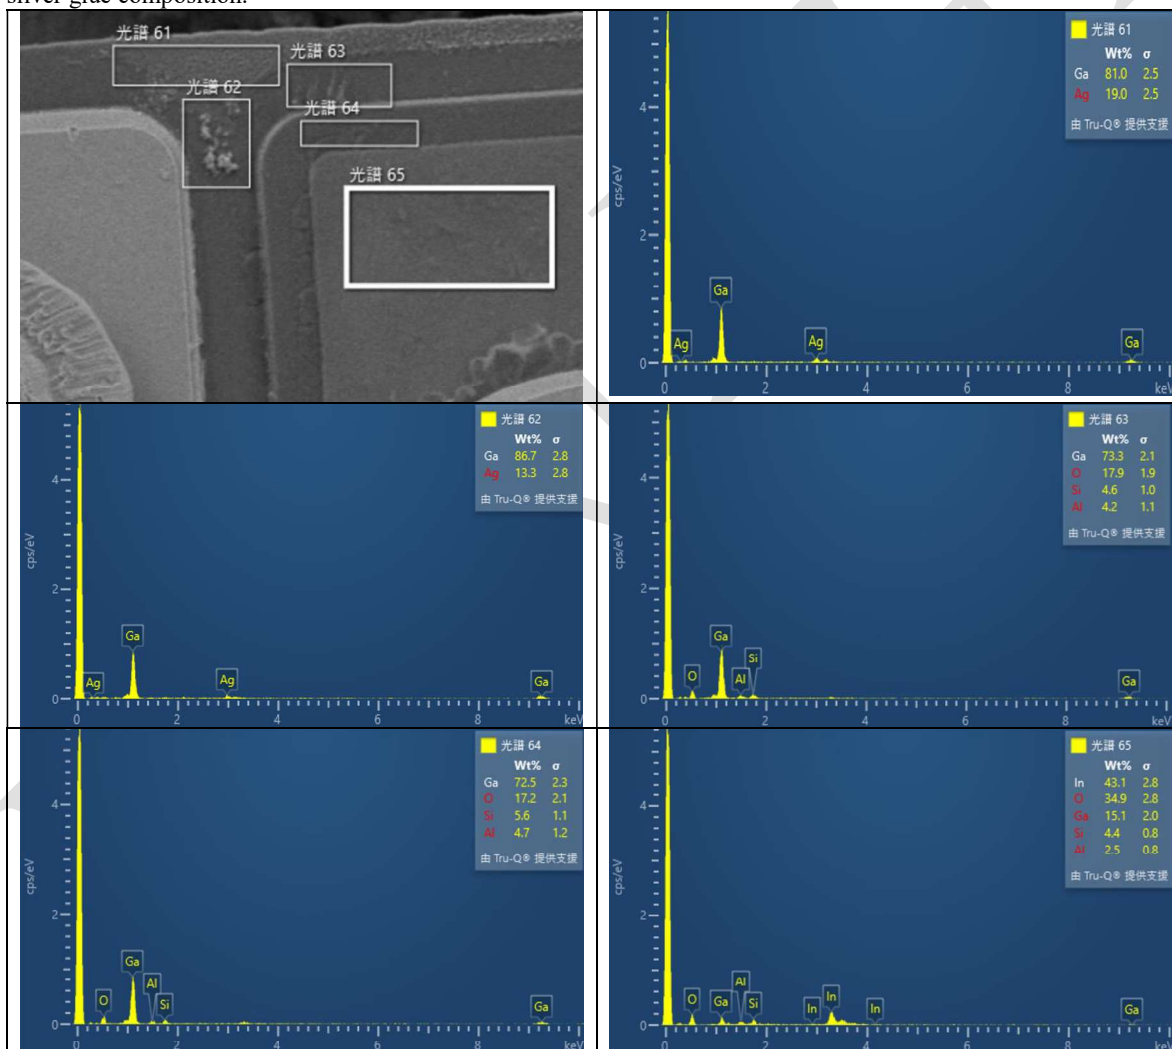
EDX(Energy-dispersive X-ray spectroscopy):

Ag, Ga, Si, Al, In after element confirmation; Among them, Ga, Al, In is the chip element /Si is the glue material /Ag is the silver glue composition.

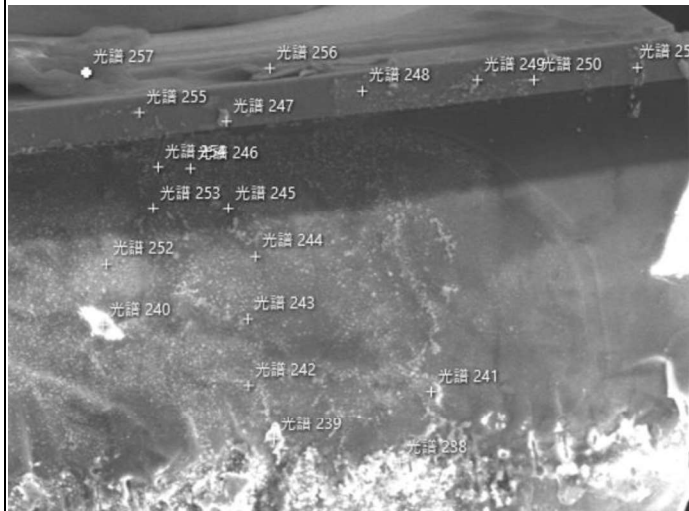
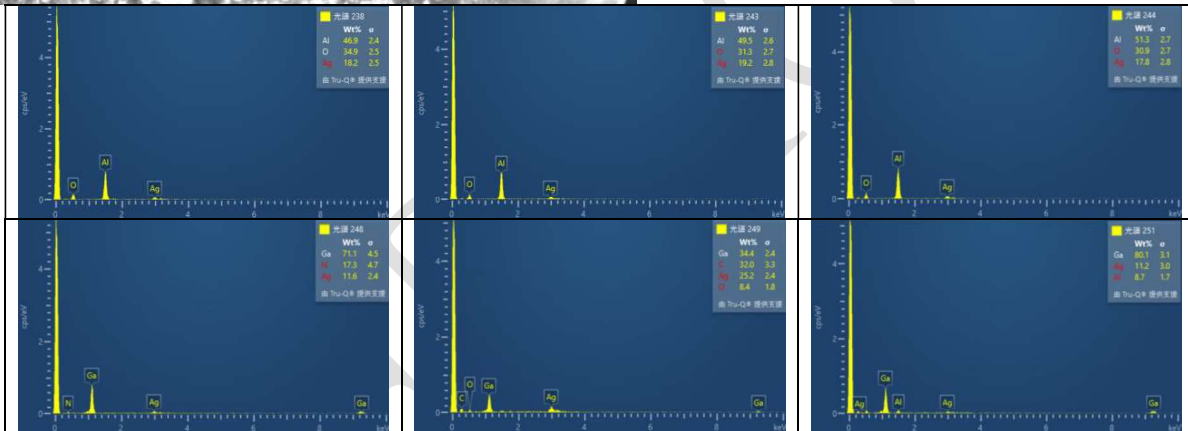
Chip side EDX(Energy-dispersive X-ray spectroscopy):

According to the results of EDX, the silver glue has disintegrated into the P/N Junction on the wafer surface, causing a short circuit.

8. The substance was confirmed by EDX(Energy-Dispersive X-Ray Spectrometry), which was confirmed to be caused by the disaggregation of silver glue to the surface of the wafer

(9) Ag migration on the surface/side of the chip is the electric field effect caused by the long time moisture absorption of the packaging glue and the reverse voltage, which results in the short circuit phenomenon of P/N junction LED caused by Ag migration °

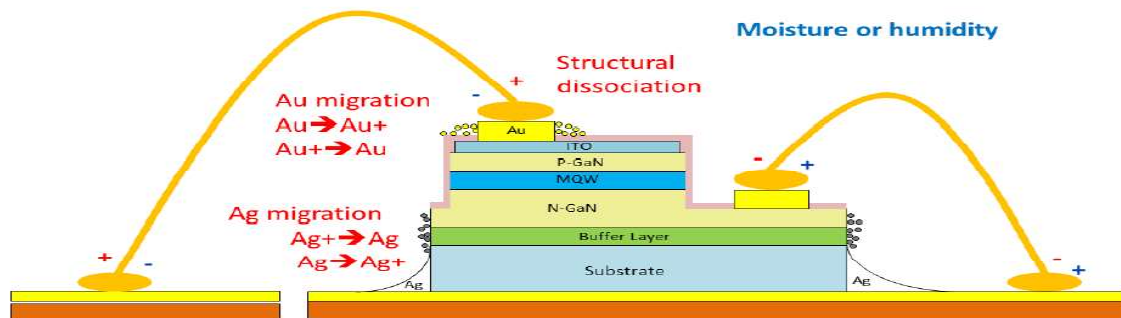
Ag Migration principle:

LED material is driven forward. When the reverse current and voltage are applied, the silver in the silver glue will be disintegrated in the form of positive ions.

It creates an environment similar to electroplating.

When the current/voltage is applied off, the silver colloidal cation migrates or precipitates along the electric field path. And then you see Ag migration.

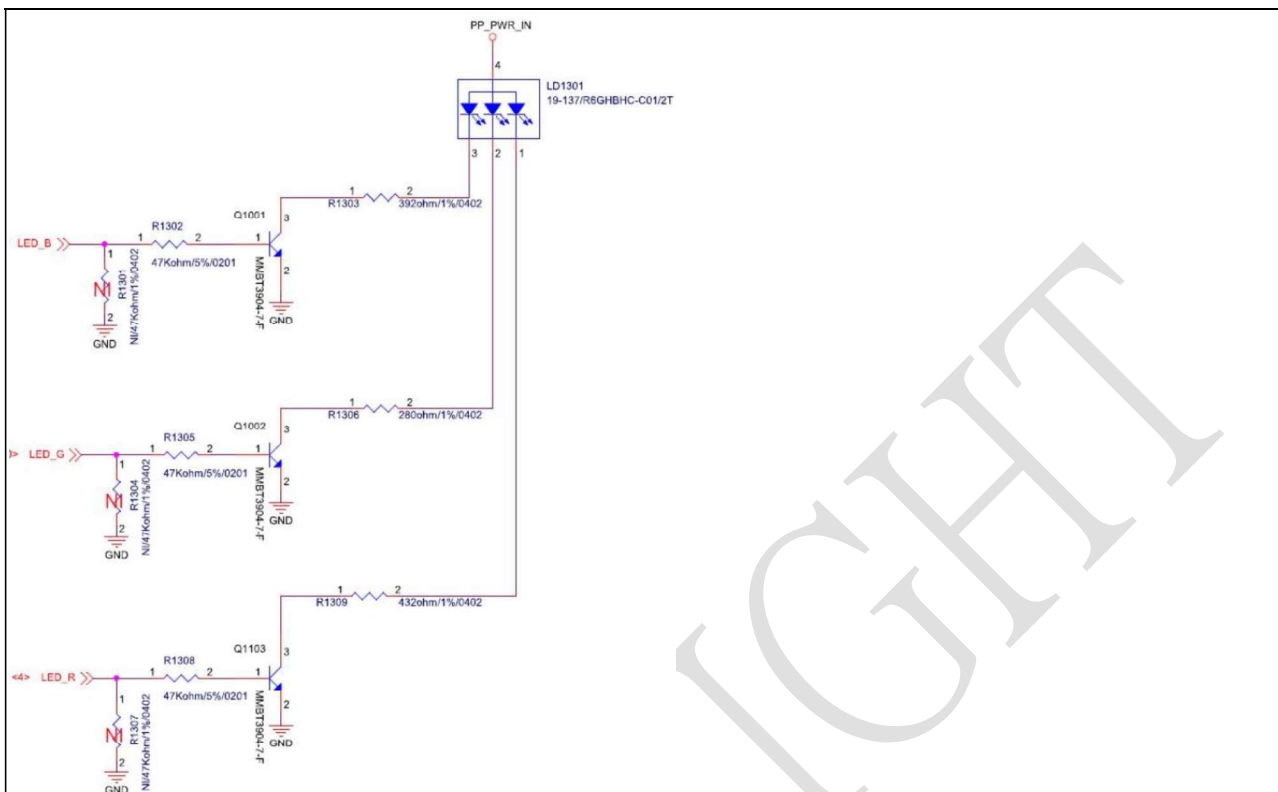
EL\_FAE and Foxconn discuss the design of the circuit. The circuit is as follows:

Verify that there is no reverse bias in the circuit ---- eliminate the problem of using reverse voltage °

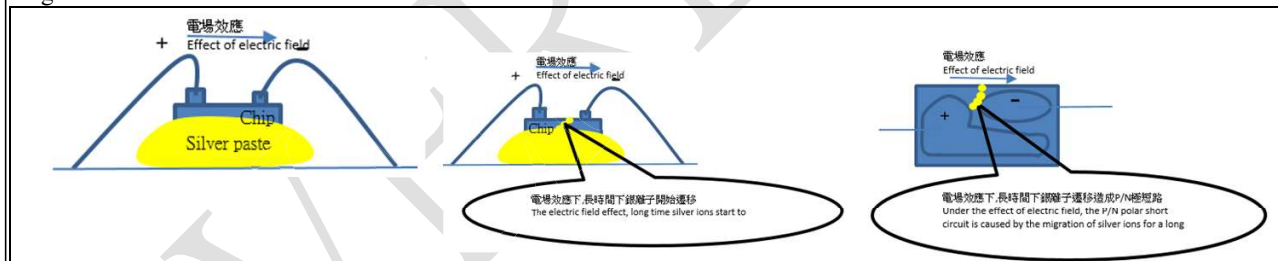
According to the EDX test results:

It is speculated that the reason may be that the amount of Silver paste is high and the migration of silver ions occurs after a long time of electric field effect.
