# Failure Analysis Report

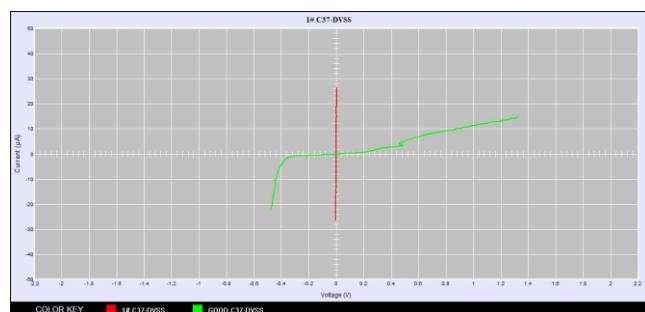
#1 USBOTG\_B\_DM(C37)-Gnd Short

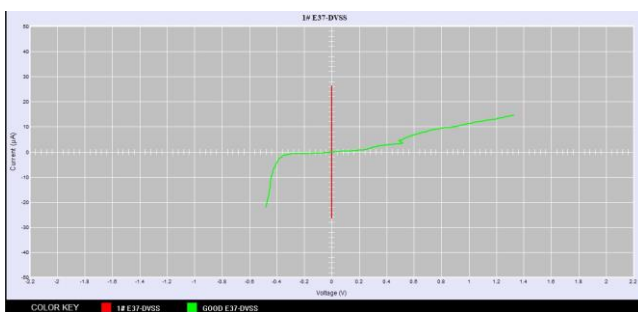
#1 USBOTG\_B\_DP(E37)-Gnd Short

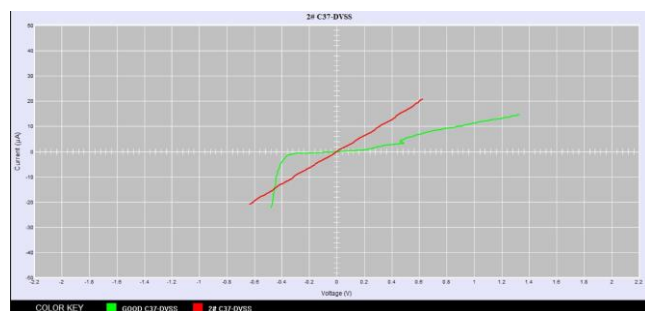
#2 USBOTG\_B\_DM(C37)-Gnd Leakage

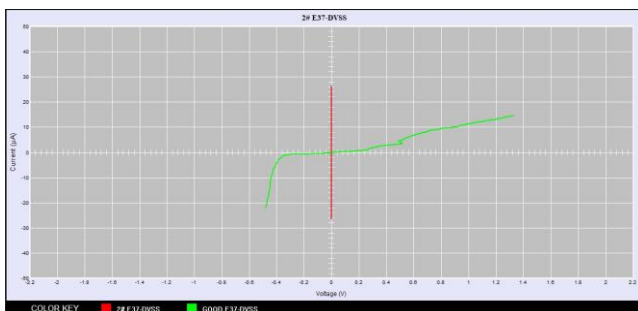
#2 USBOTG\_B\_DP(E37)-Gnd Short

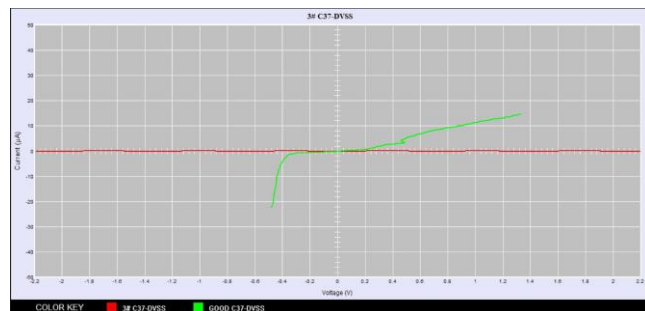
#3 USBOTG\_B\_DM(C37)-Gnd Open

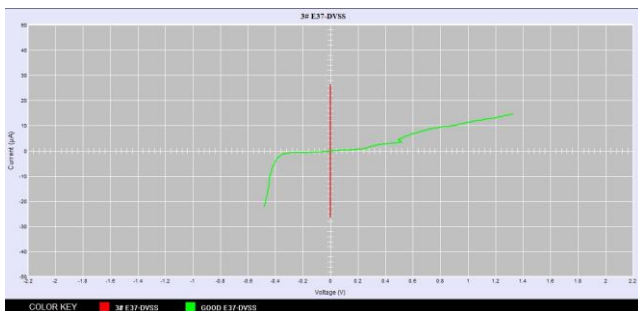
#3 USBOTG\_B\_DP(E37)-Gnd Short

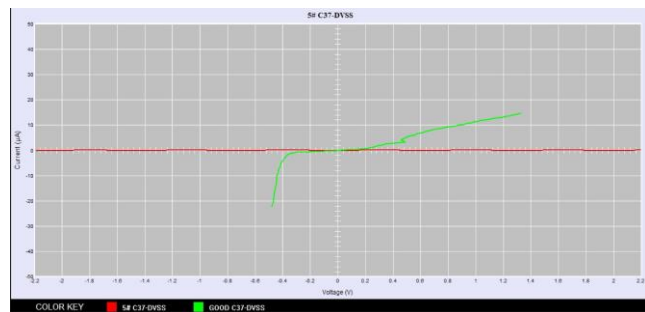
#5 USBOTG\_B\_DM(C37)-Gnd Open

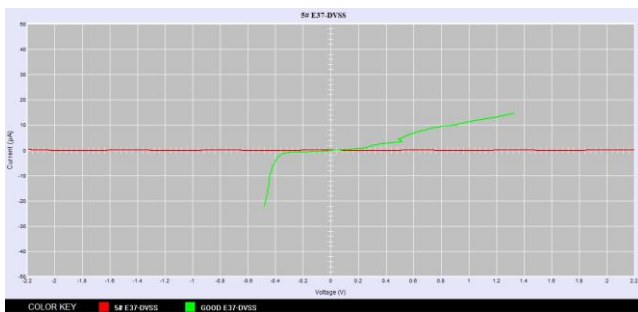
#5 USBOTG\_B\_DP(E37)-Gnd Open

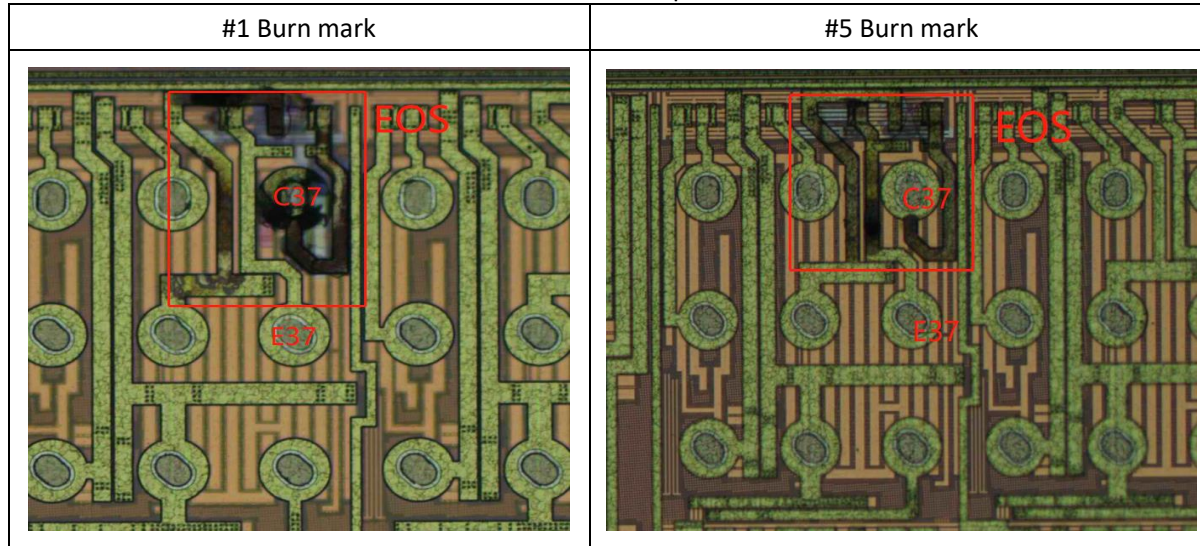
There was observed burn mark on the die surface of the chip.

1. All chips passed visual inspection.
2. All chips passed SAT except chip #2 and chip #3. The chip #2 and #3 were observed delamination.
3. Measured impedance abnormal from USBOTG\_B pins (C37/E37) to ground on the socket board except chip #4.
4. All chips failed FT with Open/Short and were observed USBOTG\_B pins O/S through the IV-Curve test except chip #4.  
The chip #4 failed function item and no observed O/S pins.
5. The chip #1 and #5 were observed burn mark on the die surface due to EOS.

Based on FA result, the returned chips were observed Pins Open/Short due to EOS except chip #4.  
The chip #4 was damaged by external stress factor(s) that are beyond the self-protection capabilities of the SoC.  
The chips went through 100% FT before shipment and the failed chips can be screened by FT.
