# FAILURE ANALYSIS REPORT

## ( KLM8G1GETF-B041)

For: FOXCONN TECHNOLOGY CO., LTD-TW

Aug 22, 2024

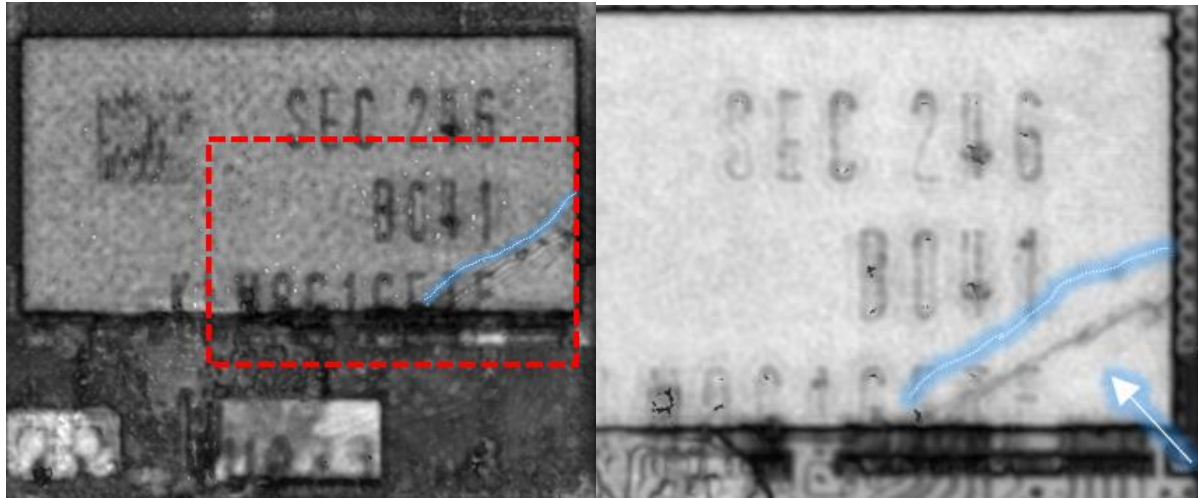
| S/N | Customer S/N | W/C | Lot No | Failure Information | Analysis Result |
|---|---|---|---|---|---|
| 5 | 5 | 246 | NUAZ9LHR | | Mechanical Damage |

| S/N | Customer S/N | DC Test | | |
|---|---|---|---|---|
| 5 | 5 | PASS | PASS | FAIL |

| S/N | Customer S/N | W/C | Lot No | Initialization Test Results | FW Analysis Results |
|---|---|---|---|---|---|
| 5 | 5 | 246 | NUAZ9LHR | FAIL | NAND ID Read Fail |

[Sample #5] – Chip Crack

Based upon our analysis, the returned unit(s) was verified as initial failure due to mechanical damage cause by some external stress (Handling mistake, etc.). This type of mechanical damage problem can come from handling mistake in user site. We have already done continuous education for the people in production line to deal with device carefully so that we can eliminate damage possibility. Thus, we believe it is low possibility that this problem happens during our packing process. Also, we kindly ask careful handling for this product at your site.
